# VEHICLE INSPECTION REPORT

**GK70ASZ**

## Audi A3 30 TFSI S Line 5dr

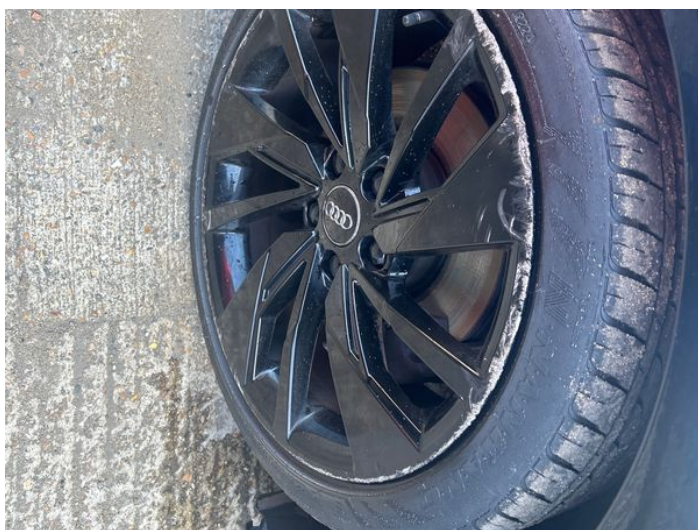
1: Wheel osf  
Scratched  
Over 50mm

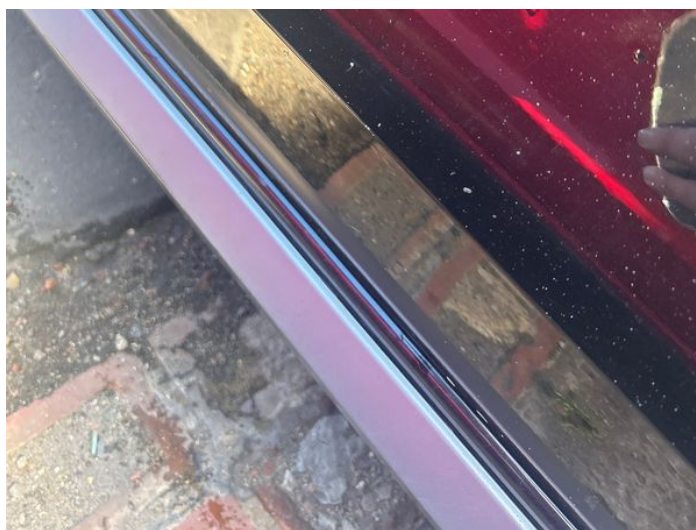
2: Door osf  
Chipped  
1 To 5

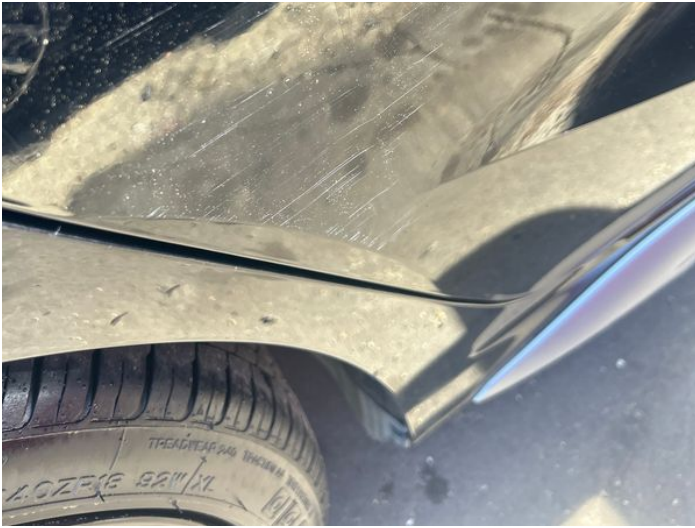
3: Door osr  
Scratched  
Over 25mm Thru Paint

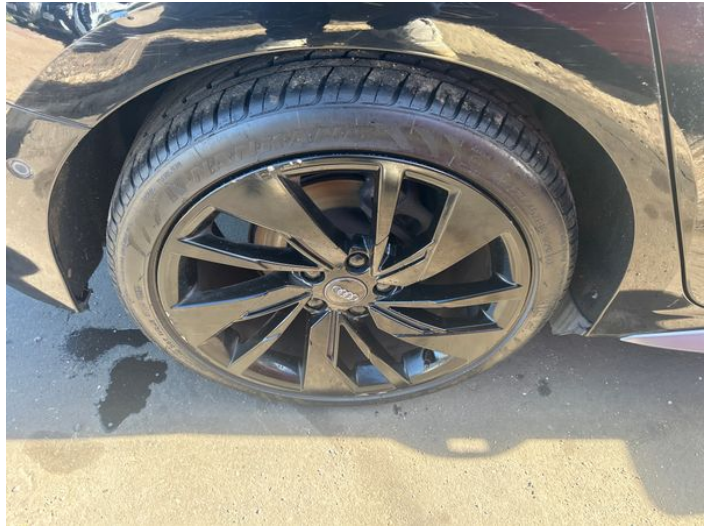
4: Wheel osr  
Scratched  
Over 50mm

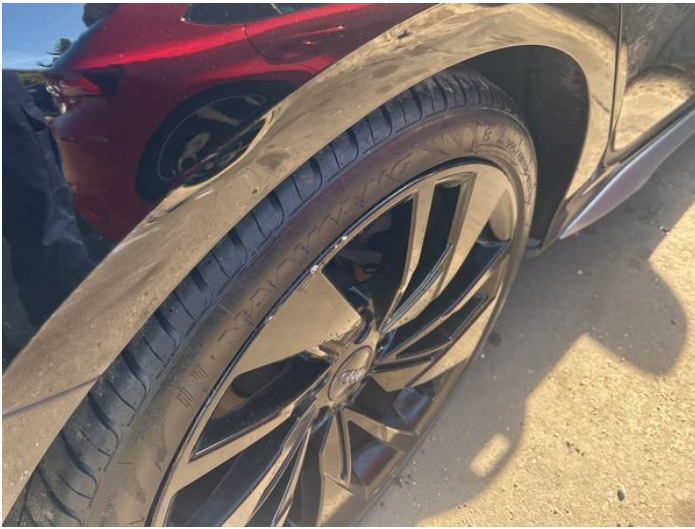
5: Qtr Panel osr  
Dented  
With Paint Damage

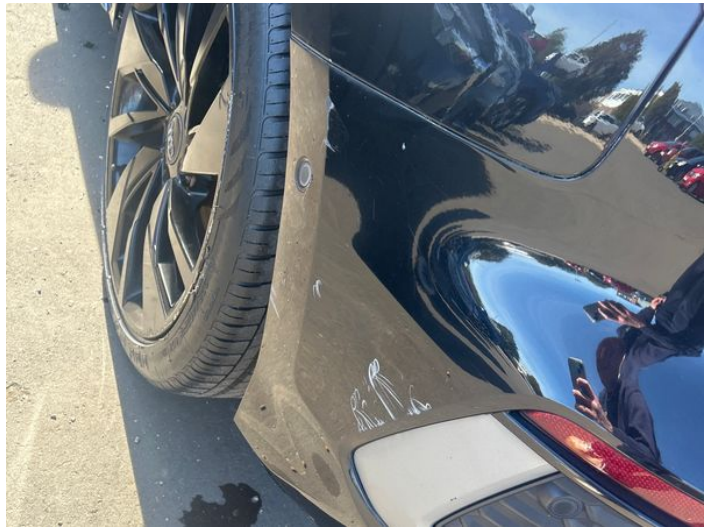
6: Bumper Rear  
Scratched  
Over 100mm Thru Paint

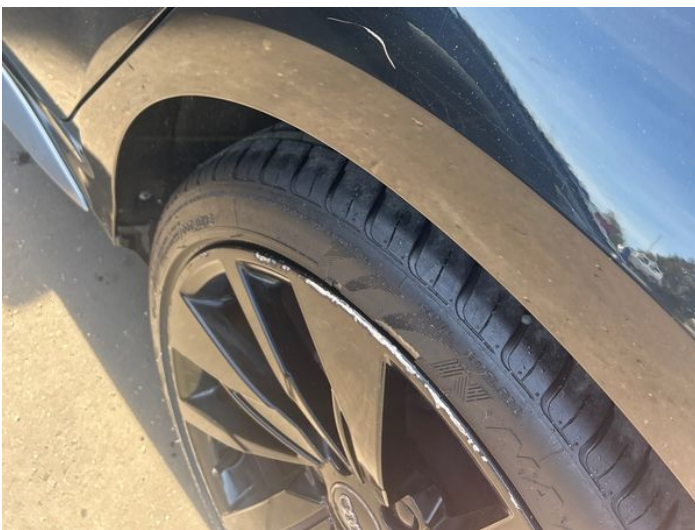
7: Qtr Panel nsr  
Scratched  
Over 25mm Thru Paint

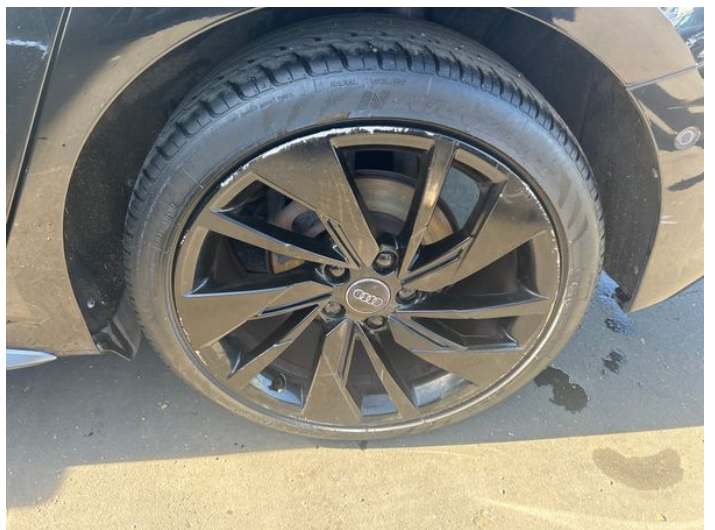
8: Wheel nsr  
Scratched  
Over 50mm

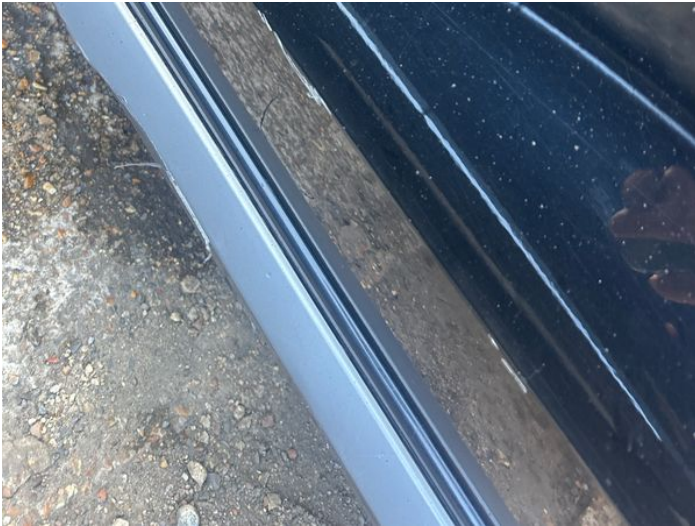
9: Door nsf  
Scratched  
Over 25mm Thru Paint

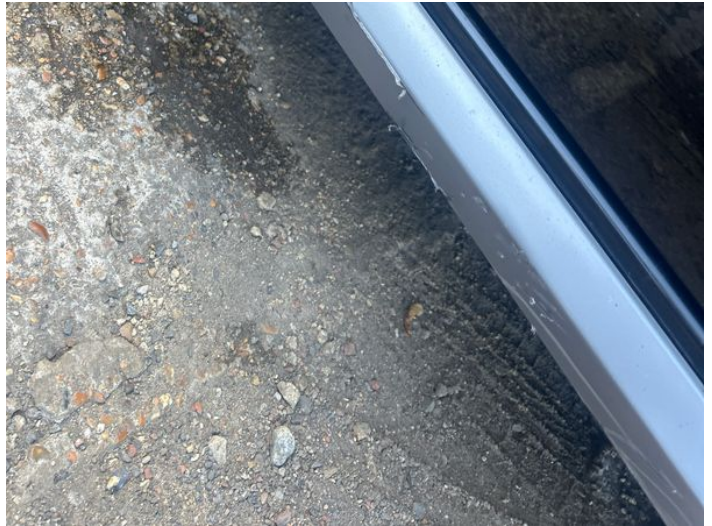
10: Sill Panel Trim ns  
Scratched (Painted)  
Over 25mm Thru Paint

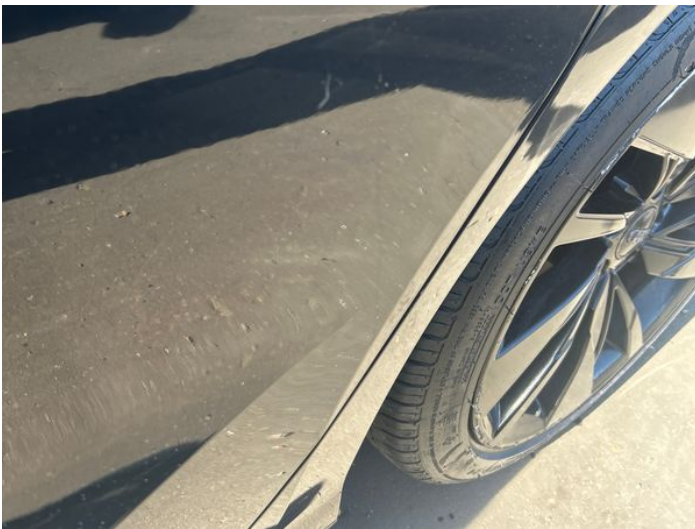
11: Door nsr  
Scratched  
UpTo 25mm Thru Paint

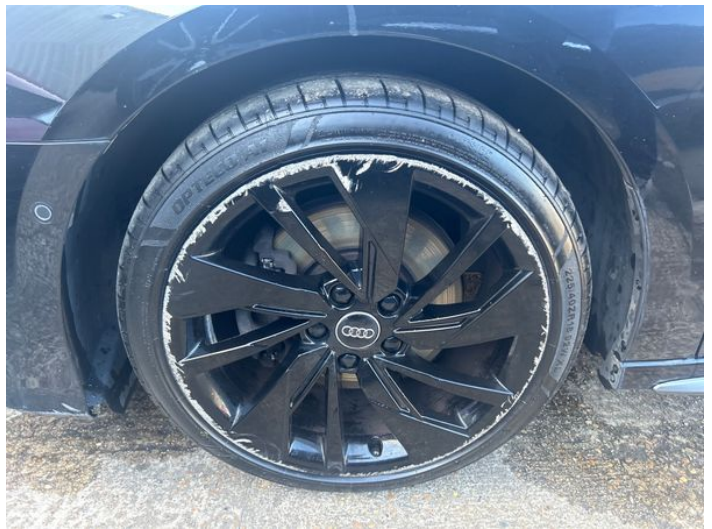
12: Wheel nsf  
Scratched  
Over 50mm

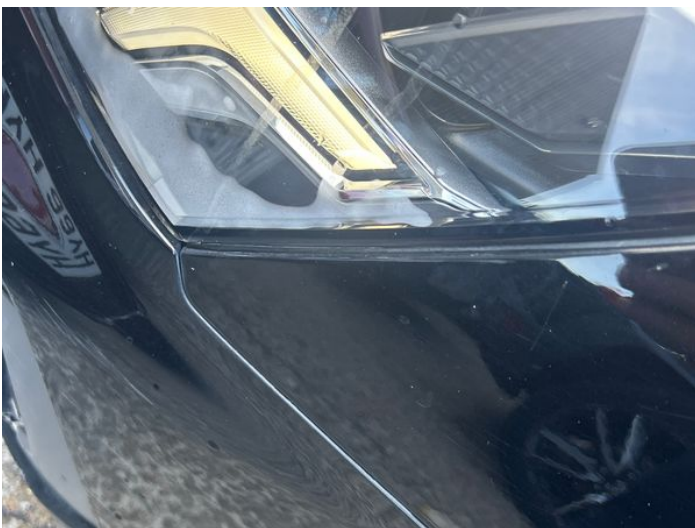
13: Wing nsf  
Chipped  
1 To 5

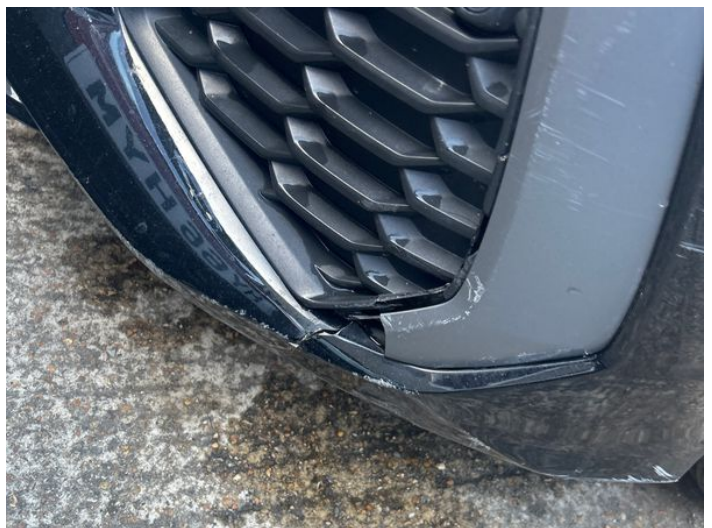
14: Bumper Front  
Cracked  
Over 25mm

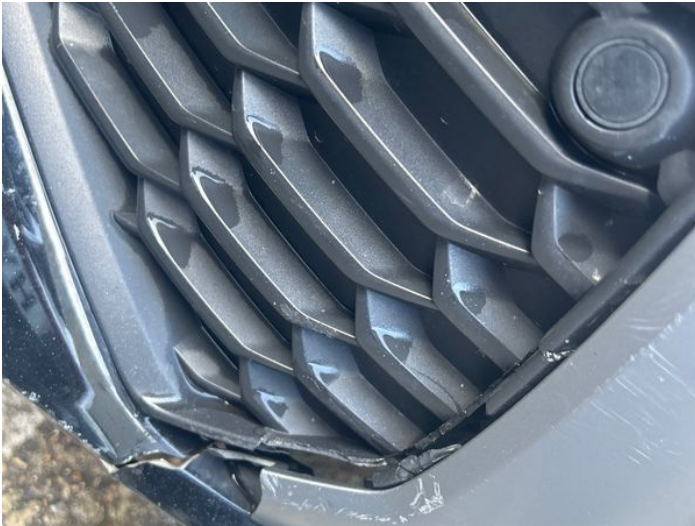
15: Bumper Front Grill  
Broken  
Replace

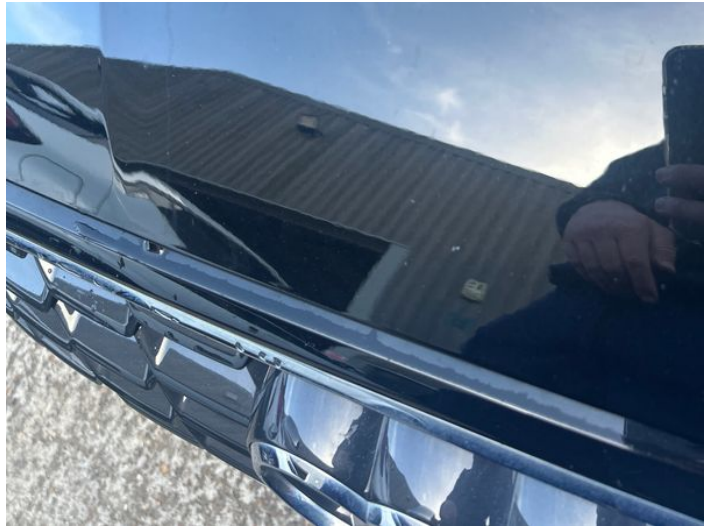
16: Bonnet  
Chipped  
1 To 5

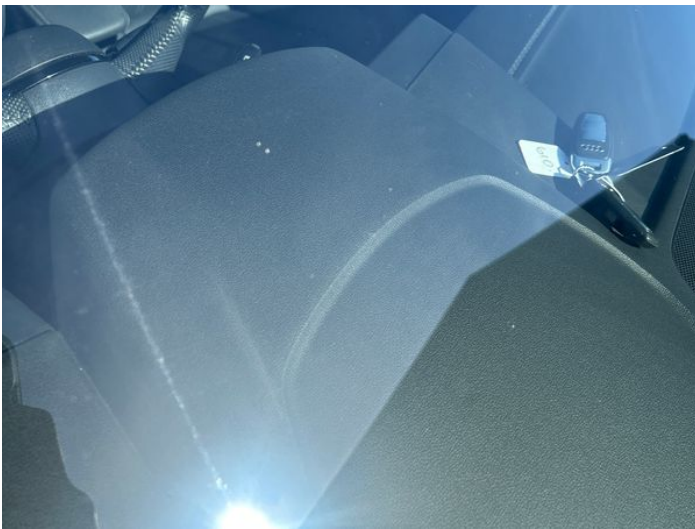
17: Screen Front  
Chipped  
UpTo 10mm

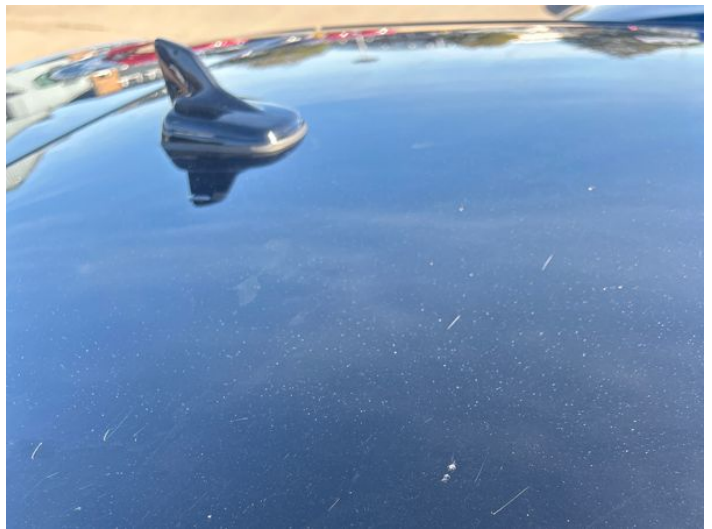
18: Roof  
Scratched  
Over 25mm Thru Paint

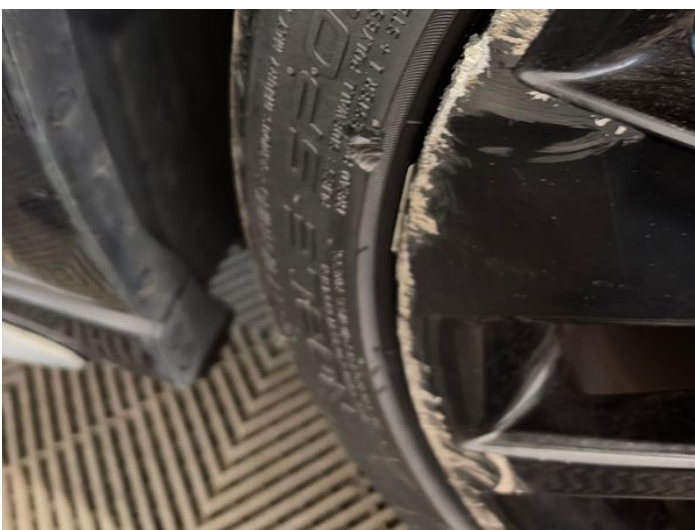
| OSF | NANKANG | Damaged |

19: Tyre osf  
Damaged  
Replace
