# VEHICLE INSPECTION REPORT

**GD18VGV**

## Audi A3 1.5 TFSI S Line 4dr

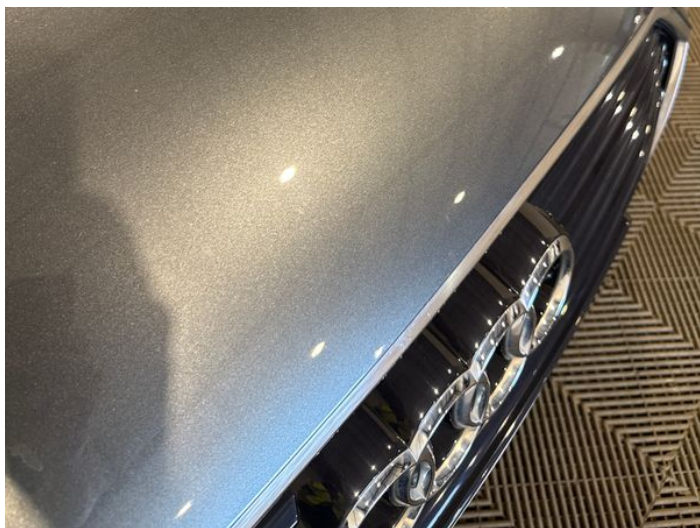
1: Bonnet  
Chipped  
1 To 5

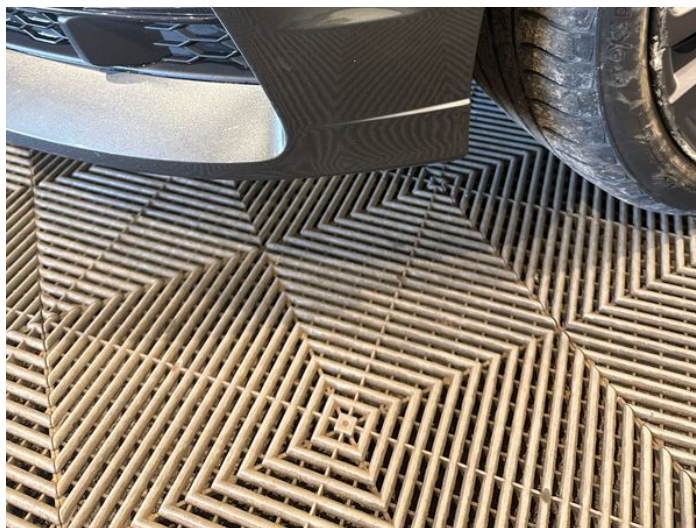
2: Bumper Front  
Scratched  
25 to 100mm Thru Paint

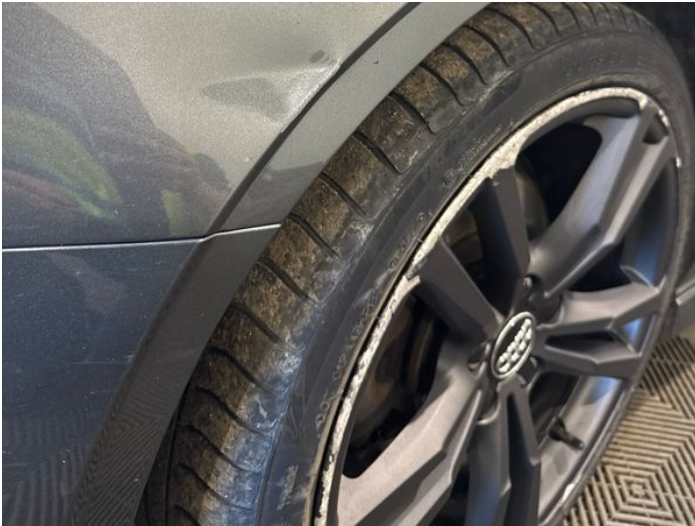
3: Wing nsf  
Dented  
With Paint Damage

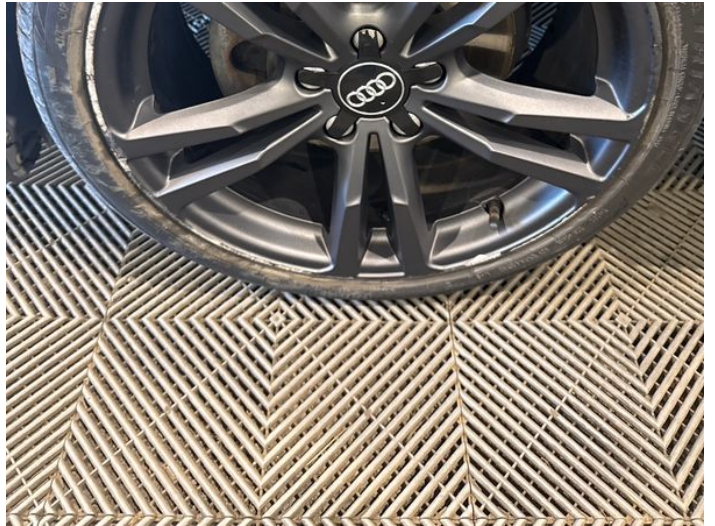
4: Wheel nsf  
Scratched  
Over 50mm

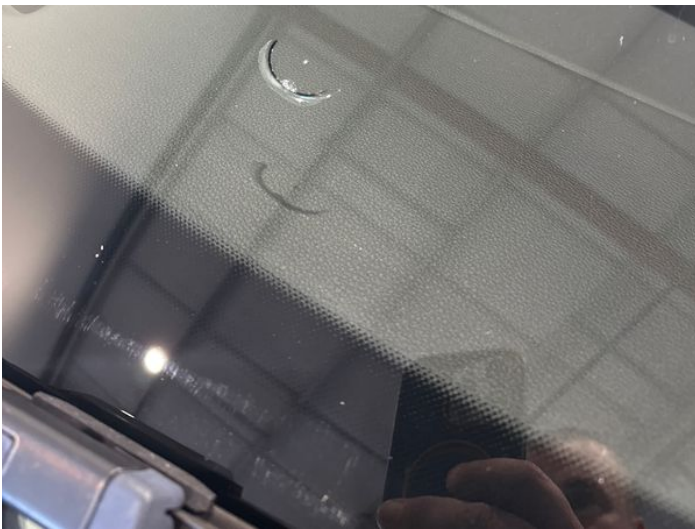
5: Screen Front  
Cracked  
Replace

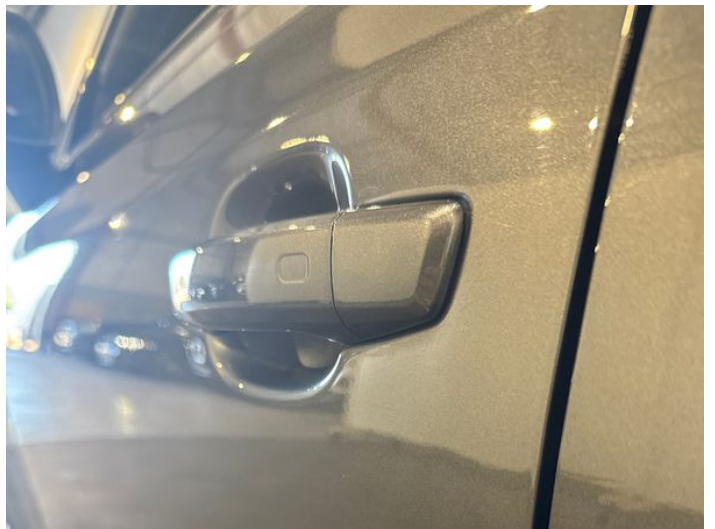
6: Door nsf  
Dented  
Between 10mm + 30mm

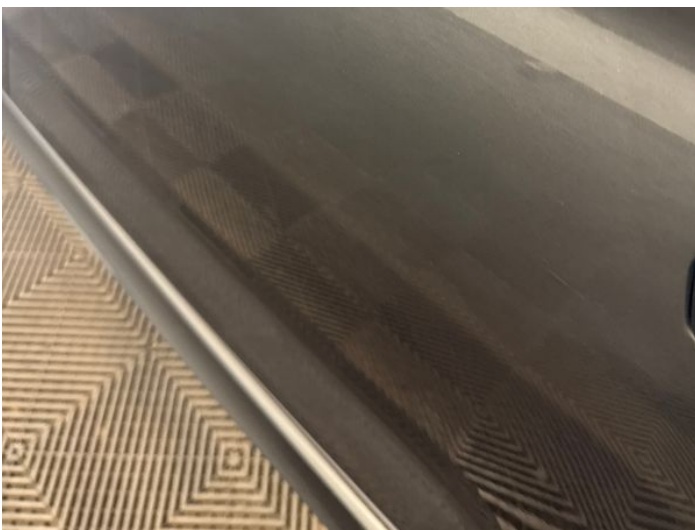
7: Door nsr  
Dented  
Between 10mm + 30mm

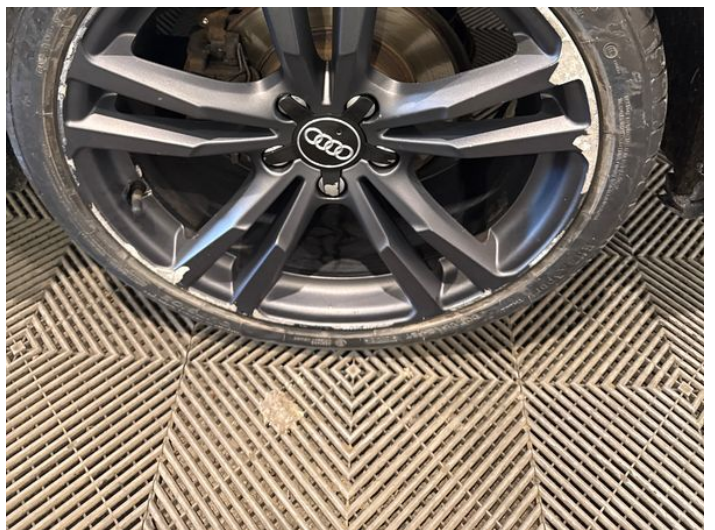
8: Wheel nsr  
Scratched  
Over 50mm

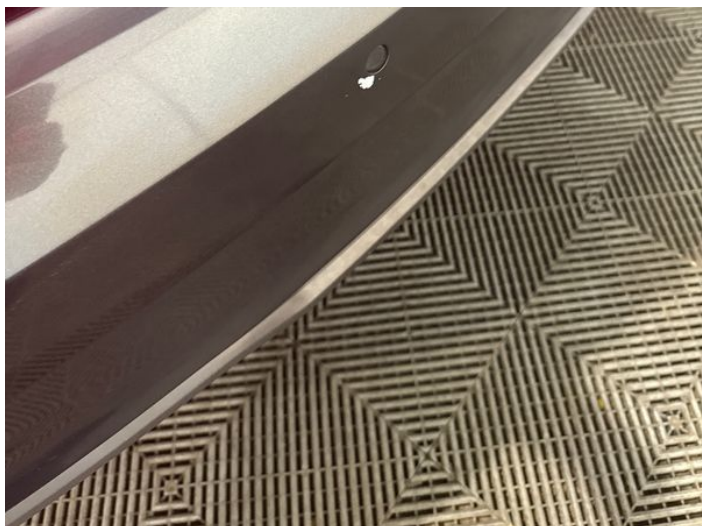
9: Bumper Rear  
Chipped  
Over 5mm

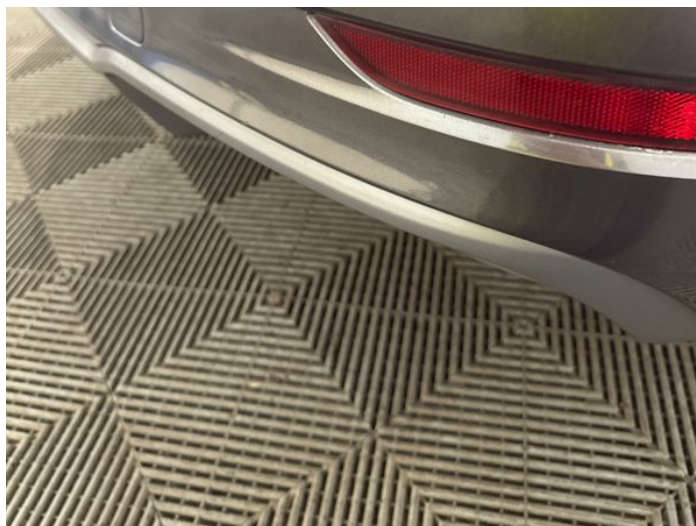
10: Bumper Rear  
Scratched  
25 to 100mm Thru Paint

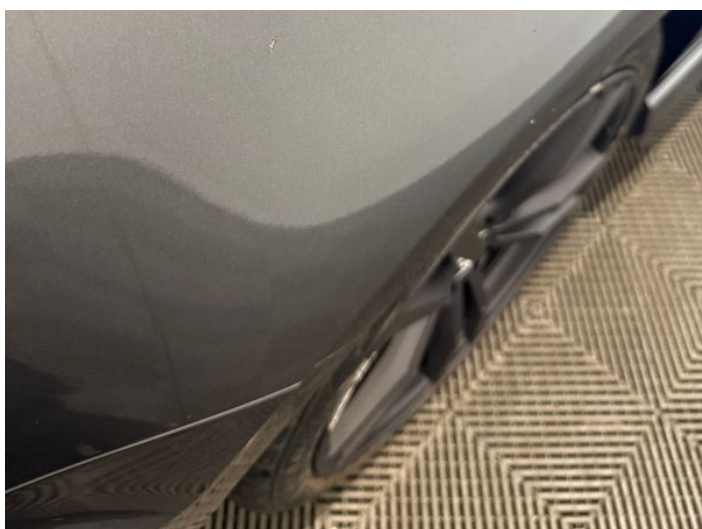
11: Qtr Panel osr  
Scratched  
UpTo 25mm Thru Paint

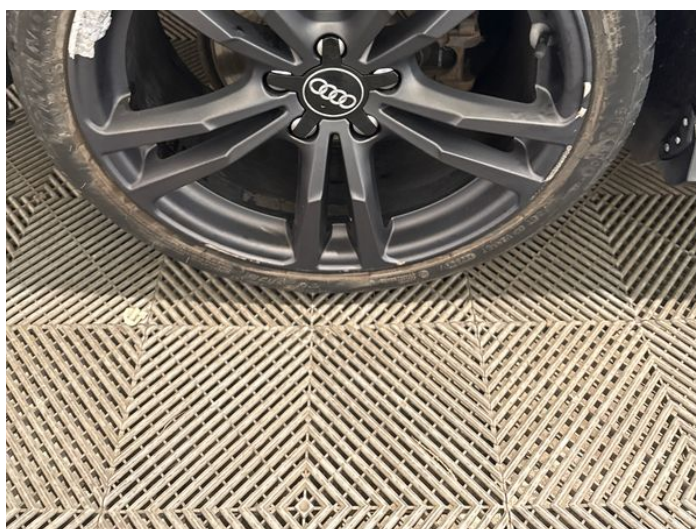
12: Wheel osr  
Scratched  
Over 50mm

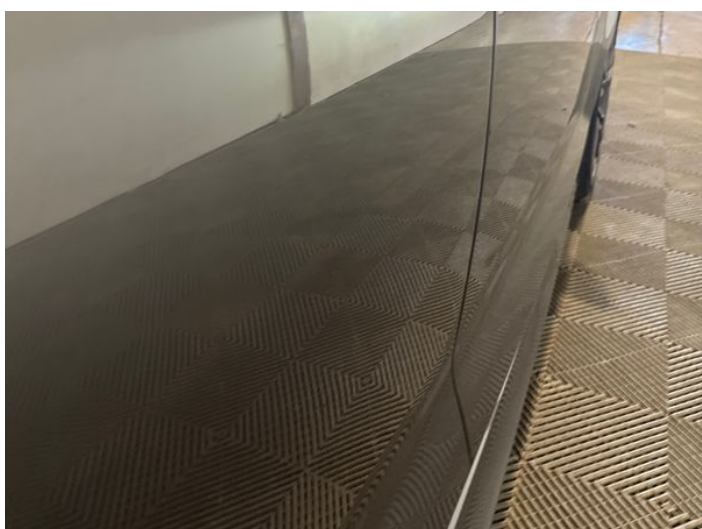
13: Door osr  
Poor Previous Repair  
Rippled UpTo 30%

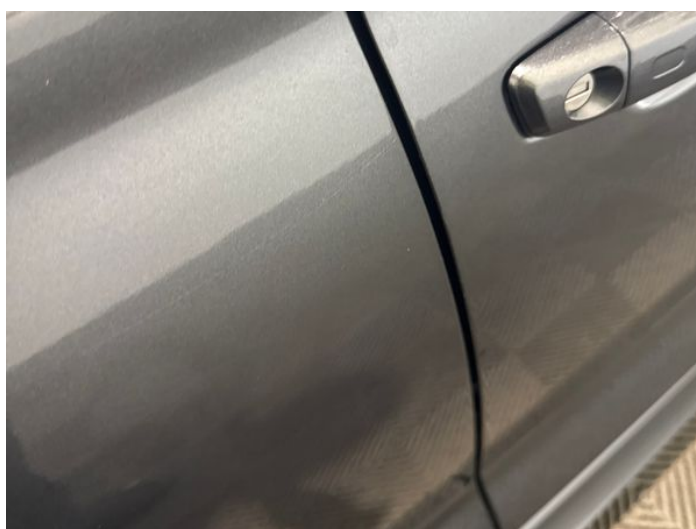
14: Door osr  
Scratched  
UpTo 25mm Thru Paint

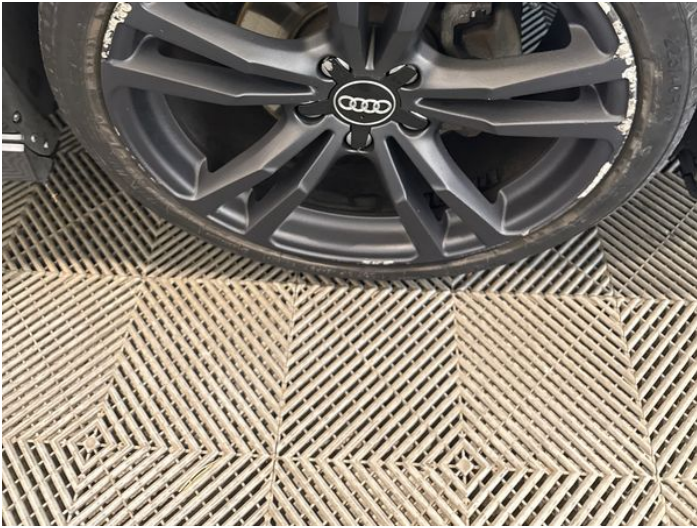
15: Wheel osf  
Scratched  
Over 50mm

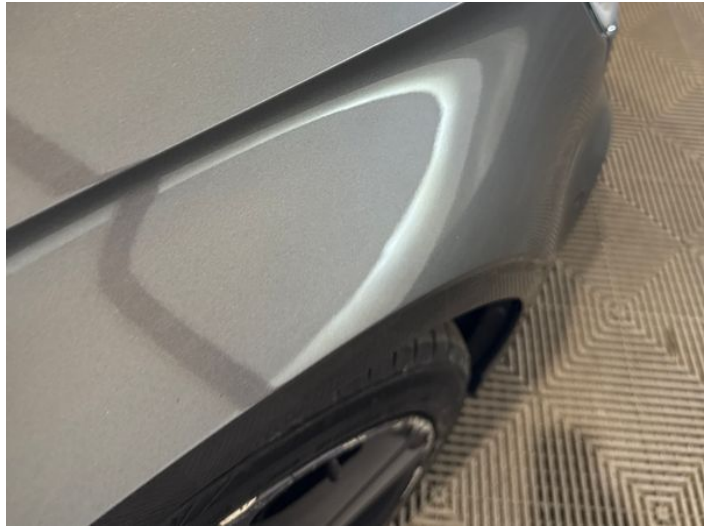
16: Wing osf  
Chipped  
1 To 5

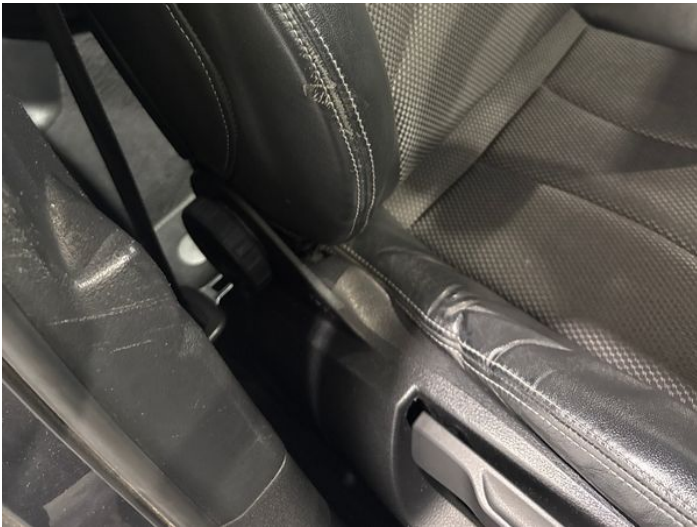
17: Seat Back Cover osf  
Scuffed  
Over 25mm

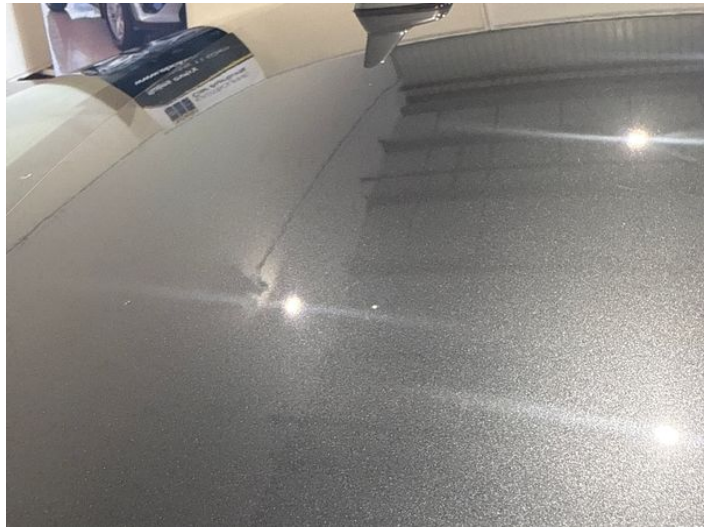
18: Roof  
Chipped  
1 To 5

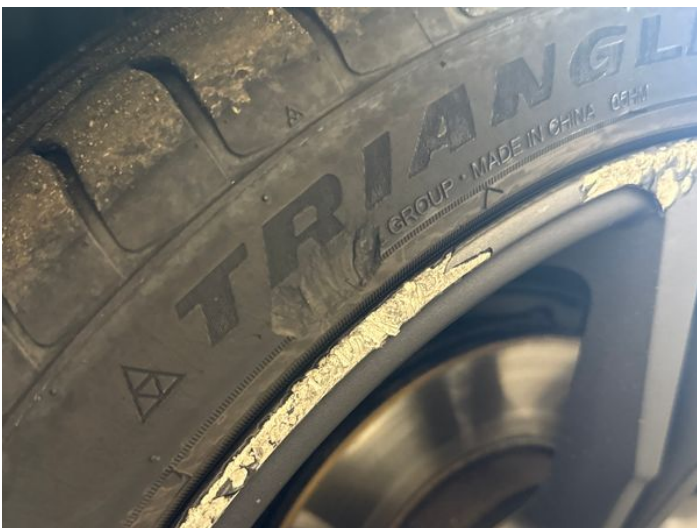
| OSF | TRIANGLE | Damaged |

19: Tyre osf  
Damaged  
Replace

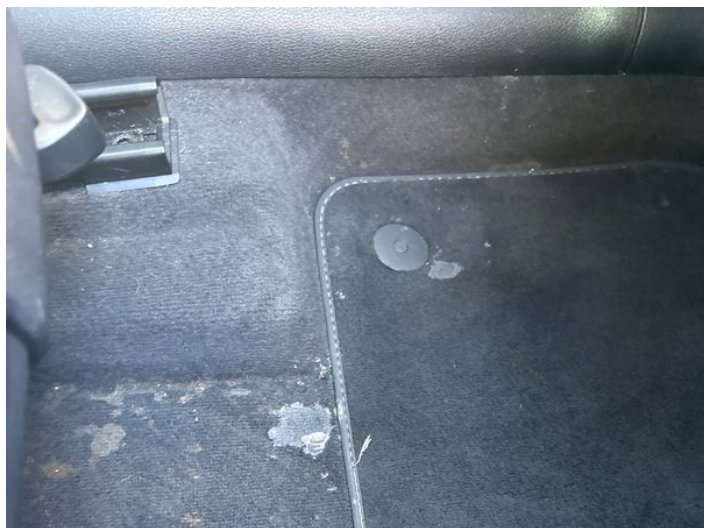
20: Carpets Front  
Soiled  
Light
