## VEHICLE INSPECTION REPORT

**GN66NSZ**

### Citroen C4 Picasso 1.6 BlueHDi Flair 5dr EAT6

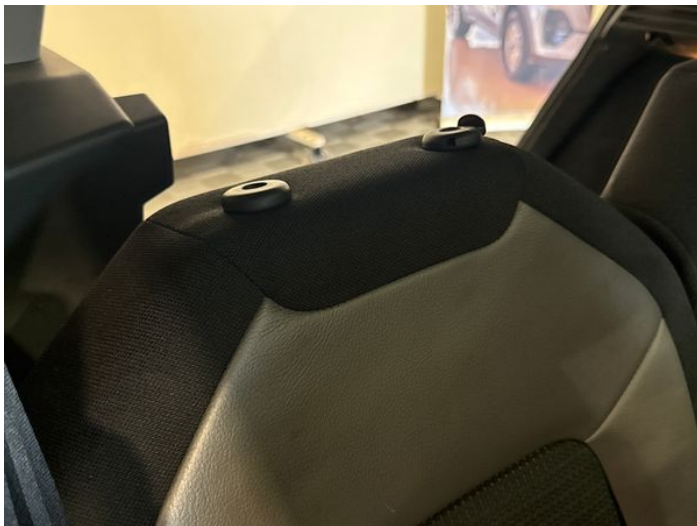
1: Headrest Assy Rear Seat os  
Missing  
Replace

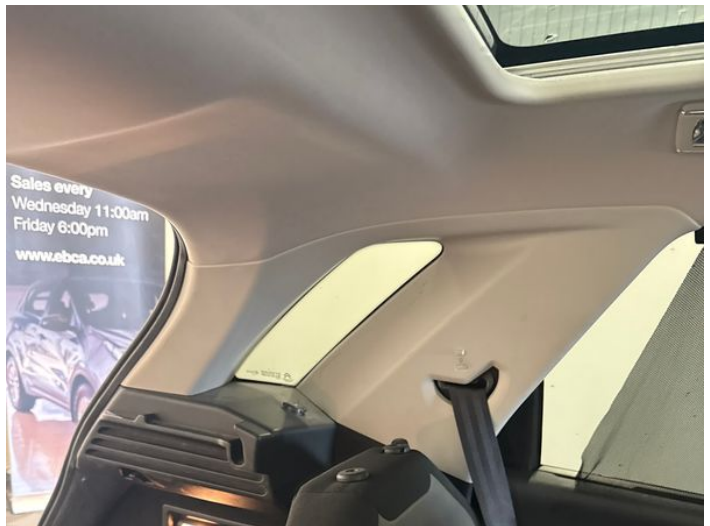
2: Headrest Assy Rear Seat ns  
Missing  
Replace

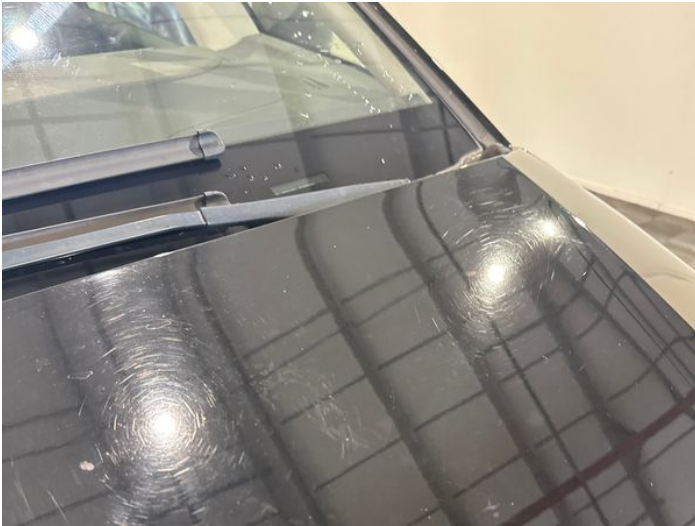
3: Bonnet  
Scratched  
Over 25mm Thru Paint

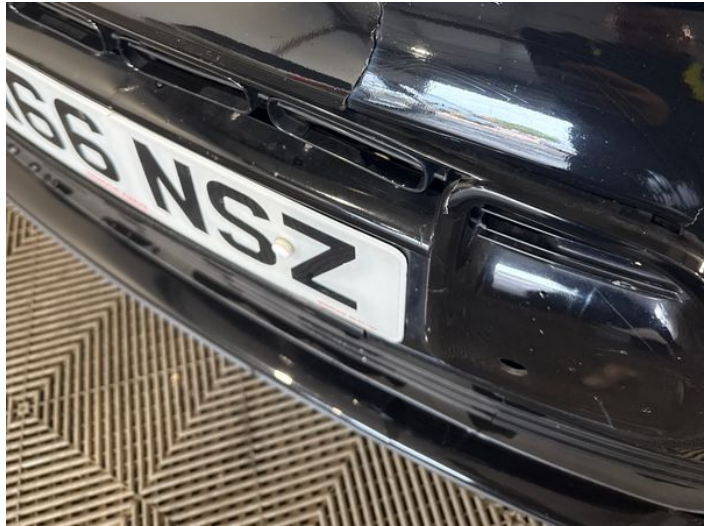
4: Bumper Front  
Cracked  
Over 25mm

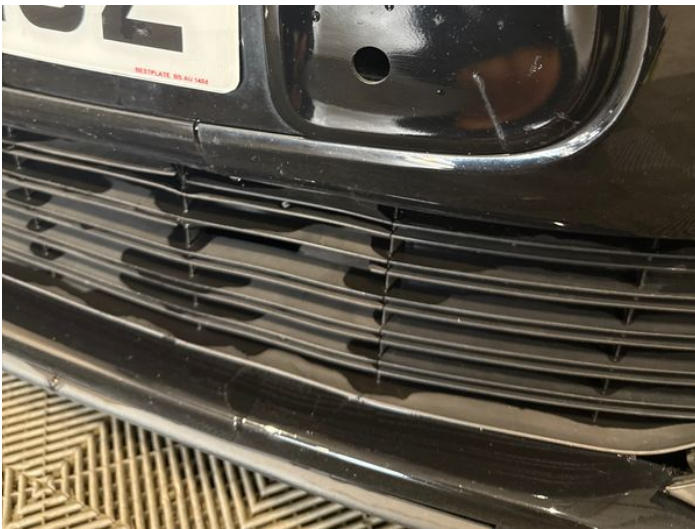
5: Parking Sensor Front  
Missing  
Replace

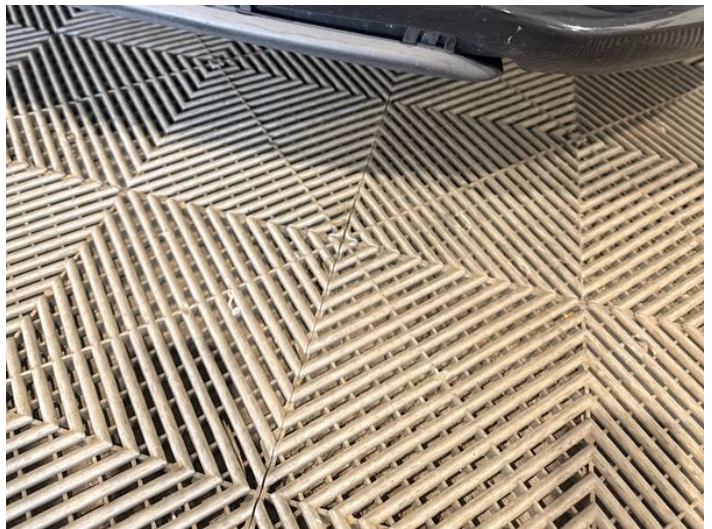
6: Bumper Front Moulding  
Broken  
Replace

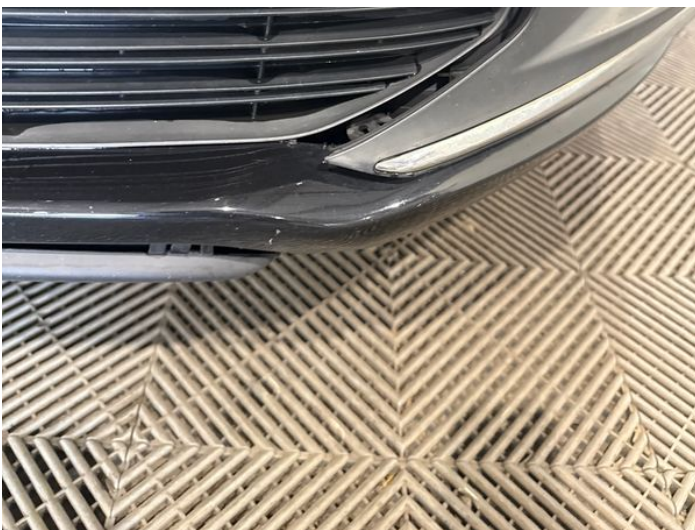
7: Bumper Front Grill  
Broken  
Replace

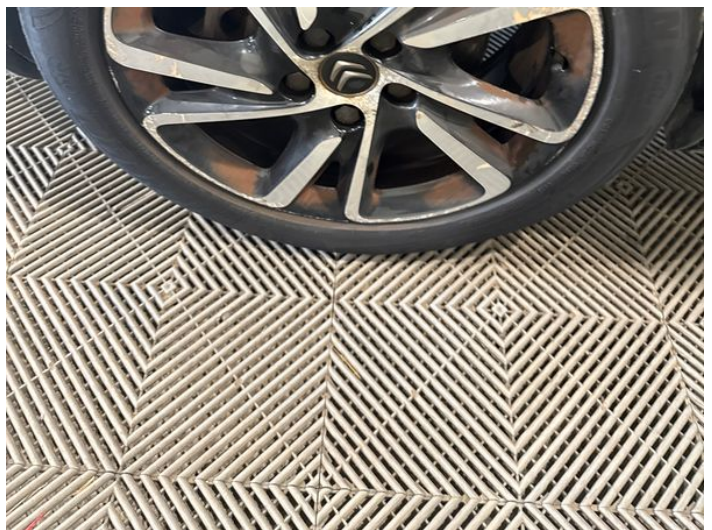
8: Wheel nsf  
Scratched  
Over 50mm

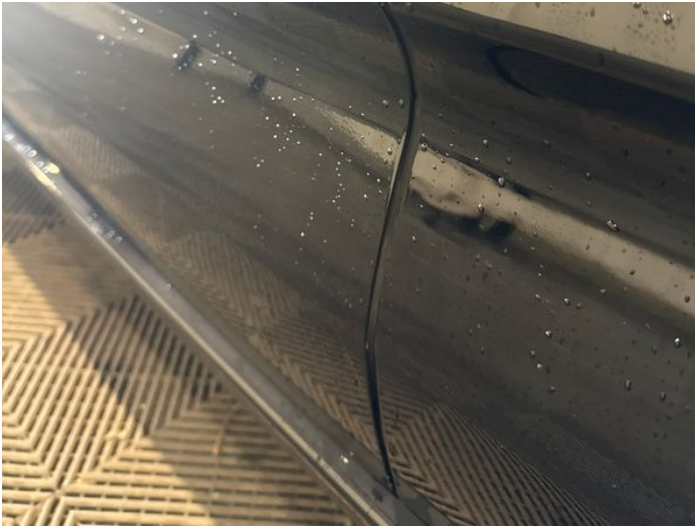
9: Door nsf  
Chipped  
Edge Chip

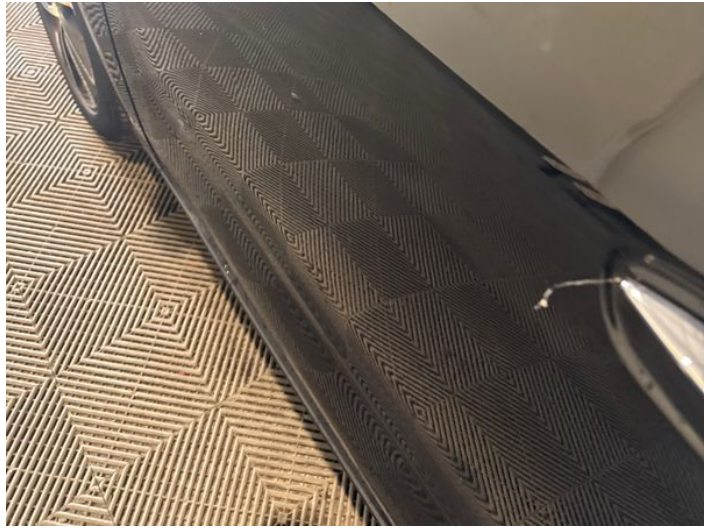
10: Door nsf  
Dented  
Over 30mm

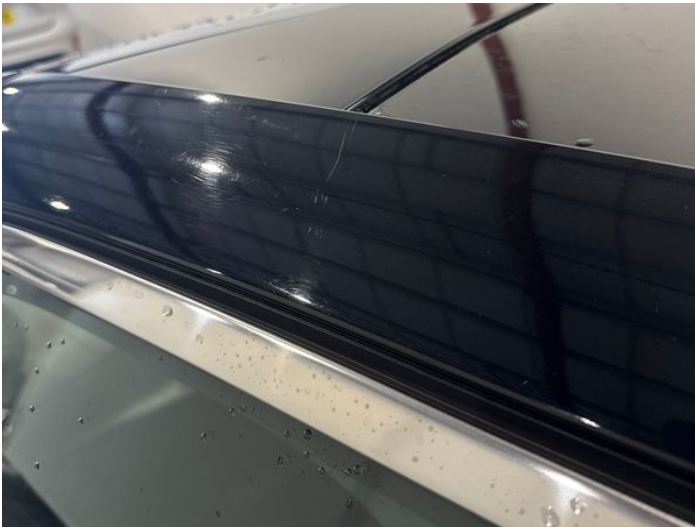
11: A Post ns  
Scratched  
UpTo 25mm Thru Paint

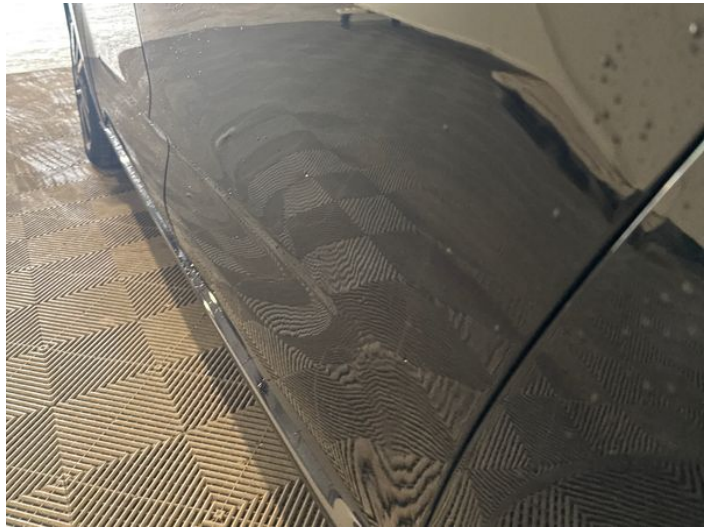
12: Door nsr  
Poor Previous Repair  
Rippled UpTo 30%

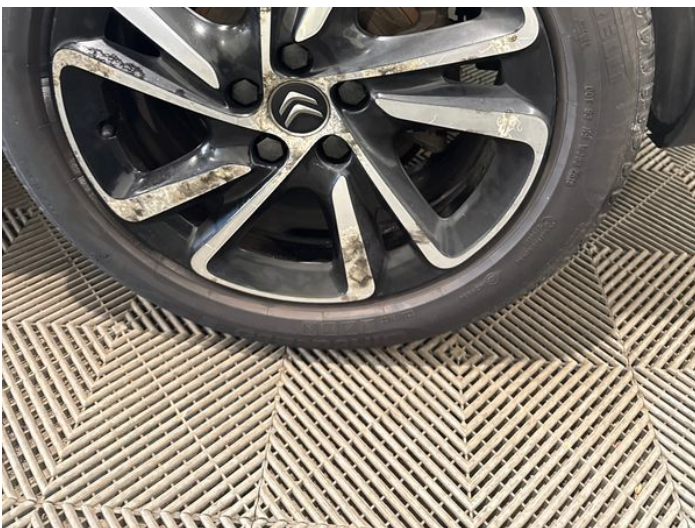
13: Wheel nsr  
Scratched  
Over 50mm

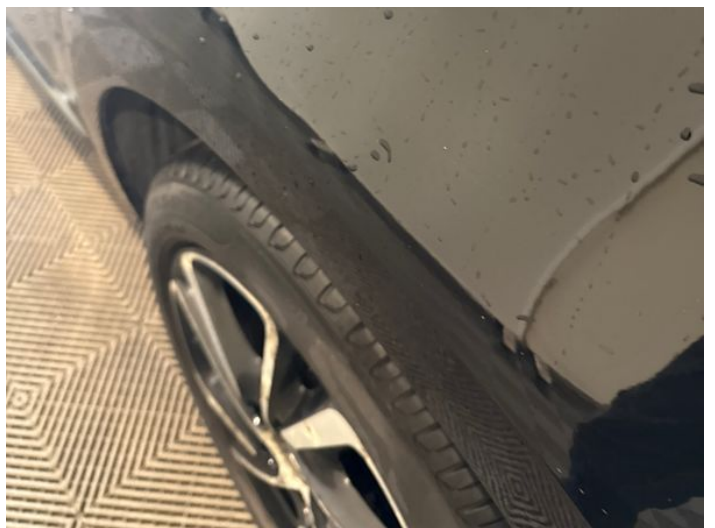
14: Qtr Panel nsr  
Dented  
Over 30mm

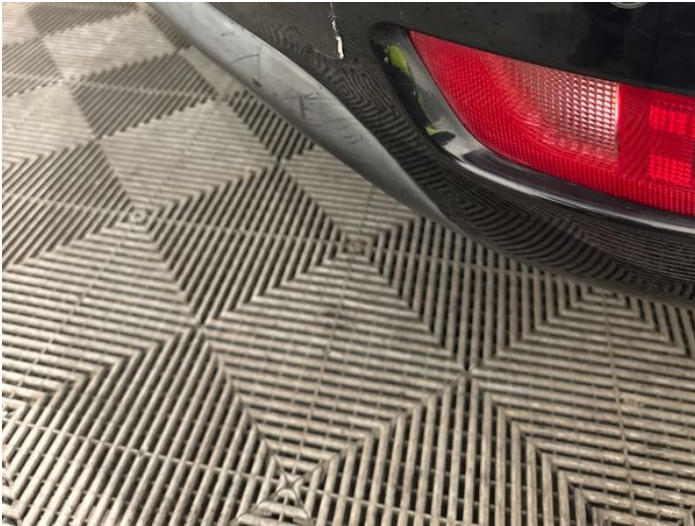
15: Bumper Rear  
Cracked  
Over 25mm

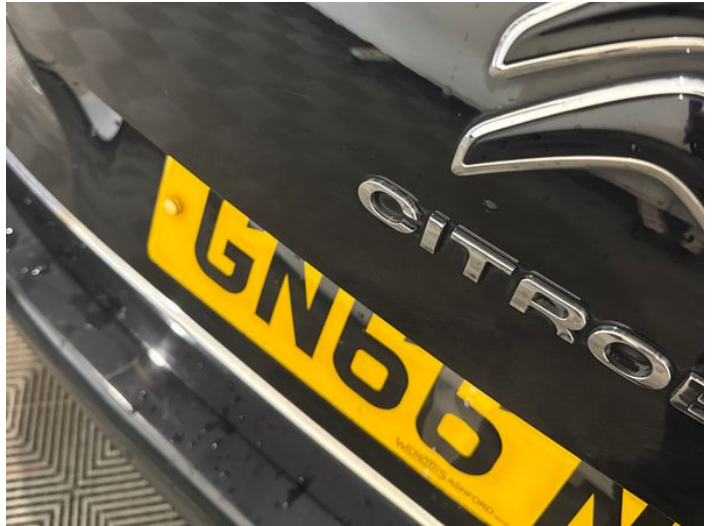
16: Tailgate  
Scratched  
UpTo 25mm Thru Paint

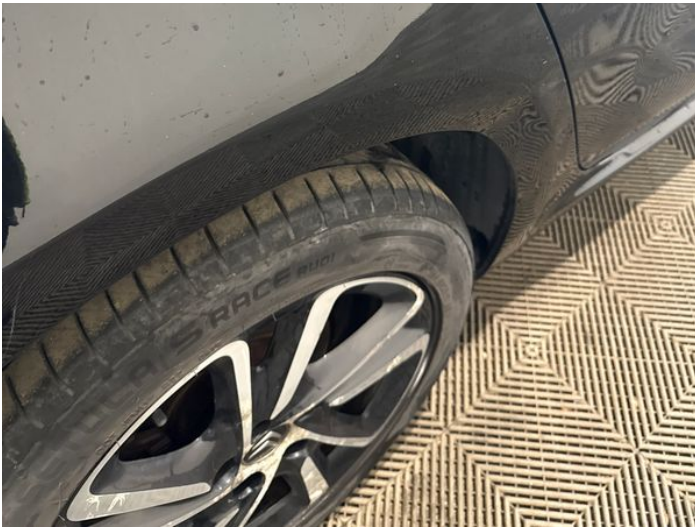
17: Qtr Panel osr  
Dented  
With Paint Damage

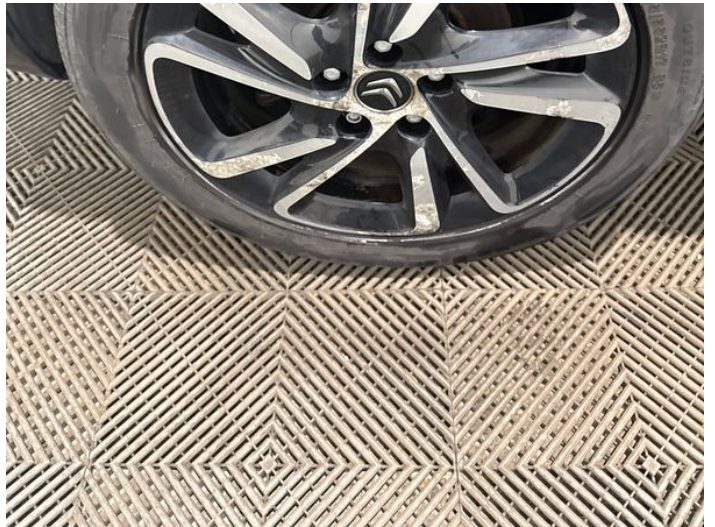
18: Wheel osr  
Scratched  
Over 50mm

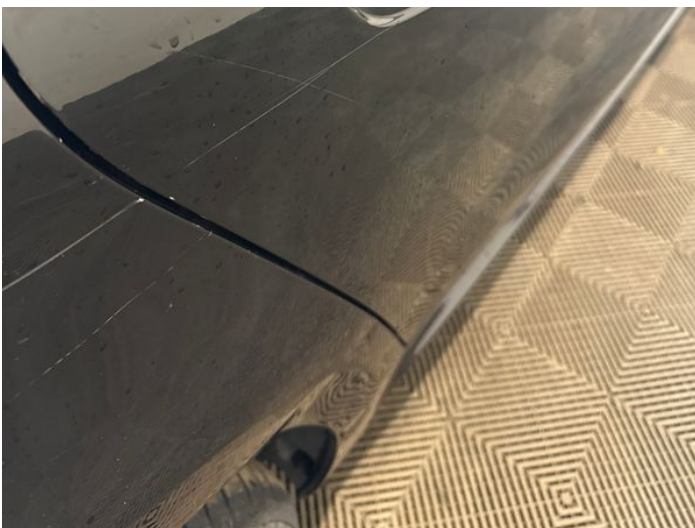
19: Door osr  
Scratched  
Over 25mm Thru Paint

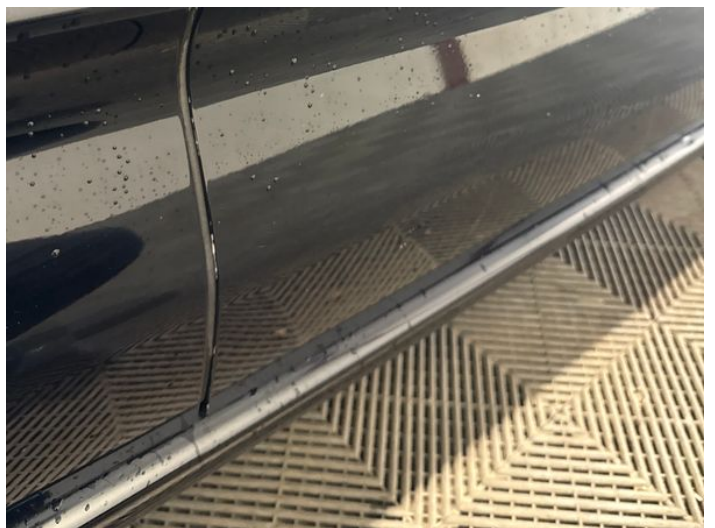
20: Door osf  
Chipped  
Edge Chip

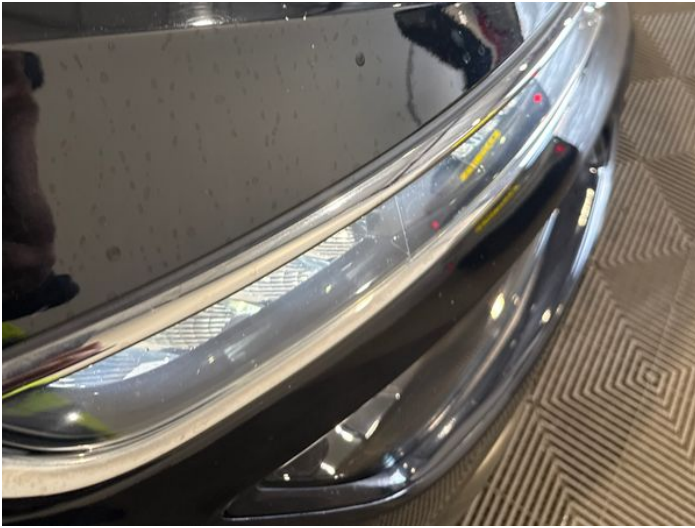
21: Wing osf  
Chipped  
1 To 5

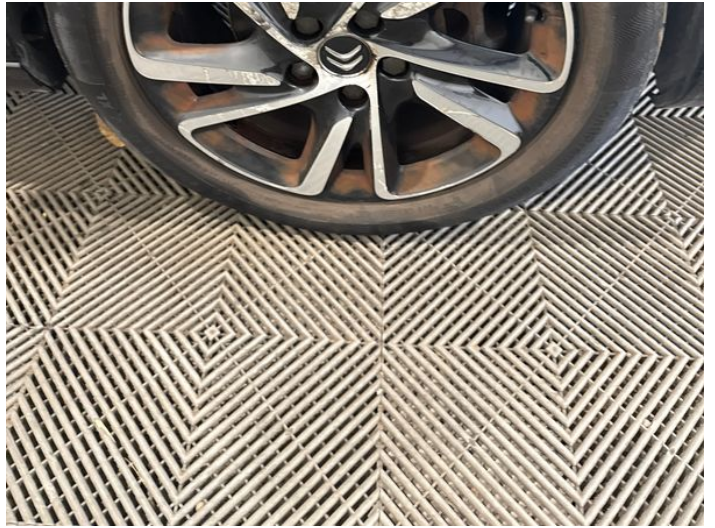
22: Wheel osf  
Scratched  
Over 50mm

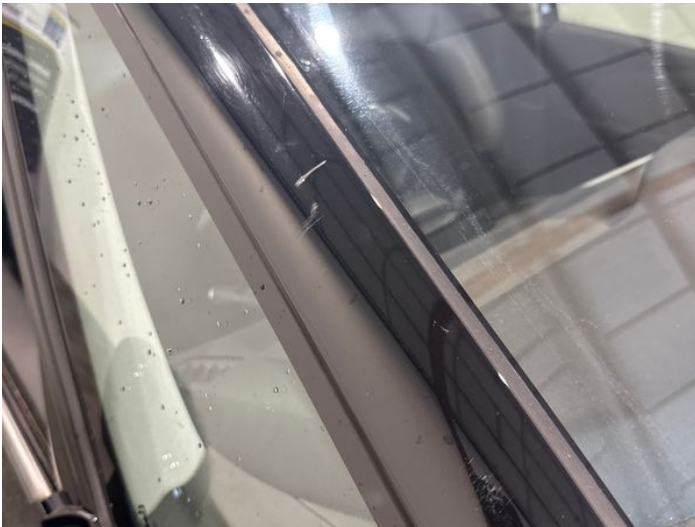
23: A Post os  
Scratched  
Over 25mm Thru Paint

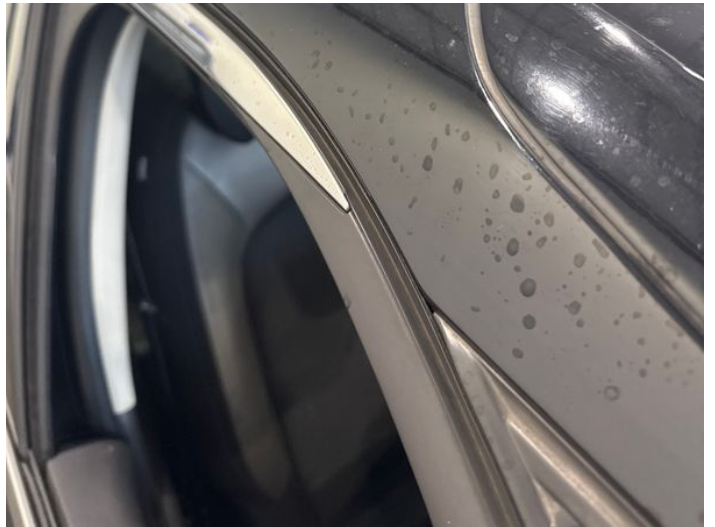
24: A Post os  
Dented  
Between 10mm + 30mm

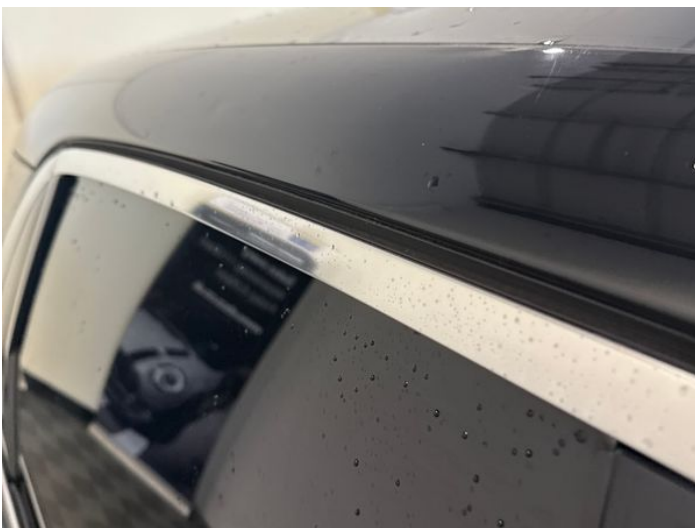
25: B Post os  
Dented  
Between 10mm + 30mm

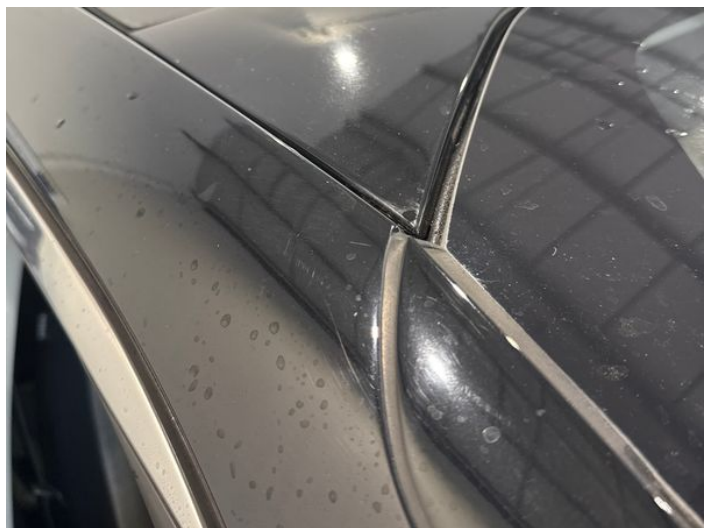
26: Roof  
Dented  
Over 30mm
