# VEHICLE INSPECTION REPORT

**EA63WTL**

## Volkswagen Golf 1.6 TDI 105 SE 5dr

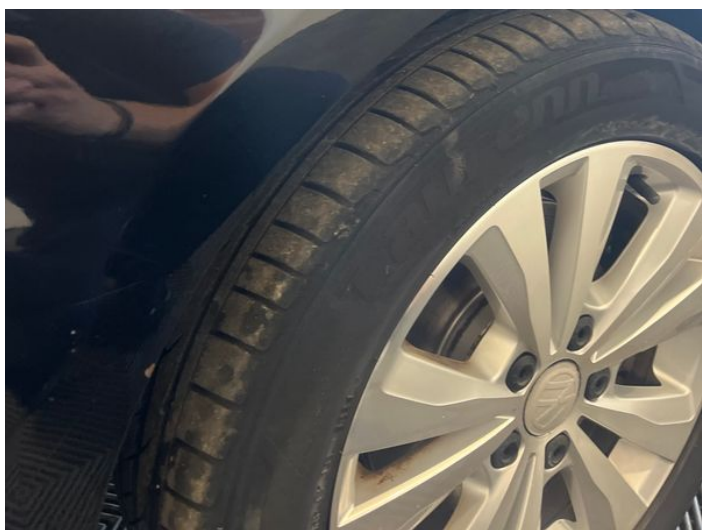
1: Wing of  
Poor Previous Repair  
Poor Paint

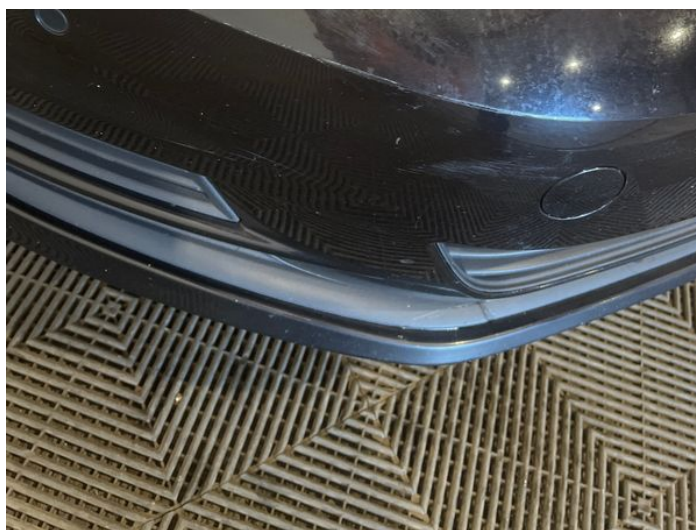
2: Bumper Front  
Scratched  
25 to 100mm Thru Paint

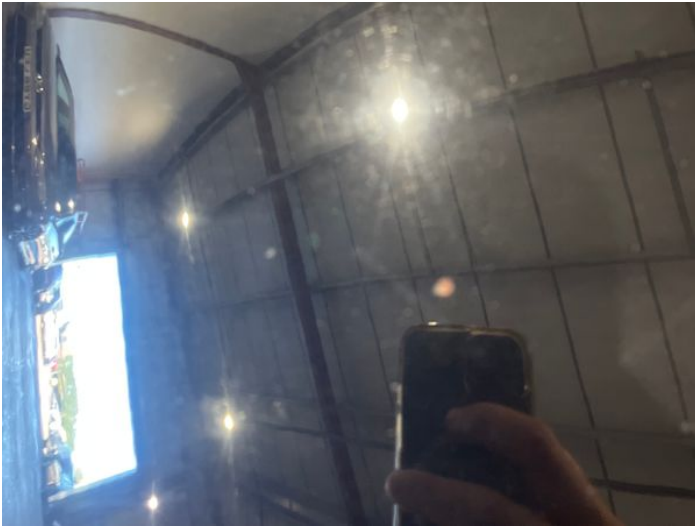
3: Bonnet  
Chipped  
1 To 5

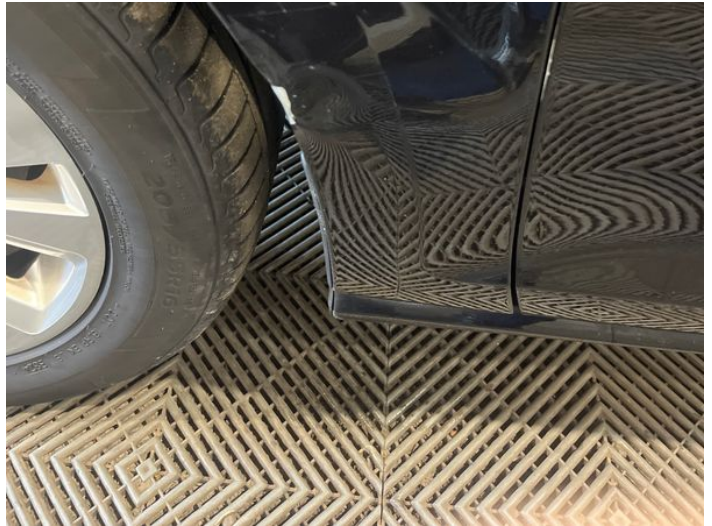
4: Wing nsf  
Dented  
With Paint Damage

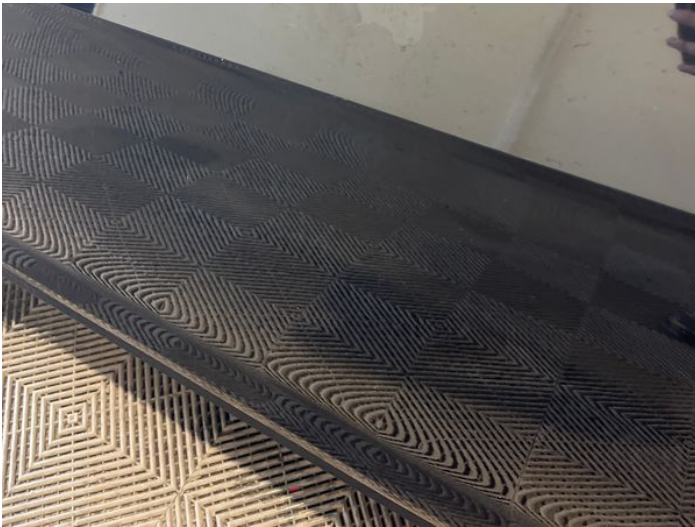
5: Door nsf  
Poor Previous Repair  
Paint Flake

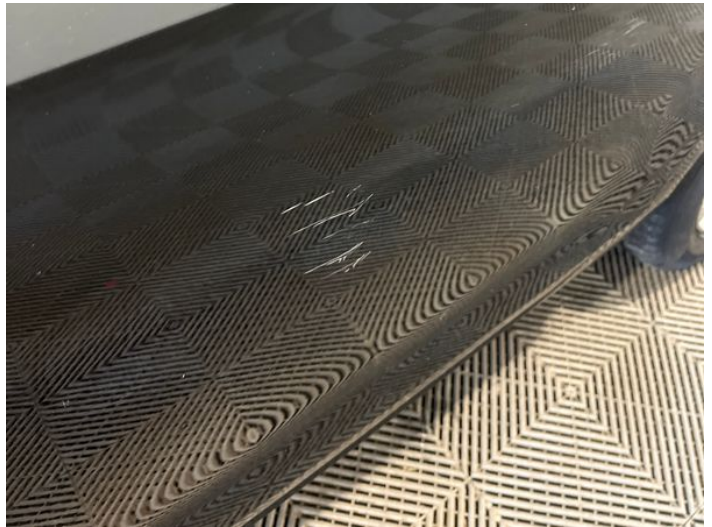
6: Door nsr  
Scratched  
Over 25mm Thru Paint

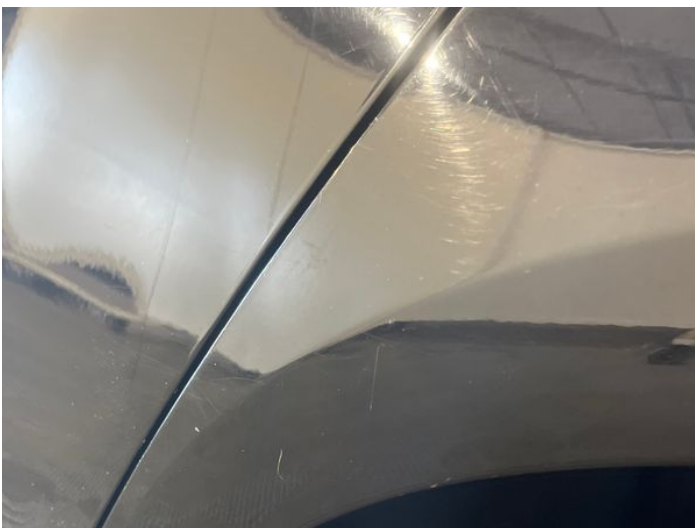
7: Qtr Panel nsr  
Scratched  
Over 25mm Thru Paint

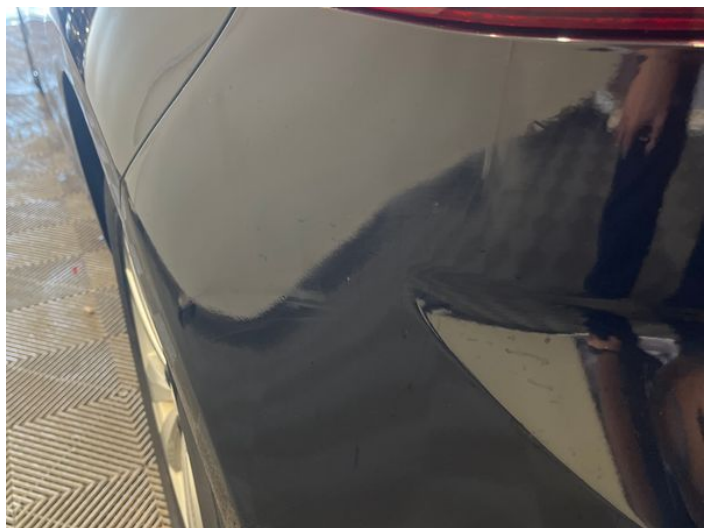
8: Bumper Rear  
Poor Previous Repair  
Poor Paint

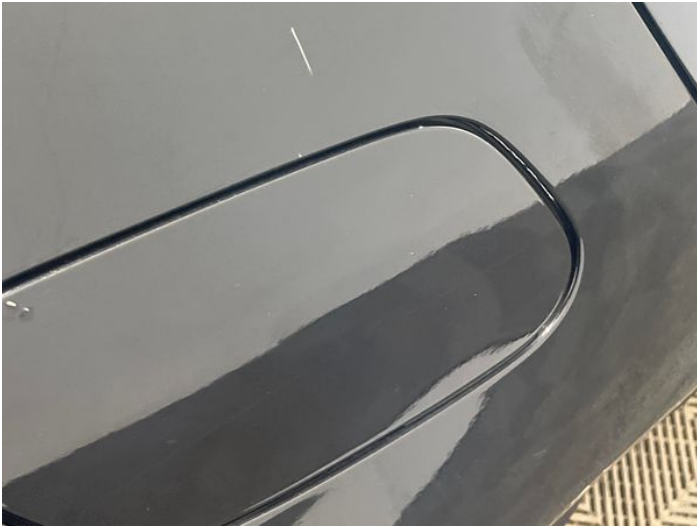
9: Qtr Panel osr  
Scratched  
Over 25mm Thru Paint

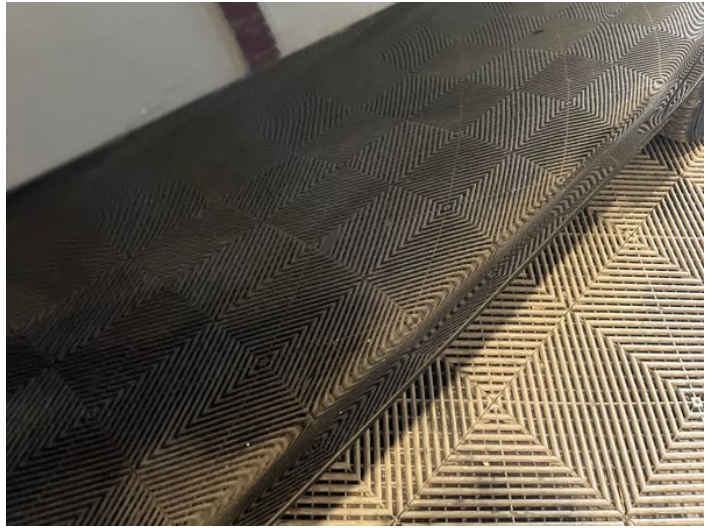
10: Door osf  
Poor Previous Repair  
Poor Paint

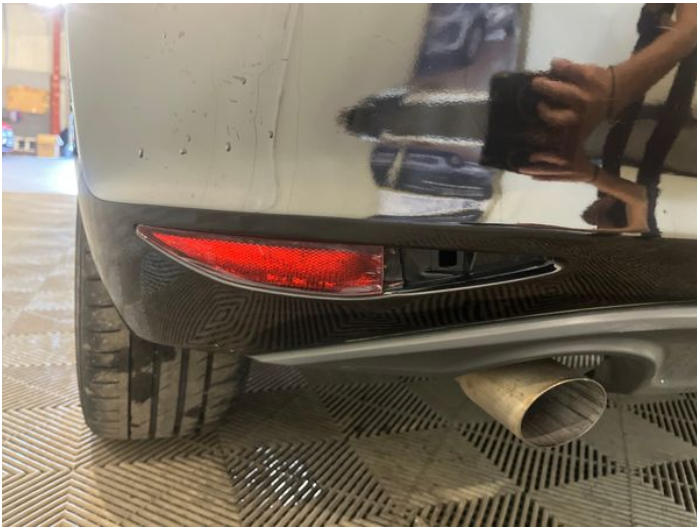
11: Reflector nsr  
Broken  
Replace

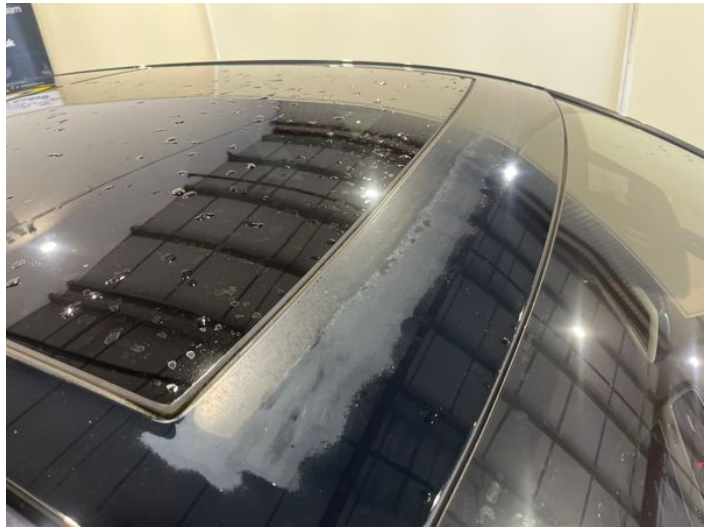
12: Roof  
Scratched  
Over 25mm Thru Paint

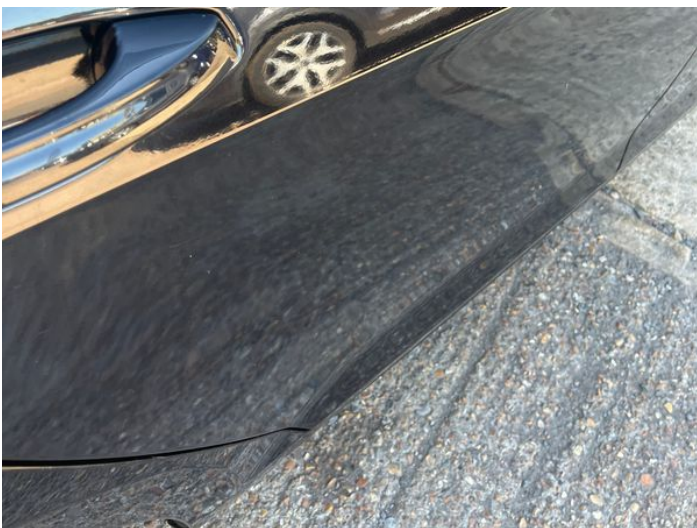
13: Door osr  
Poor Previous Repair  
Poor Paint
