# VEHICLE INSPECTION REPORT

**GL66BMY**

## Kia Sportage 1.6 GDi 1 5dr

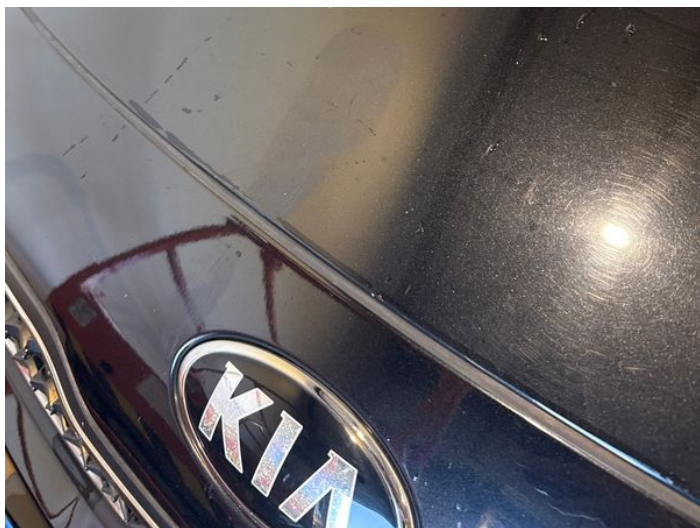
1: Bonnet  
Scratched  
Over 25mm Thru Paint

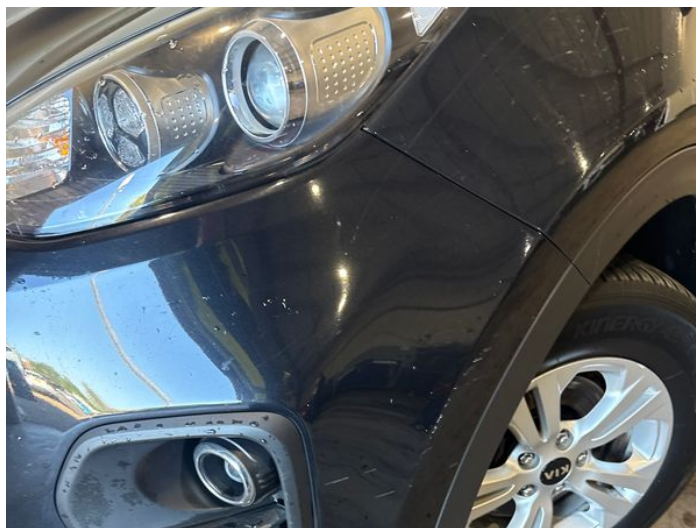
2: Bumper Front  
Scratched  
UpTo 25mm Thru Paint

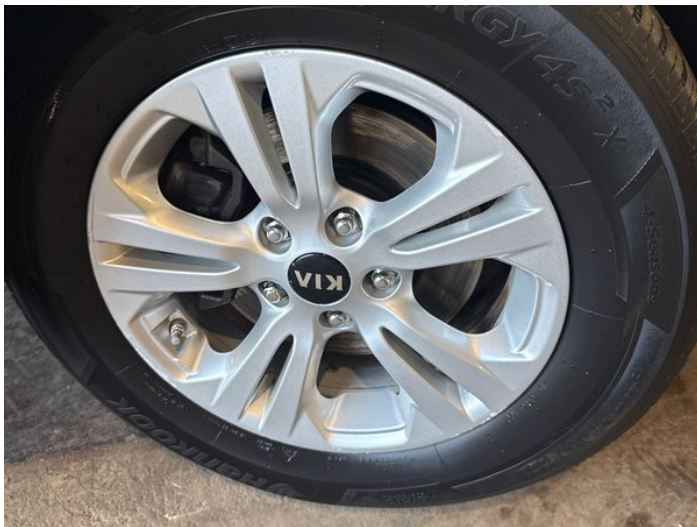
3: Wheel nsf  
Scratched  
Over 50mm

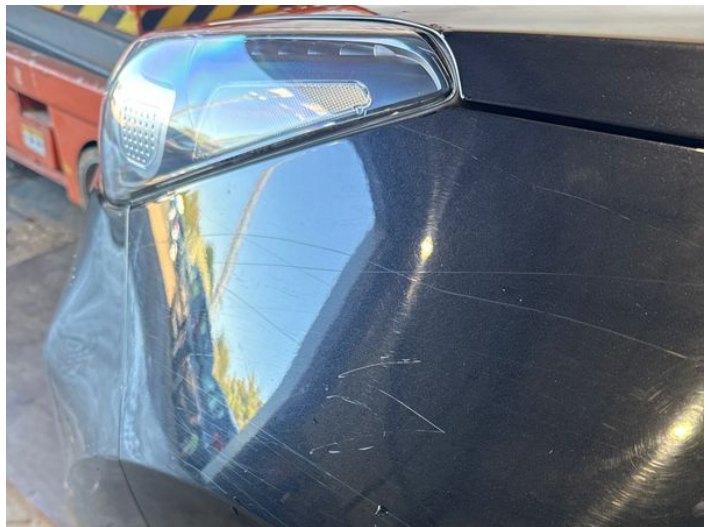
4: Wing nsf  
Scratched  
Over 25mm Thru Paint

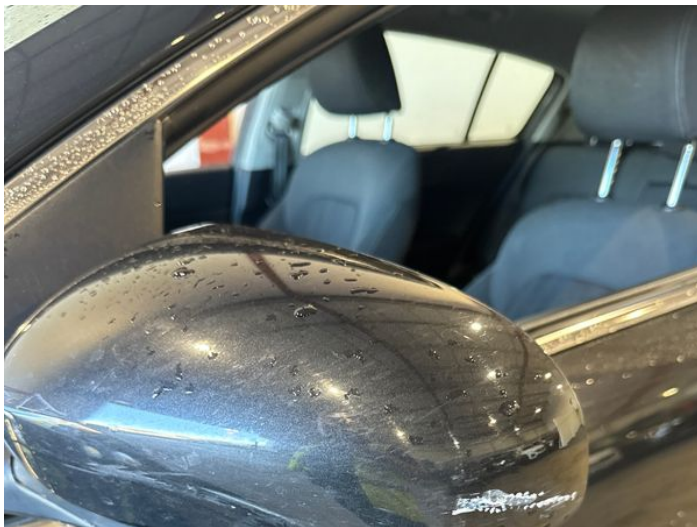
5: Door Mirror Assy nsf  
Scratched (Painted)  
Over 25mm Thru Paint

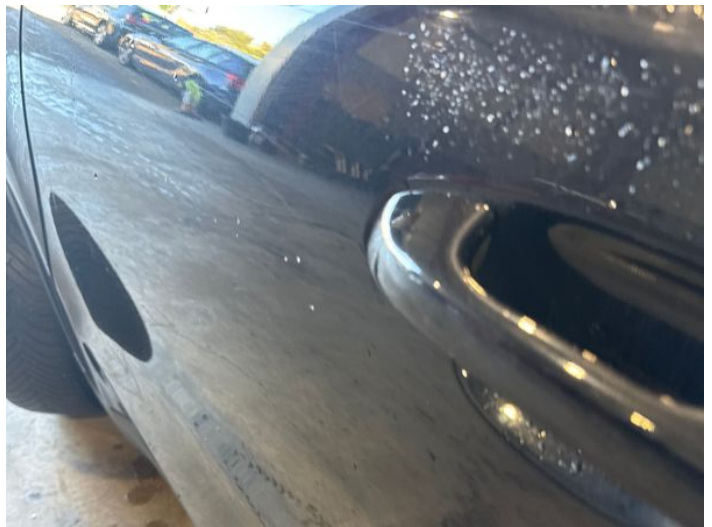
6: Door nsf  
Chipped  
Multiple Chips

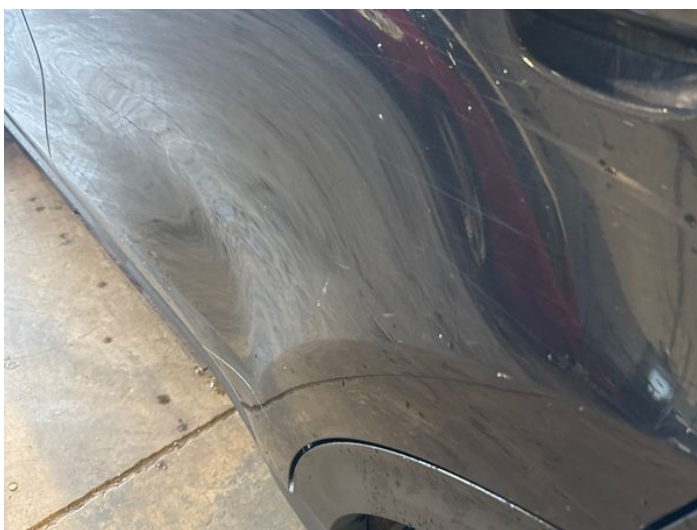
7: Door nsr  
Scratched  
Over 25mm Thru Paint

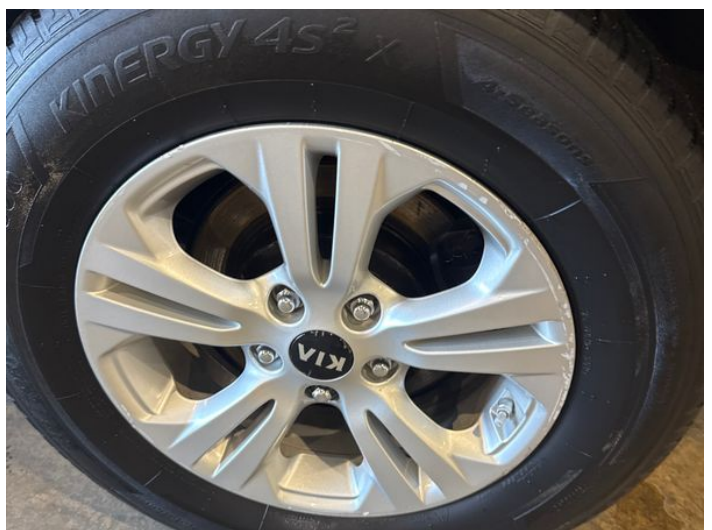
8: Wheel nsr  
Scratched  
Over 50mm

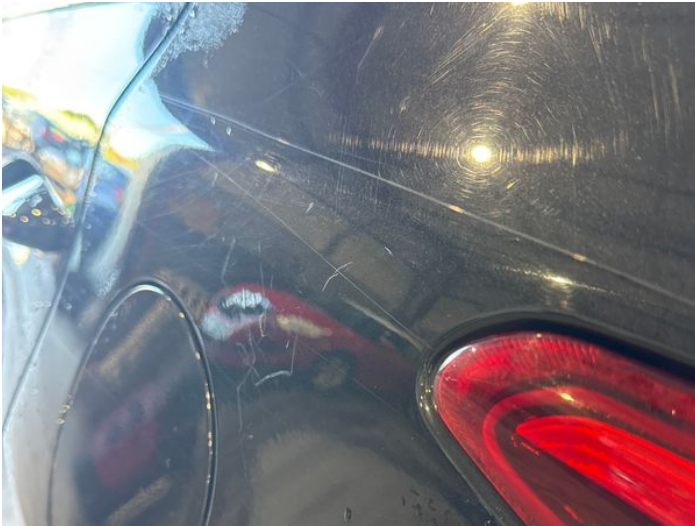
9: Qtr Panel nsr  
Dented  
With Paint Damage

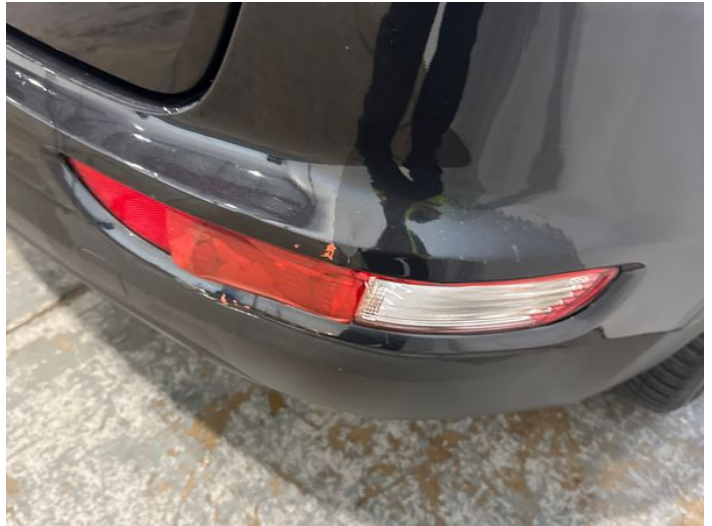
10: Bumper Rear  
Dented  
With Paint Damage

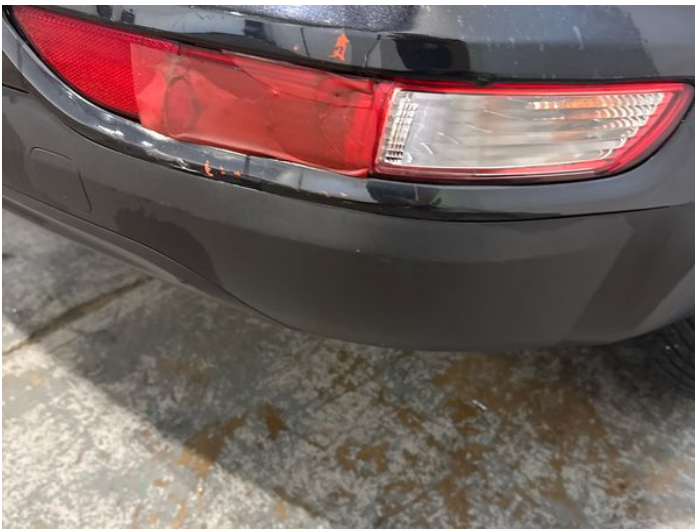
11: Bumper Reflector osr  
Broken  
Replace

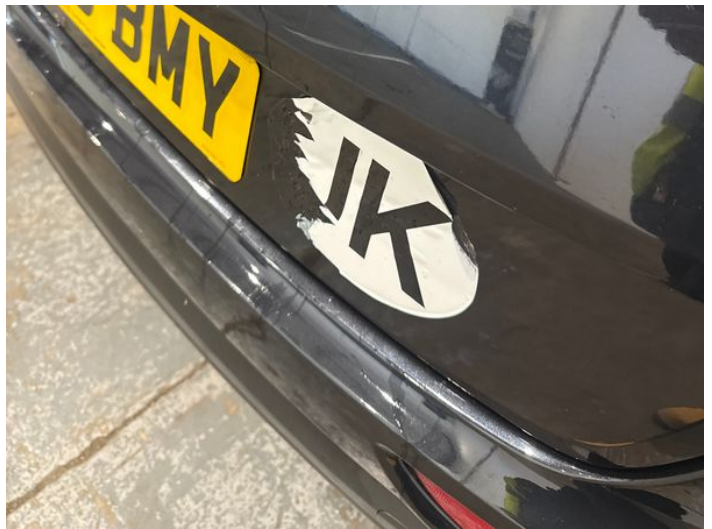
12: Tailgate  
Scratched  
Over 25mm Thru Paint

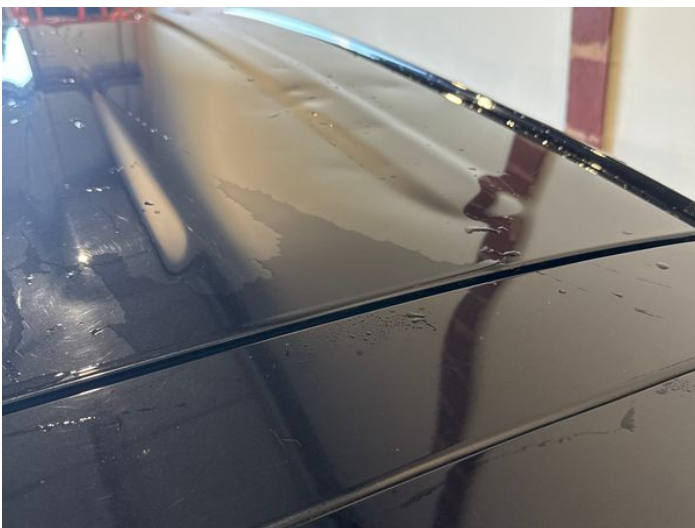
13: Roof  
Dented  
Over 30mm

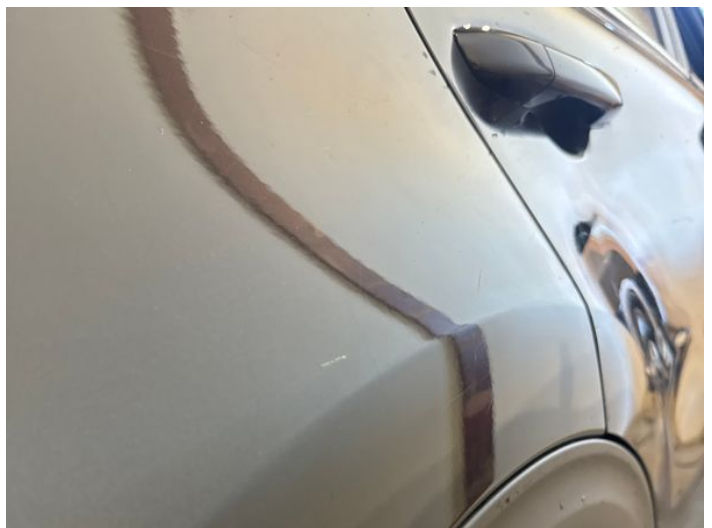
14: Qtr Panel osr  
Dented  
Between 10mm + 30mm

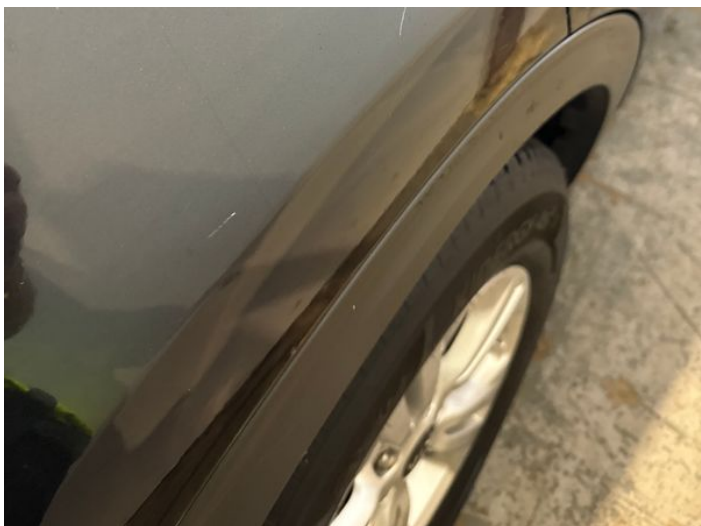
15: Qtr Panel osr  
Scratched  
UpTo 25mm Thru Paint

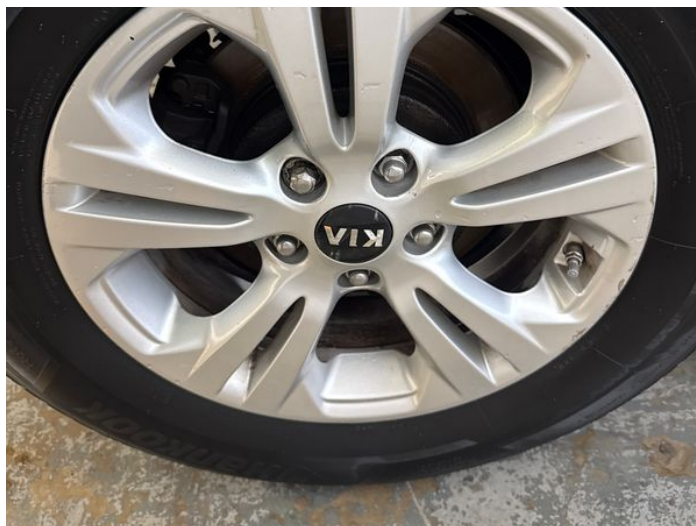
16: Wheel osr  
Scratched  
Over 50mm

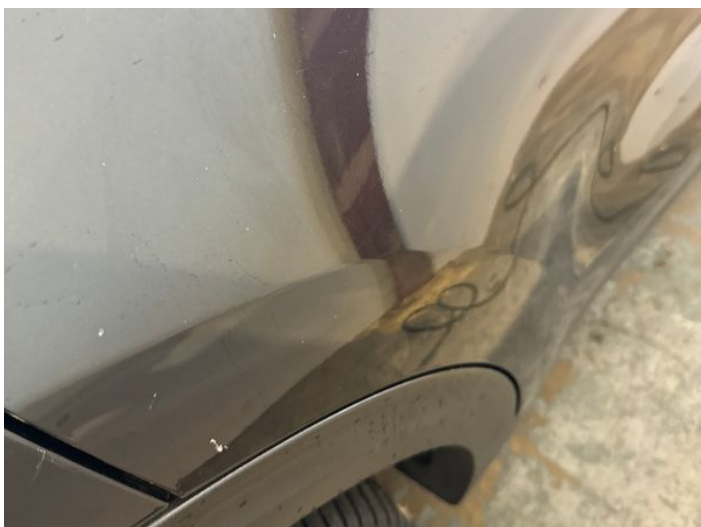
17: Door osr  
Scratched  
Over 25mm Thru Paint

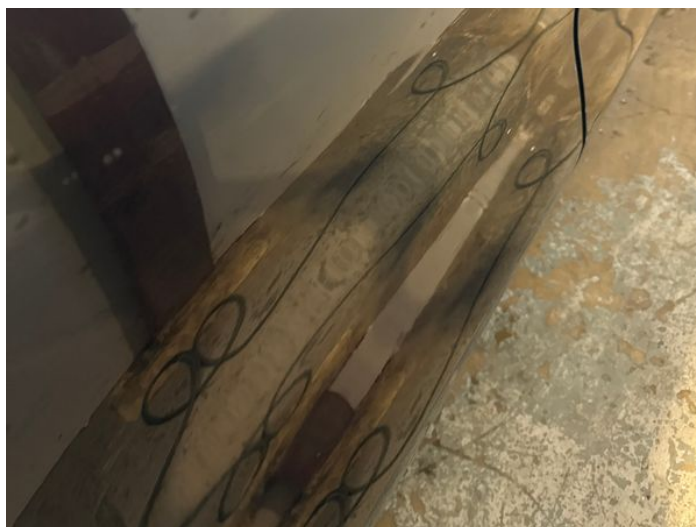
18: Door osr  
Dented  
Between 10mm + 30mm

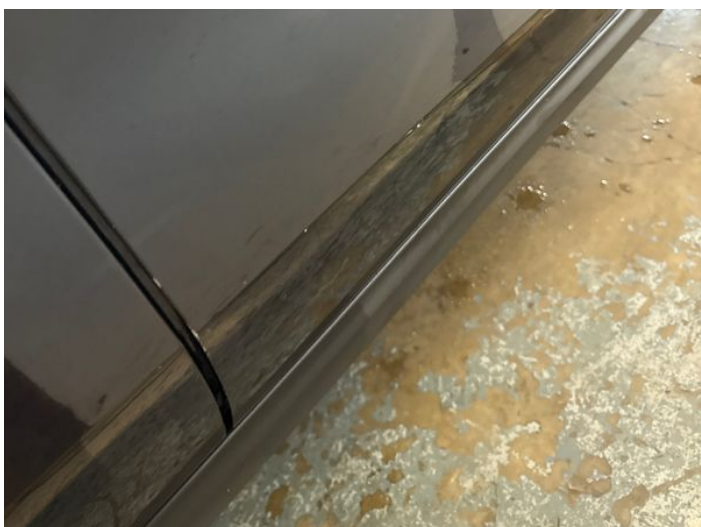
19: Door osf  
Scratched  
Over 25mm Thru Paint

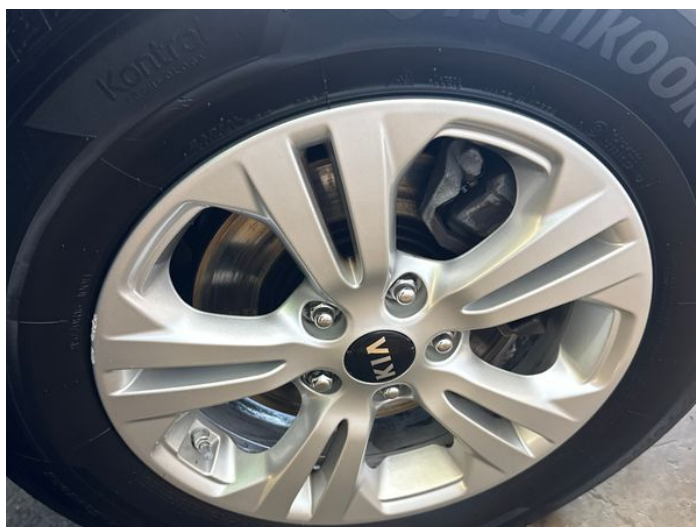
20: Wheel osf  
Scratched  
Over 50mm

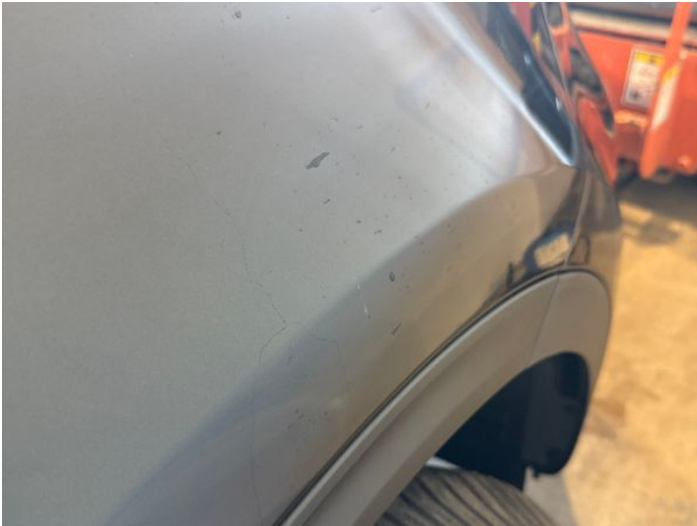
21: Wing osf  
 Scratched  
 UpTo 25mm Thru Paint

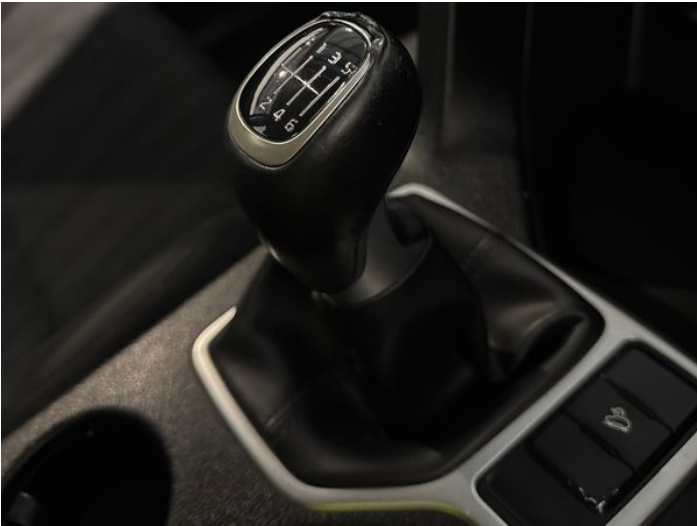
22: Switches And Controls  
 Broken  
 Replace
