# VEHICLE INSPECTION REPORT

**DP17WXH**

## Vauxhall Corsa 1.4 Design 5dr

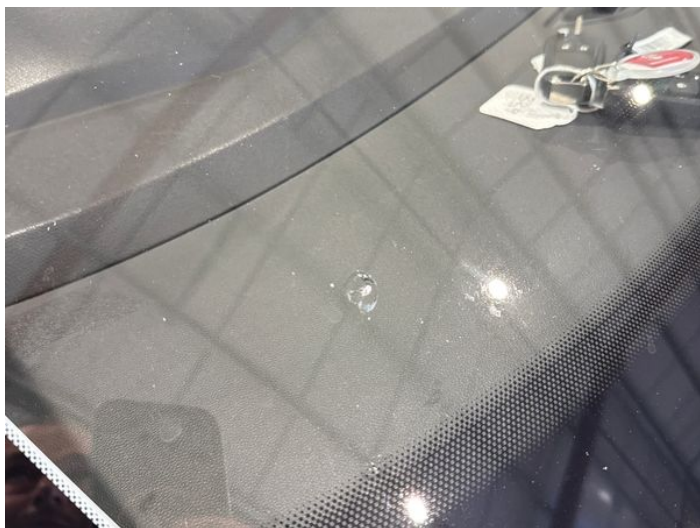
1: Screen Front  
Chipped  
Over 10mm

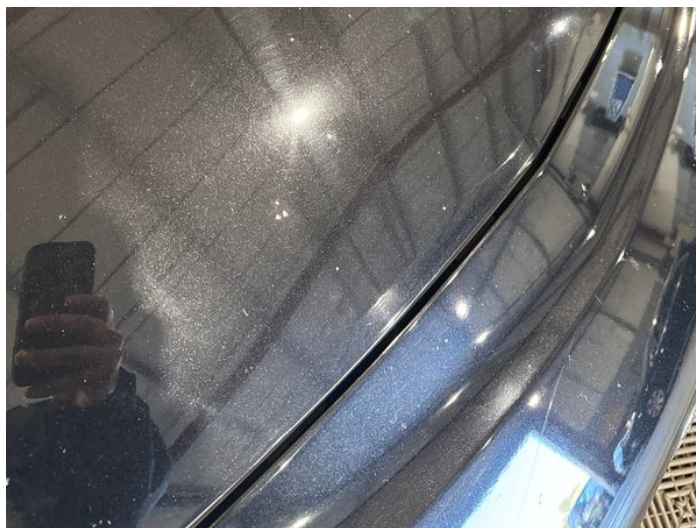
2: Bonnet  
Scratched  
Over 25mm Thru Paint

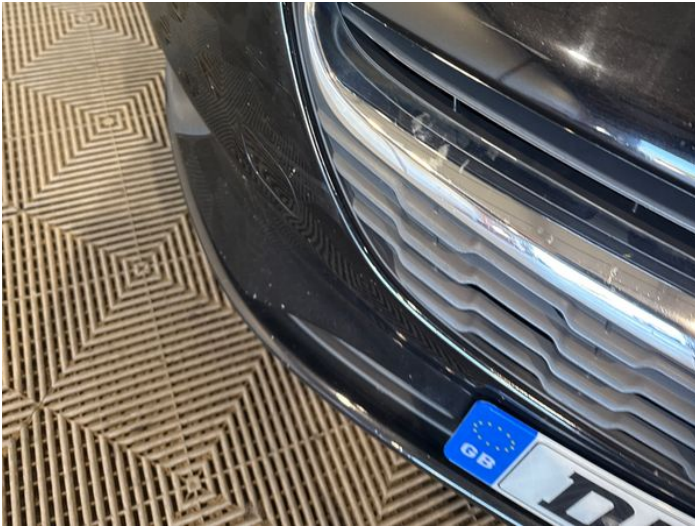
3: Bumper Front  
Scratched  
Over 100mm Thru Paint

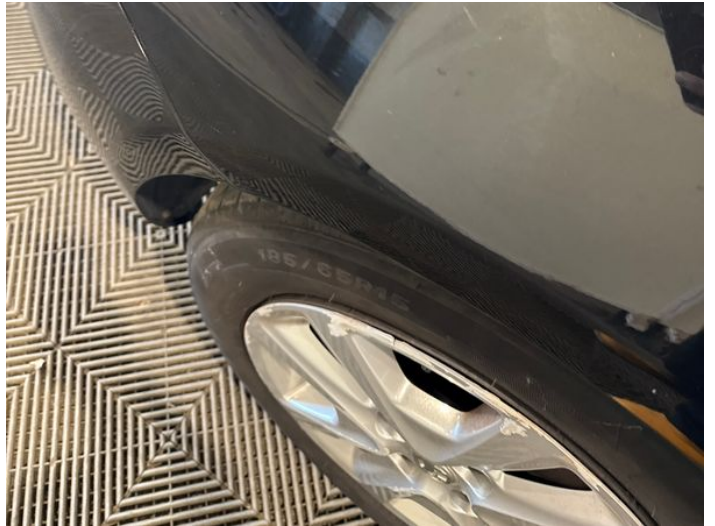
4: Wing nsf  
Scratched  
UpTo 25mm Thru Paint

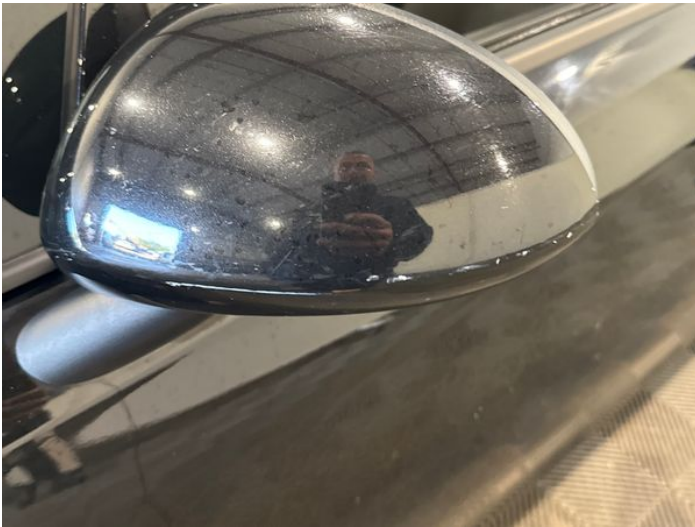
5: Door Mirror Assy nsf  
Scratched (Painted)  
Over 25mm Thru Paint

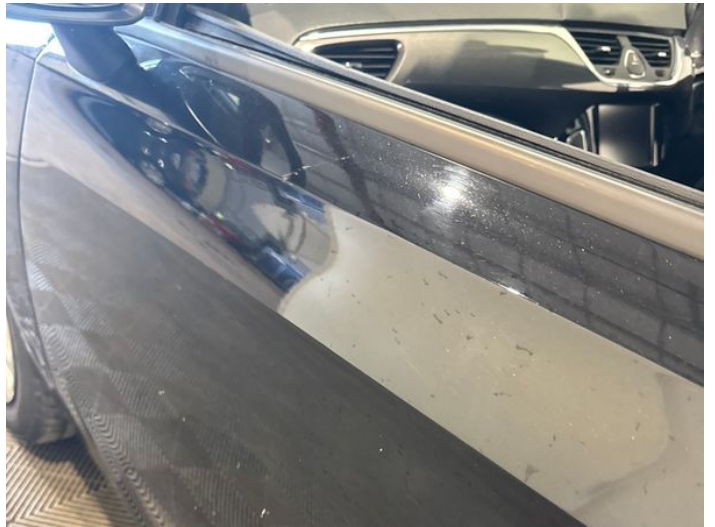
6: Door nsf  
Scratched  
Over 25mm Thru Paint

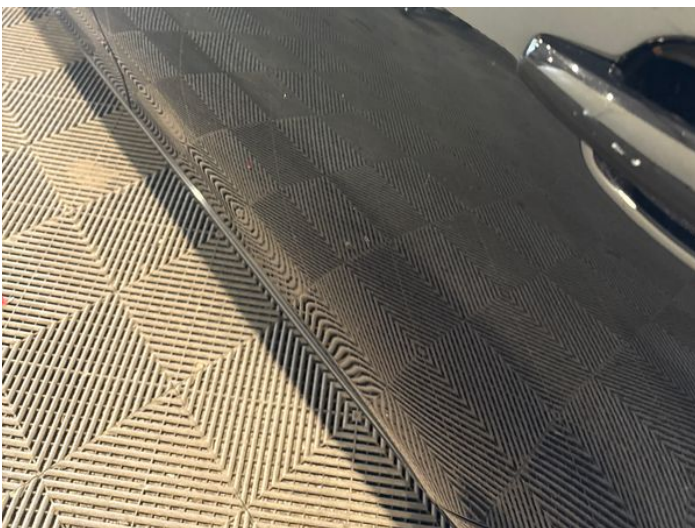
7: Door nsr  
Scratched  
Over 25mm Thru Paint

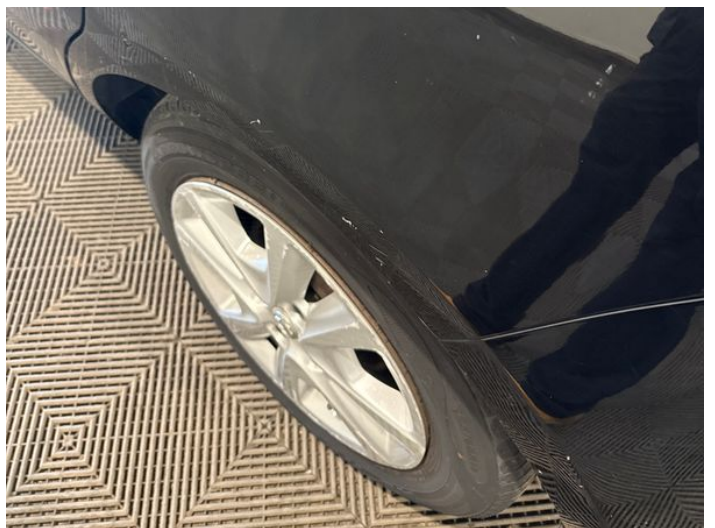
8: Qtr Panel nsr  
Chipped  
Multiple Chips

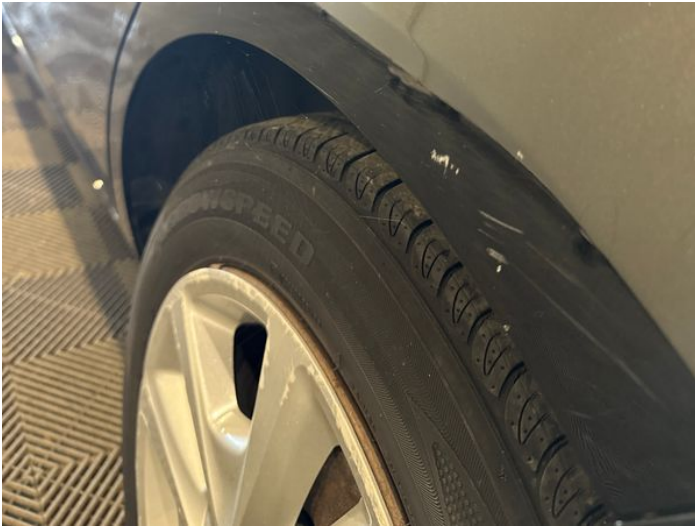
9: Qtr Panel nsr  
Dented  
Between 10mm + 30mm

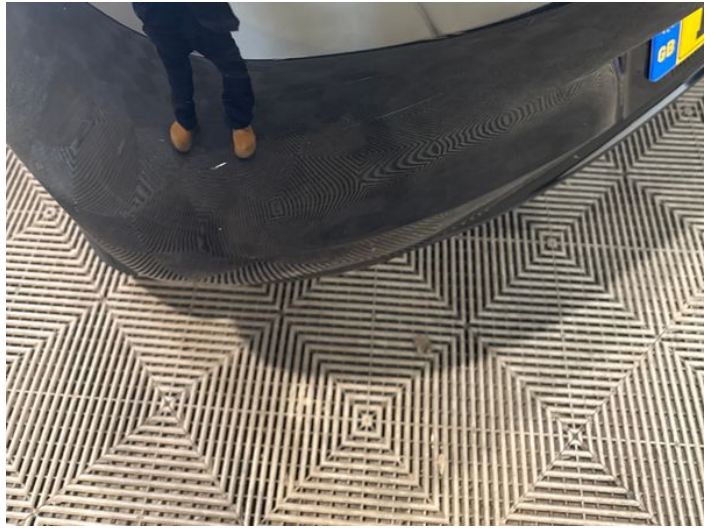
10: Bumper Rear  
Poor Previous Repair  
Paint Flake

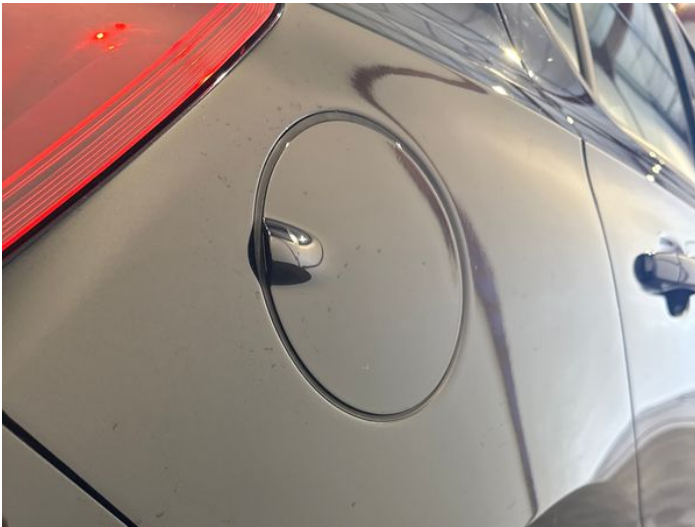
11: Qtr Panel osr  
Dented  
Between 10mm + 30mm

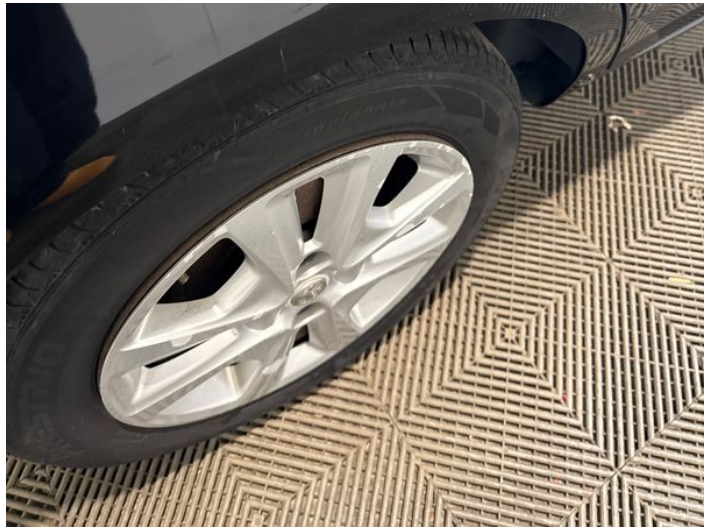
12: Qtr Panel osr  
Scratched  
UpTo 25mm Thru Paint

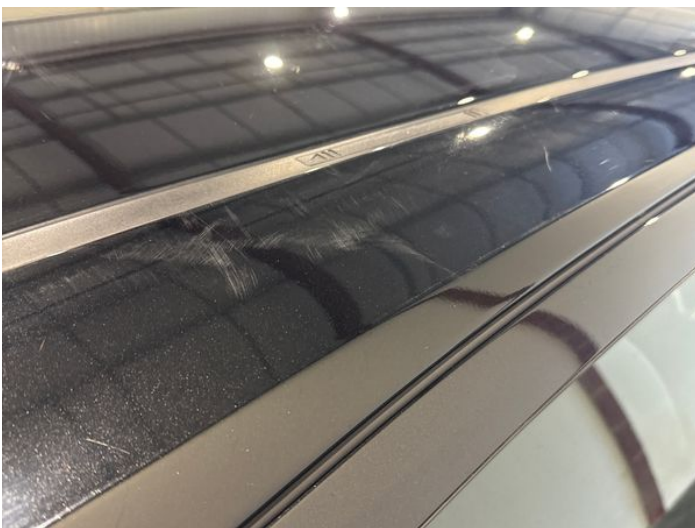
13: B Post os  
Scratched  
Over 25mm Thru Paint

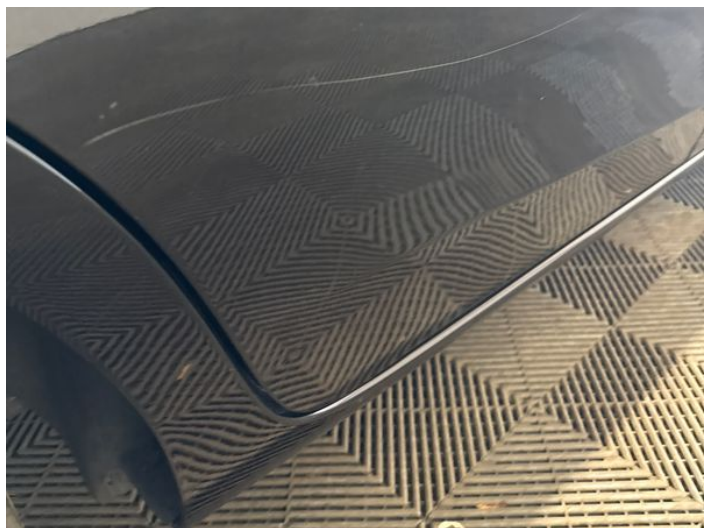
14: Door osr  
Scratched  
Over 25mm Thru Paint

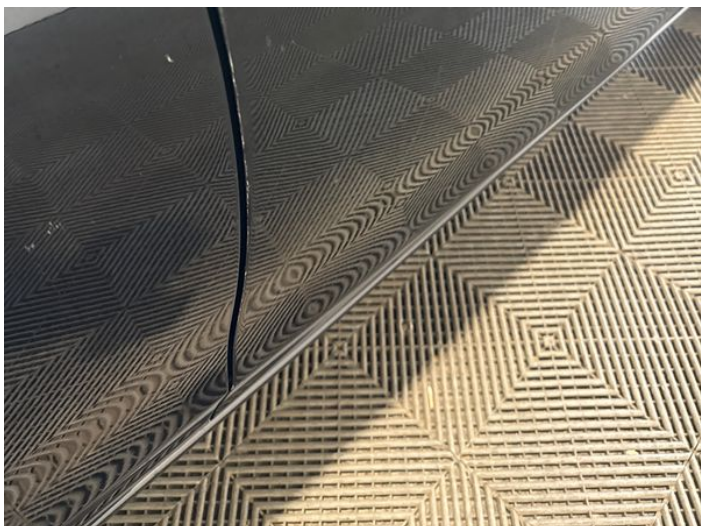
15: Door osf  
Scratched  
Over 25mm Thru Paint

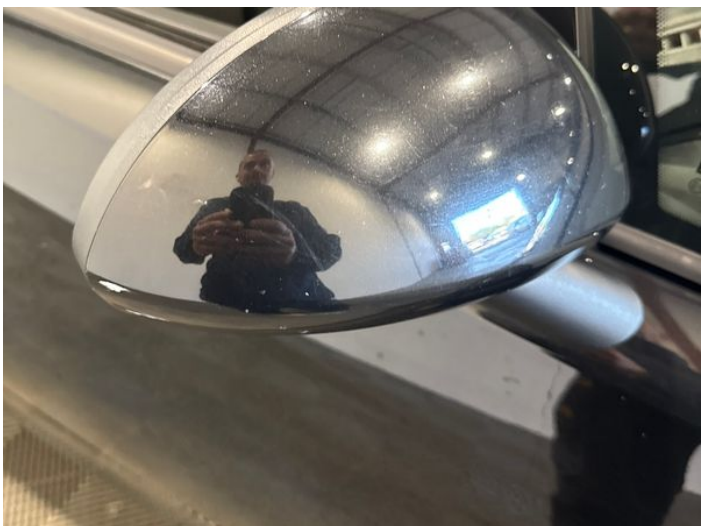
16: Door Mirror Assy osf  
Scratched (Painted)  
UpTo 25mm Thru Paint

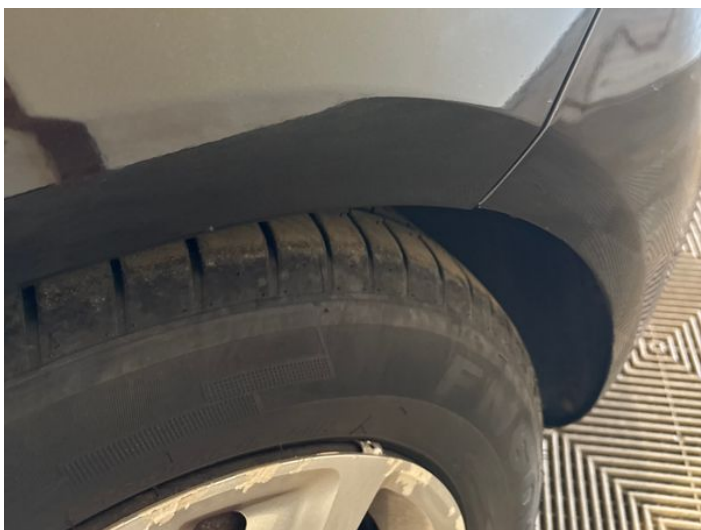
17: Wing osf  
Chipped  
1 To 5

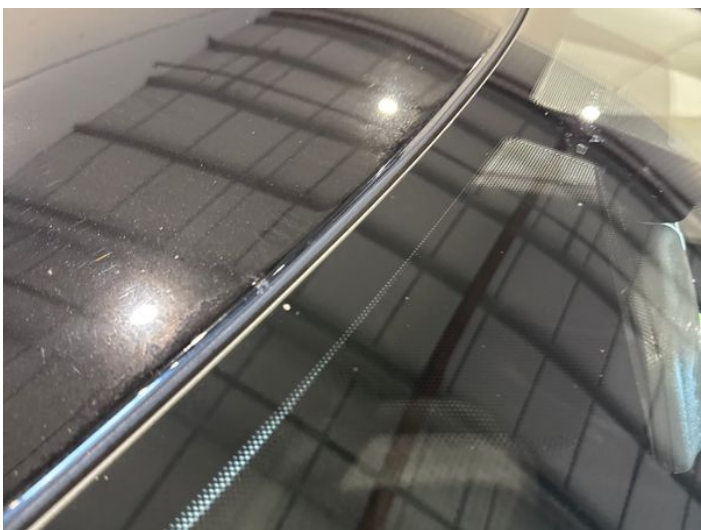
18: Roof  
Chipped  
Edge Chip
