# VEHICLE INSPECTION REPORT

**MW62LDV**

## Volkswagen Polo 1.2 60 Match 5dr

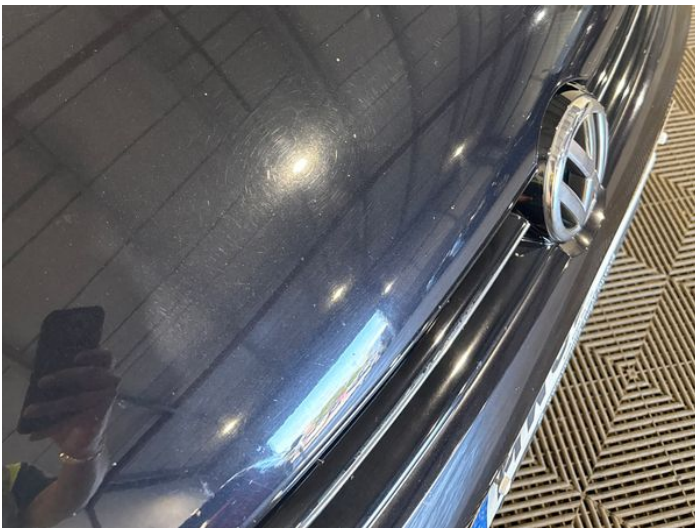
1: Bonnet  
Chipped  
Multiple Chips

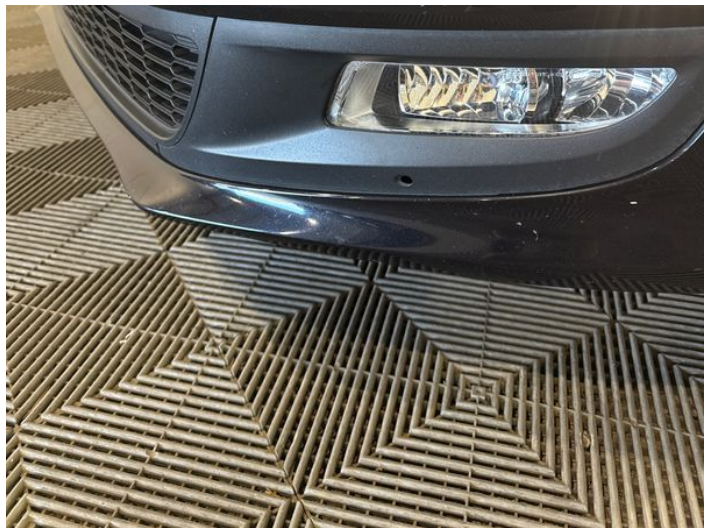
2: Bumper Front  
Poor Previous Repair  
Poor Paint

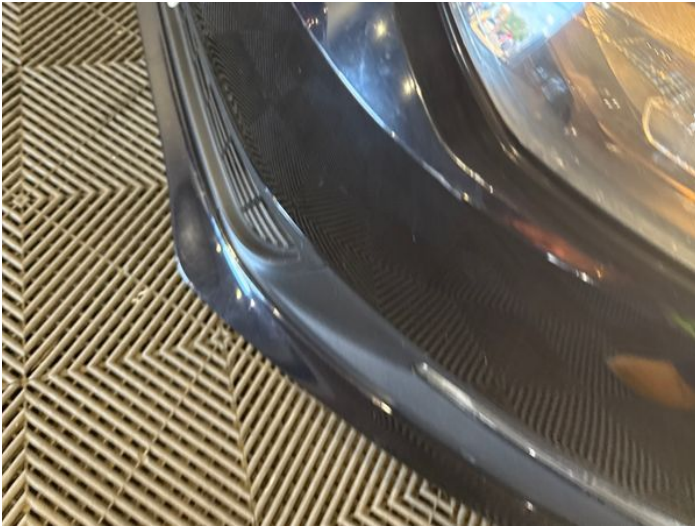
3: Bumper Front  
Chipped  
Multiple Chips

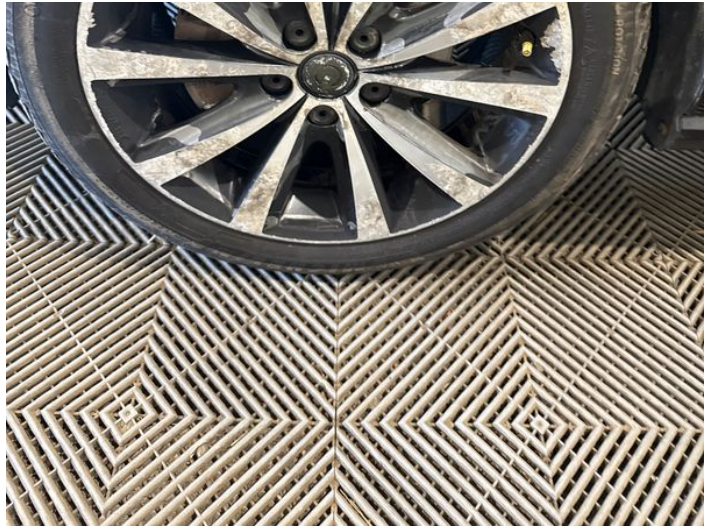
4: Wheel nsf  
Scratched  
Over 50mm

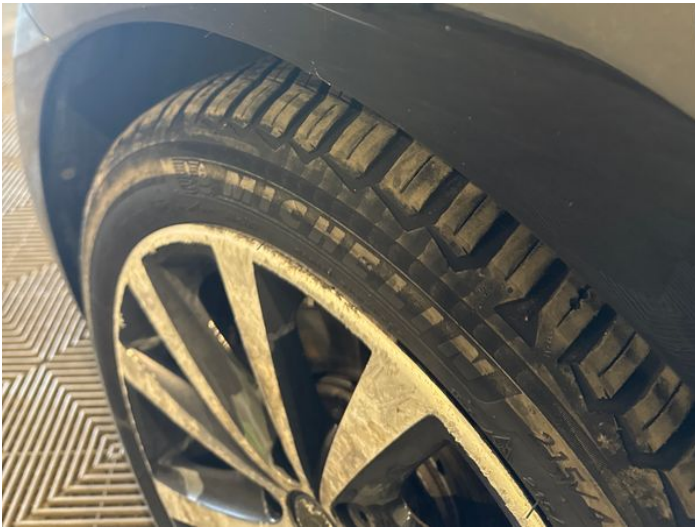
5: Wing nsf  
Scratched  
Over 25mm Thru Paint

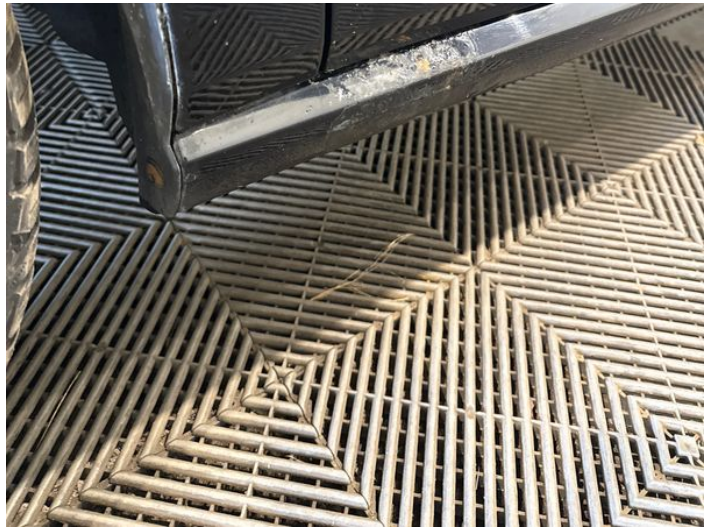
6: Sill ns  
Rusted  
Over 5mm

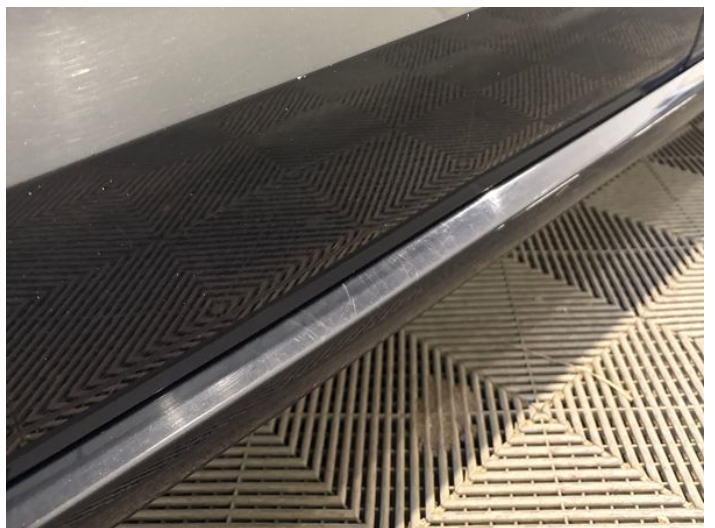
8: Door nsf  
Chipped  
Multiple Chips

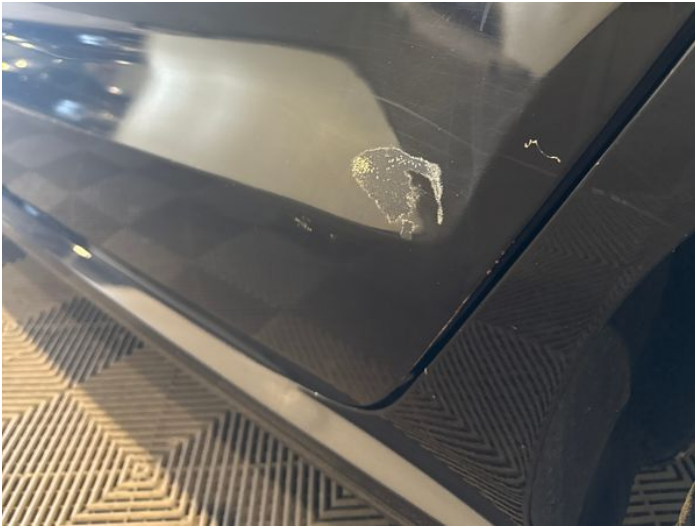
9: Door nsr  
Dented  
With Paint Damage

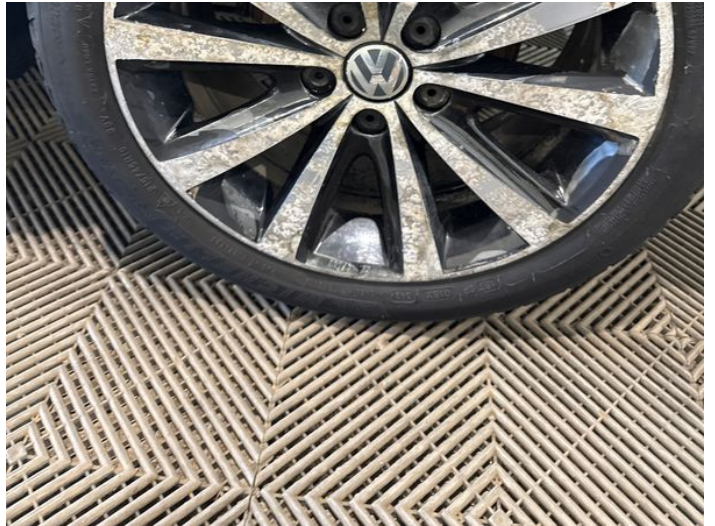
10: Wheel nsr  
Scratched  
Over 50mm

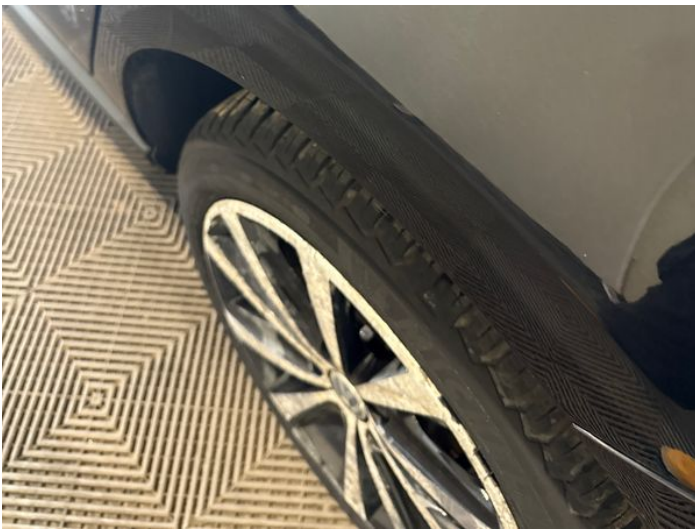
11: Qtr Panel nsr  
Scratched  
UpTo 25mm Thru Paint

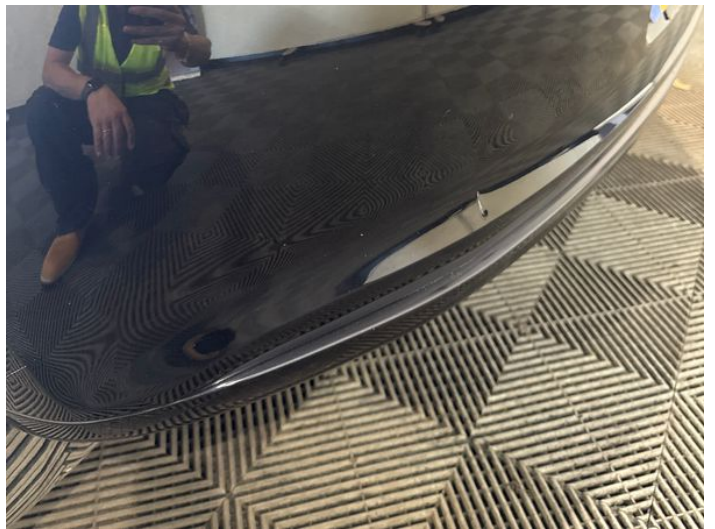
12: Bumper Rear  
Cracked  
UpTo 25mm

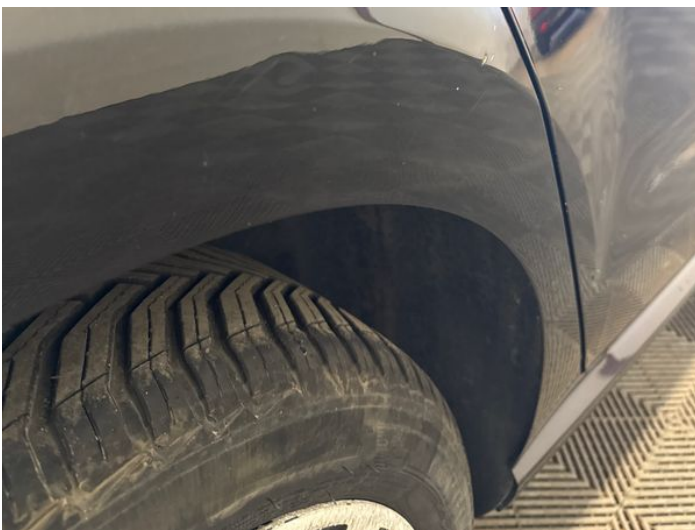
13: Qtr Panel osr  
Dented  
Over 2 UpTo 10mm

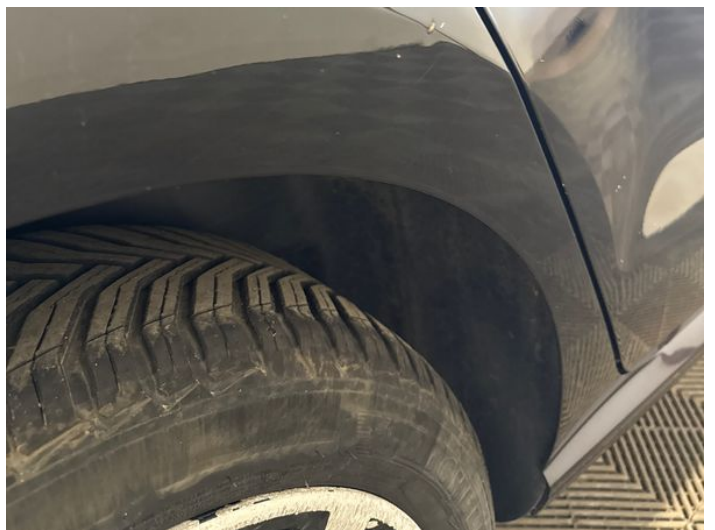
14: Qtr Panel osr  
Chipped  
1 To 5

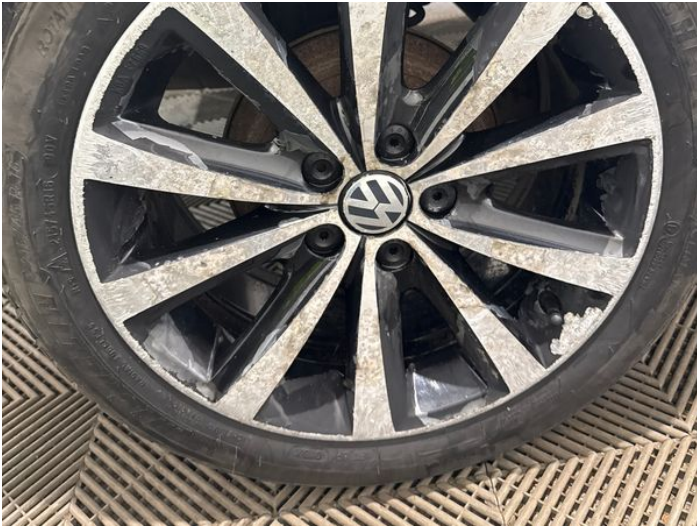
15: Wheel osr  
Scratched  
Over 50mm

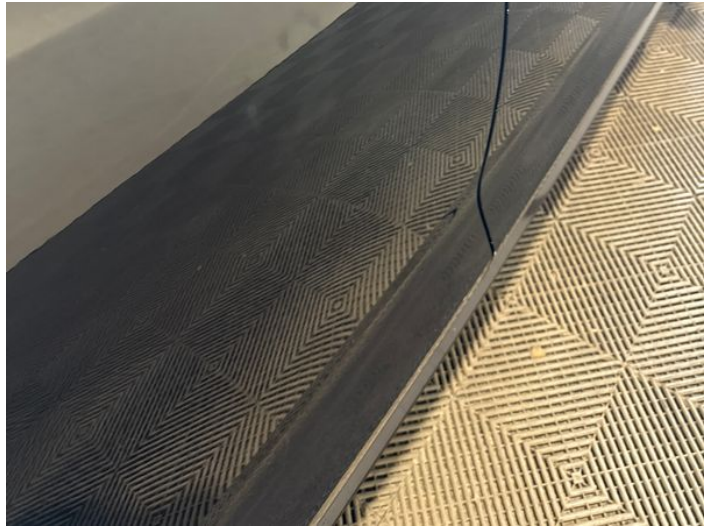
16: Door osr  
Dented  
Between 10mm + 30mm

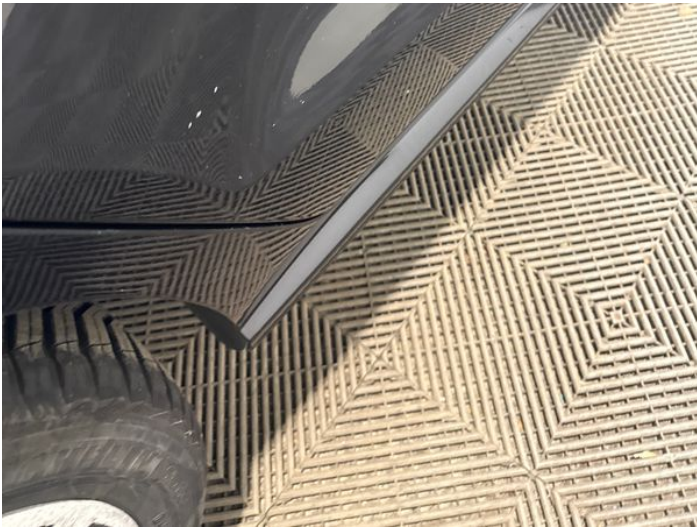
17: Door osr  
Chipped  
Multiple Chips

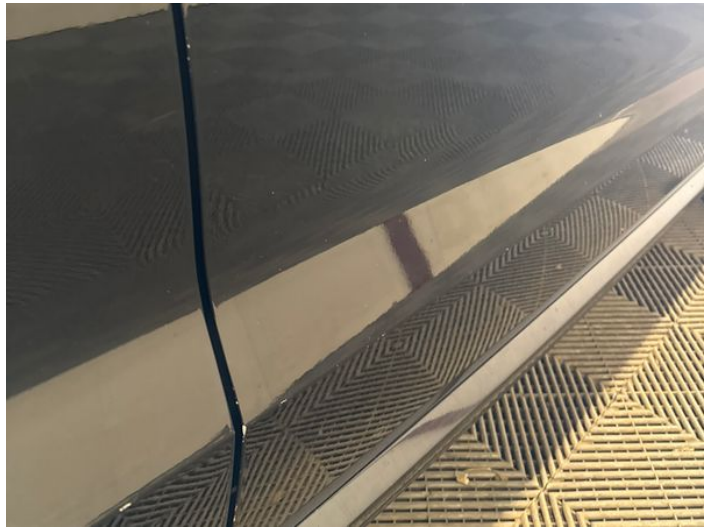
18: Door osf  
Chipped  
Multiple Chips

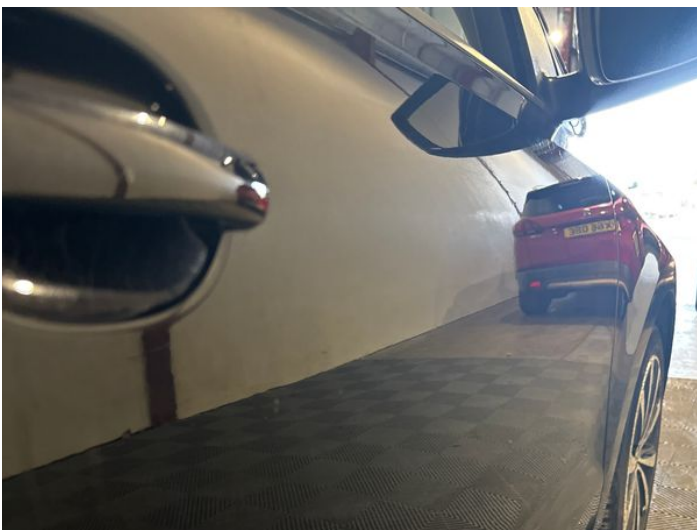
19: Door osf  
Dented  
2 Or Less UpTo 10mm

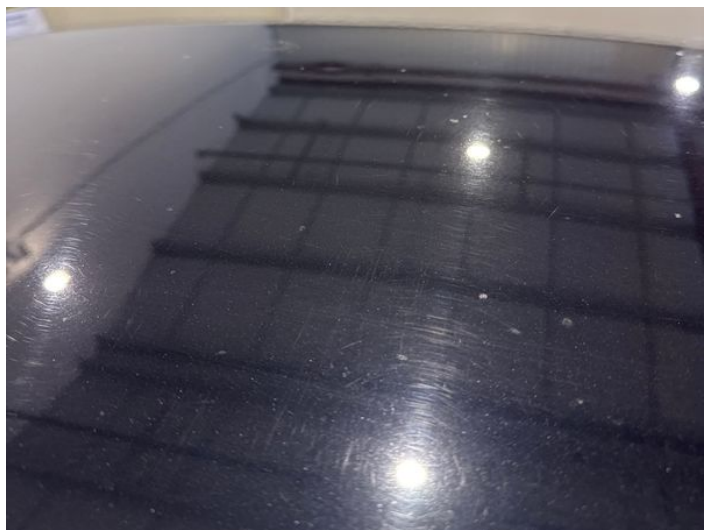
20: Roof  
Dented  
Between 10mm + 30mm

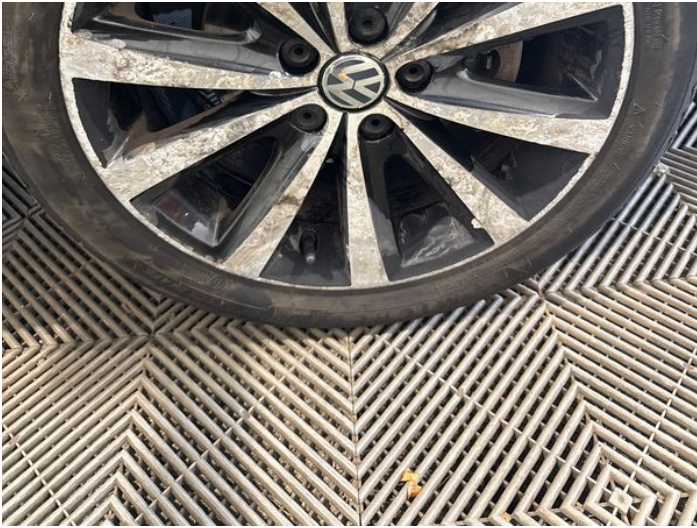
21: Wheel osf  
Scratched  
Over 50mm

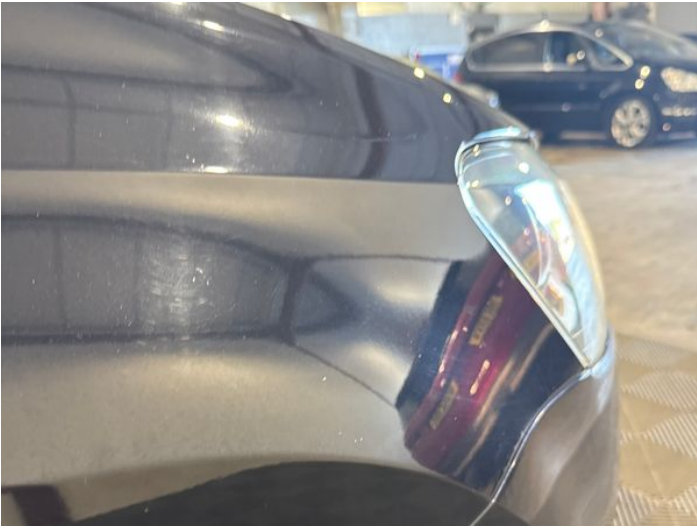
22: Wing osf  
Chipped  
1 To 5

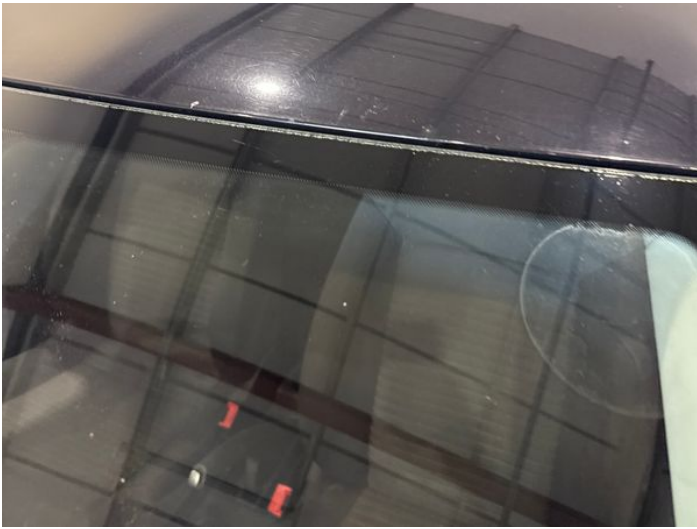
23: Roof  
Chipped  
Edge Chip
