## VEHICLE INSPECTION REPORT

**GV17WBN**

### Suzuki Sx4 S-Cross 1.0 Boosterjet SZ-T 5dr

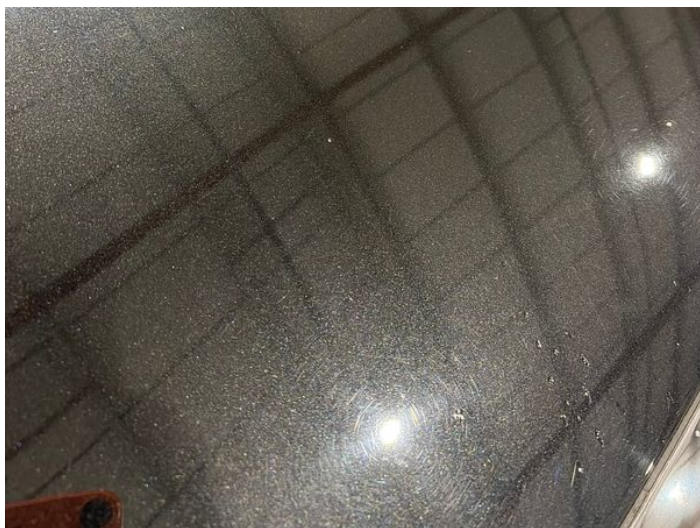
1: Bonnet  
Chipped  
1 To 5

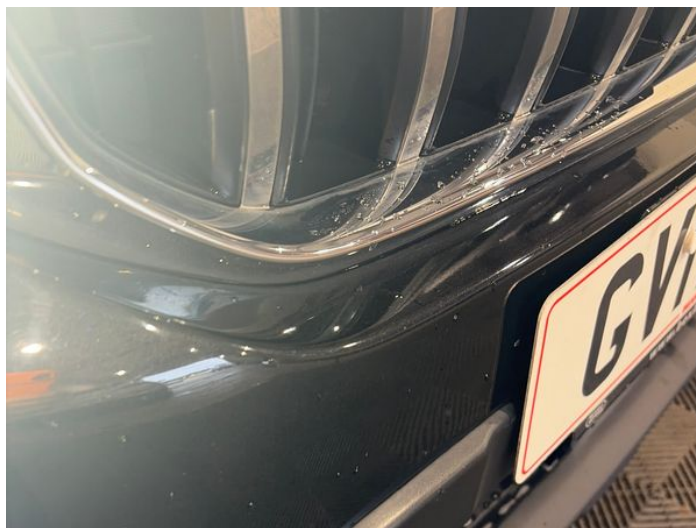
2: Bumper Front  
Chipped  
1 To 5

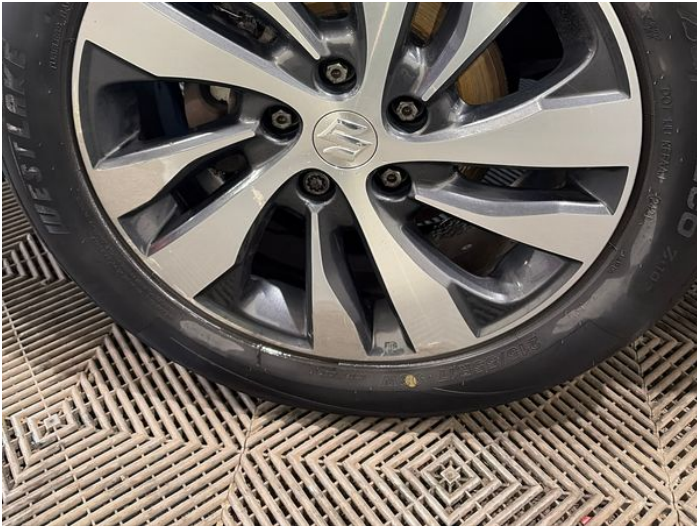
3: Wheel nsf  
Scratched  
Over 50mm

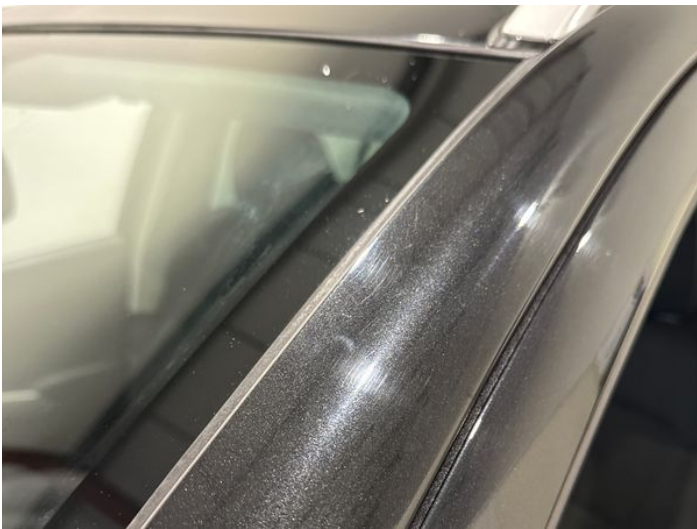
5: A Post ns  
Chipped  
1 To 5

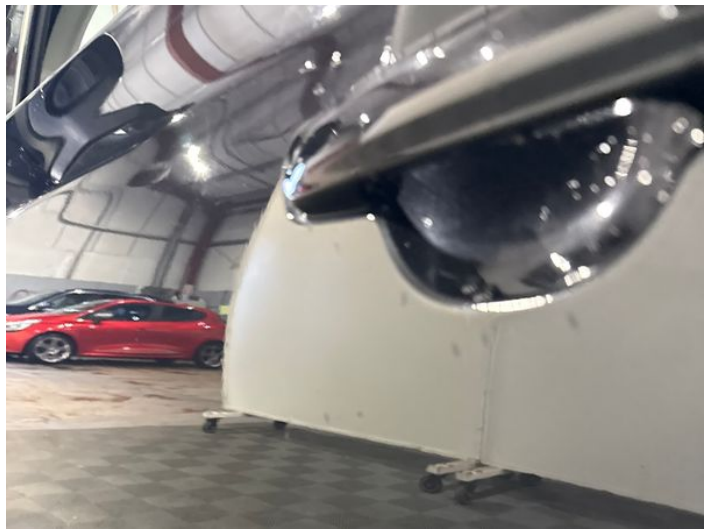
6: Door nsf  
Chipped  
1 To 5

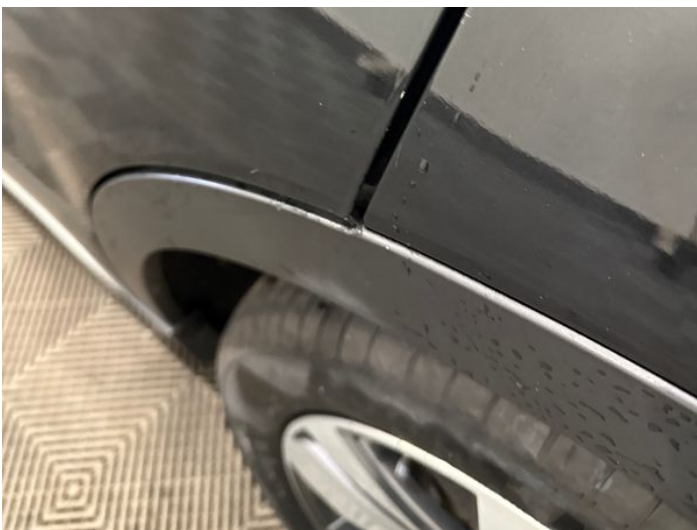
7: Door nsr  
Chipped  
Edge Chip

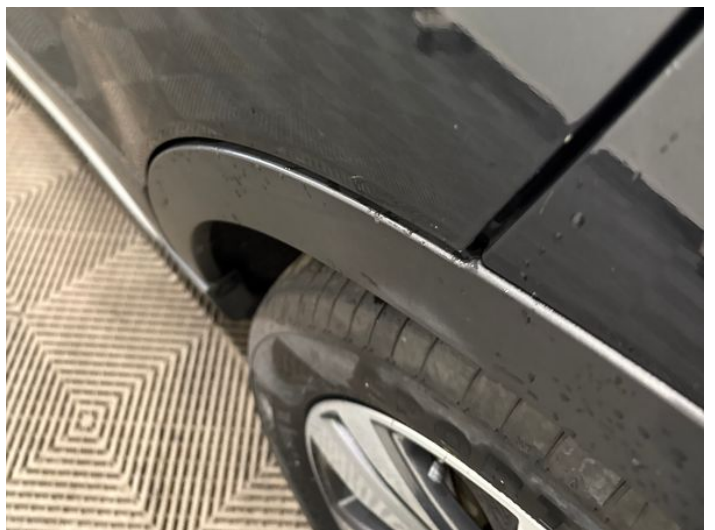
8: Door nsr  
Chipped  
1 To 5

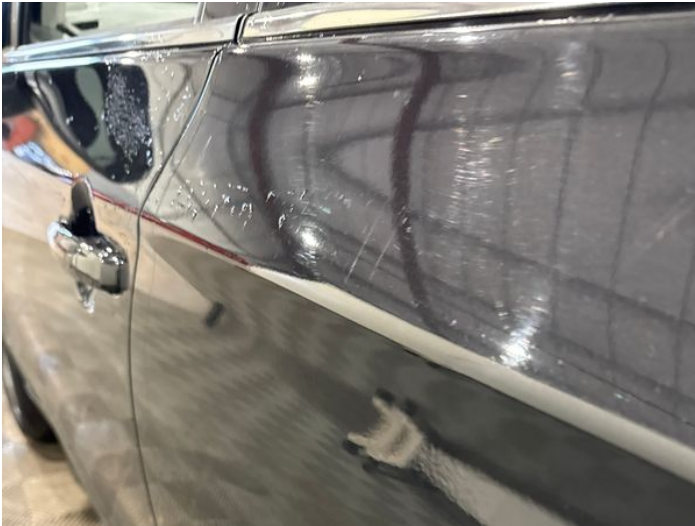
9: Door nsr  
Dented  
Between 10mm + 30mm

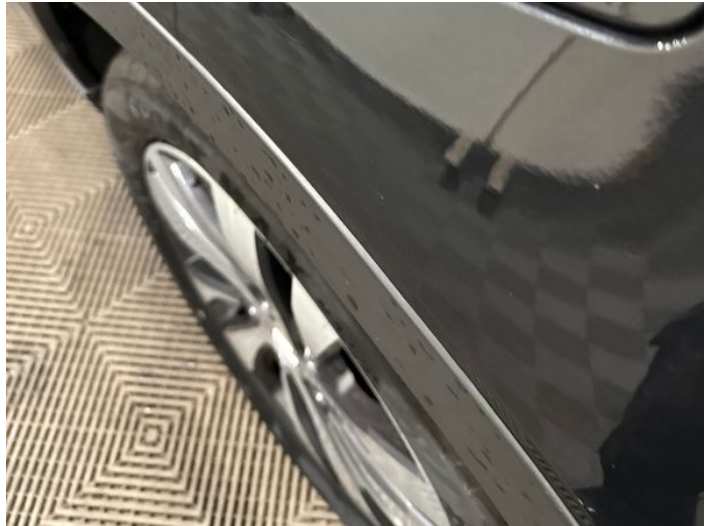
10: Qtr Panel nsr  
Scratched  
UpTo 25mm Thru Paint

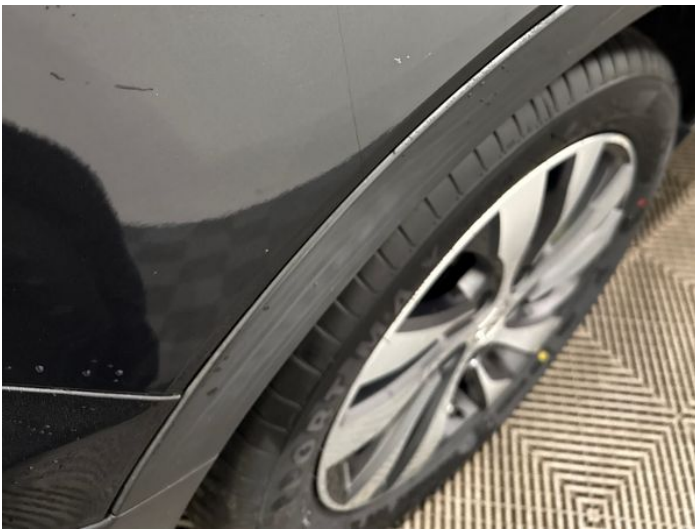
11: Qtr Panel nsr  
Chipped  
1 To 5

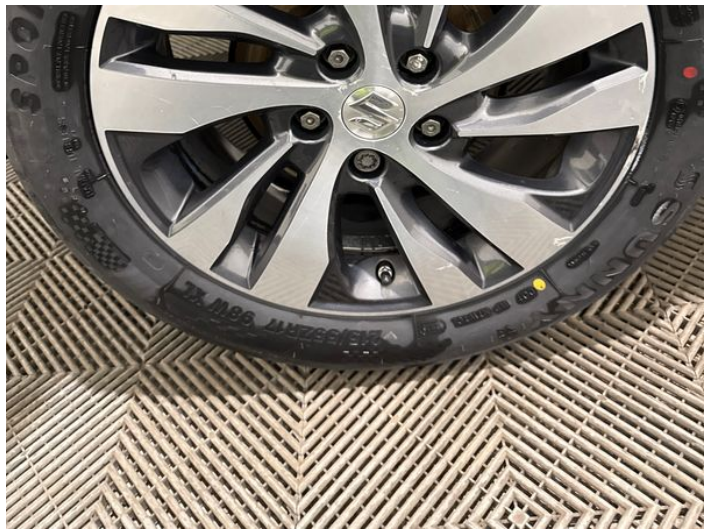
12: Wheel osr  
Scratched  
Over 50mm

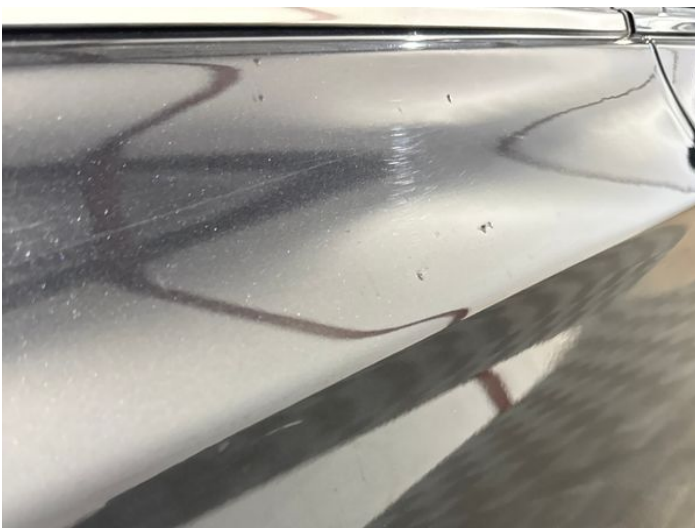
13: Door osr  
Scratched  
UpTo 25mm Thru Paint

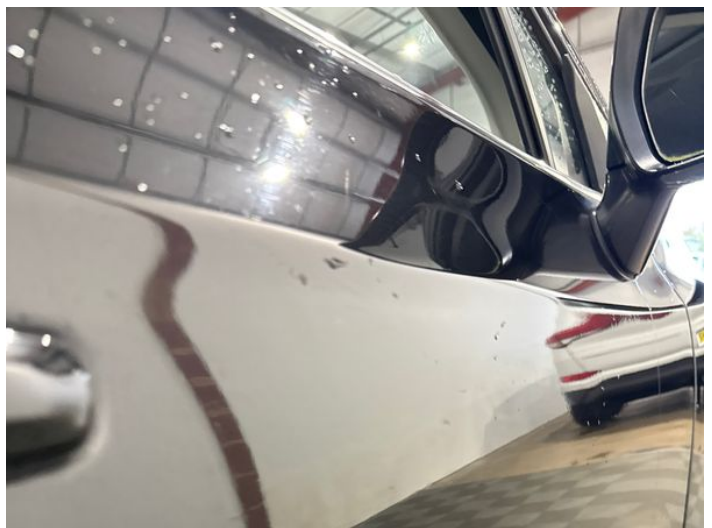
14: Door osf  
Dented  
2 Or Less UpTo 10mm

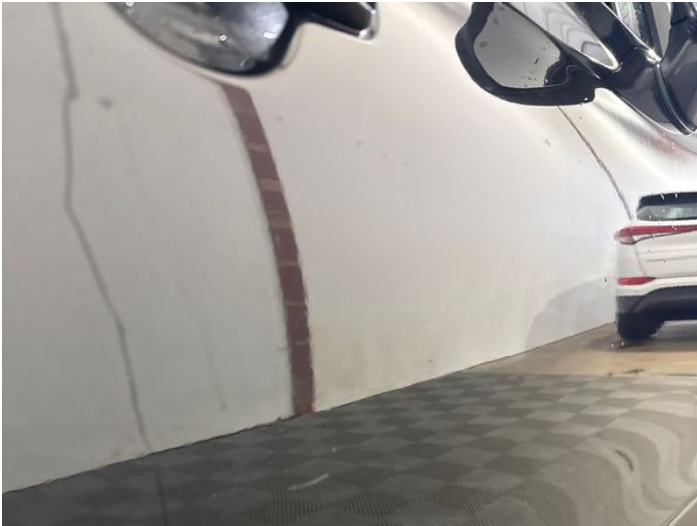
15: Door osf  
Scratched  
UpTo 25mm Thru Paint

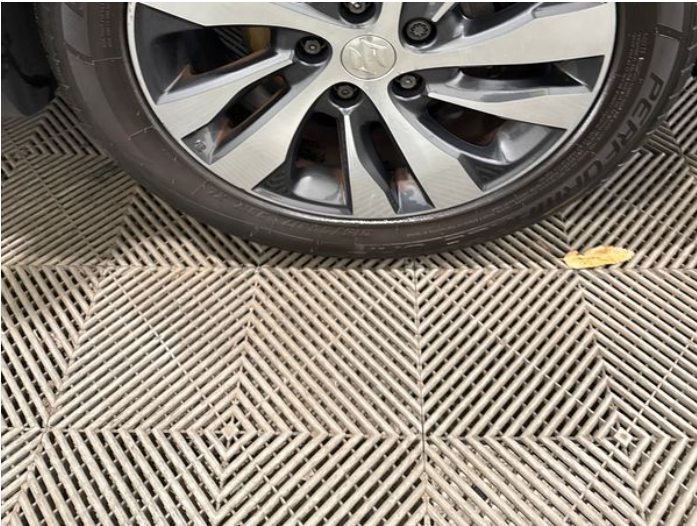
16: Wheel osf  
Scratched  
Up To 50mm

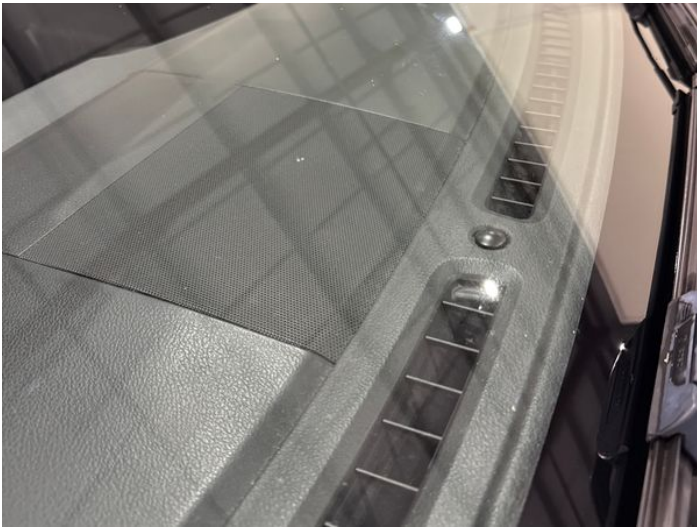
17: Screen Front  
Chipped  
UpTo 10mm

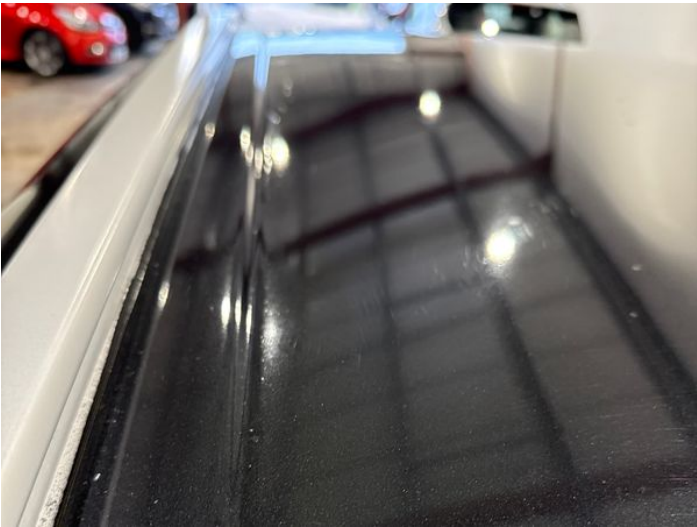
18: Roof  
Dented  
Between 10mm + 30mm
