# VEHICLE INSPECTION REPORT

**EX18MFK**

## Peugeot 3008 1.2 PureTech GT Line 5dr

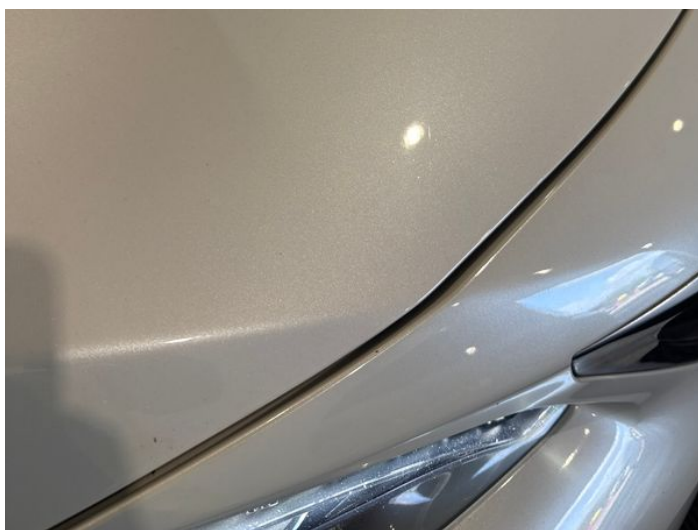
1: Bonnet  
Chipped  
1 To 5

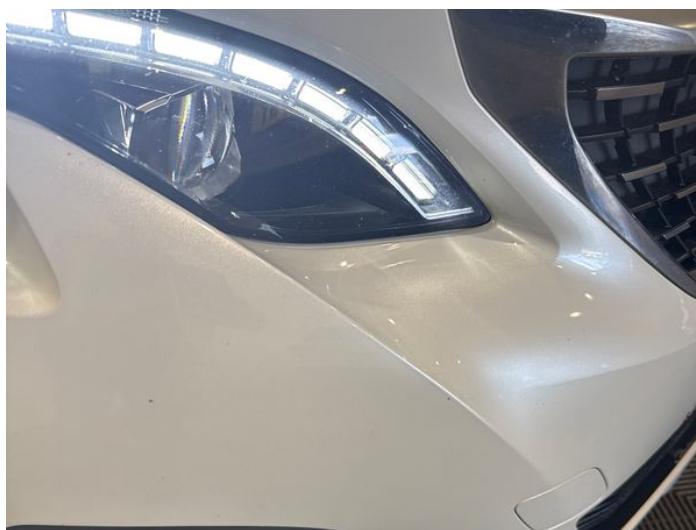
2: Bumper Front  
Chipped  
1 To 5

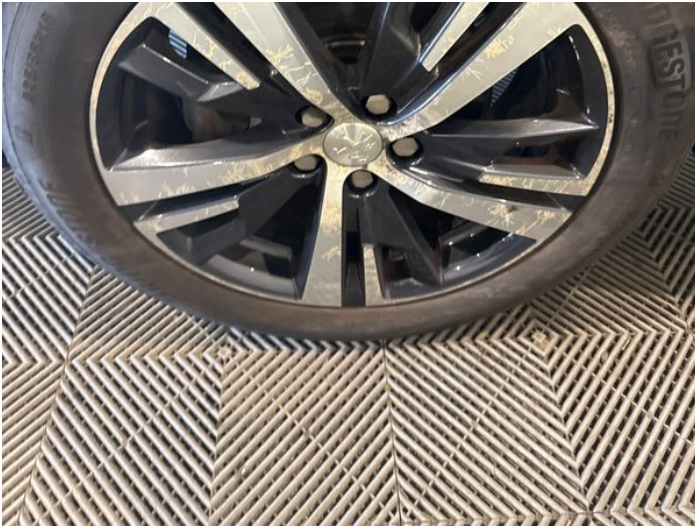
3: Wheel nsf  
Scratched  
Over 50mm

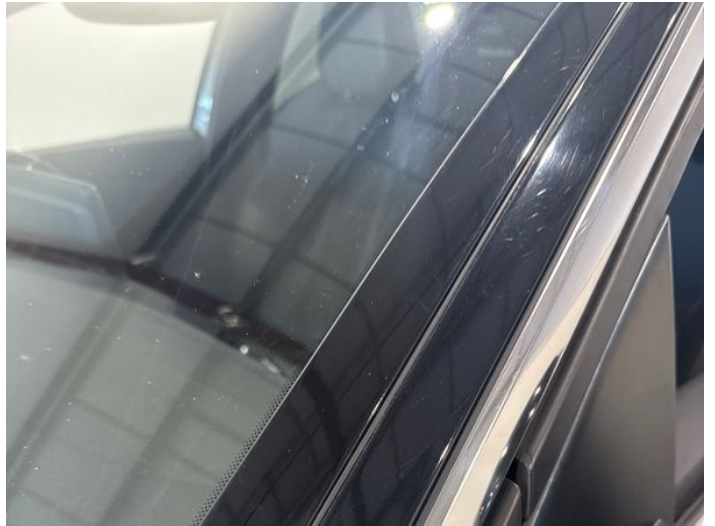
4: A Post ns  
Chipped  
1 To 5

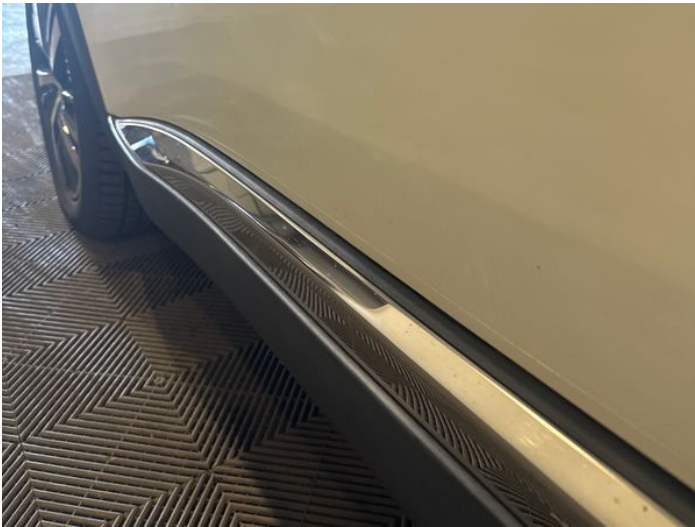
5: Door nsf  
Dented  
With Paint Damage

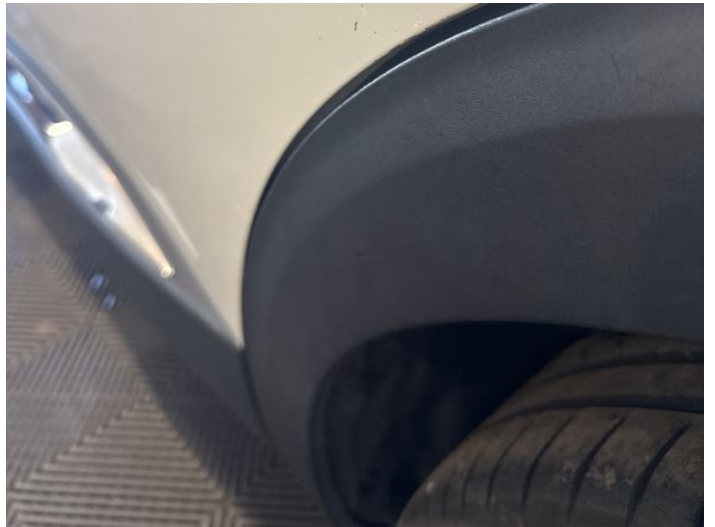
6: Door nsr  
Scratched  
Over 25mm Thru Paint

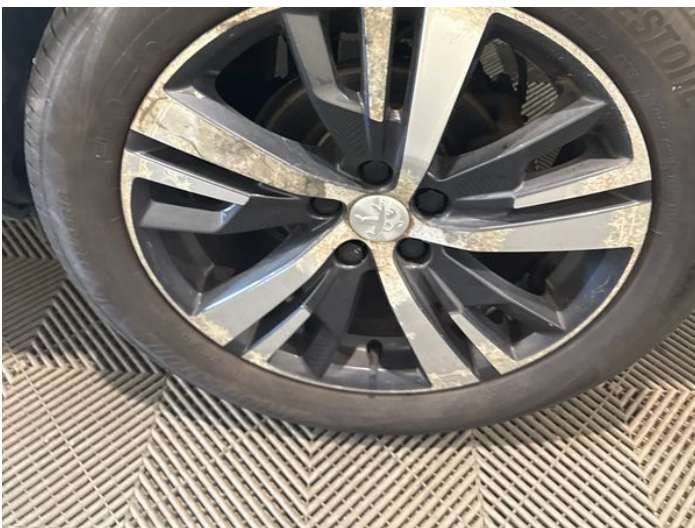
7: Wheel nsr  
Scratched  
Over 50mm

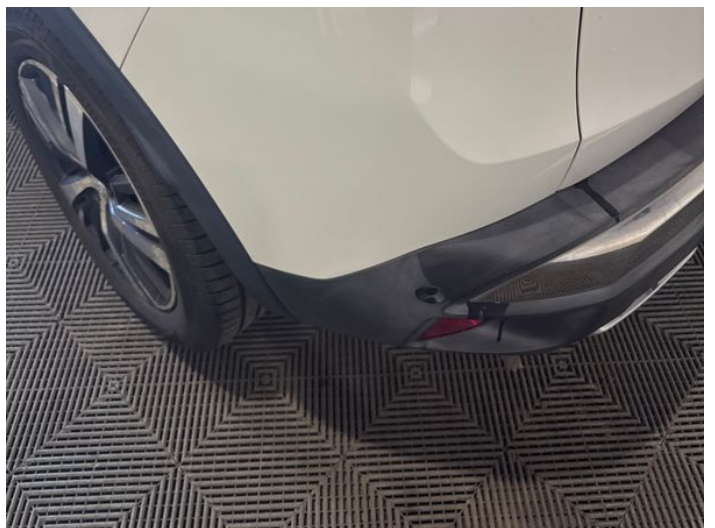
8: Bumper Rear  
Scratched  
25 to 100mm Thru Paint

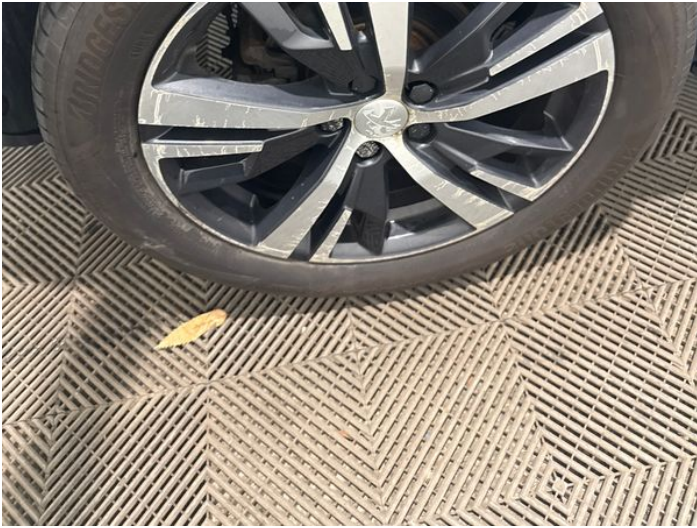
9: Wheel osr  
Scratched  
Over 50mm

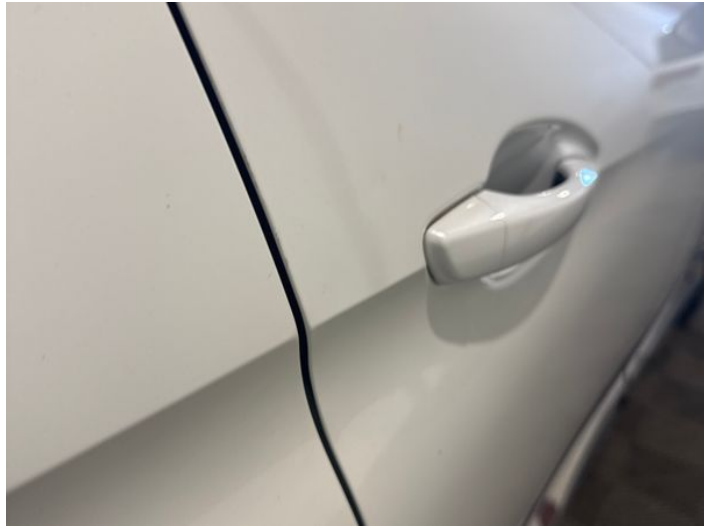
10: Door osr  
Dented  
Between 10mm + 30mm

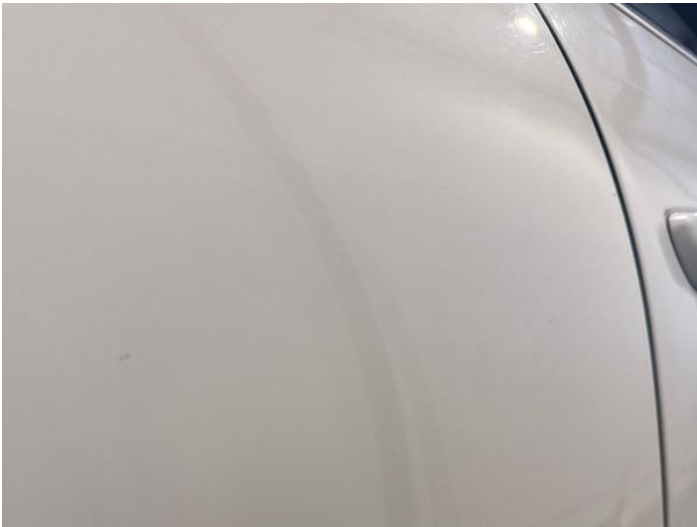
11: Door osr  
Chipped  
1 To 5

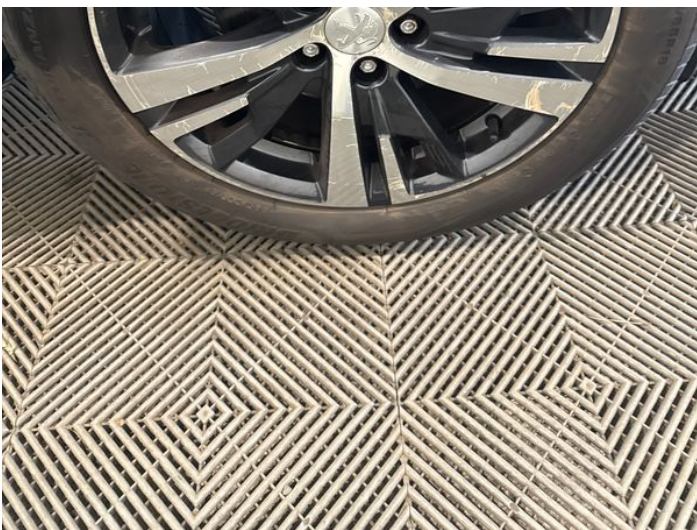
13: Wheel osf  
Scratched  
Over 50mm

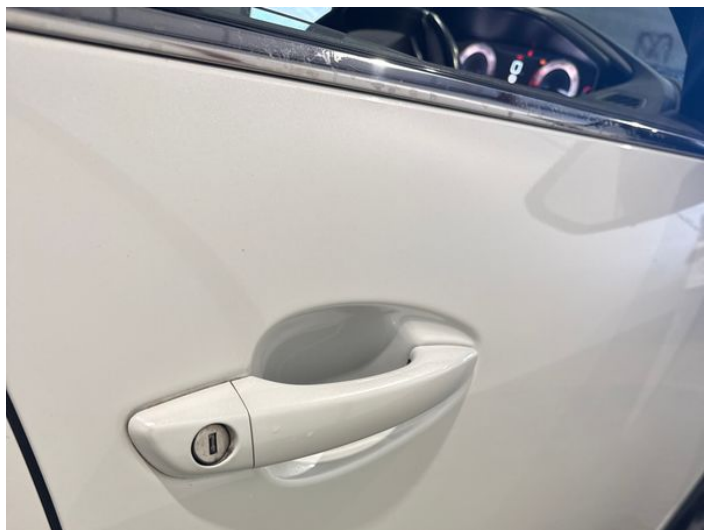
14: Door osf  
Poor Previous Repair  
Poor Paint

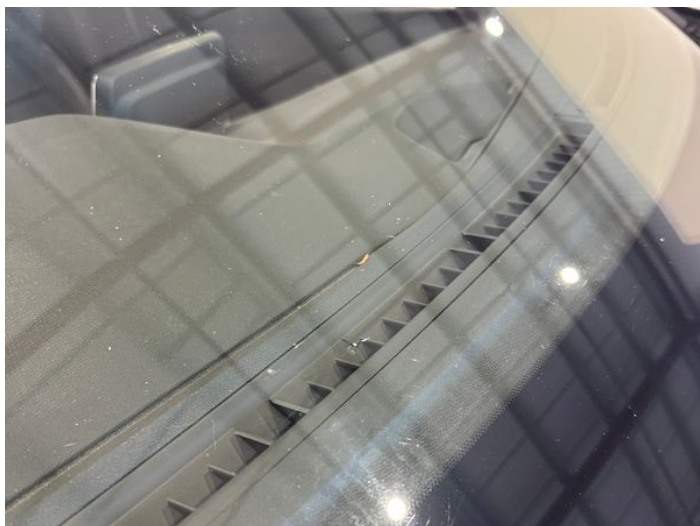
15: Screen Front  
Cracked  
Replace
