## VEHICLE INSPECTION REPORT

**LD68RXJ**

### Land Rover Range Rover Sport 2.0 P400e HSE Dynamic 5dr Auto

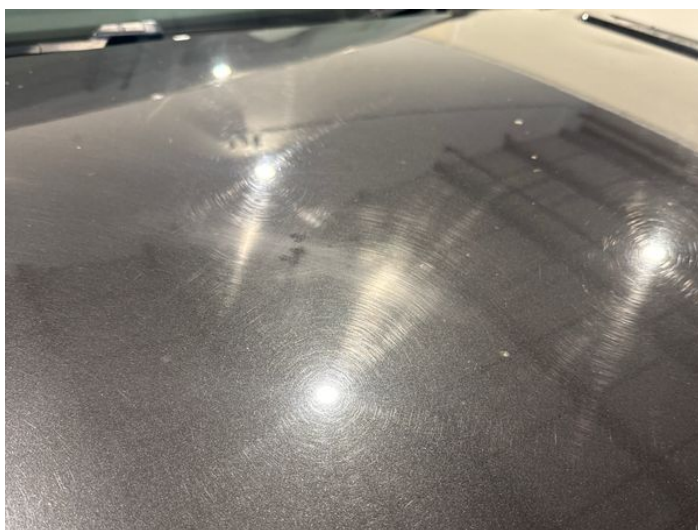
1: Bonnet  
Scratched  
Over 25mm Thru Paint

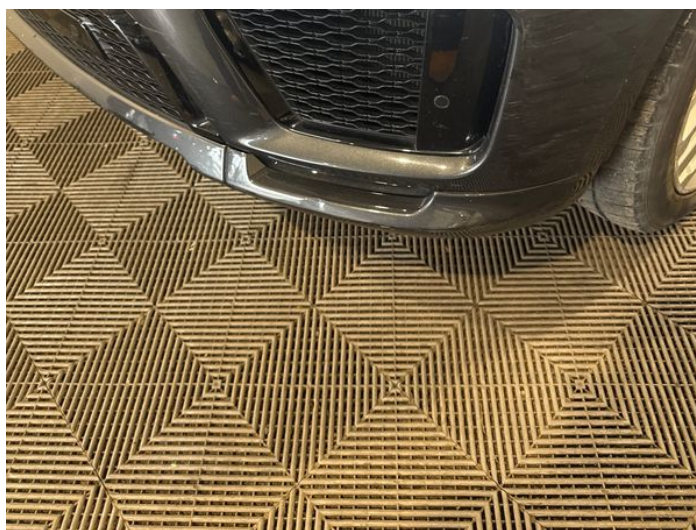
2: Bumper Front  
Dented  
With Paint Damage

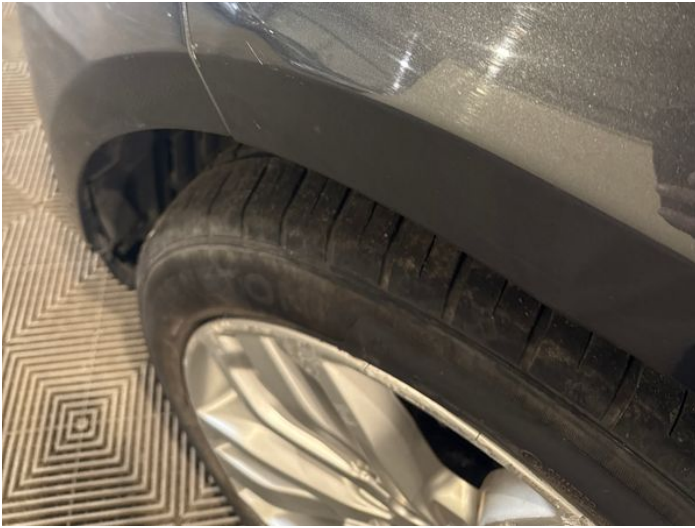
3: Wing nsf  
Dented  
Over 30mm

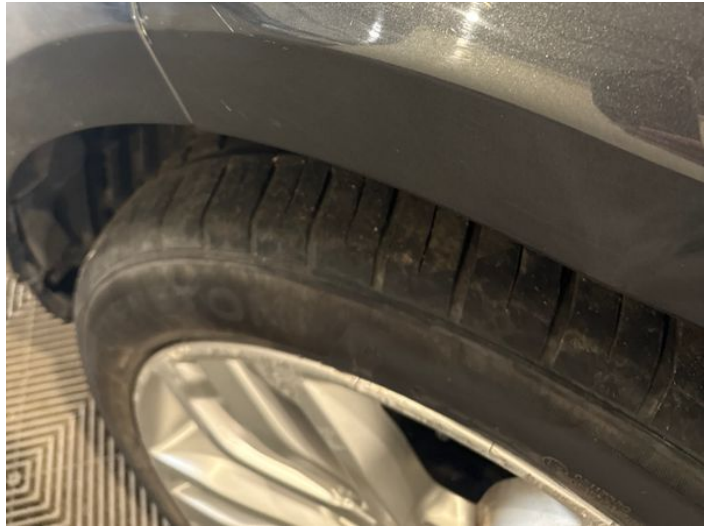
4: Wing nsf  
Scratched  
UpTo 25mm Thru Paint

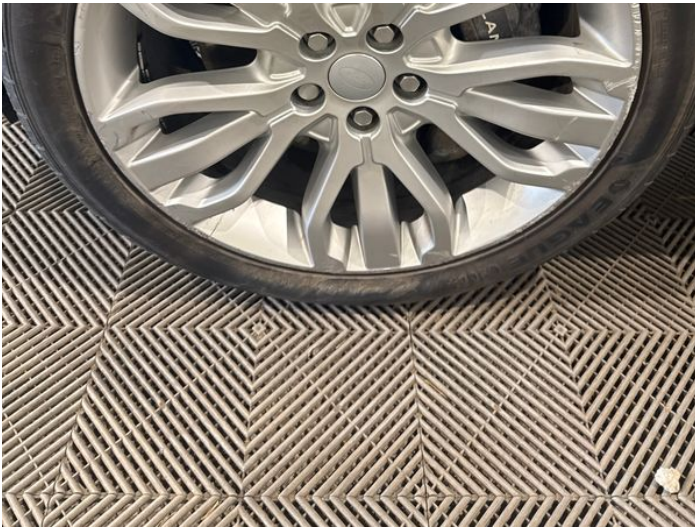
5: Wheel nsf  
Scratched  
Over 50mm

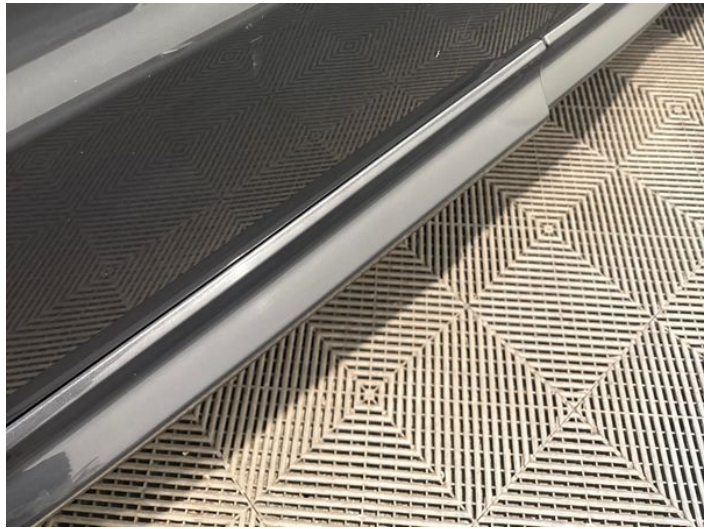
6: Door nsf  
Scratched  
Over 25mm Thru Paint

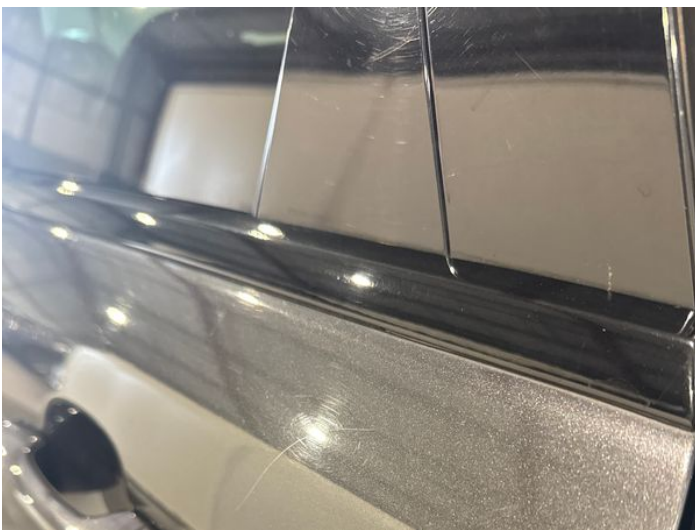
7: Door nsr  
Scratched  
Over 25mm Thru Paint

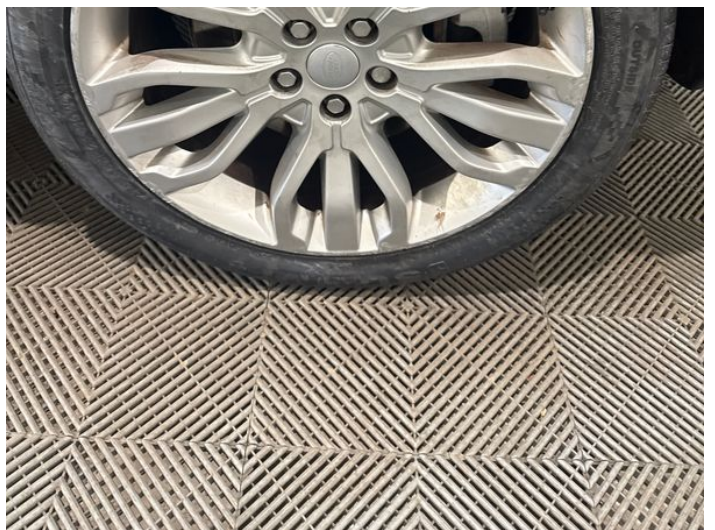
8: Wheel nsr  
Scratched  
Over 50mm

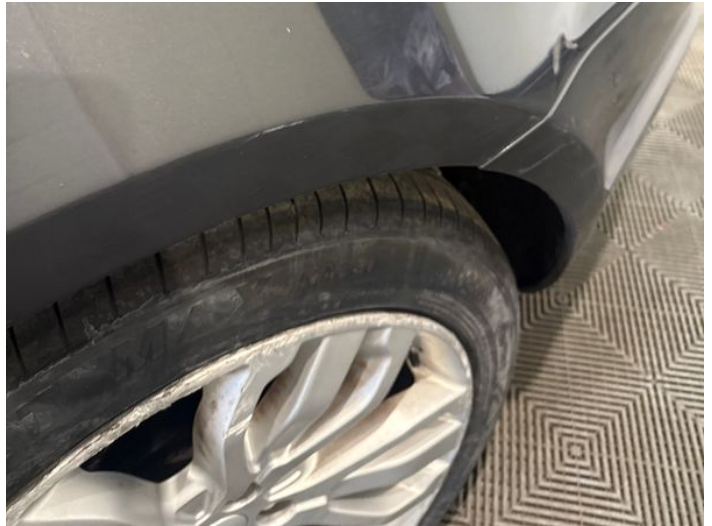
10: Qtr Panel osr  
Scratched  
Over 25mm Thru Paint

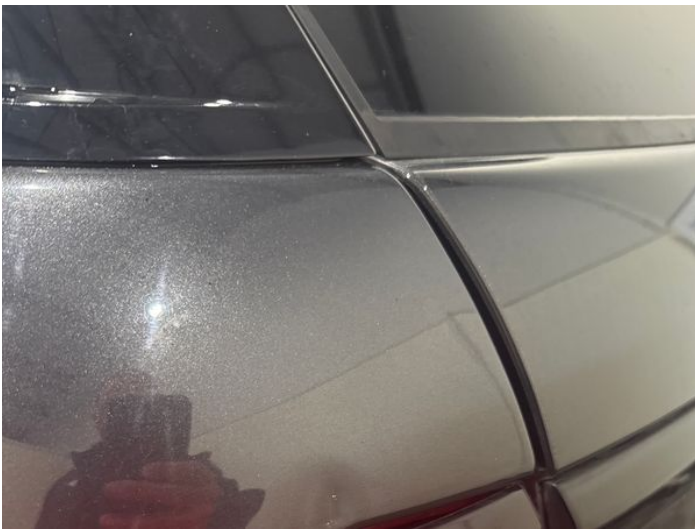
11: Qtr Panel nsr  
Dented  
Between 10mm + 30mm

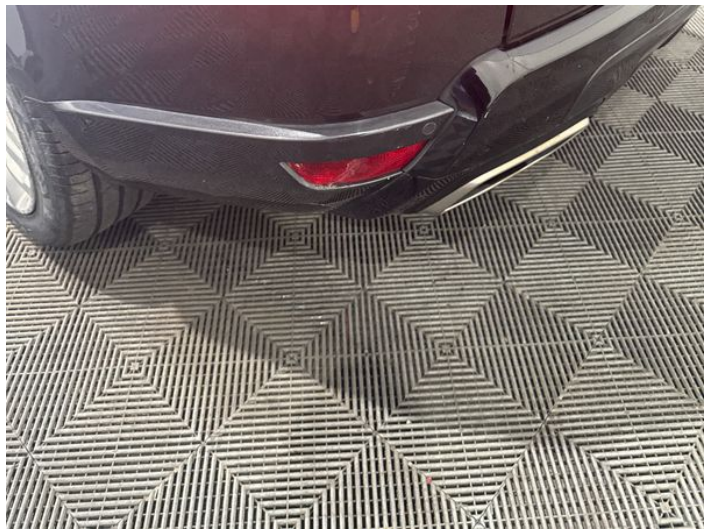
12: Bumper Rear Moulding  
Scratched (Painted)  
Over 25mm Thru Paint

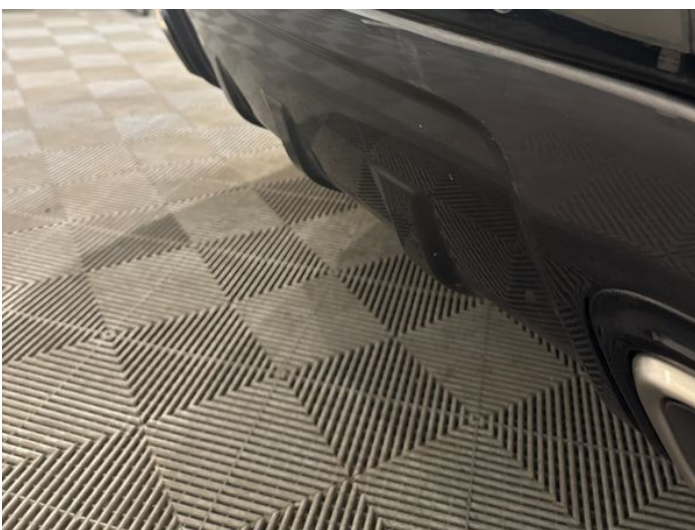
13: Bumper Rear  
Dented  
With Paint Damage

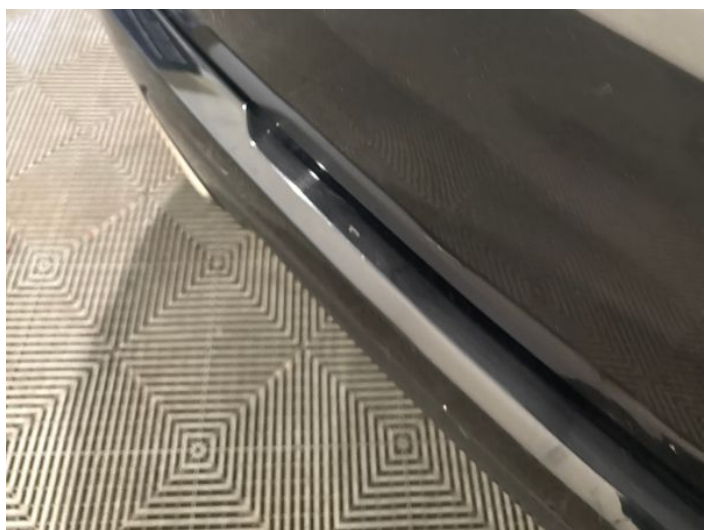
14: Tailgate  
Scratched  
Over 25mm Thru Paint

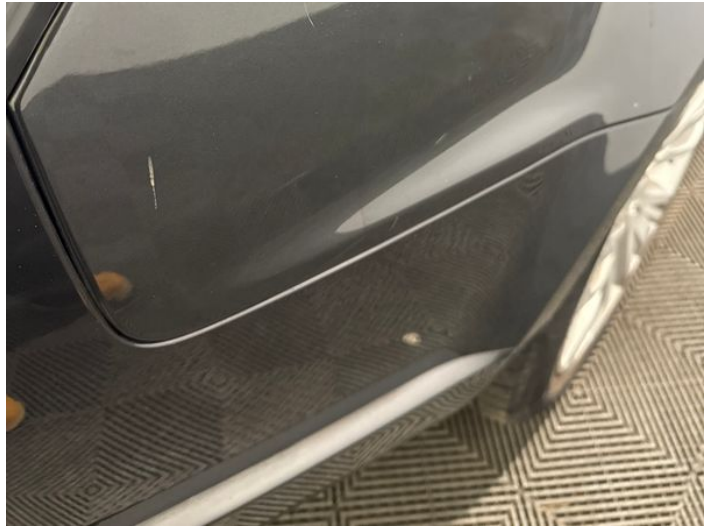
16: Qtr Panel osr  
Scratched  
UpTo 25mm Thru Paint

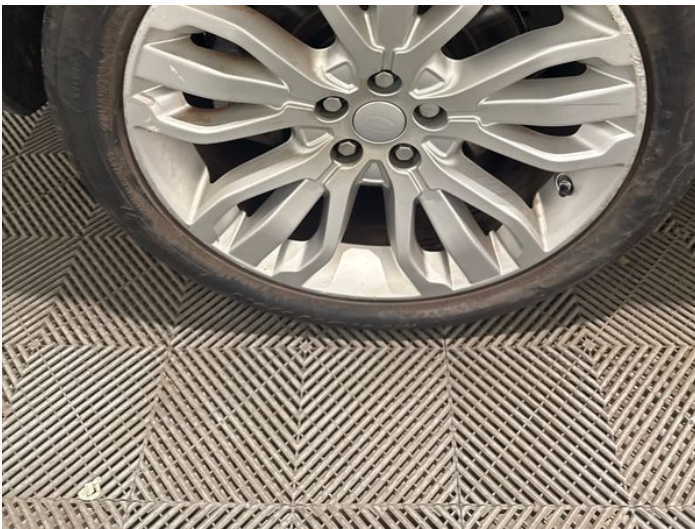
17: Wheel osr  
Scratched  
Over 50mm

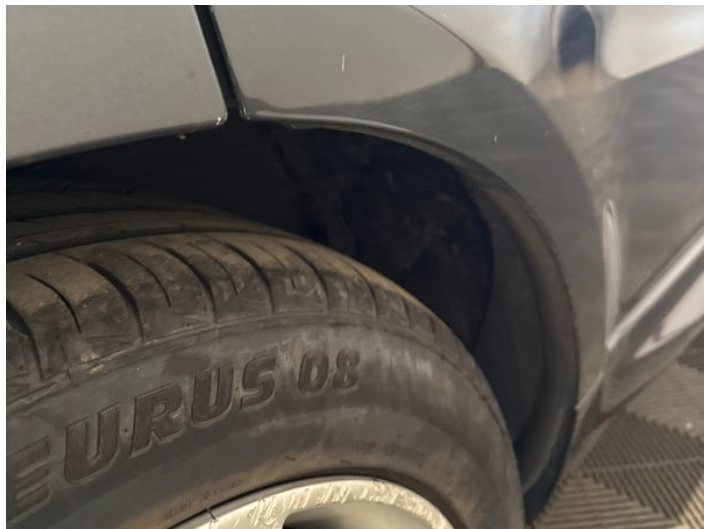
18: Door nsr  
Chipped  
1 To 5

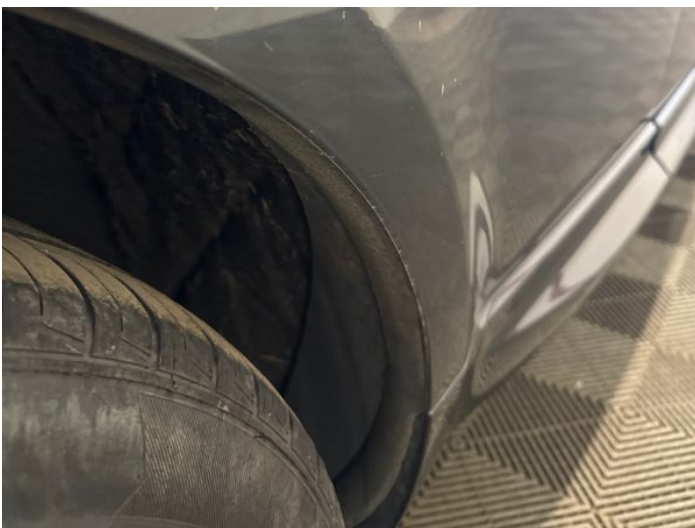
19: Door osr  
Dented  
2 Or Less UpTo 10mm

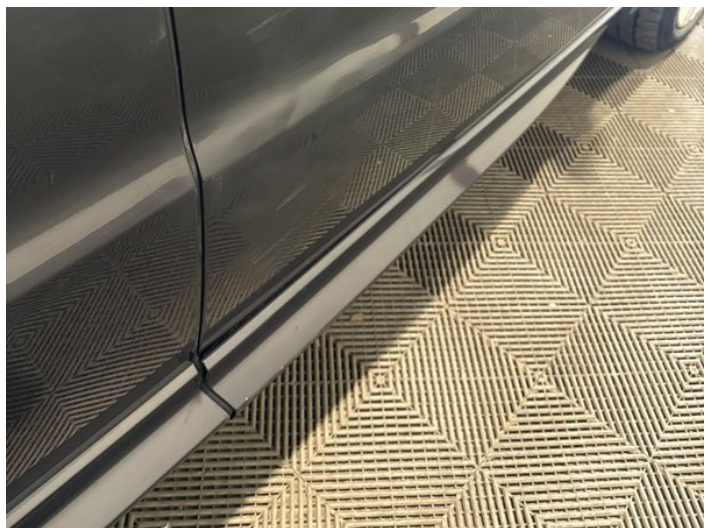
20: Door osf  
Dented  
With Paint Damage

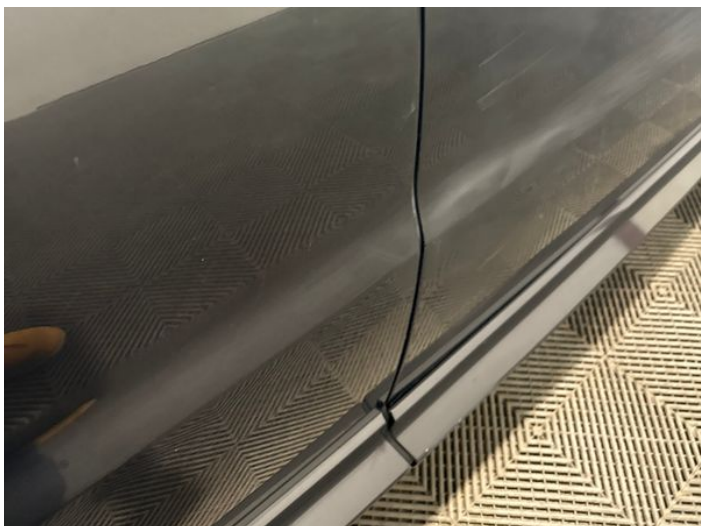
21: Door osr  
Scratched  
Over 25mm Thru Paint

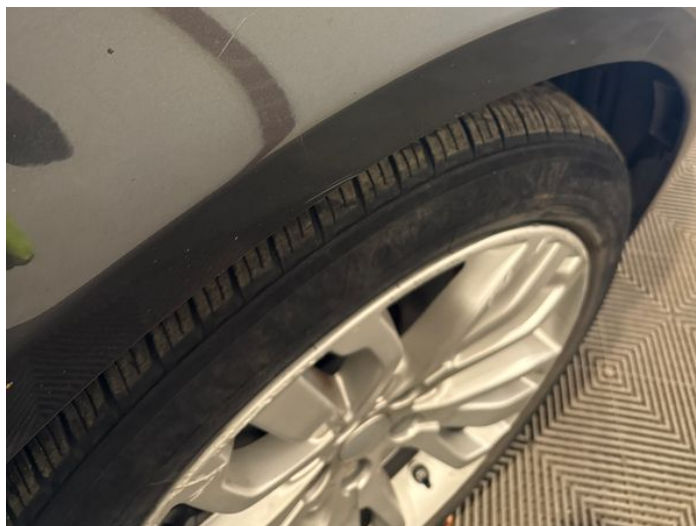
22: Wing osf  
Scratched  
Over 25mm Thru Paint

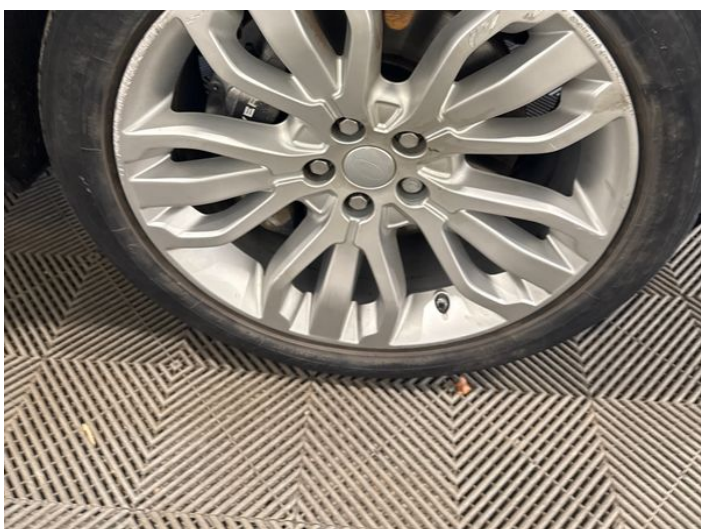
23: Wheel osf  
Scratched  
Over 50mm

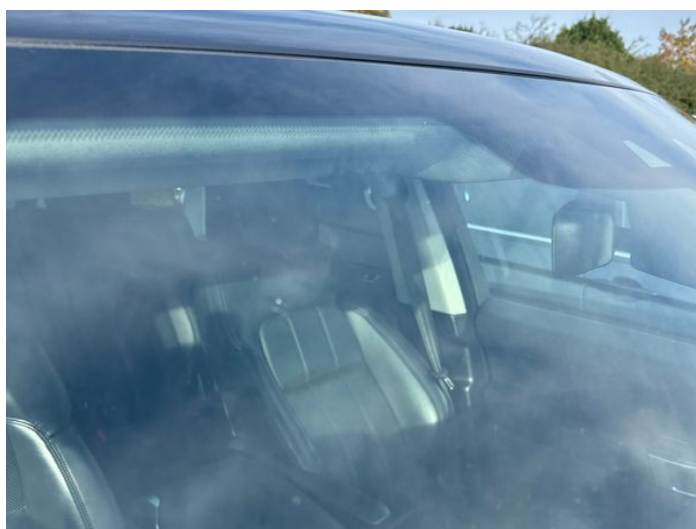
24: Screen Front  
Cracked  
Replace
