## VEHICLE INSPECTION REPORT

**GY69ZHP**

nama  
GRADE  
4

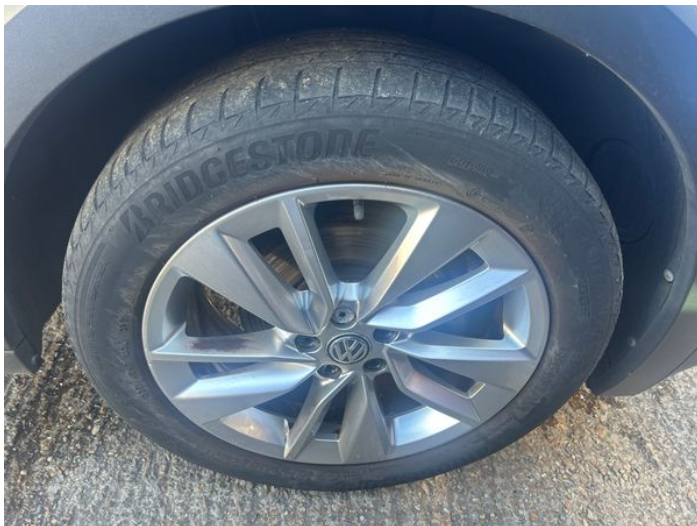
1: Wheel osf  
Scratched  
Up To 50mm

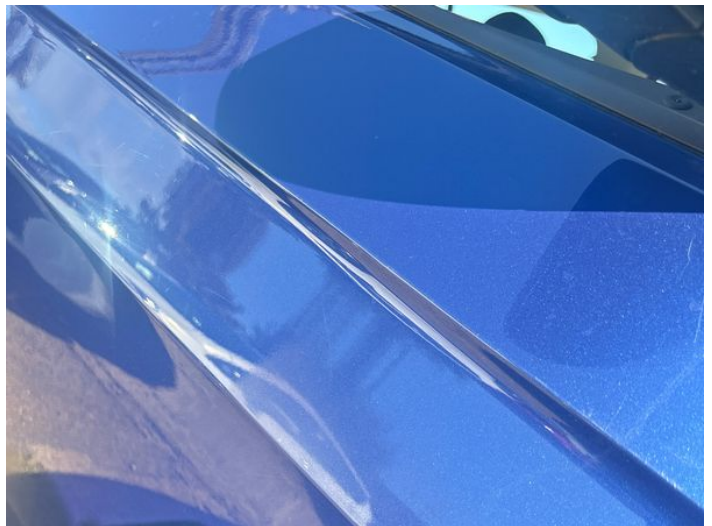
2: Door osf  
Poor Previous Repair  
Poor Paint

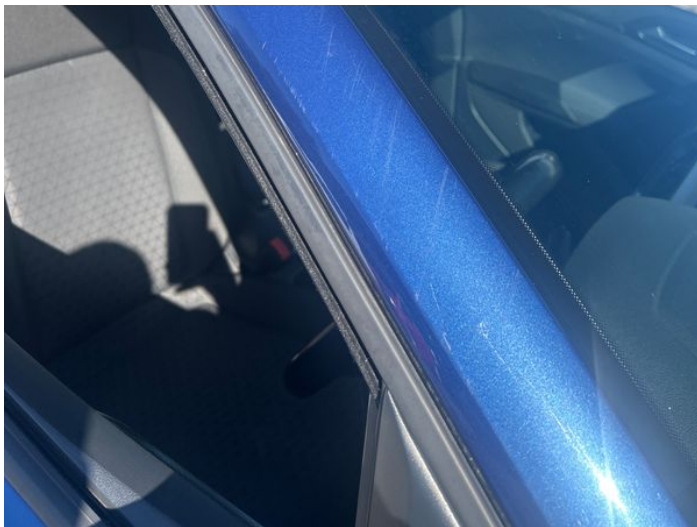
3: A Post os  
Scratched  
Over 25mm Thru Paint

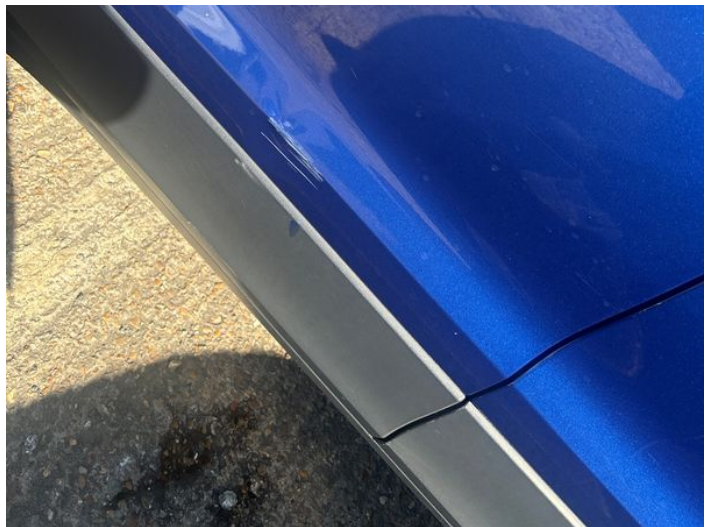
4: Door osr  
Scratched  
Over 25mm Thru Paint

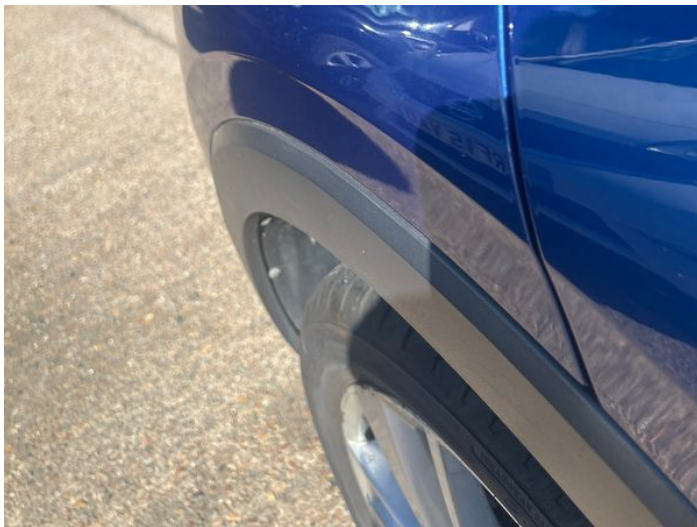
5: Qtr Panel osr  
Dented  
2 Or Less UpTo 10mm

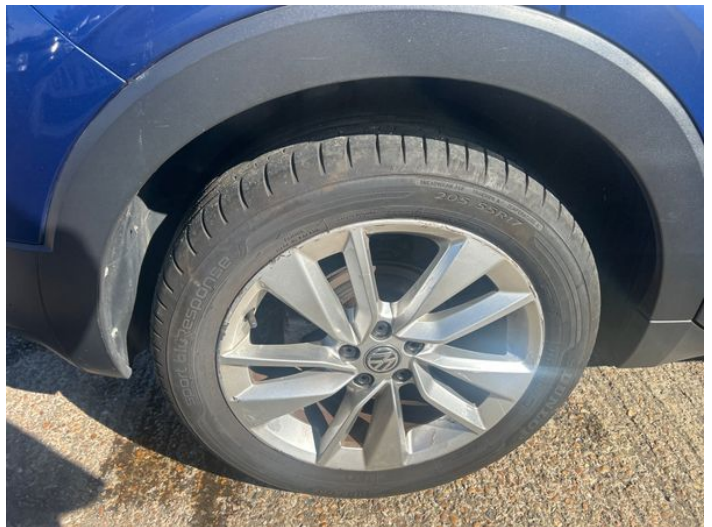
6: Wheel osr  
Scratched  
Over 50mm

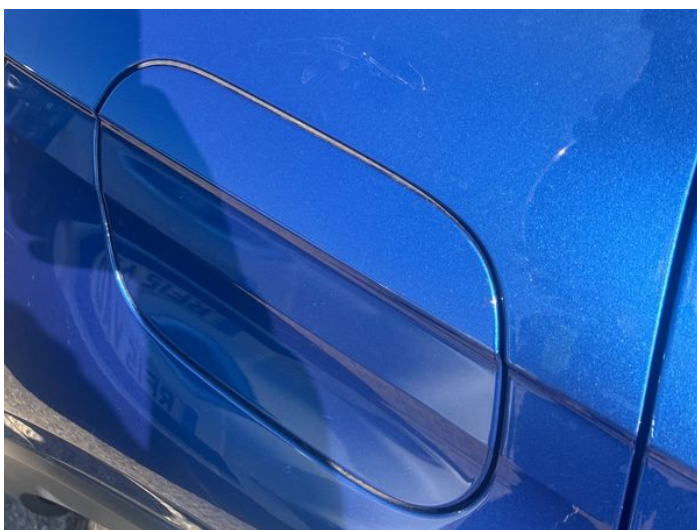
7: Qtr Panel osr  
Scratched  
UpTo 25mm Thru Paint

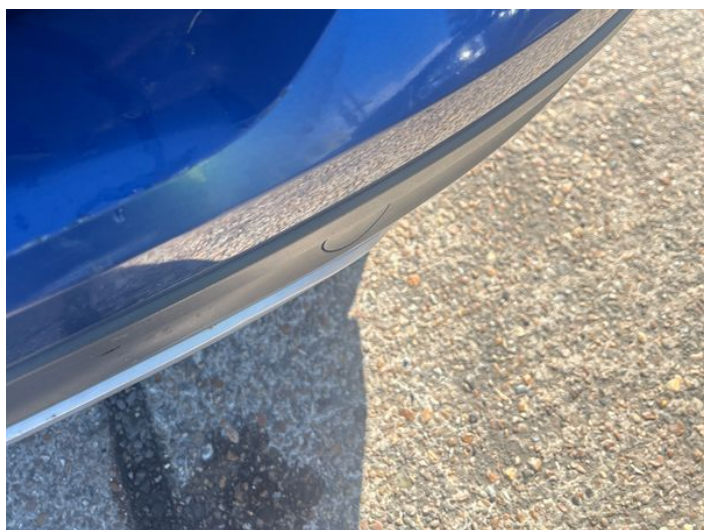
8: Bumper Rear  
Poor Previous Repair  
Poor Paint

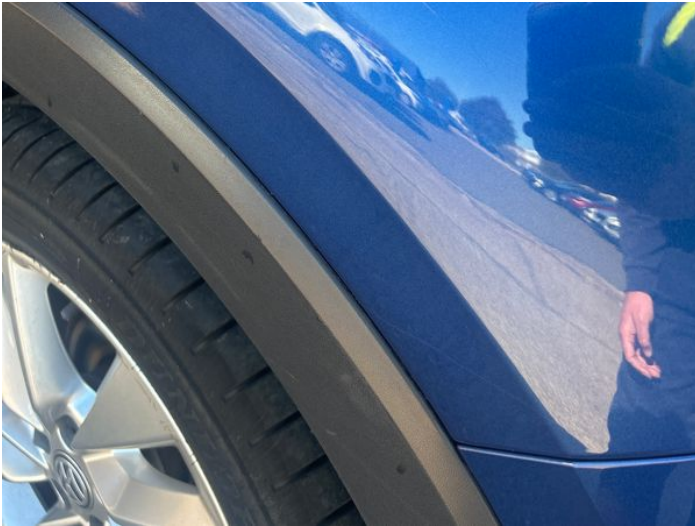
9: Qtr Panel nsr  
Scratched  
Over 25mm Thru Paint

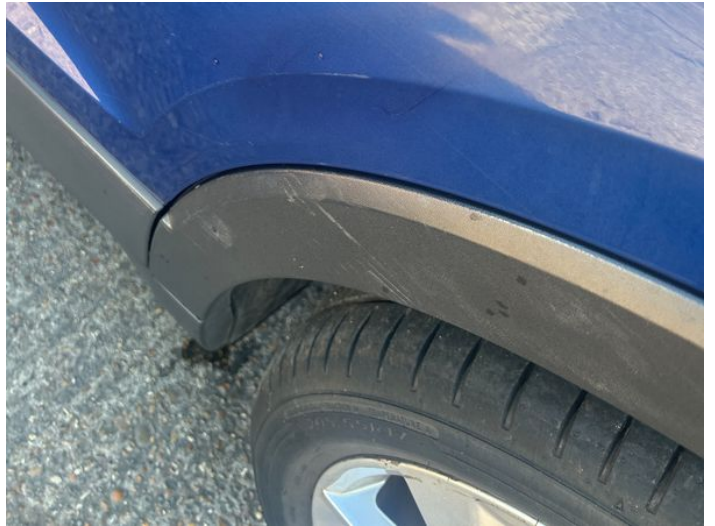
10: Door nsr  
Poor Previous Repair  
Poor Paint

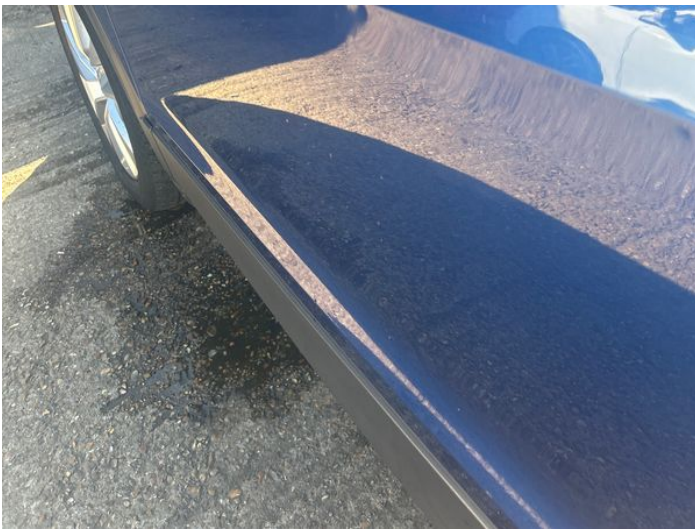
11: Door nsf  
Dented  
With Paint Damage

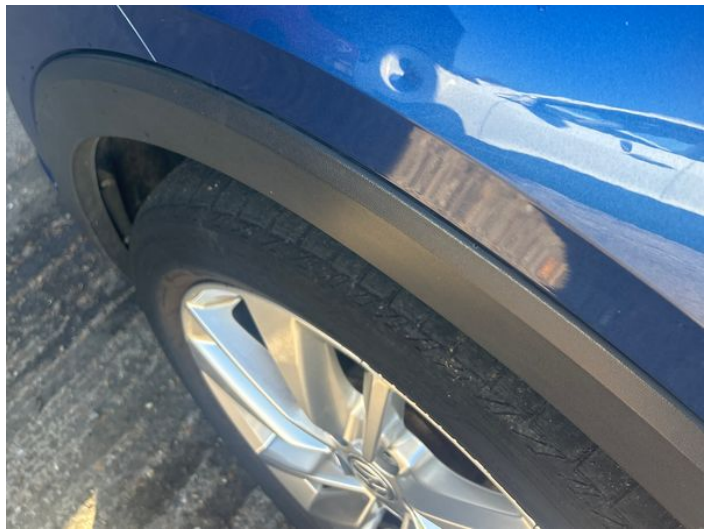
12: Wing nsf  
Dented  
Between 10mm + 30mm

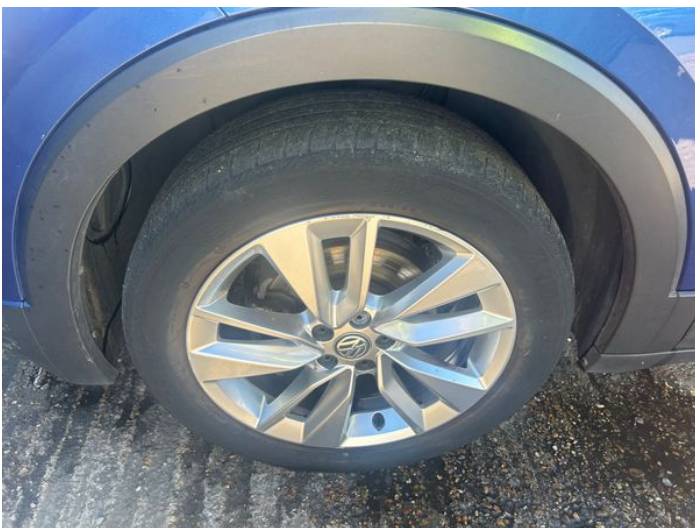
13: Wheel nsf  
Scratched  
Over 50mm

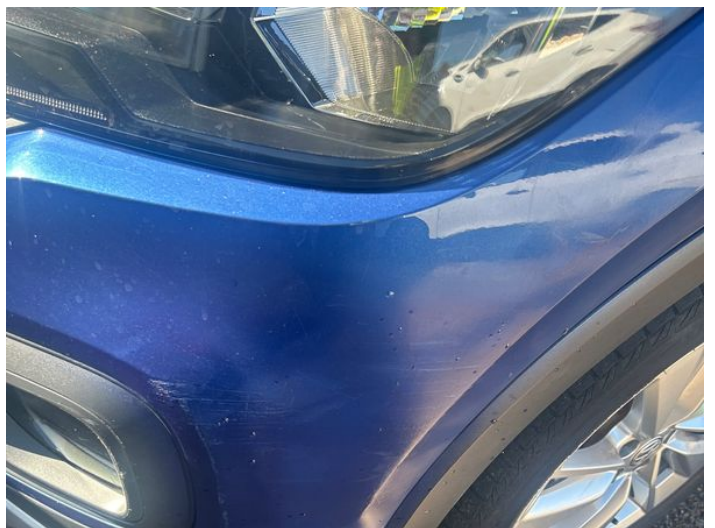
14: Bumper Front  
Poor Previous Repair  
Poor Paint

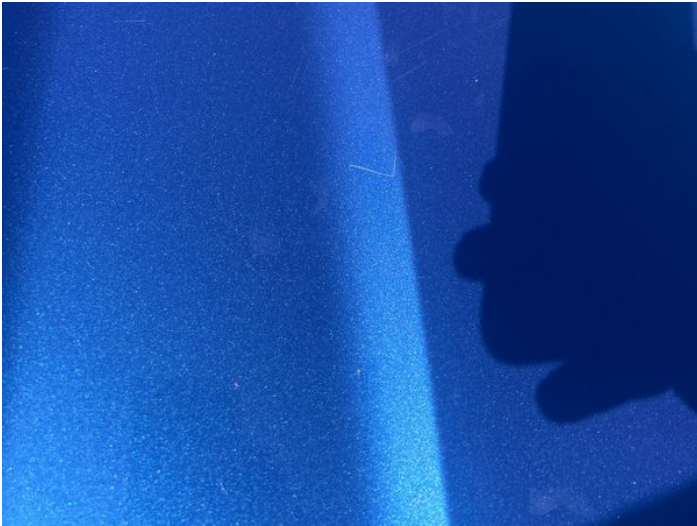
15: Bonnet  
Scratched  
UpTo 25mm Thru Paint

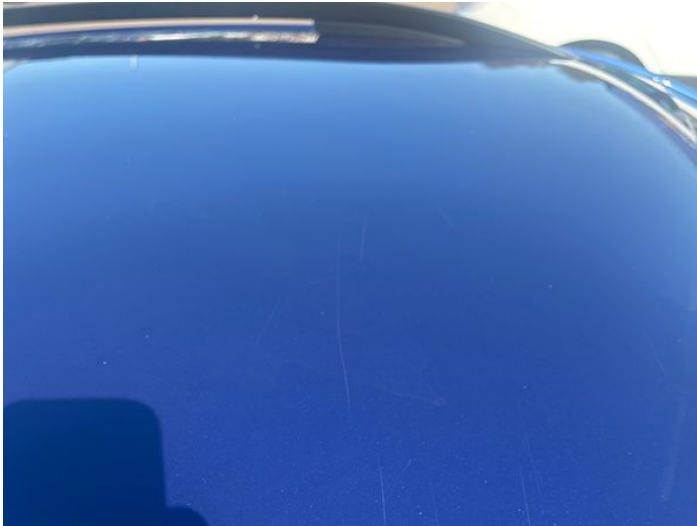
16: Roof  
Scratched  
Over 25mm Thru Paint

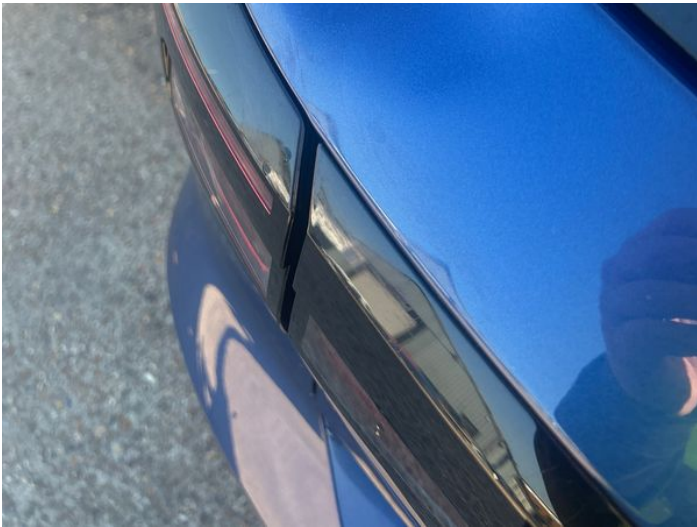
17: Tailgate  
Dented  
With Paint Damage
