# VEHICLE INSPECTION REPORT

**GF22TBX**

## Skoda Kodiaq 1.5 TSI SE 5dr

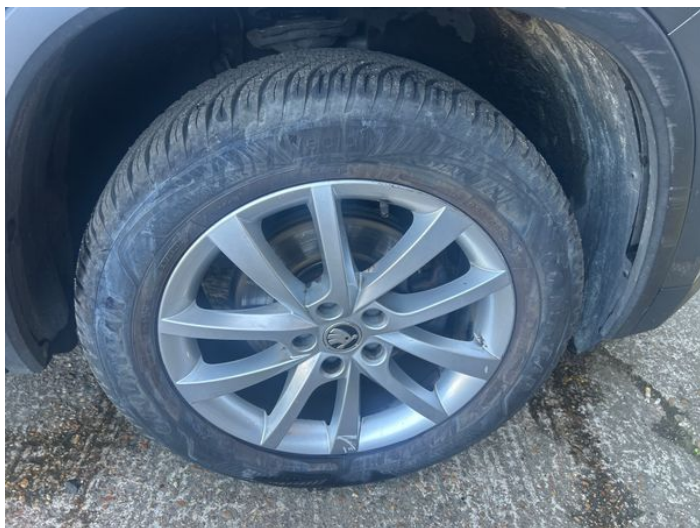
1: Wheel osf  
Scratched  
Over 50mm

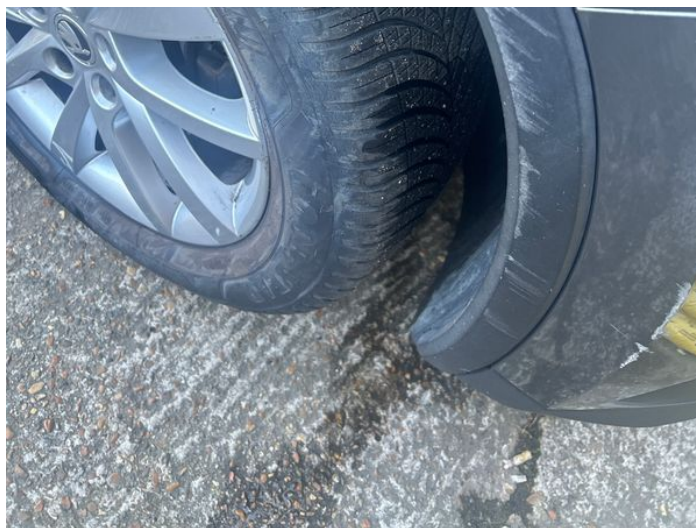
2: Wing Front Arch Extension os  
Scuffed (Unpainted)  
Over 100mm

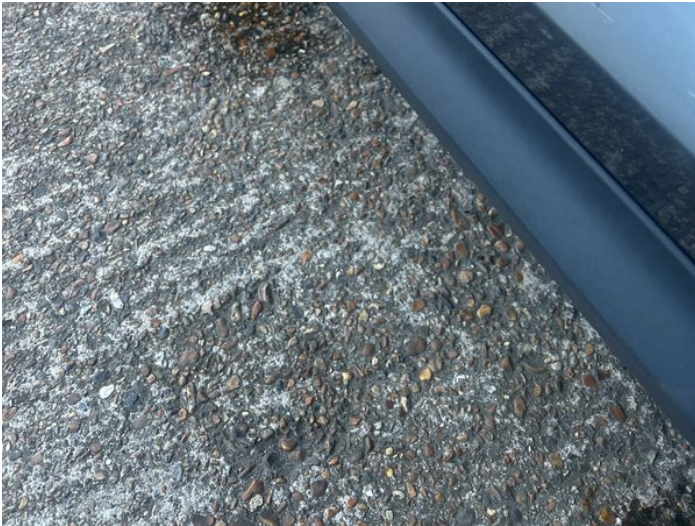
3: Door osf  
Dented  
Between 10mm + 30mm

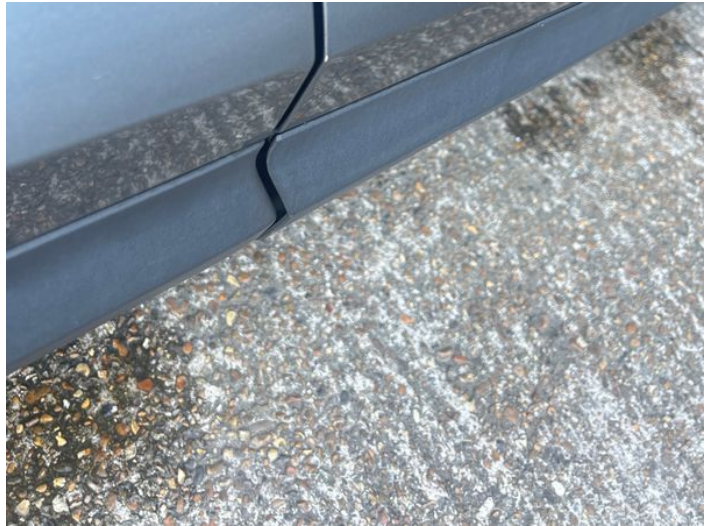
4: Door osf  
Chipped  
Edge Chip

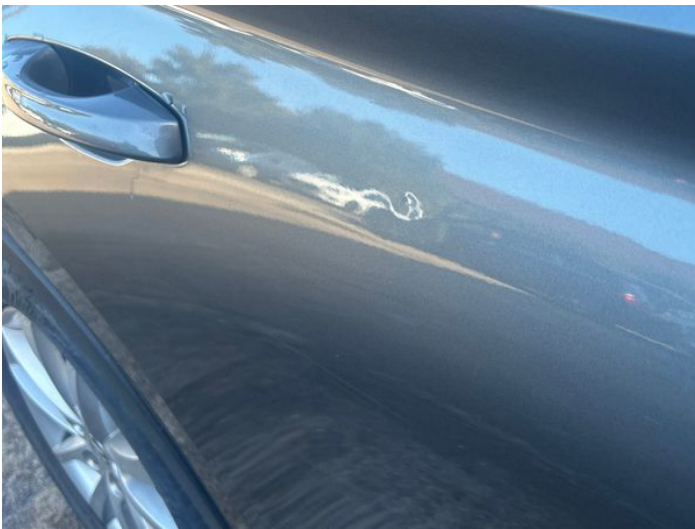
5: Door osr  
Dented  
2 Or Less UpTo 10mm

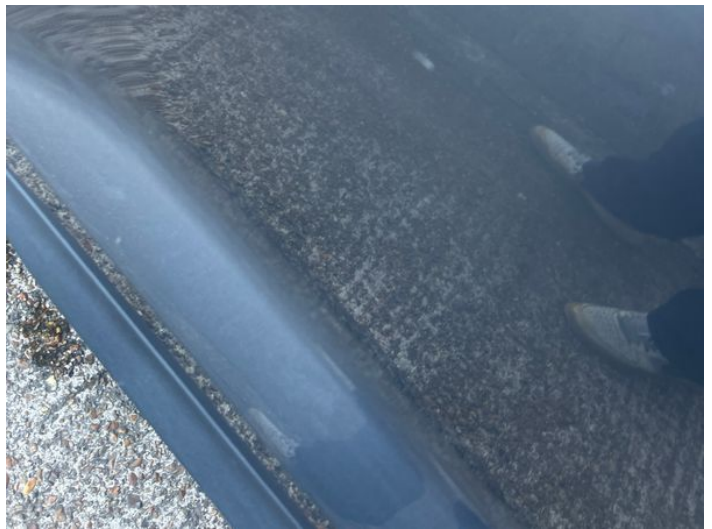
6: Door osr  
Chipped  
1 To 5

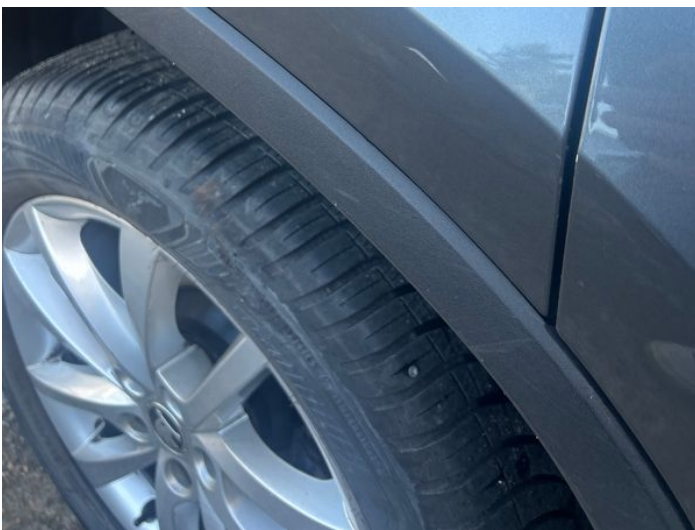
7: Qtr Panel osr  
Scratched  
UpTo 25mm Thru Paint

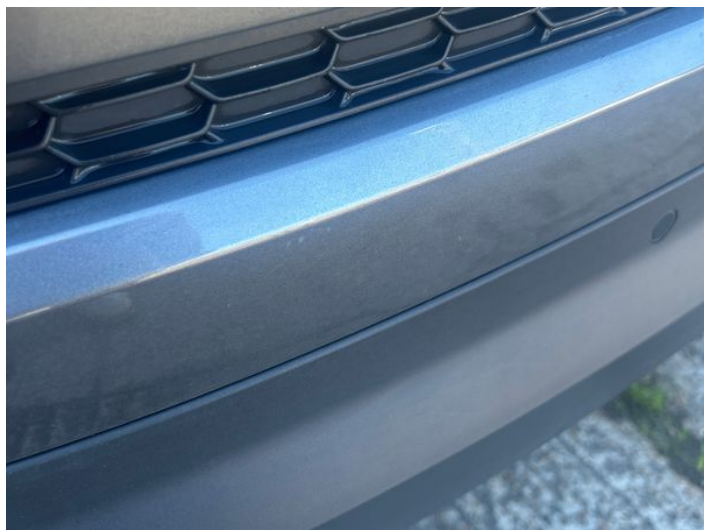
8: Bumper Rear  
Chipped  
1 To 5

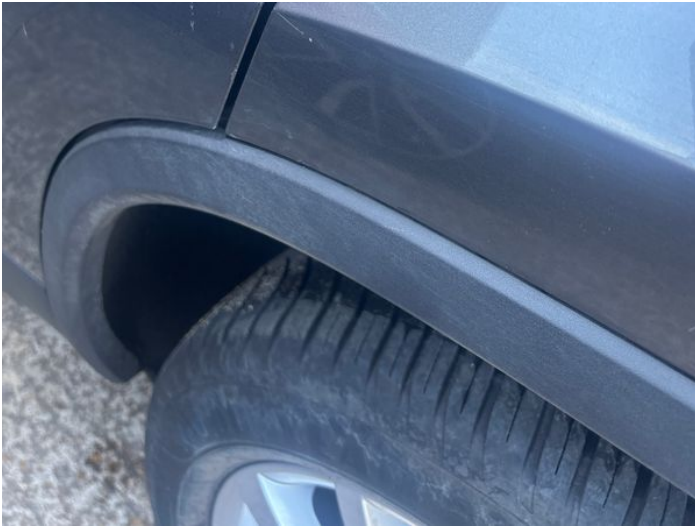
9: Qtr Panel nsr  
Scratched  
UpTo 25mm Thru Paint

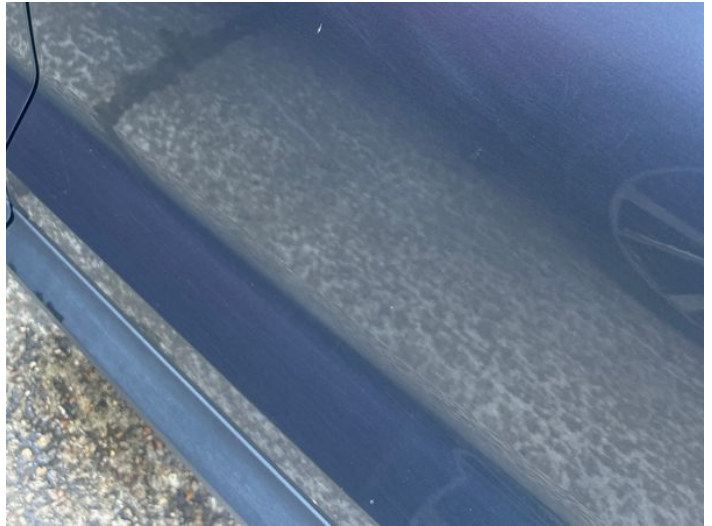
10: Door nsr  
Chipped  
1 To 5

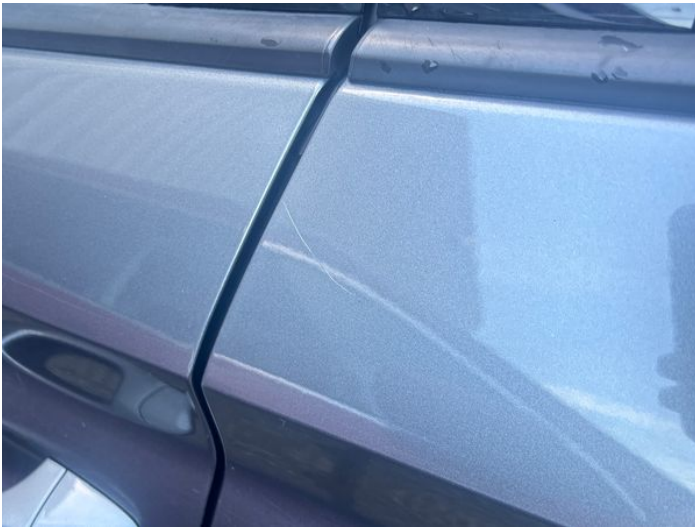
11: Door nsr  
Scratched  
UpTo 25mm Thru Paint

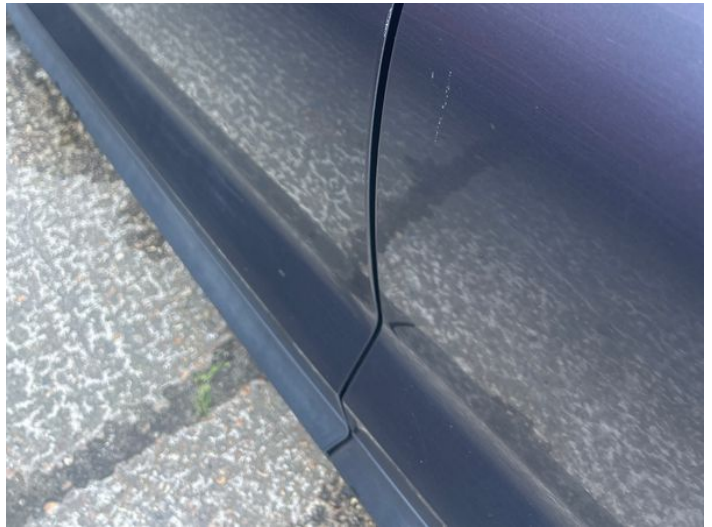
12: Door nsf  
Chipped  
Edge Chip

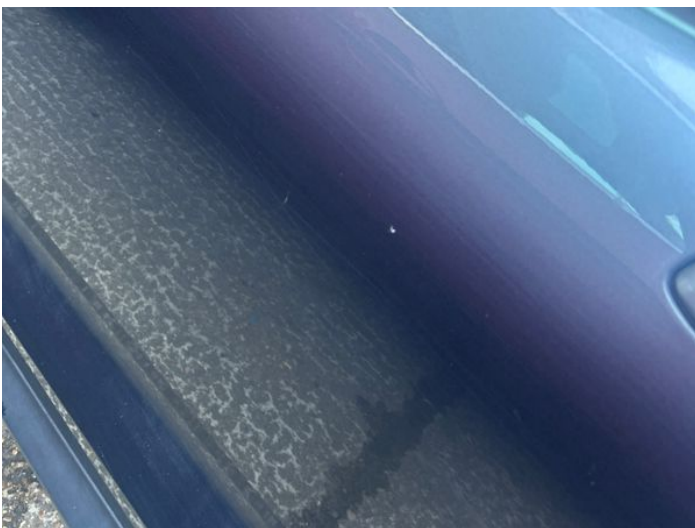
13: Door nsf  
Chipped  
1 To 5

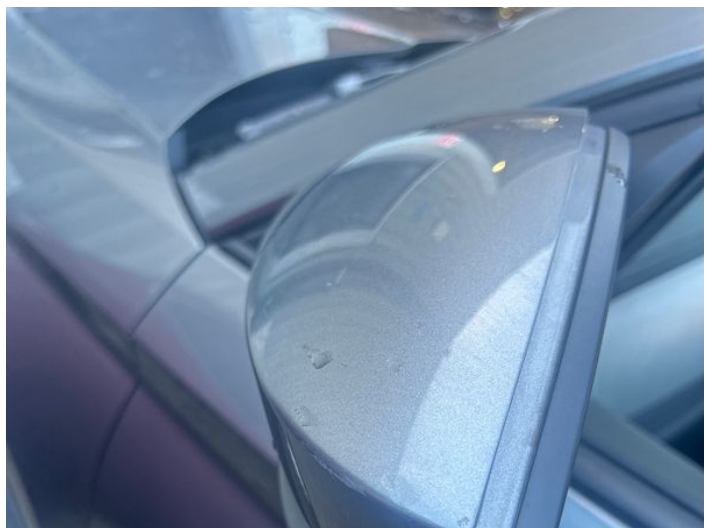
14: Door Mirror Assy nsf  
Scratched (Painted)  
UpTo 25mm Thru Paint

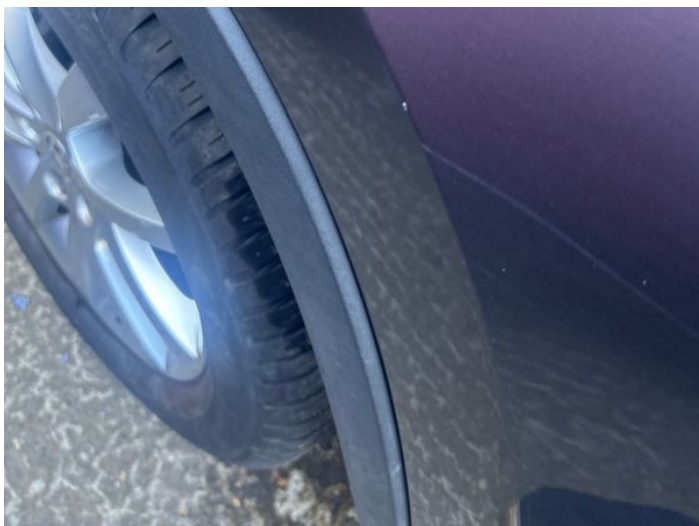
15: Wing nsf  
Chipped  
1 To 5

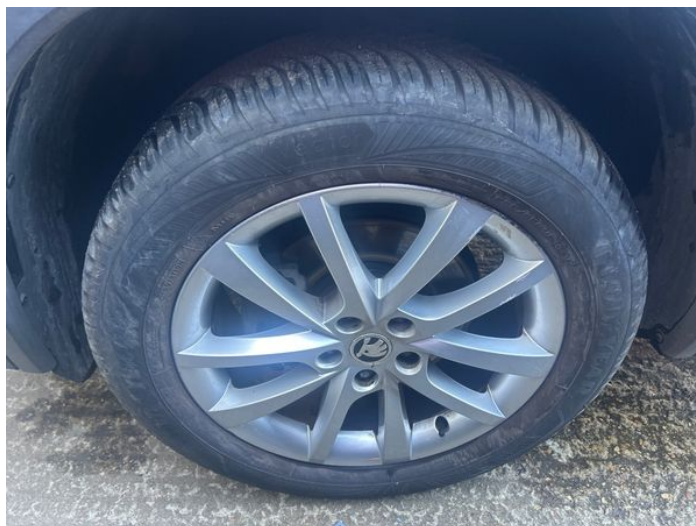
16: Wheel nsf  
Scratched  
Up To 50mm

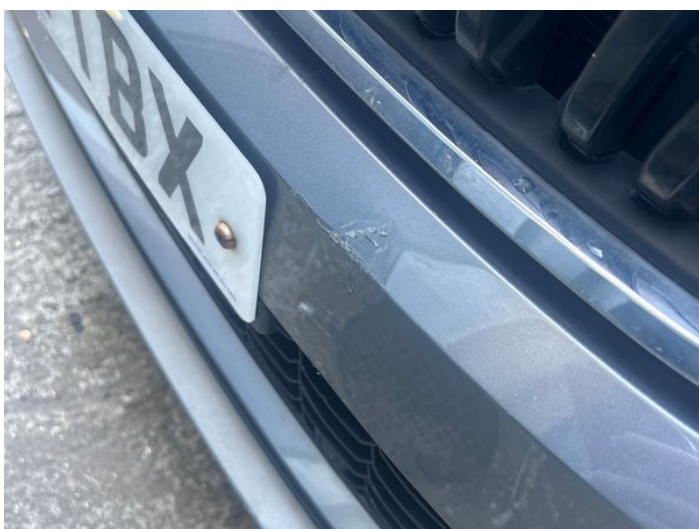
17: Bumper Front  
Dented  
With Paint Damage

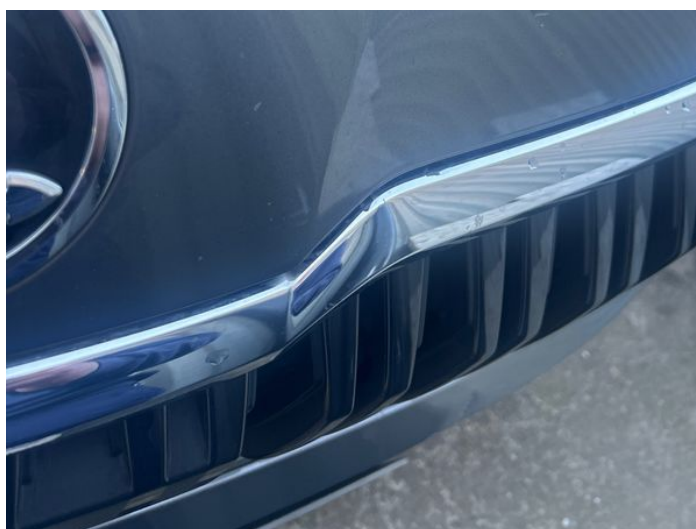
18: Bonnet  
Chipped  
1 To 5
