# VEHICLE INSPECTION REPORT

OIG4849

## Vauxhall Corsa 1.4T [100] Limited Edition 3dr

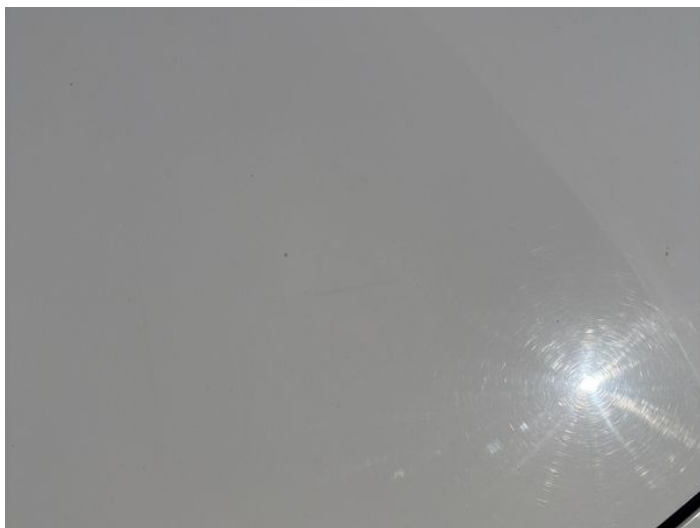
1: Bonnet  
Chipped  
1 To 5

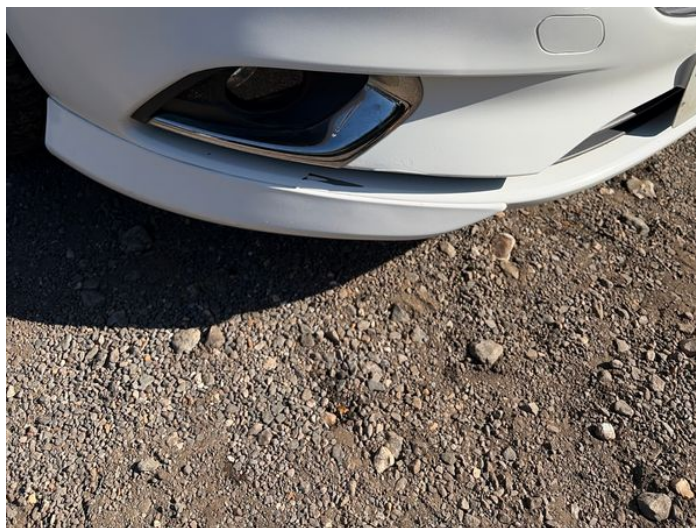
2: Bumper Front  
Poor Previous Repair  
Poor Paint

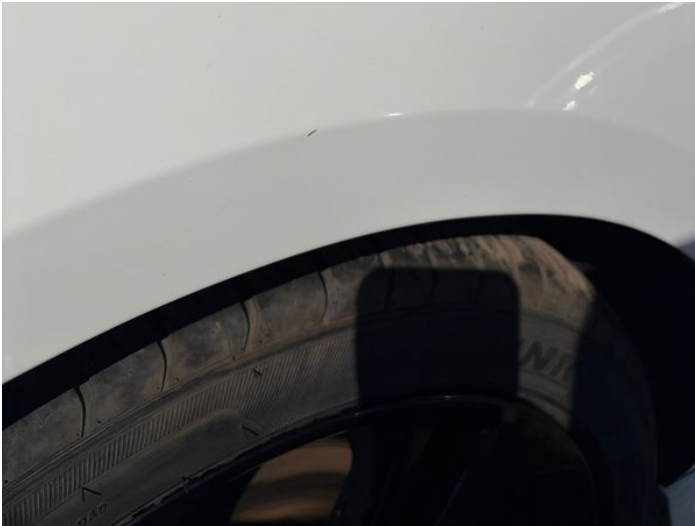
3: Wing nsf  
Chipped  
1 To 5

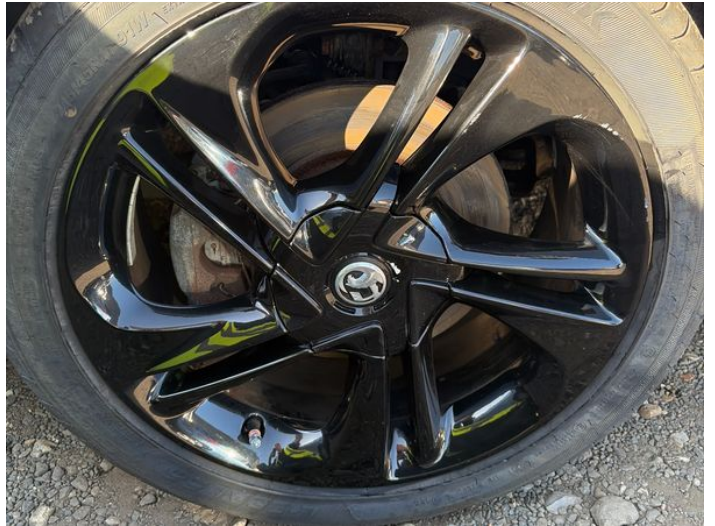
4: Wheel nsf  
Scratched  
Over 50mm

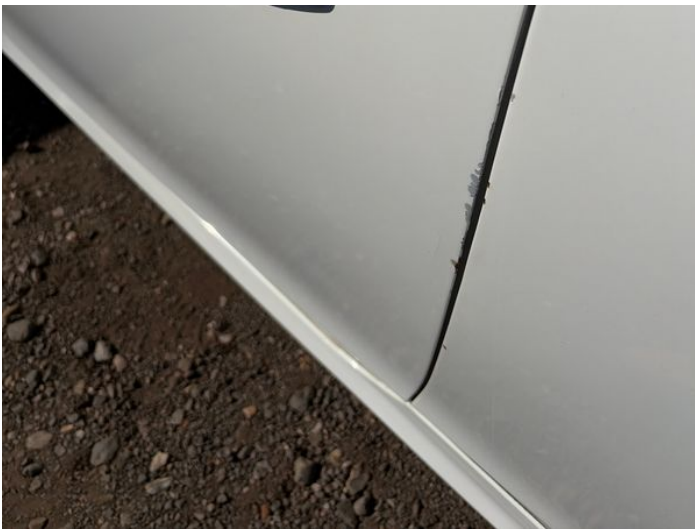
5: Door nsf  
Scratched  
Over 25mm Thru Paint

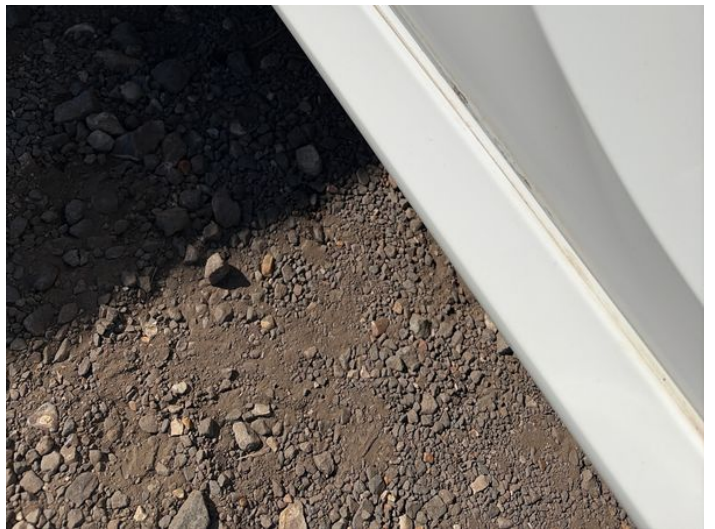
6: Sill Panel Trim ns  
Broken  
Replace

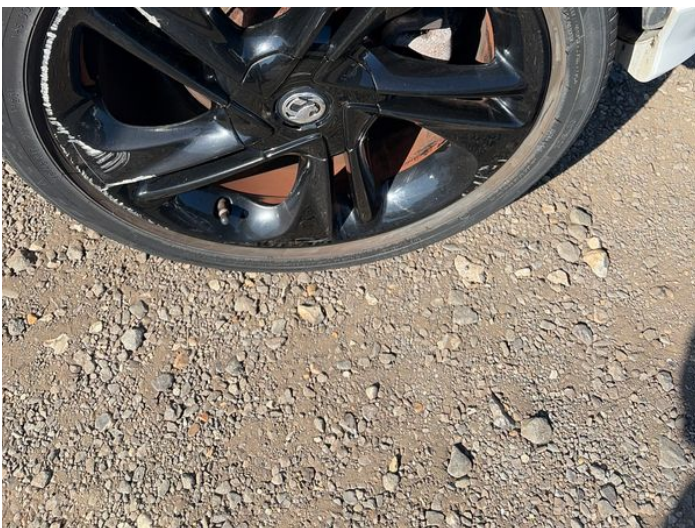
7: Wheel nsr  
Scratched  
Over 50mm

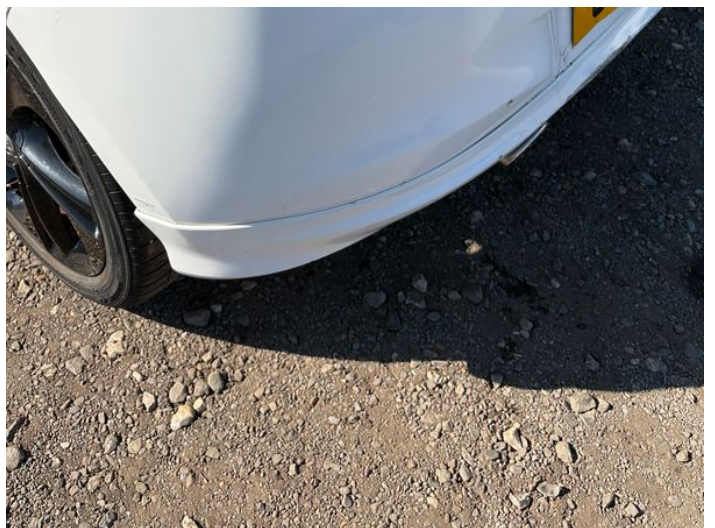
8: Bumper Rear  
Poor Previous Repair  
Poor Paint

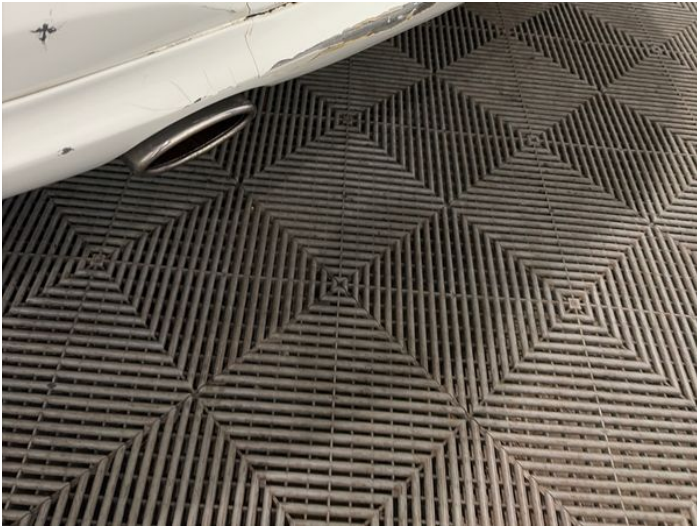
9: Bumper Rear  
Dented  
With Paint Damage

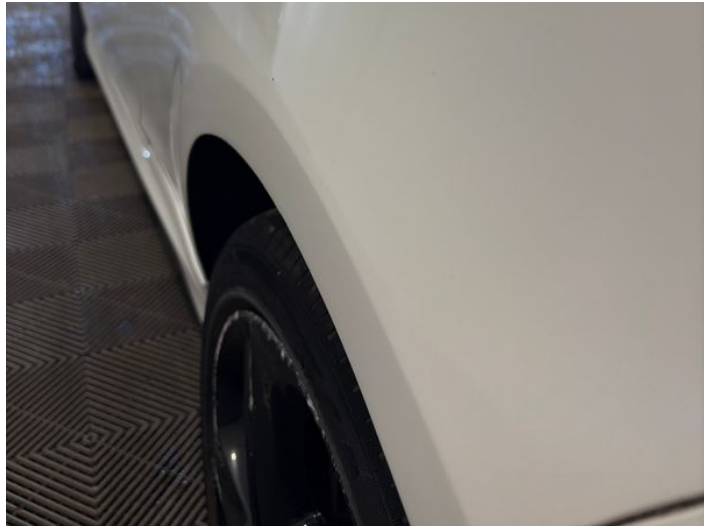
10: Qtr Panel nsr  
Poor Previous Repair  
Rippled UpTo 30%

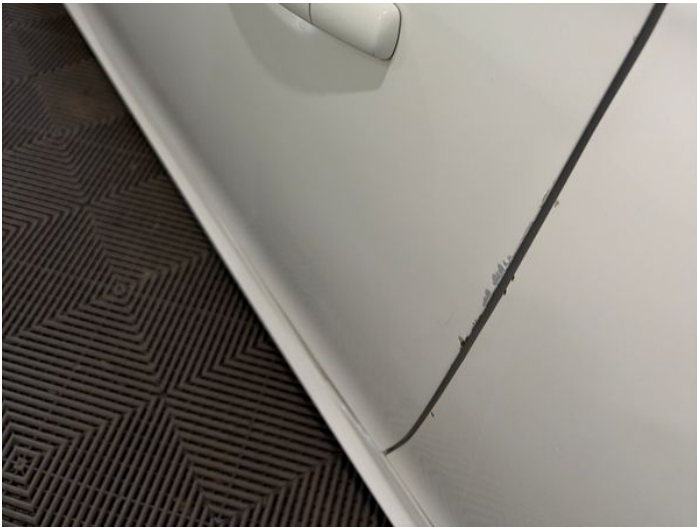
11: Door nsf  
Dented  
Over 30mm

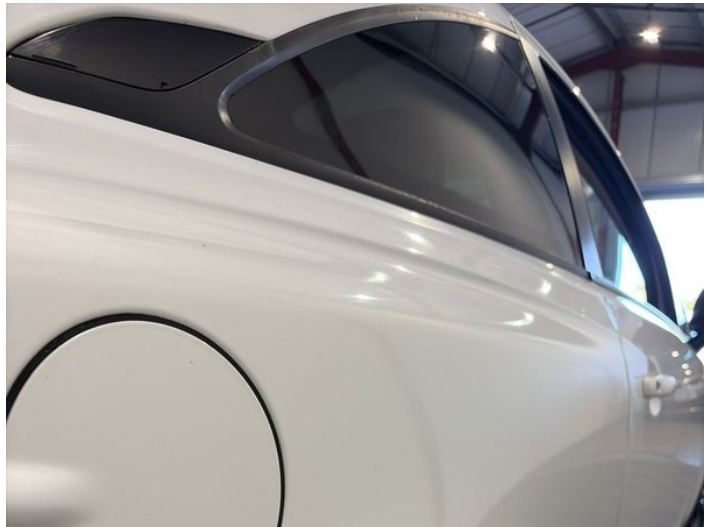
12: Qtr Panel osr  
Poor Previous Repair  
Rippled UpTo 30%

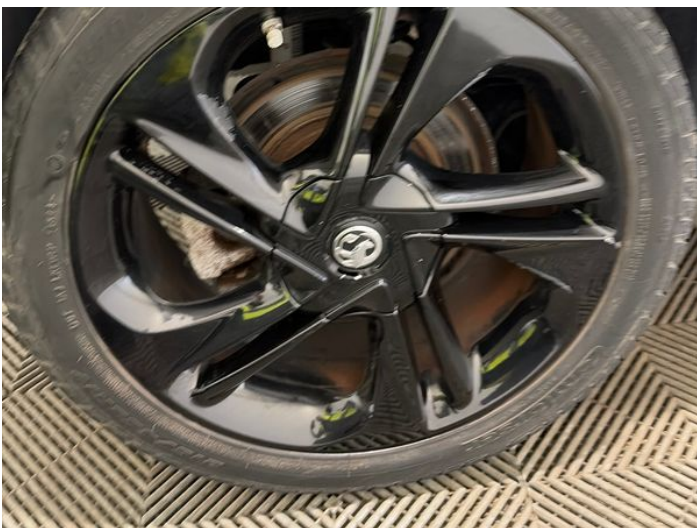
13: Wheel osr  
Scratched  
Up To 50mm

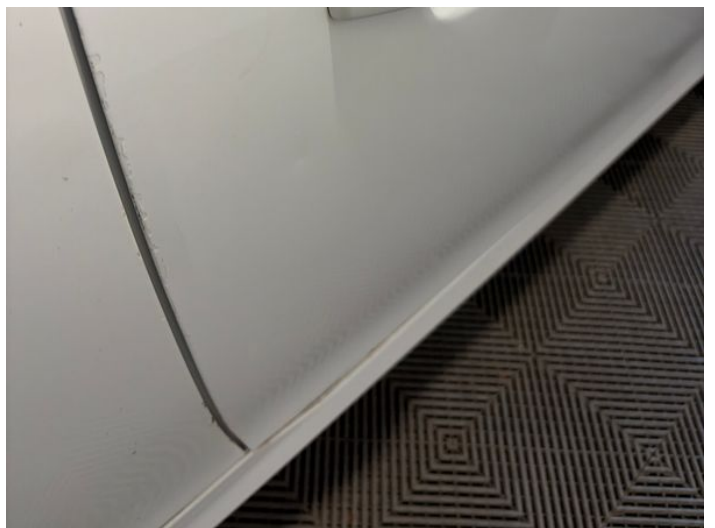
14: Door osf  
Dented  
With Paint Damage

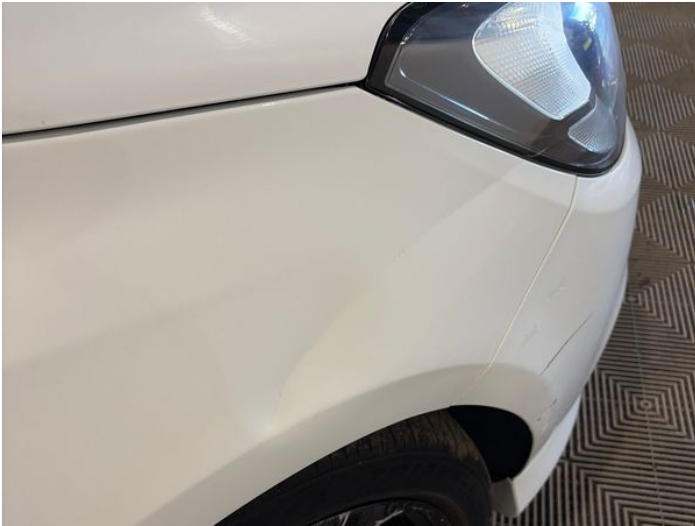
15: Wing osf  
Dented  
Over 30mm

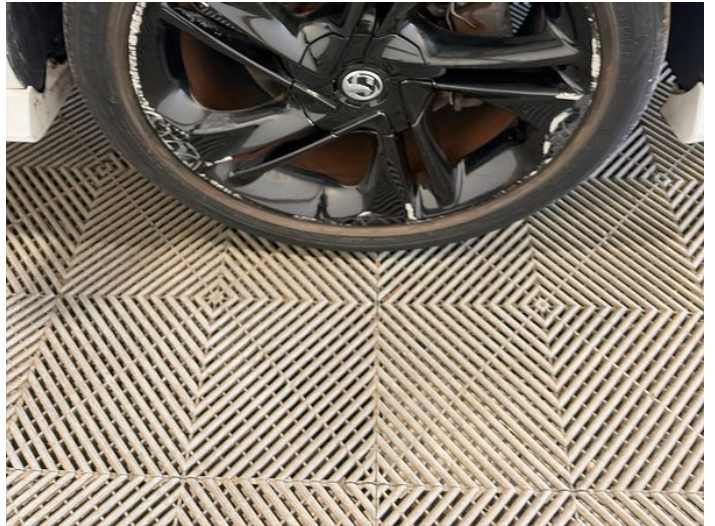
16: Wheel osf  
Scratched  
Over 50mm

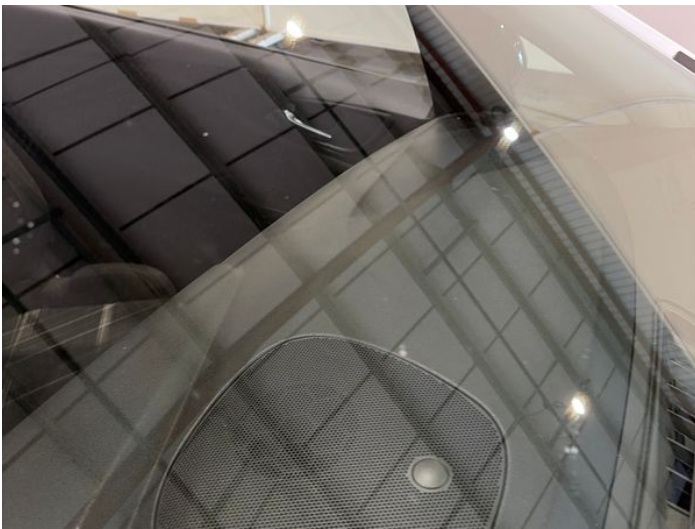
17: Screen Front  
Chipped  
UpTo 10mm

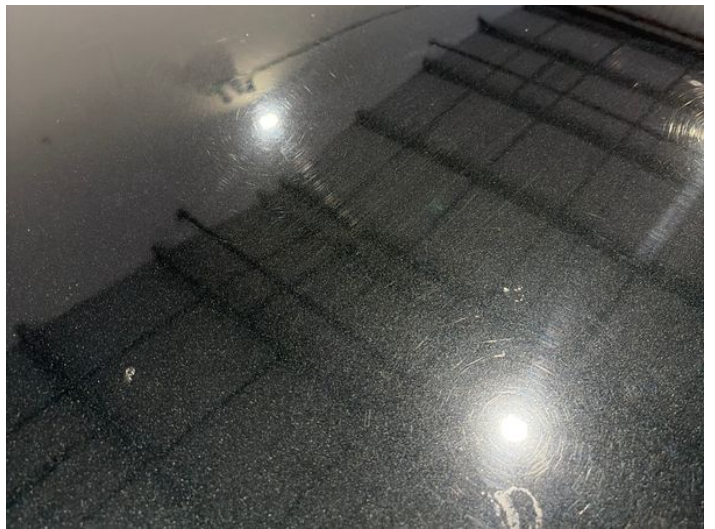
18: Roof  
Scratched  
Over 25mm Thru Paint

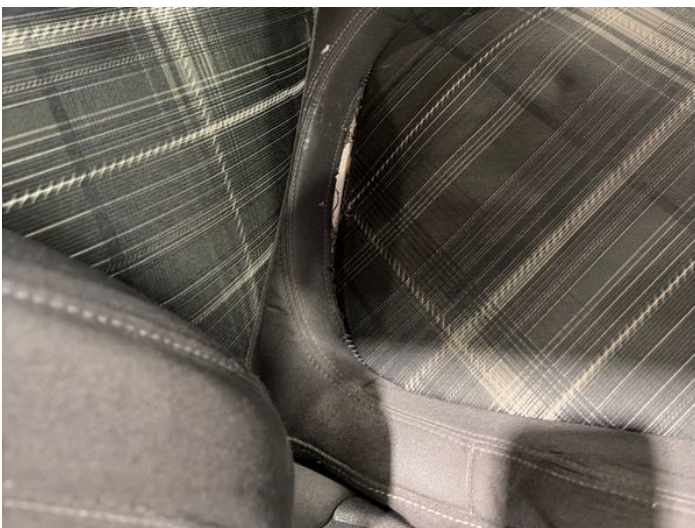
19: Seat Base Cover osf  
Torn  
Over 3mm

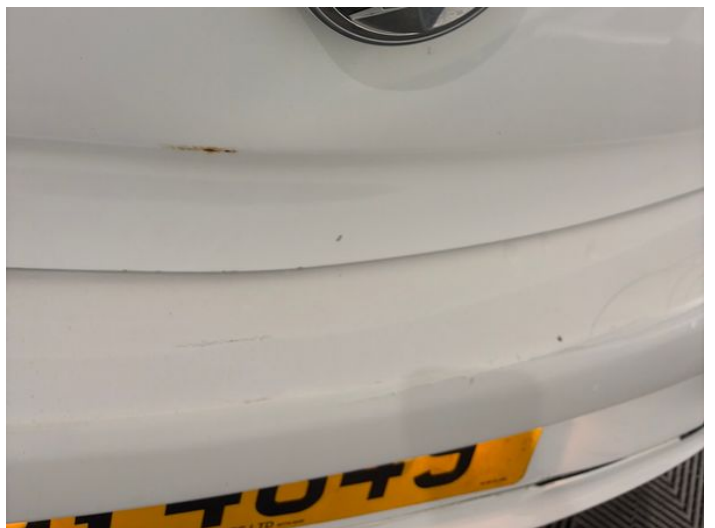
20: Tailgate  
Cracked  
Replace
