# VEHICLE INSPECTION REPORT

**GX65ZZY**

## Vauxhall Viva 1.0 ecoFLEX SE 5dr

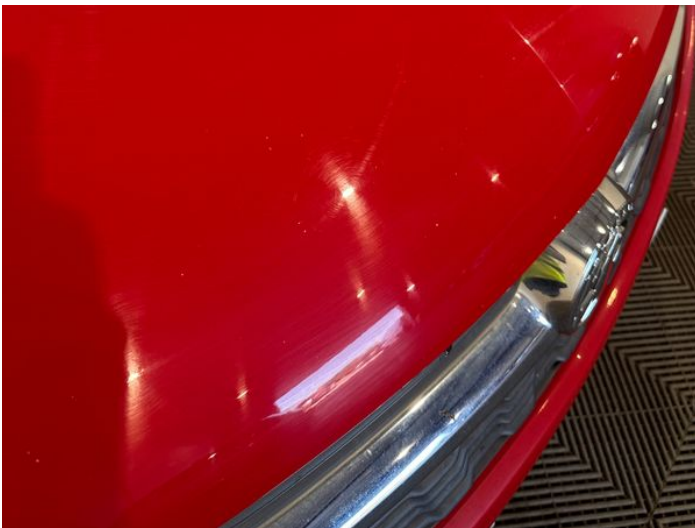
1: Bonnet  
Chipped  
Multiple Chips

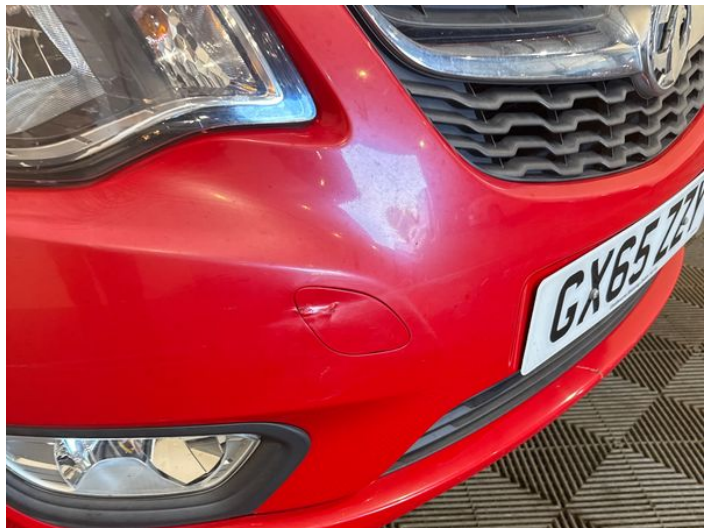
2: Bumper Front  
Dented  
With Paint Damage

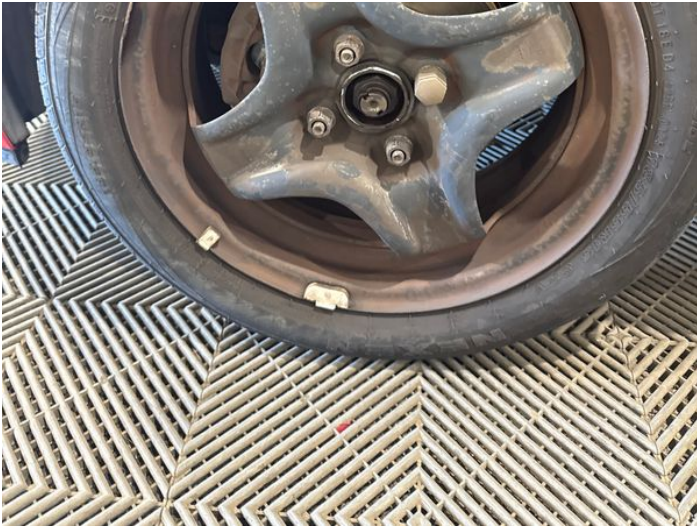
3: Wheel Trim nsf  
Broken  
Replace

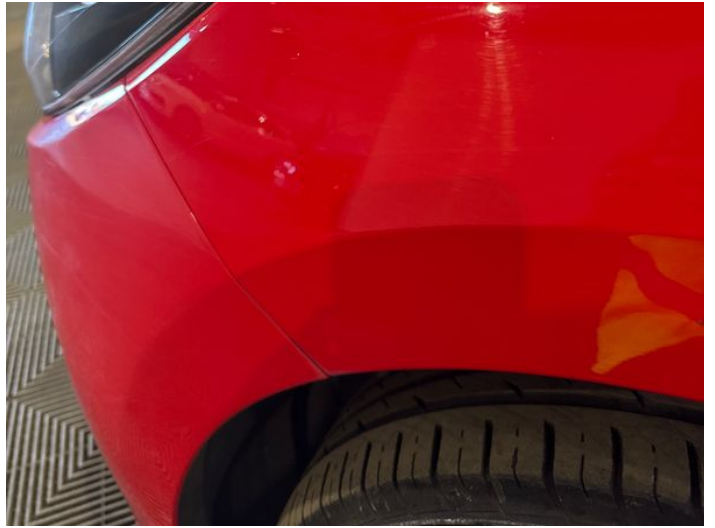
4: Wing nsf  
Chipped  
1 To 5

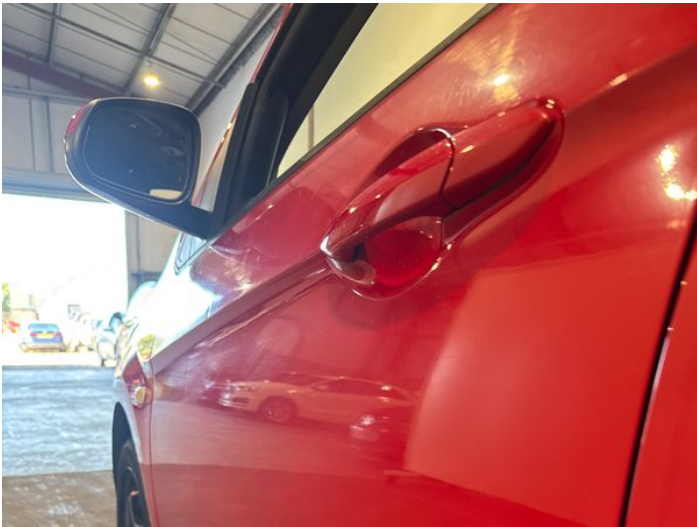
5: Door nsf  
Poor Previous Repair  
Rippled UpTo 30%

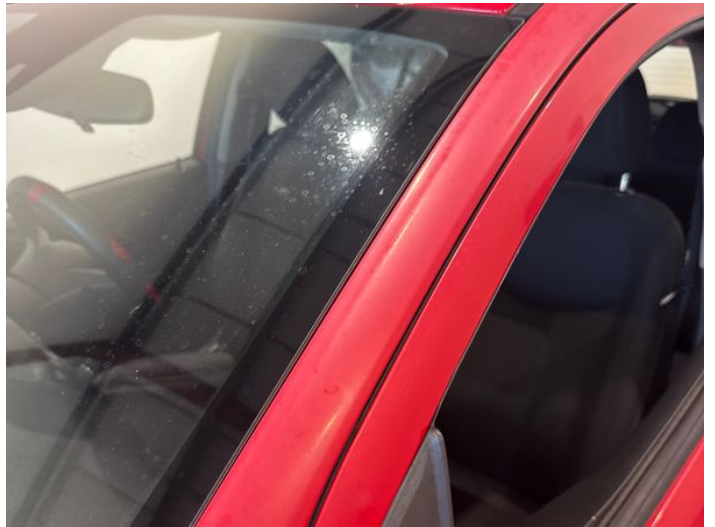
6: A Post ns  
Scratched  
Over 25mm Thru Paint

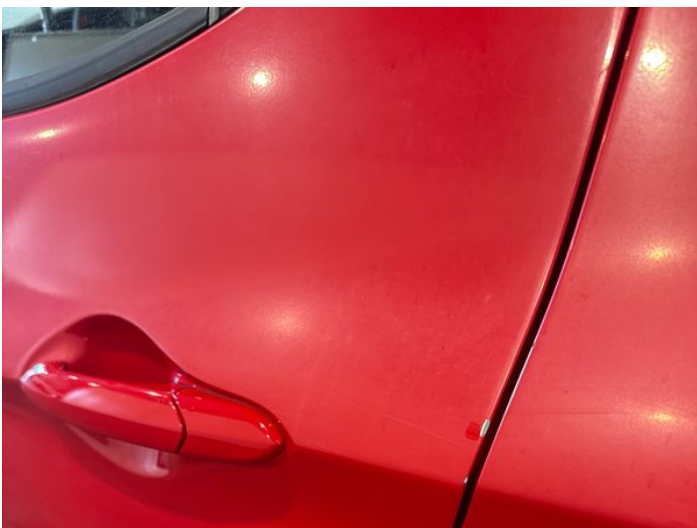
7: Door nsr  
Chipped  
Multiple Chips

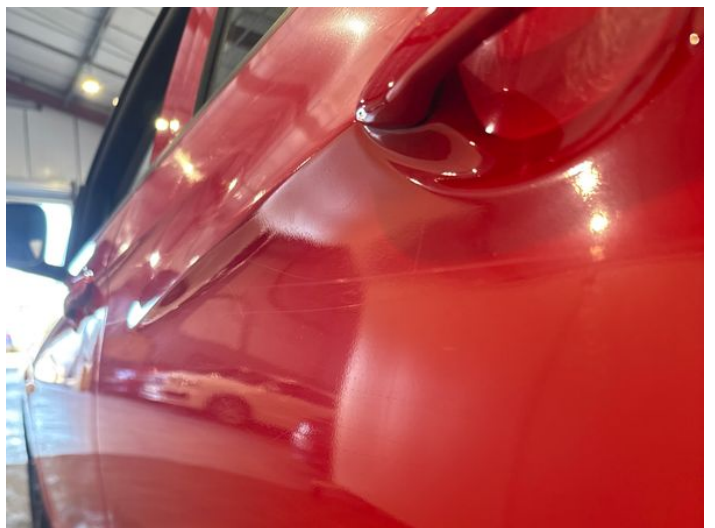
8: Door nsr  
Poor Previous Repair  
Rippled UpTo 30%

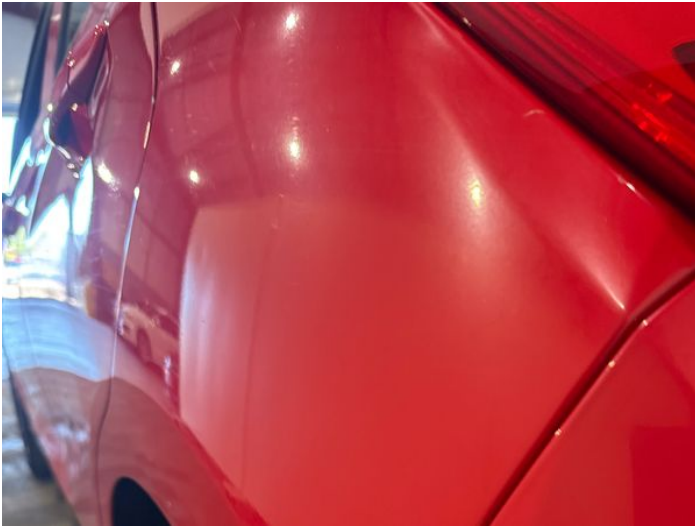
9: Qtr Panel nsr  
Dented  
Over 30mm

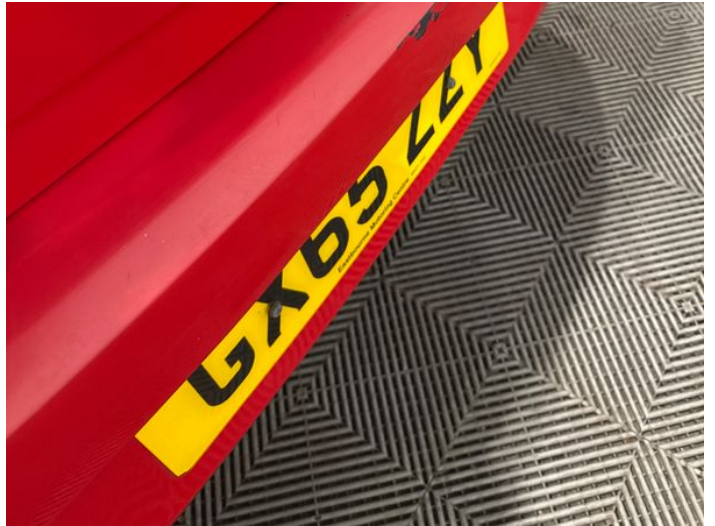
10: Bumper Rear  
Scratched  
Over 100mm Thru Paint

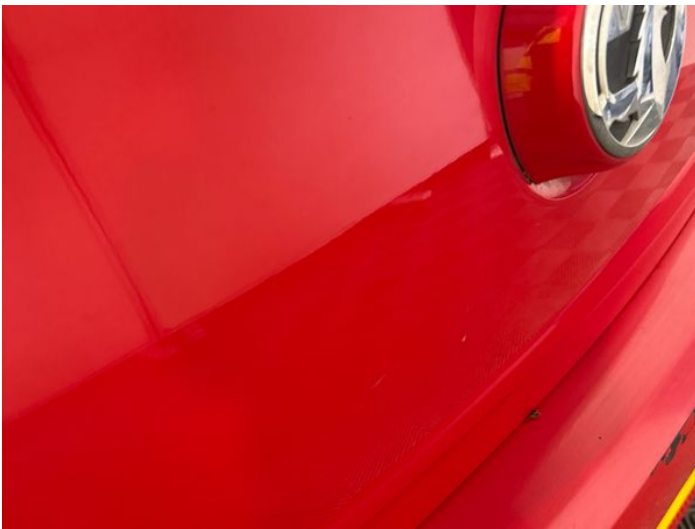
11: Tailgate  
Scratched  
UpTo 25mm Thru Paint

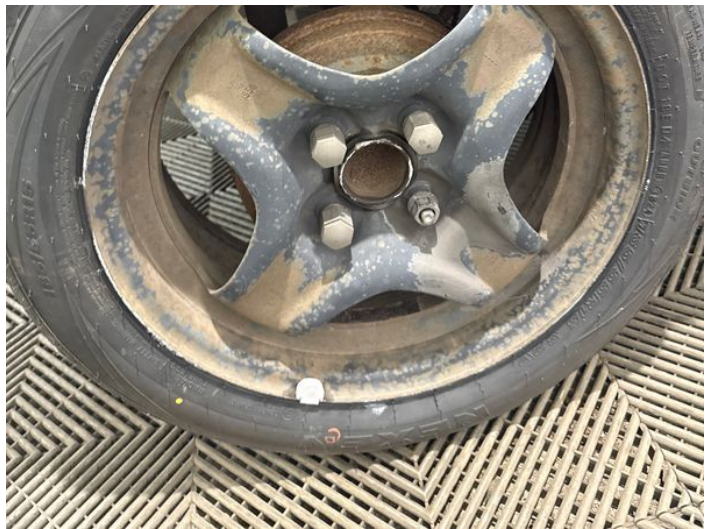
12: Wheel Trim osr  
Missing  
Replace

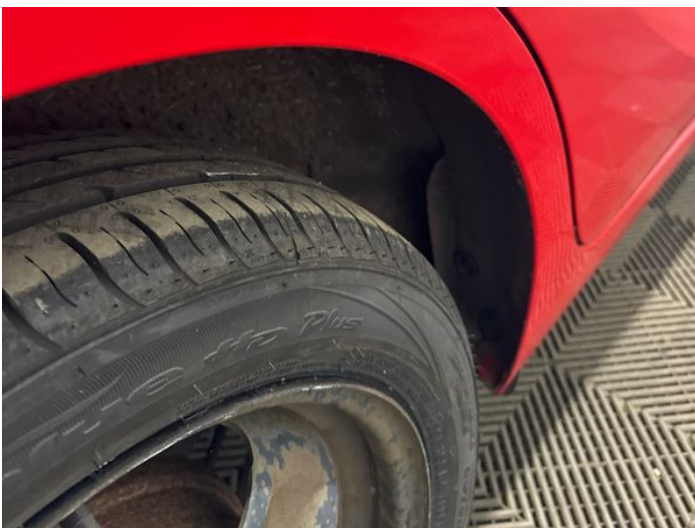
13: Qtr Panel osr  
Chipped  
1 To 5

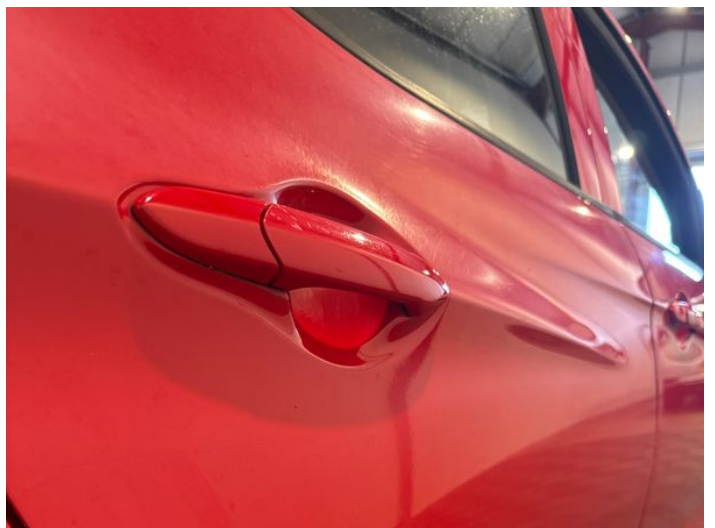
14: Door osr  
Poor Previous Repair  
Rippled UpTo 30%

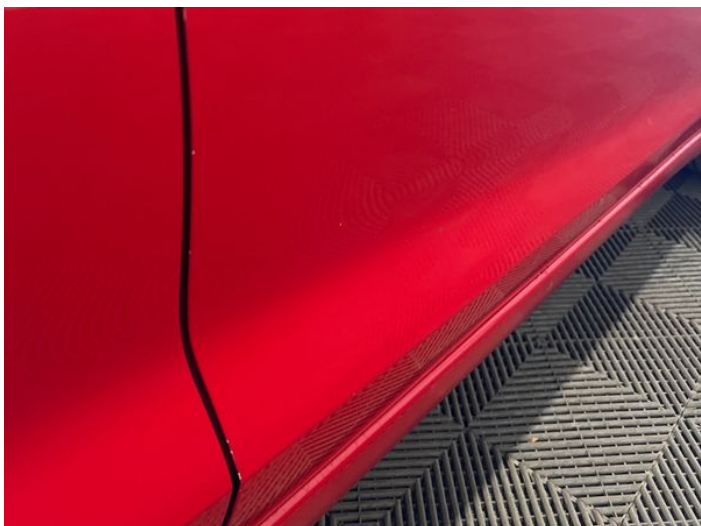
15: Door osf  
Chipped  
Edge Chip

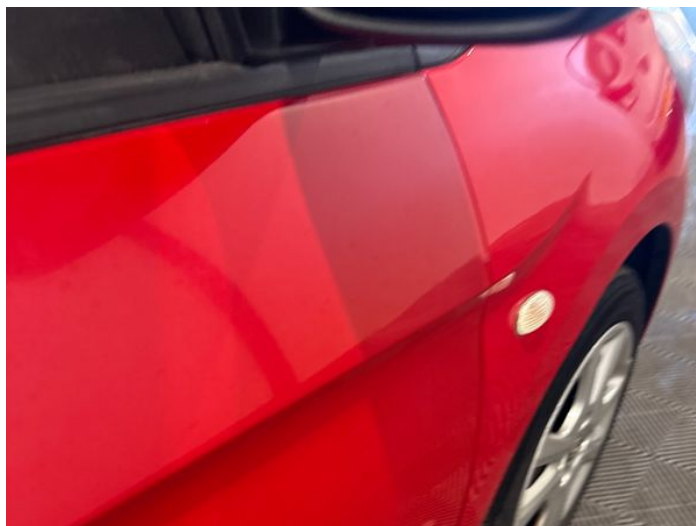
16: Door osf  
Dented  
With Paint Damage

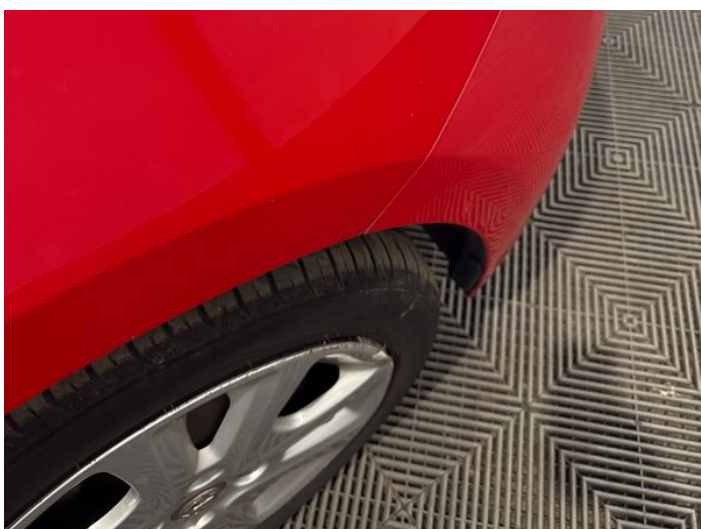
17: Wing osf  
Chipped  
1 To 5

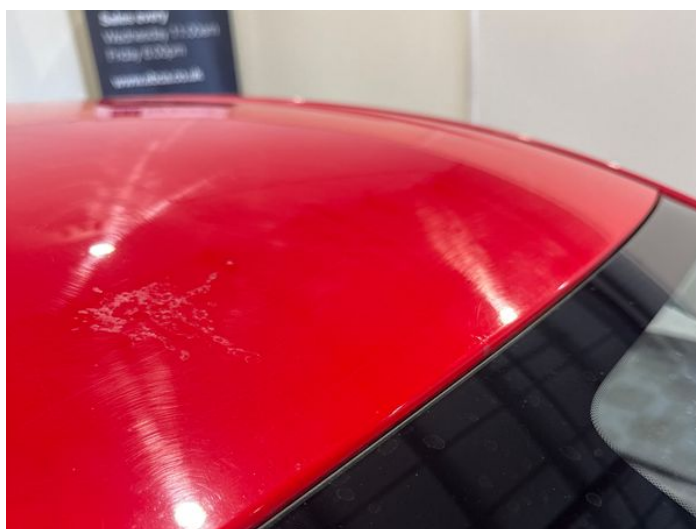
18: Roof  
Chipped  
Edge Chip
