# VEHICLE INSPECTION REPORT

**GY12KFT**

## BMW 3 Series 320d SE 4dr

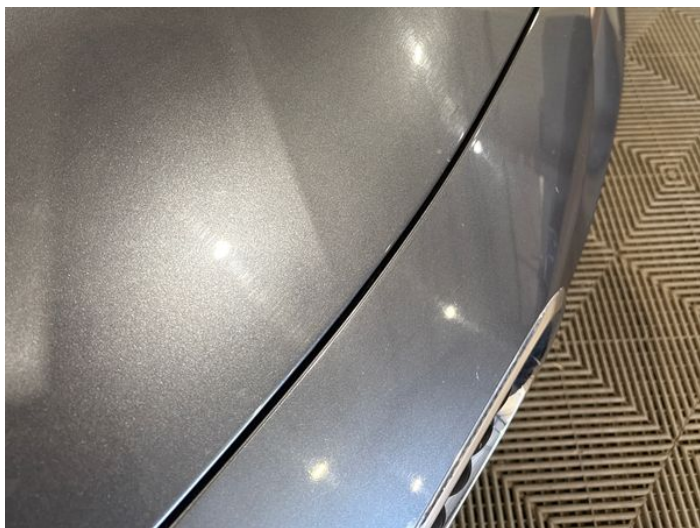
1: Bonnet  
Chipped  
Multiple Chips

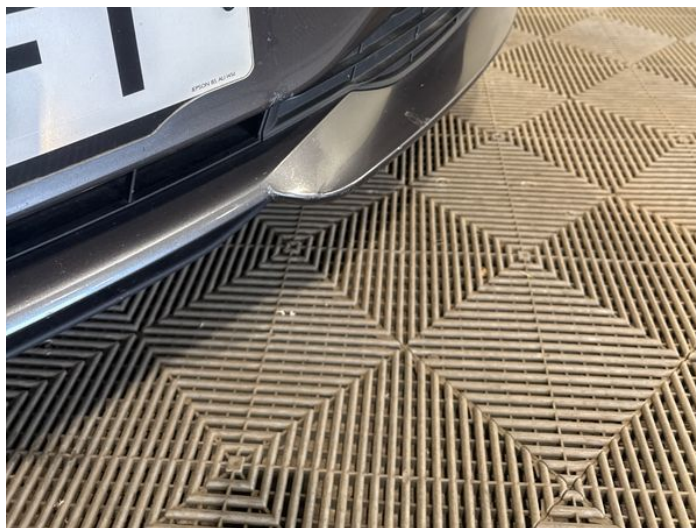
2: Bumper Front  
Dented  
With Paint Damage

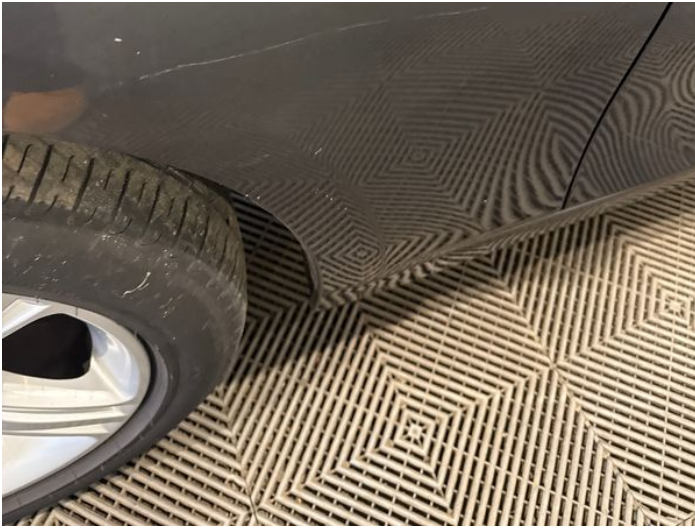
3: Wing nsf  
Scratched  
Over 25mm Thru Paint

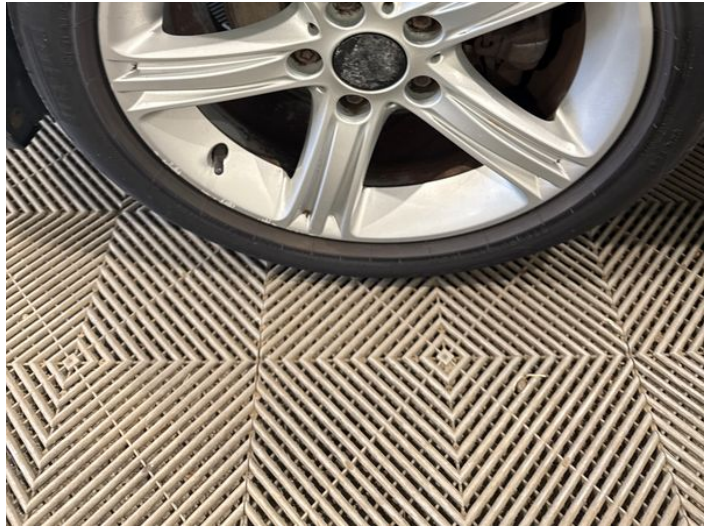
4: Wheel nsf  
Scratched  
Over 50mm

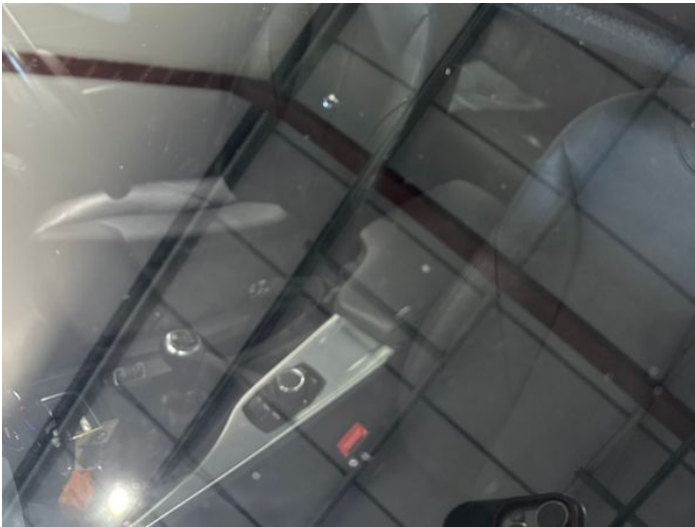
5: Screen Front  
Chipped  
Over 10mm

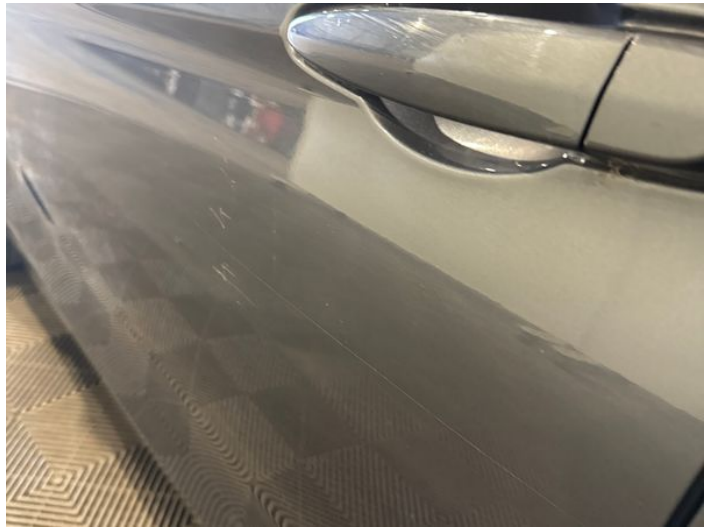
6: Door nsf  
Dented  
With Paint Damage

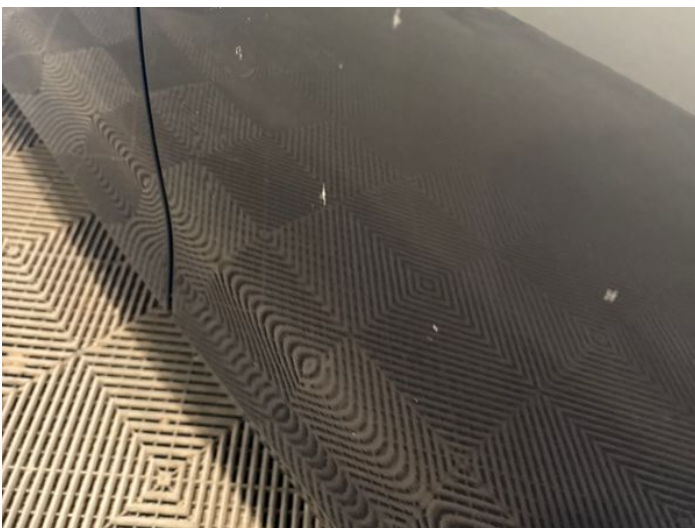
7: Door nsr  
Dented  
With Paint Damage

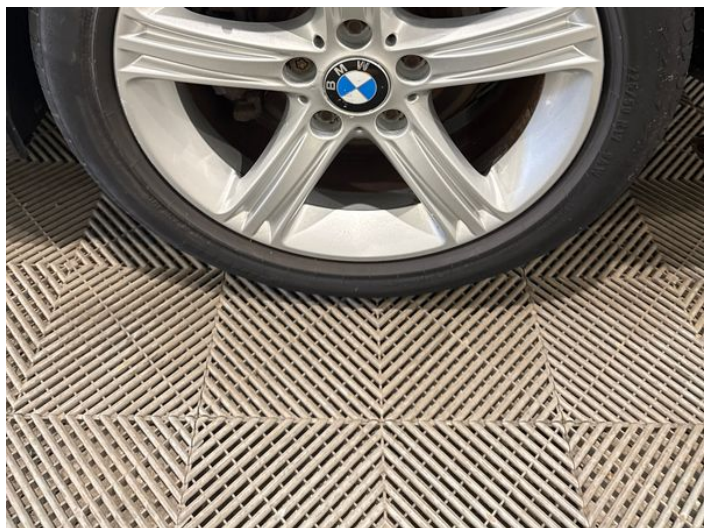
8: Wheel nsr  
Scratched  
Over 50mm

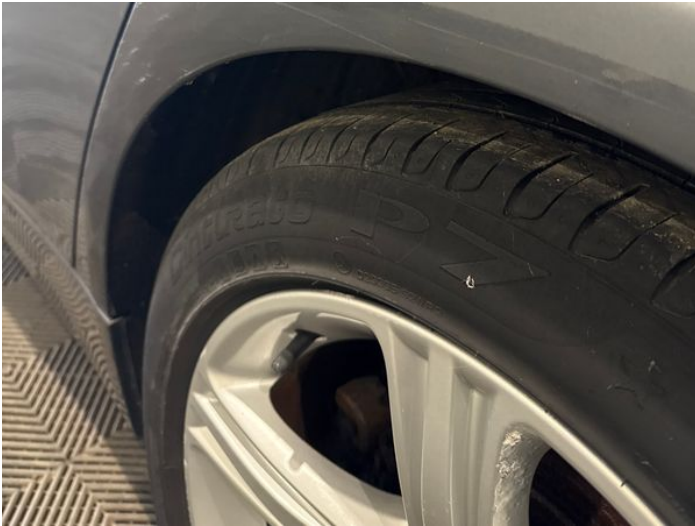
9: Qtr Panel nsr  
Dented  
With Paint Damage

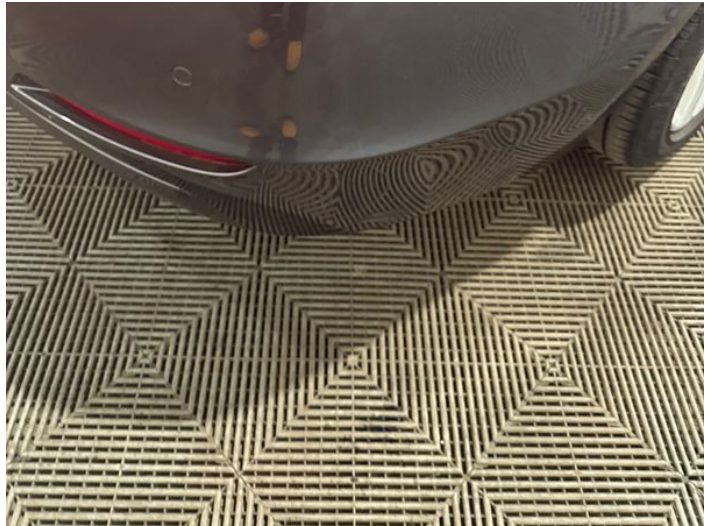
10: Bumper Rear  
Scratched  
Over 100mm Thru Paint

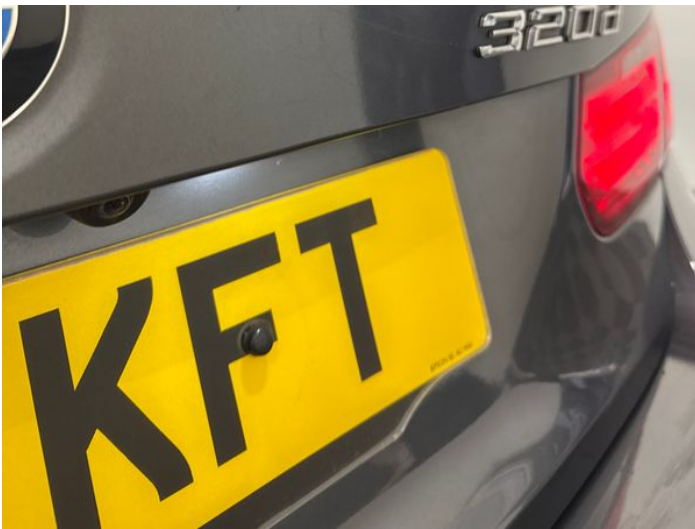
11: Boot Lid  
Scratched  
Over 25mm Thru Paint

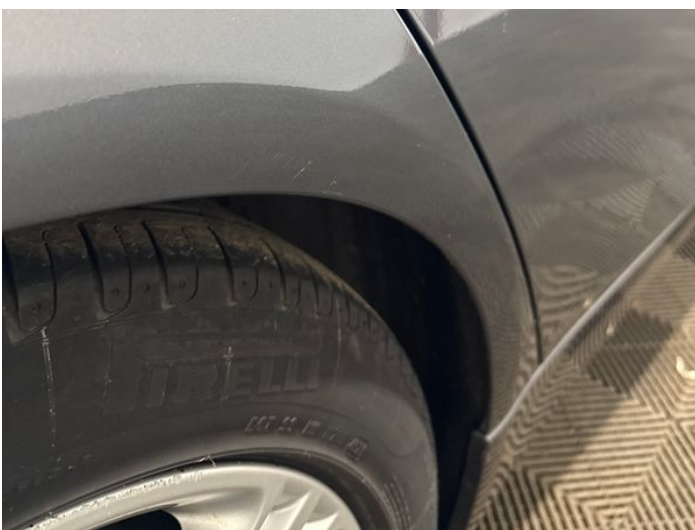
13: Qtr Panel osr  
Dented  
Between 10mm + 30mm

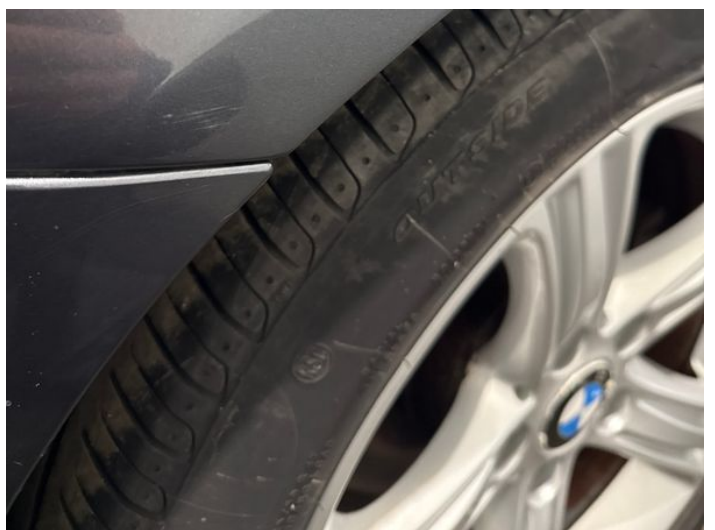
14: Qtr Panel osr  
Scratched  
UpTo 25mm Thru Paint

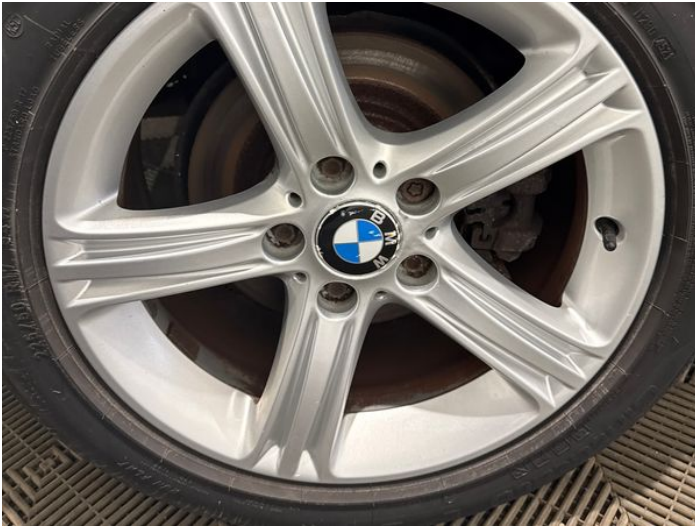
15: Wheel osr  
Scratched  
Over 50mm

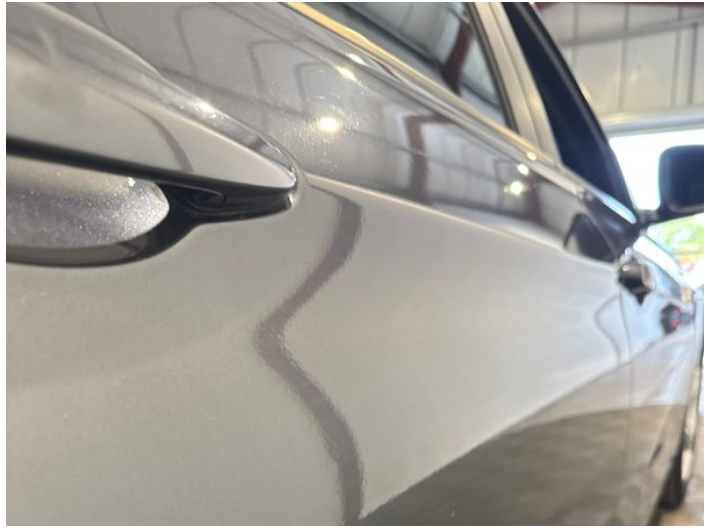
16: Door osr  
Dented  
2 Or Less UpTo 10mm

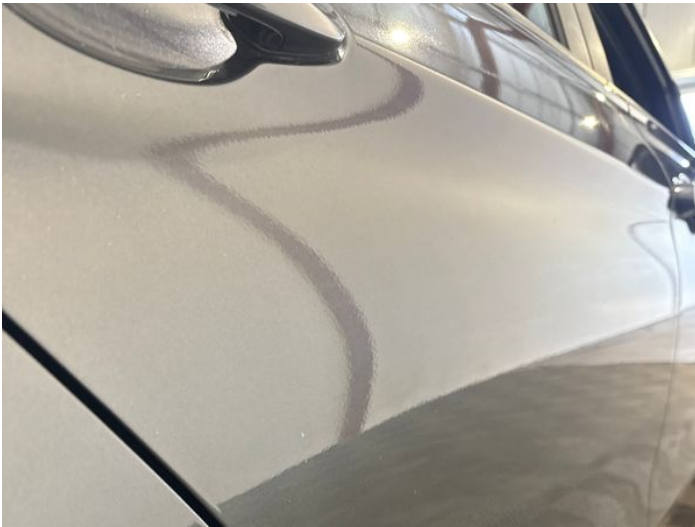
17: Door osr  
Chipped  
1 To 5

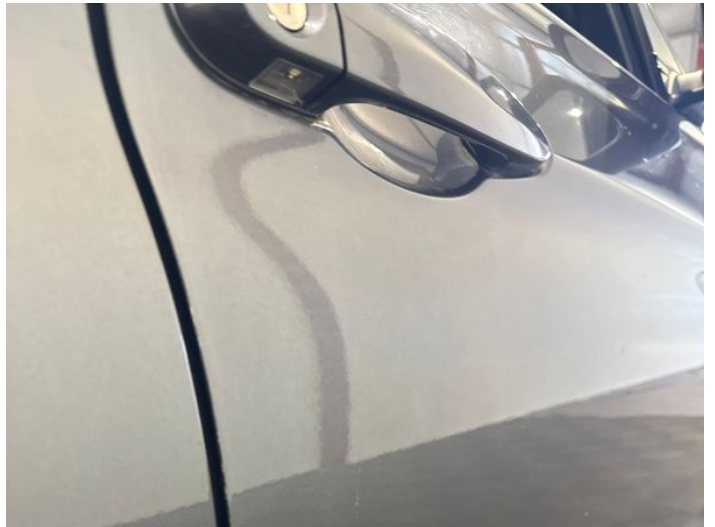
18: Door osf  
Chipped  
Edge Chip

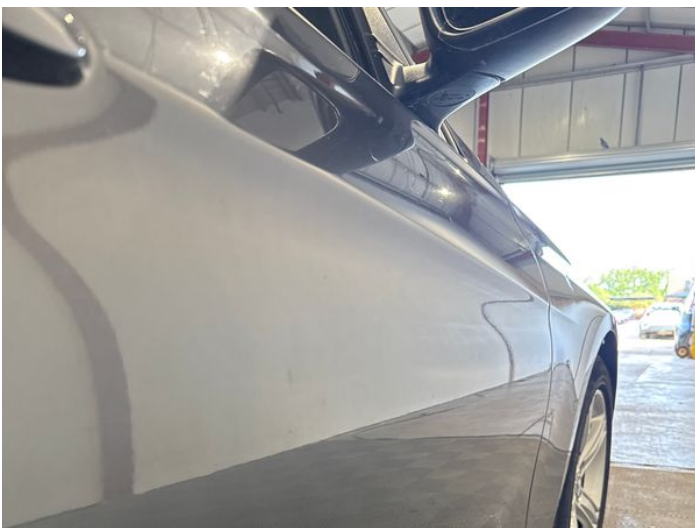
19: Door osf  
Dented  
Between 10mm + 30mm

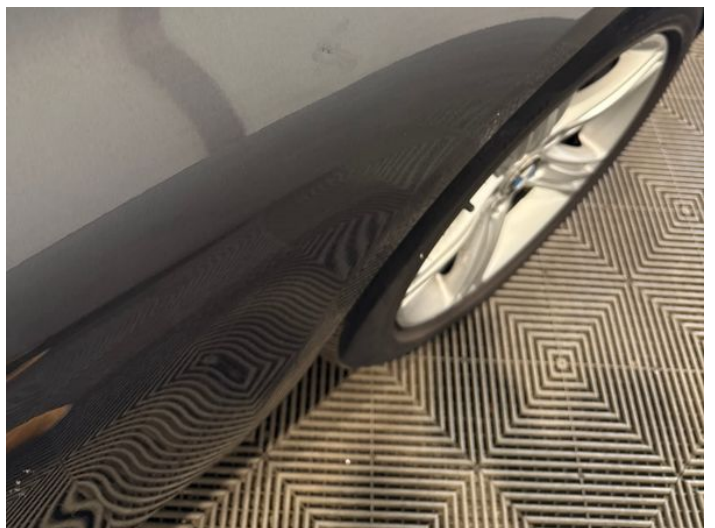
20: Wing osf  
Dented  
Between 10mm + 30mm

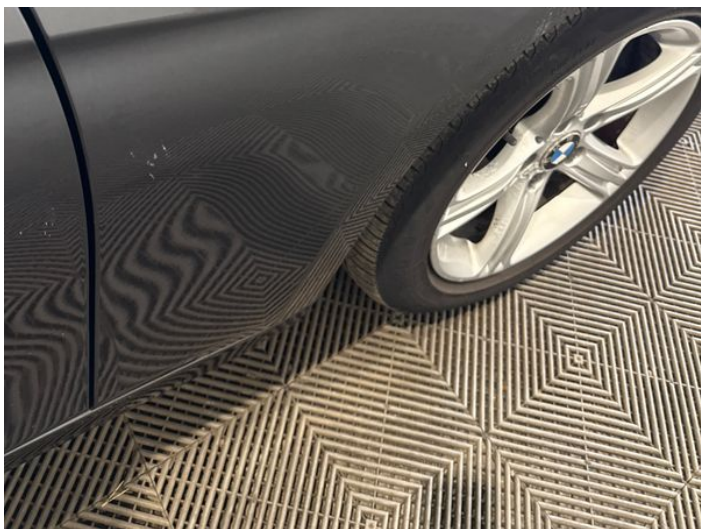
21: Wing osf  
Scratched  
Over 25mm Thru Paint

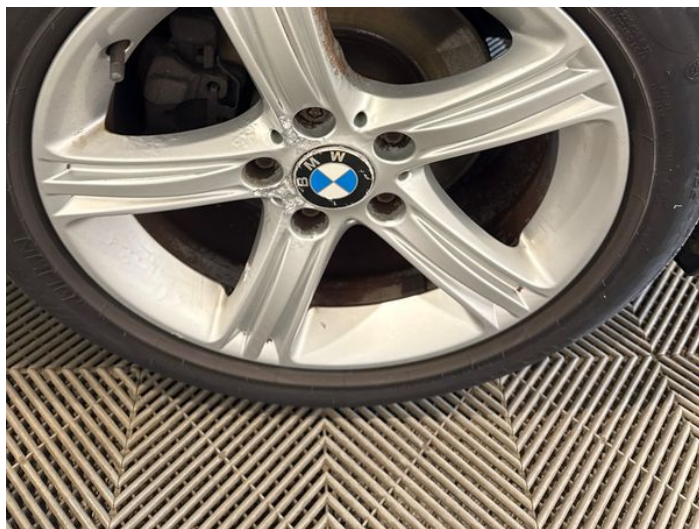
22: Wheel osf  
Scratched  
Over 50mm

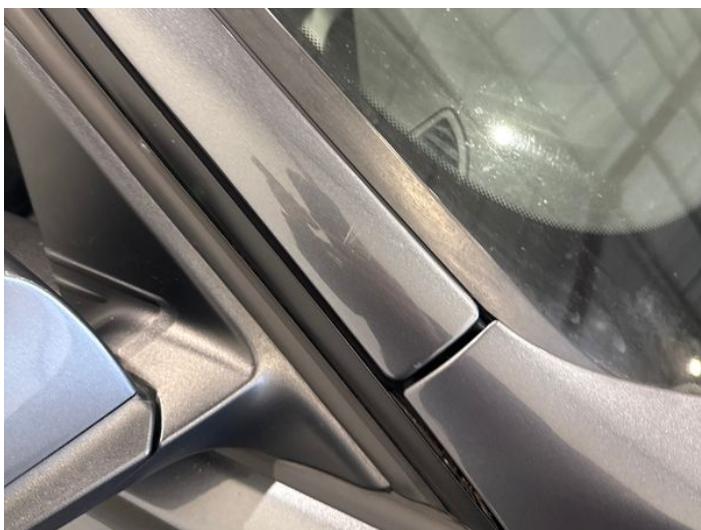
23: A Post os  
Scratched  
UpTo 25mm Thru Paint

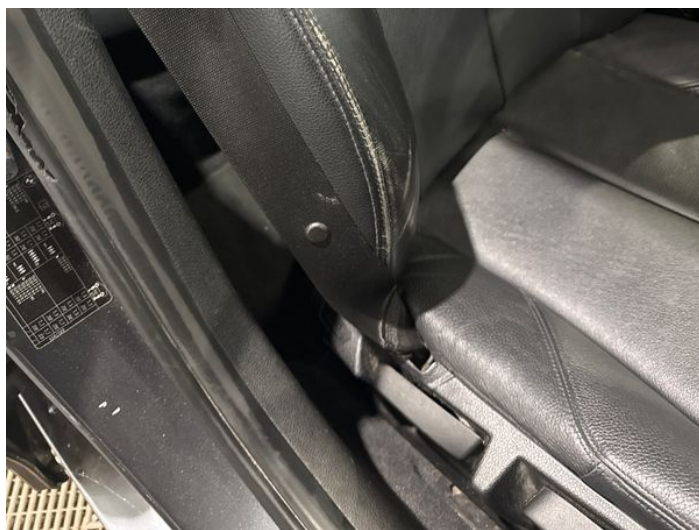
24: Seat Back Cover osf  
Scuffed  
Over 25mm

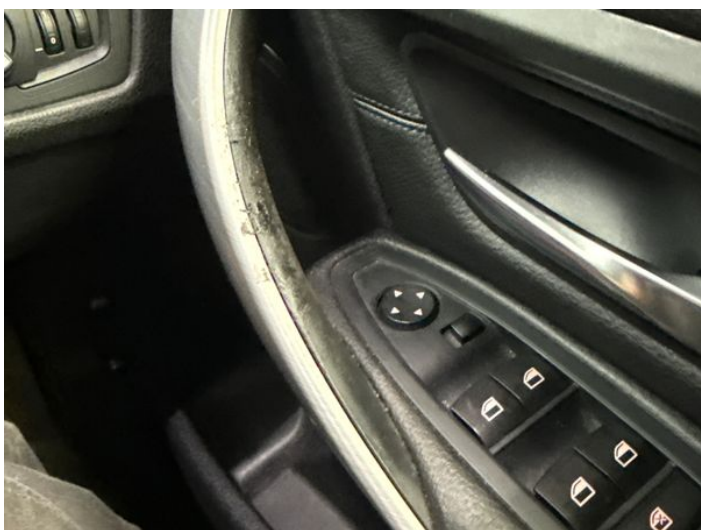
25: Door Pad osf  
Scuffed  
Over 25mm
