# VEHICLE INSPECTION REPORT

**EX11HOJ**

## Hyundai I30 1.4 Comfort 5dr

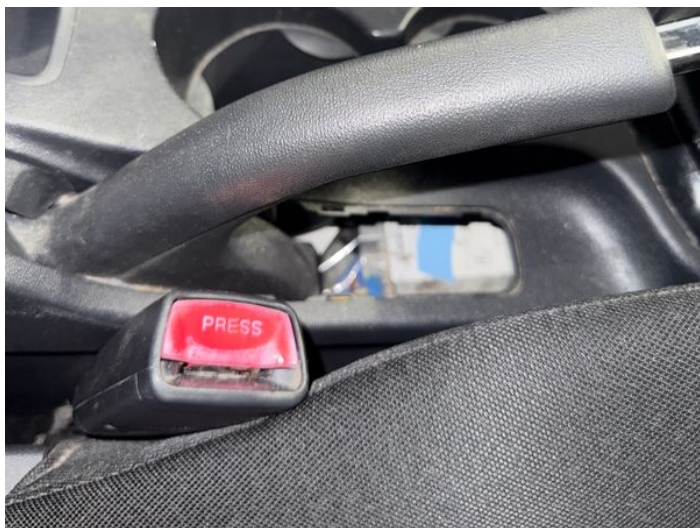
1: Fascia Trim  
Missing  
Replace

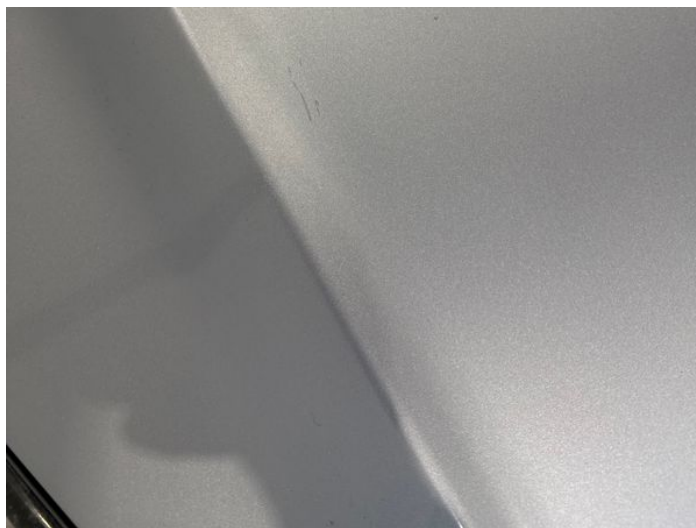
2: Bonnet  
Scratched  
Over 25mm Thru Paint

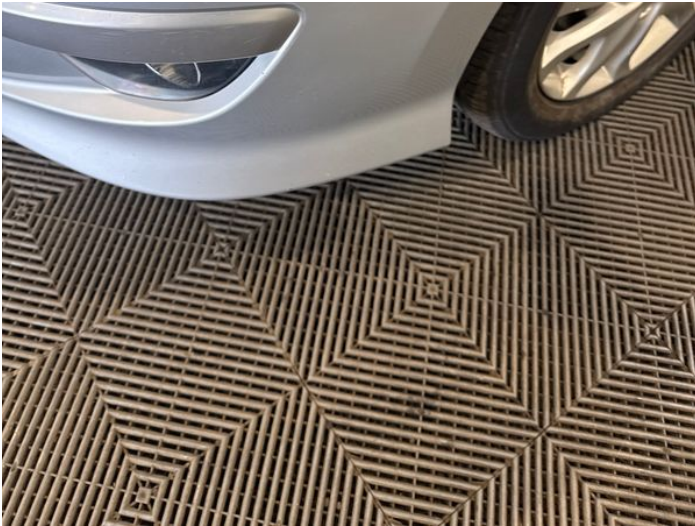
3: Bumper Front  
Scratched  
25 to 100mm Thru Paint

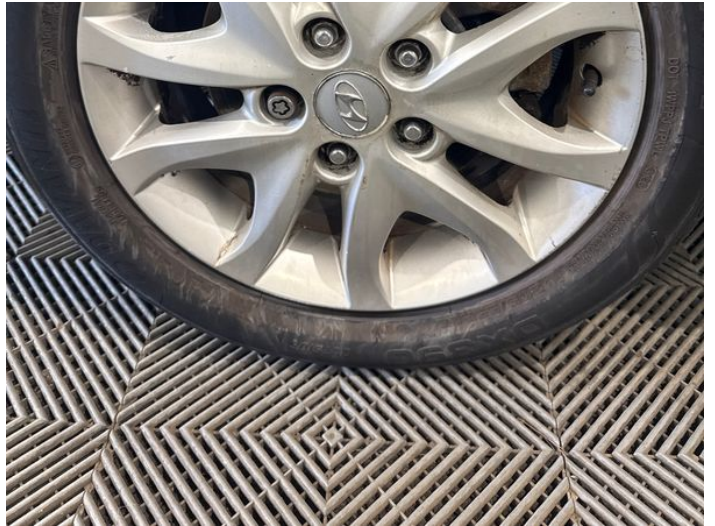
4: Wheel nsf  
Scratched  
Up To 50mm

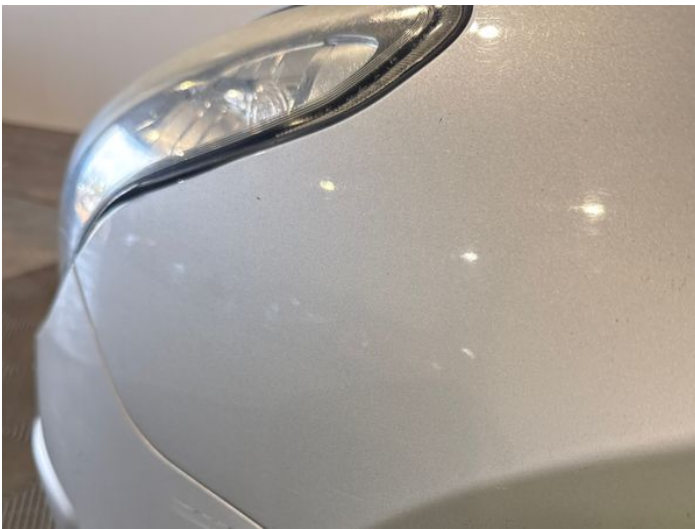
5: Wing nsf  
Chipped  
1 To 5

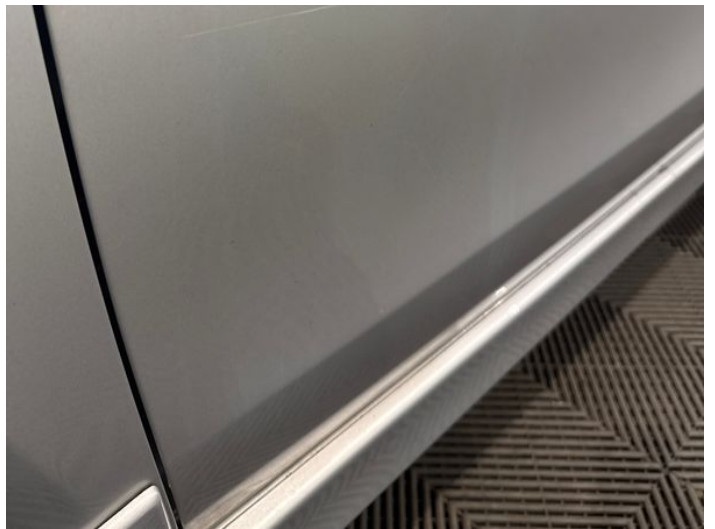
6: Door nsf  
Scratched  
Over 25mm Thru Paint

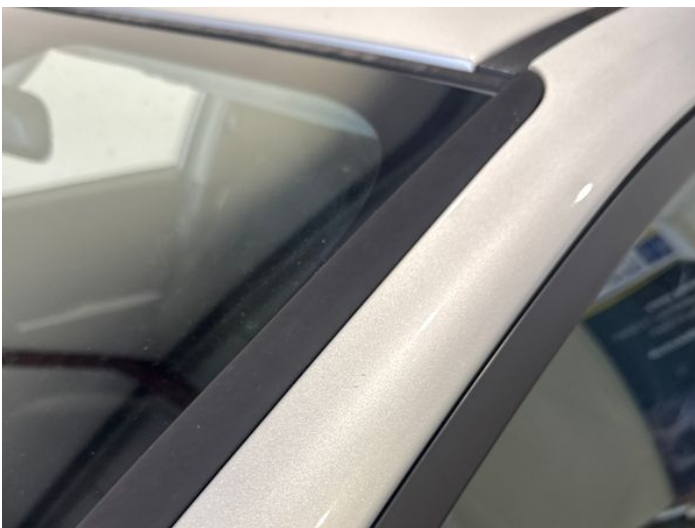
7: A Post ns  
Chipped  
1 To 5

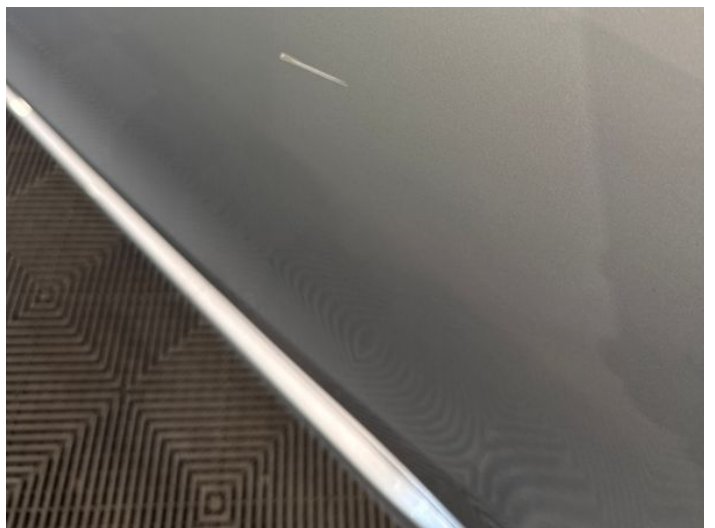
8: Door nsr  
Scratched  
Over 25mm Thru Paint

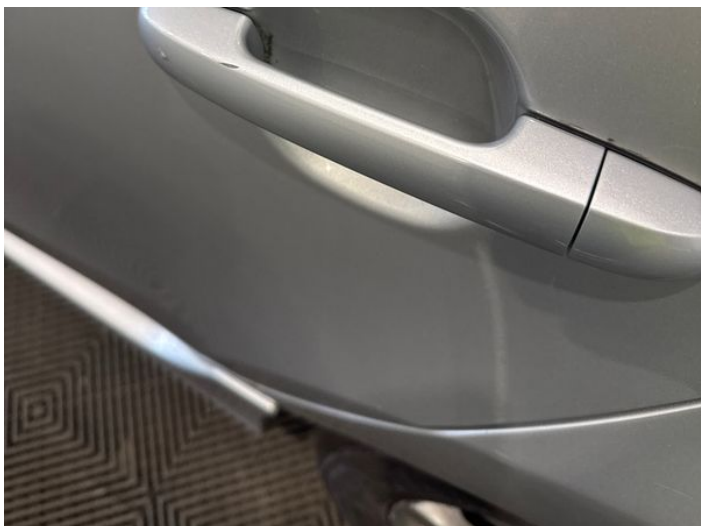
9: Door nsr  
Scratched  
UpTo 25mm Thru Paint

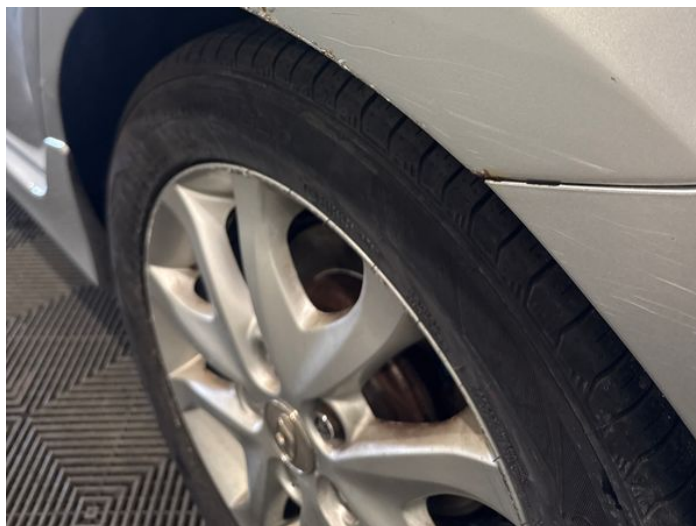
10: Qtr Panel nsr  
Scratched  
Rusted

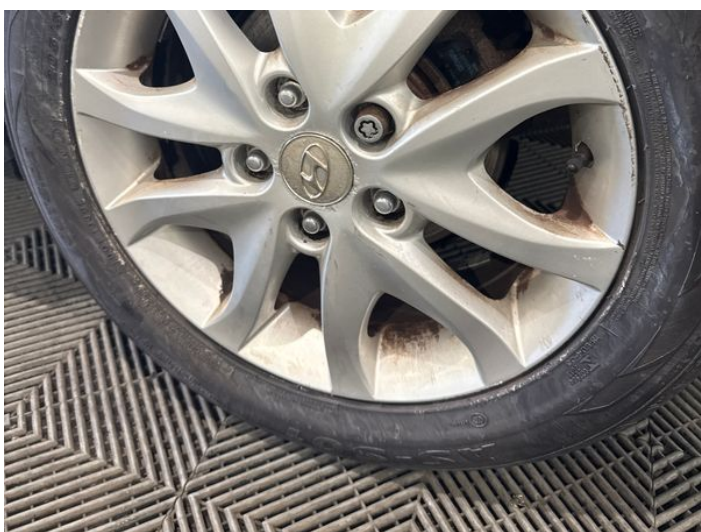
11: Wheel nsr  
Scratched  
Over 50mm

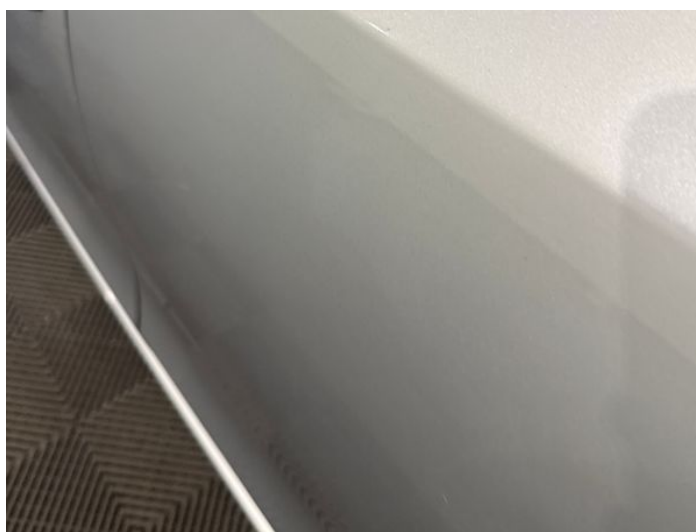
12: Door nsr  
Dented  
Between 10mm + 30mm

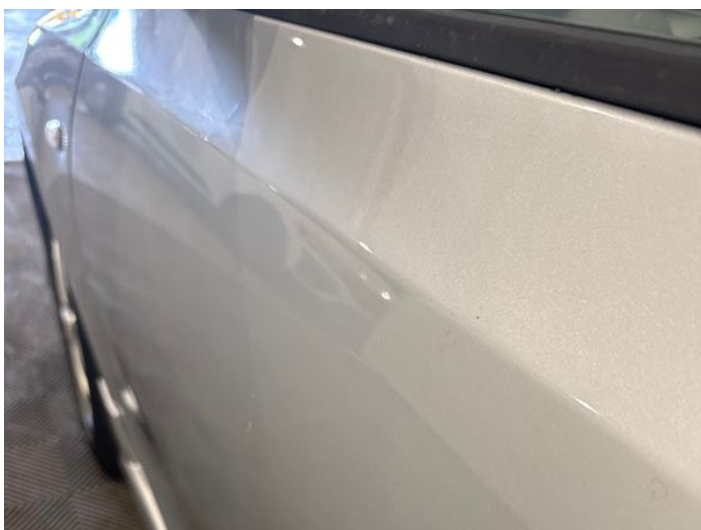
13: Door nsf  
Dented  
Over 30mm

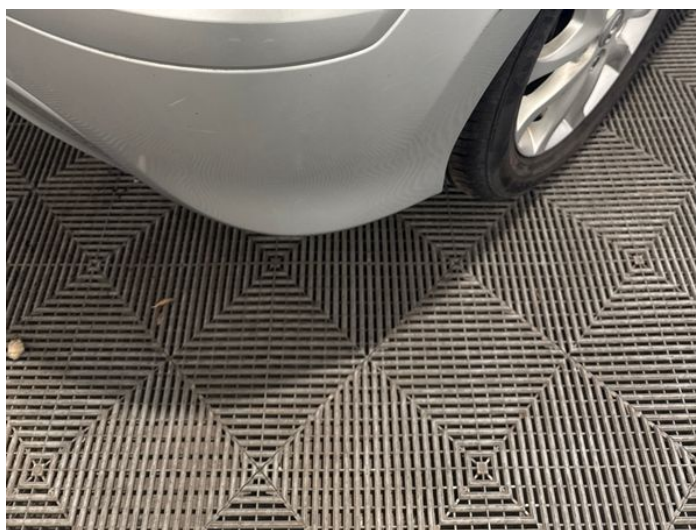
14: Bumper Rear  
Scratched  
25 to 100mm Thru Paint

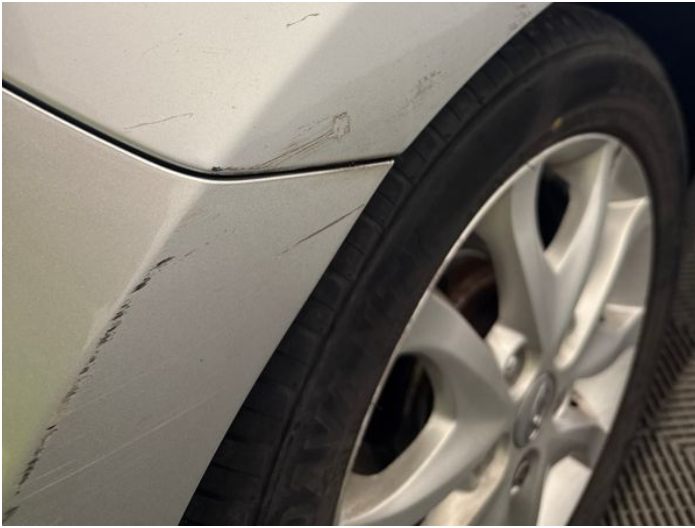
15: Qtr Panel osr  
Scratched  
Over 25mm Thru Paint

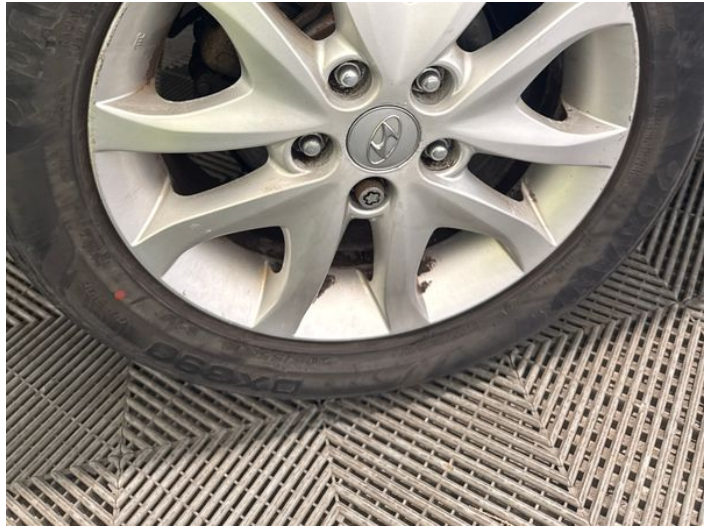
16: Wheel osr  
Scratched  
Over 50mm

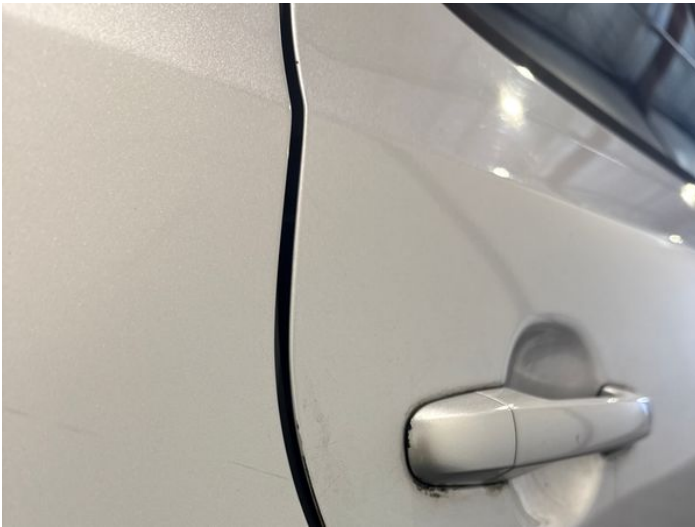
17: Door osr  
Scratched  
Over 25mm Thru Paint

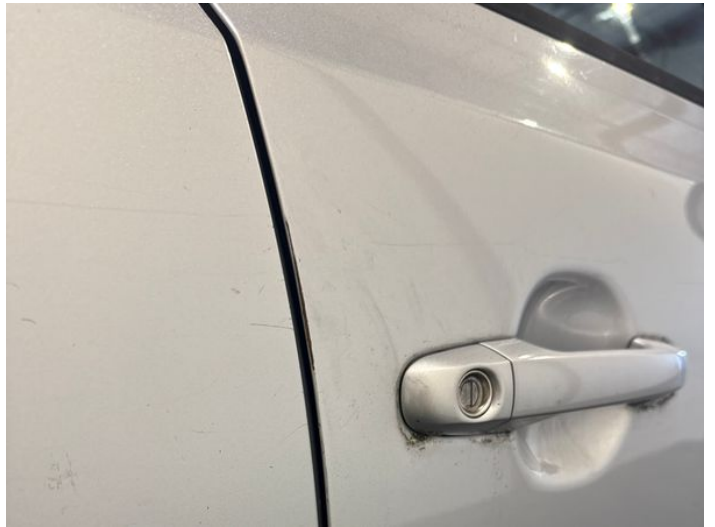
18: Door osf  
Scratched  
Over 25mm Thru Paint

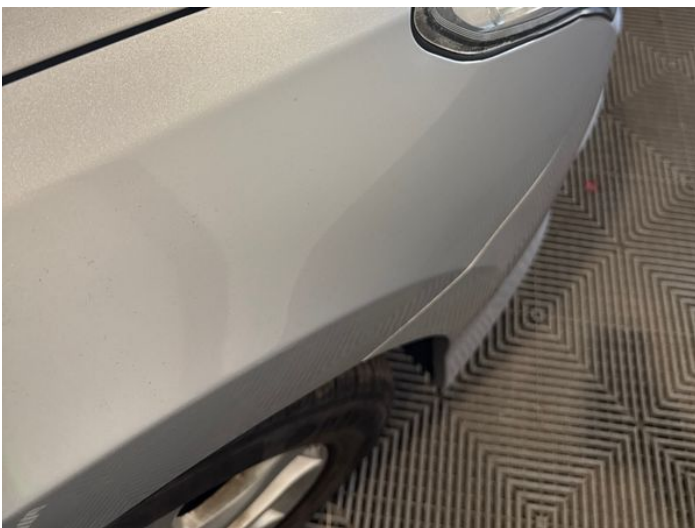
19: Wing osf  
Chipped  
1 To 5

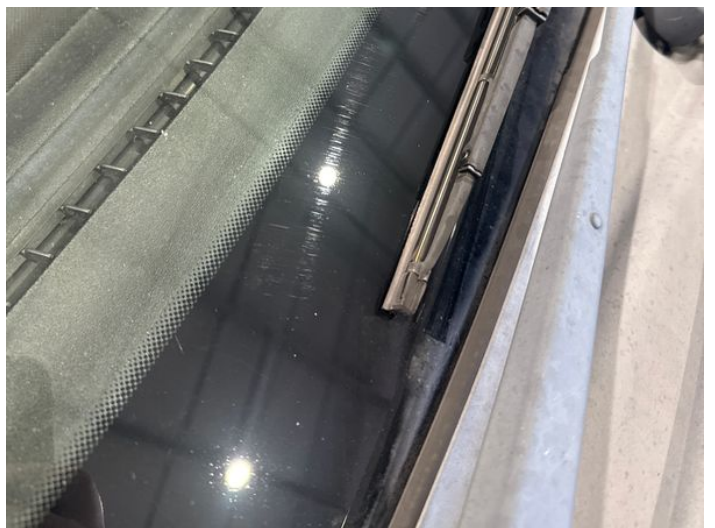
20: Screen Front  
Chipped  
Over 10mm

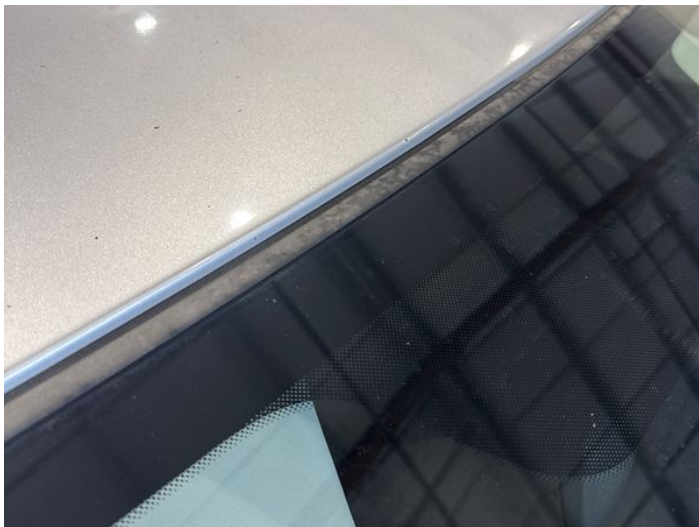
21: Roof  
Chipped  
Edge Chip
