# VEHICLE INSPECTION REPORT

**KO16WMX**

## Nissan Qashqai 1.6 dCi N-Connecta 5dr Xtronic

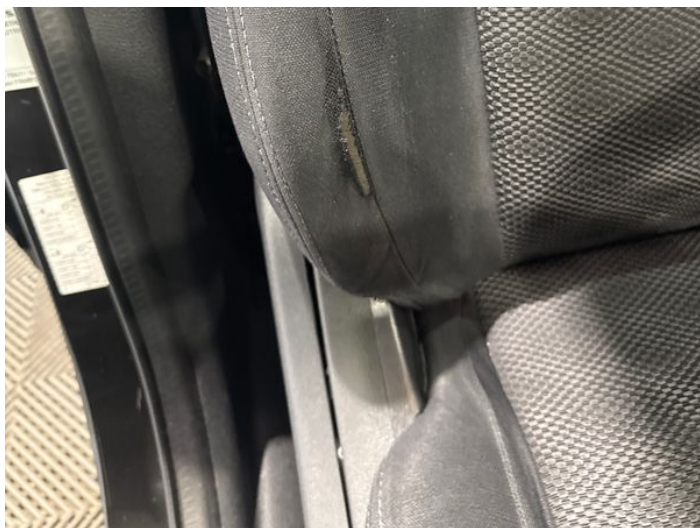
1: Seat Back Cover osf  
Scuffed  
Over 25mm

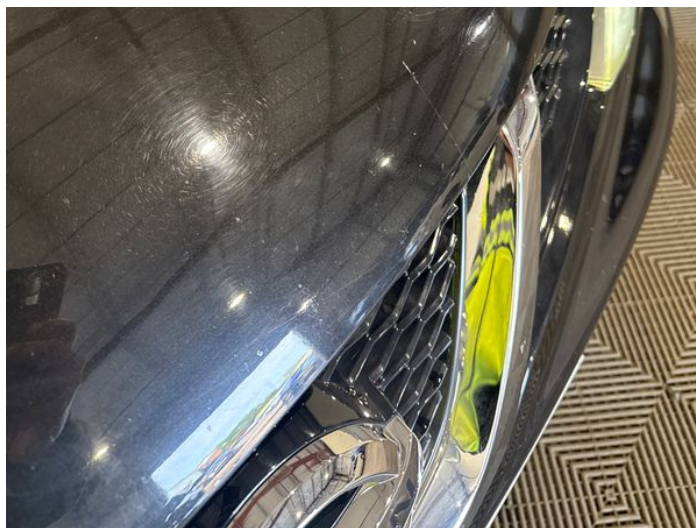
2: Bonnet  
Scratched  
Over 25mm Thru Paint

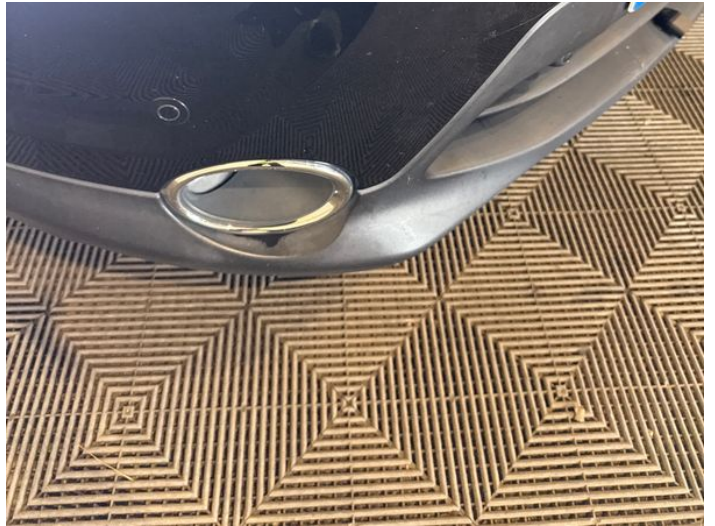
4: Bumper Front  
Scratched  
25 to 100mm Thru Paint

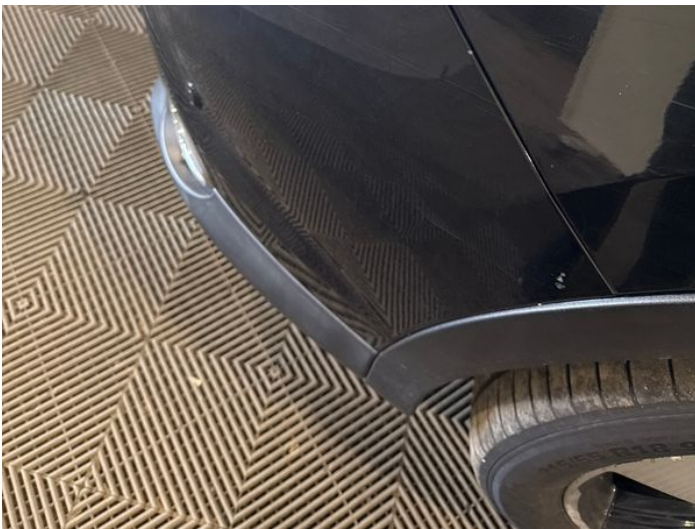
5: Bumper Front  
Scratched  
25 to 100mm Thru Paint

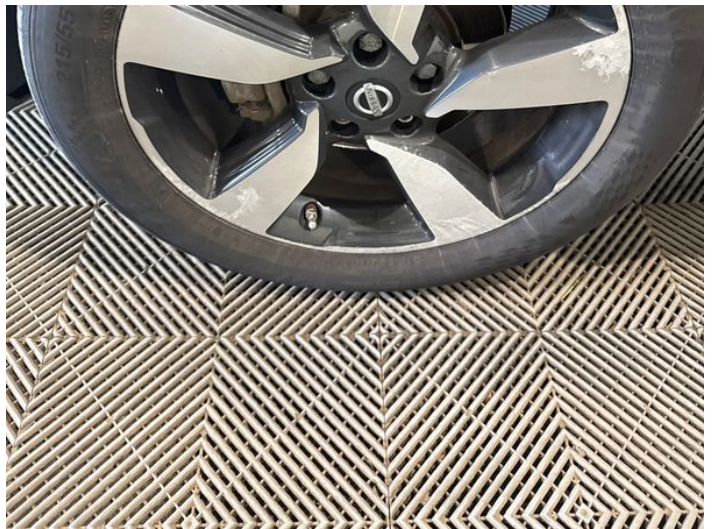
6: Wheel nsf  
Scratched  
Over 50mm

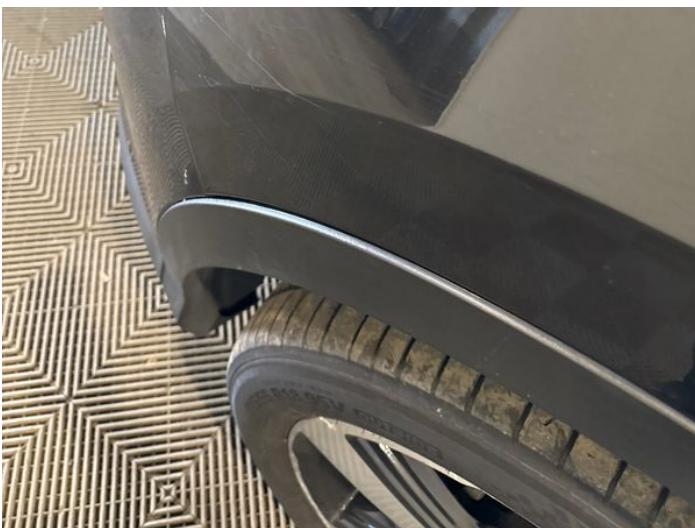
7: Wing nsf  
Chipped  
1 To 5

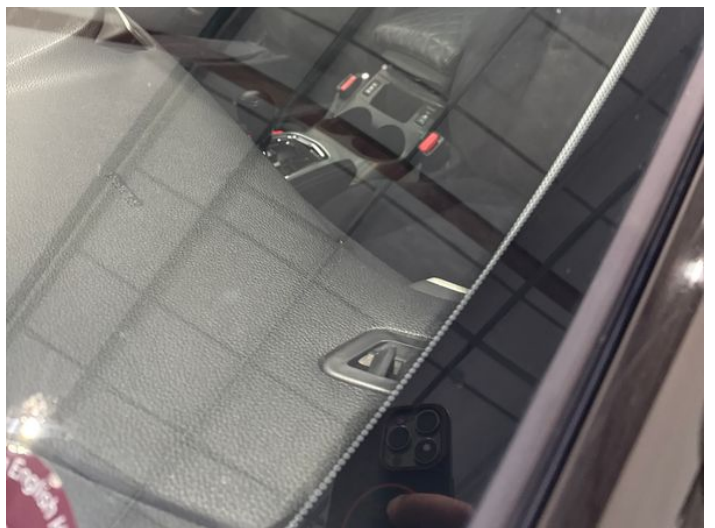
8: Screen Front  
Chipped  
UpTo 10mm

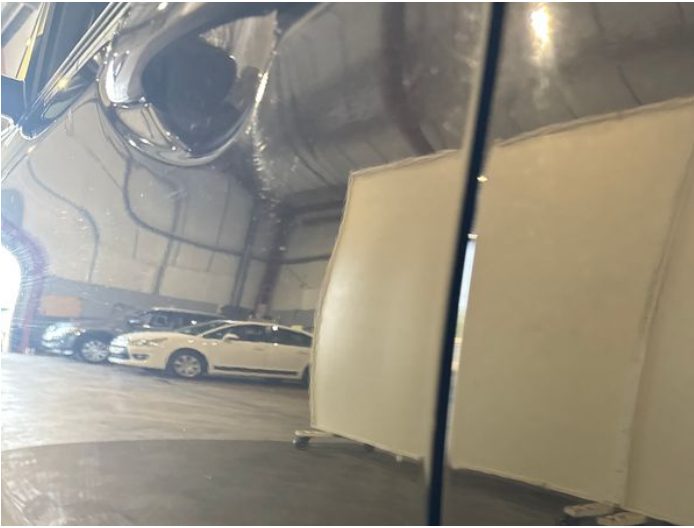
9: Door nsf  
Dented  
Between 10mm + 30mm

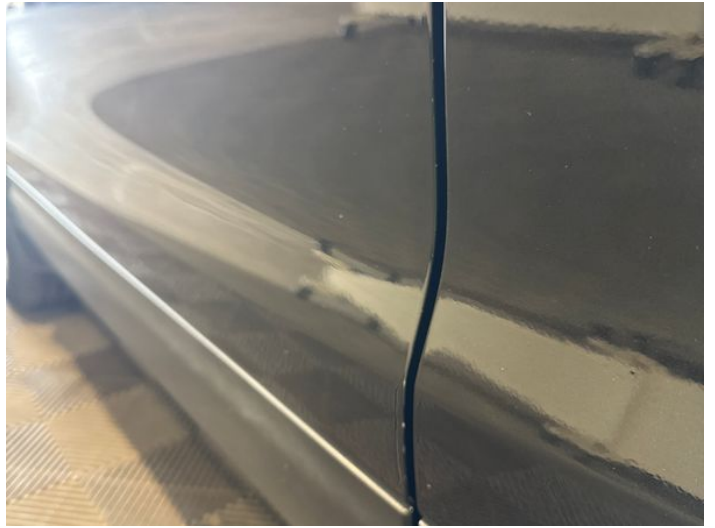
10: Door nsf  
Chipped  
Edge Chip

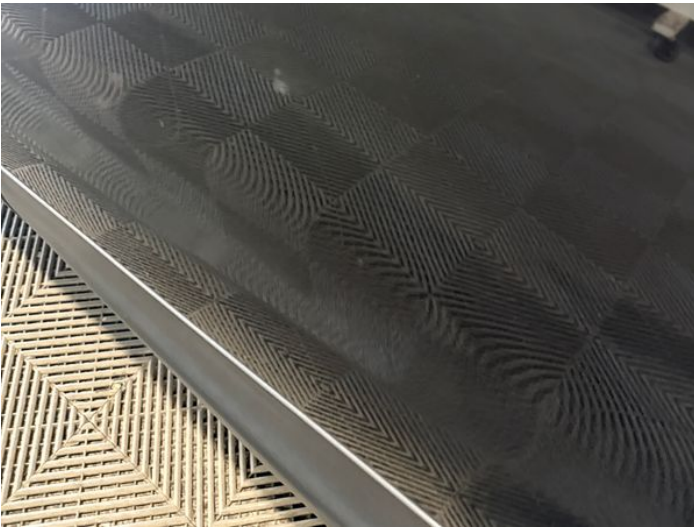
11: Door nsr  
Scratched  
UpTo 25mm Thru Paint

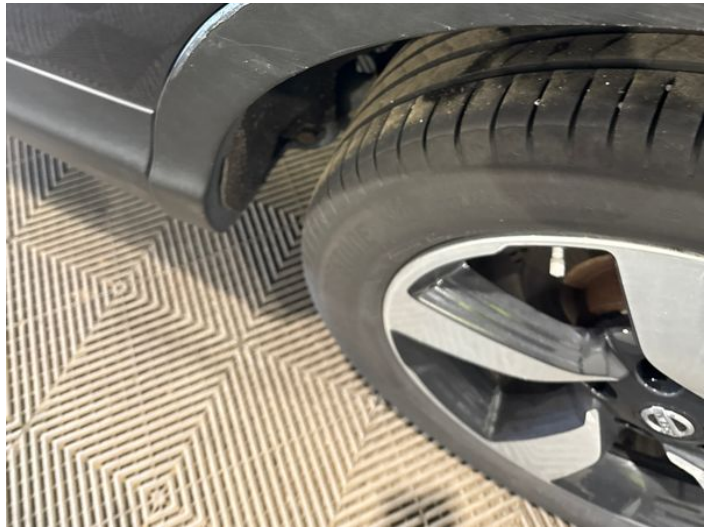
12: Qtr Panel Moulding ns  
Scuffed (Unpainted)  
Over 100mm

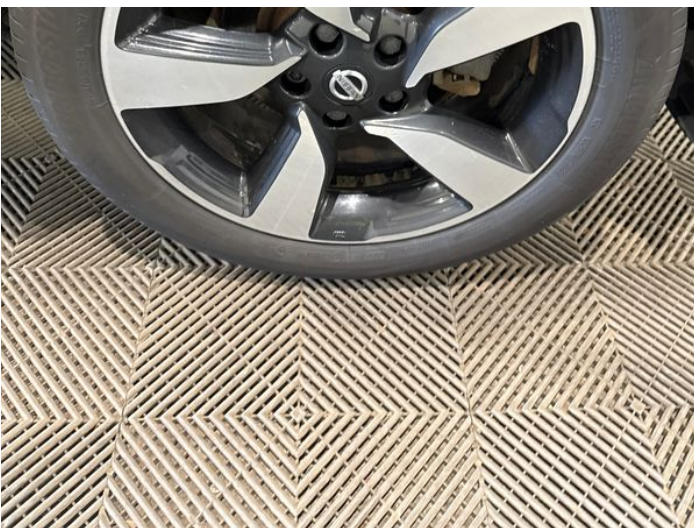
13: Wheel osr  
Scratched  
Over 50mm

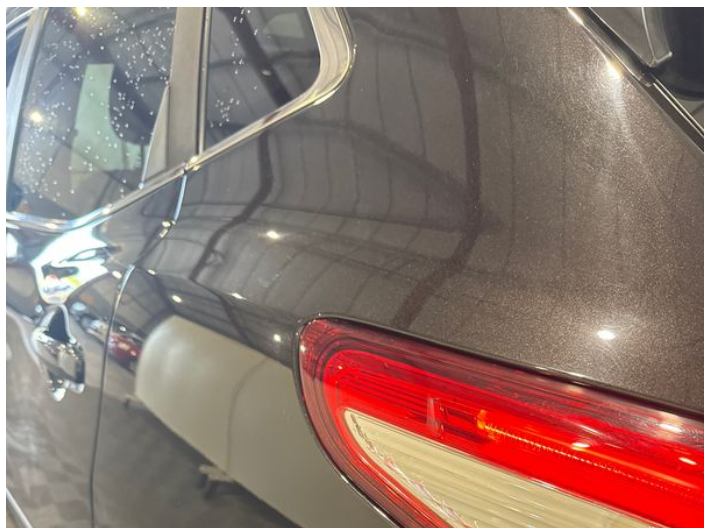
14: Qtr Panel nsr  
Poor Previous Repair  
Rippled UpTo 30%

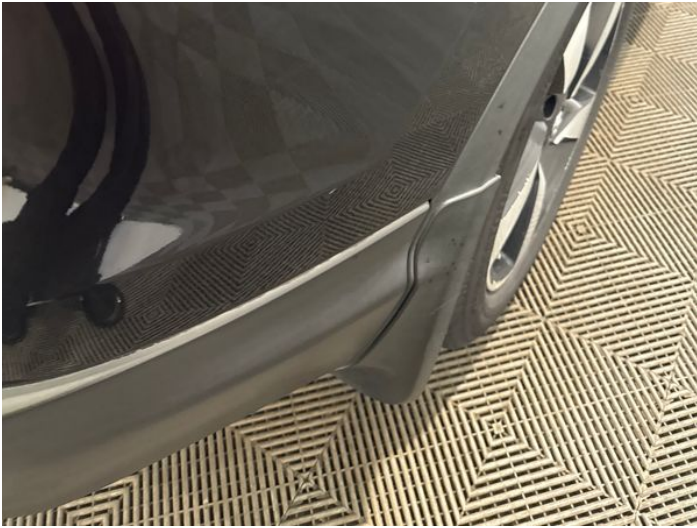
15: Bumper Rear  
Scratched  
Up To 25mm Thru Paint

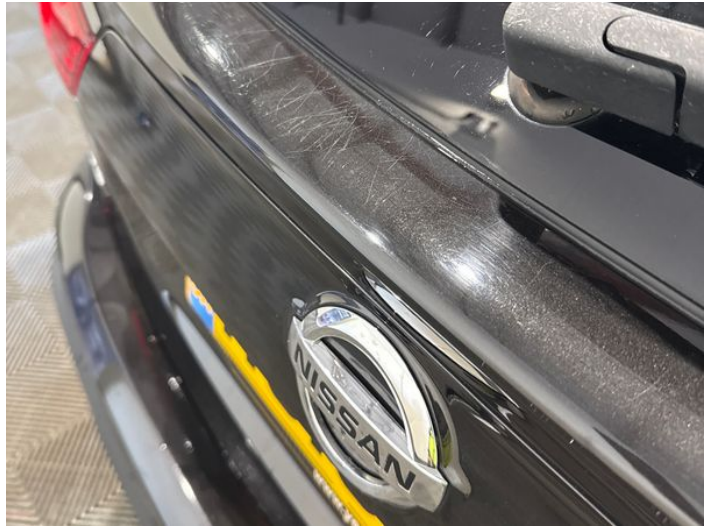
16: Tailgate  
Scratched  
Over 25mm Thru Paint

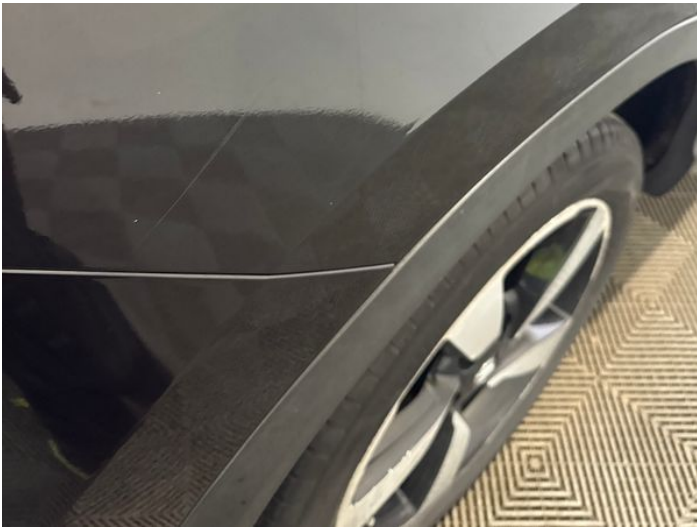
17: Qtr Panel osr  
Scratched  
Over 25mm Thru Paint

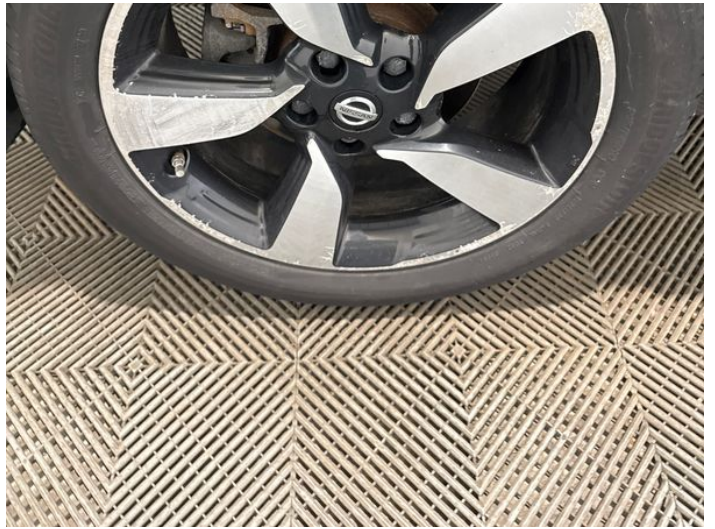
18: Wheel osr  
Scratched  
Over 50mm

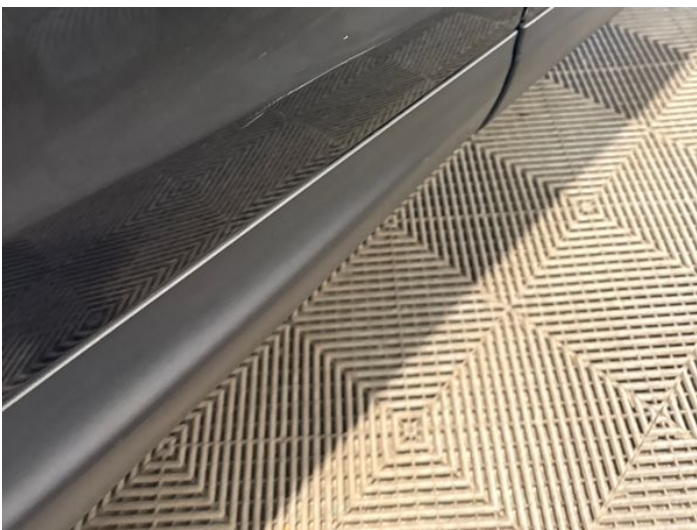
19: Door osr  
Scratched  
Over 25mm Thru Paint

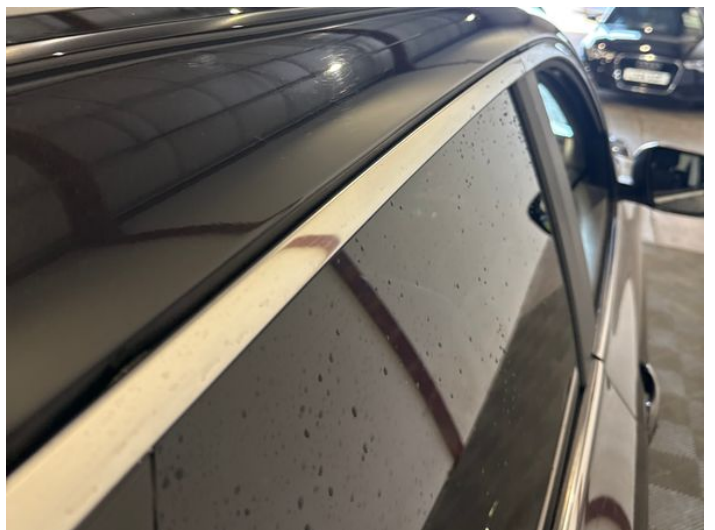
20: B Post os  
Dented  
Between 10mm + 30mm

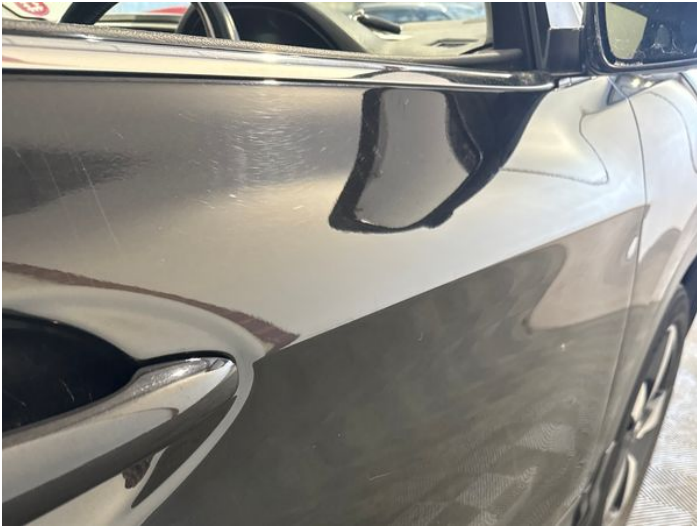
21: Door osf  
Scratched  
Over 25mm Thru Paint

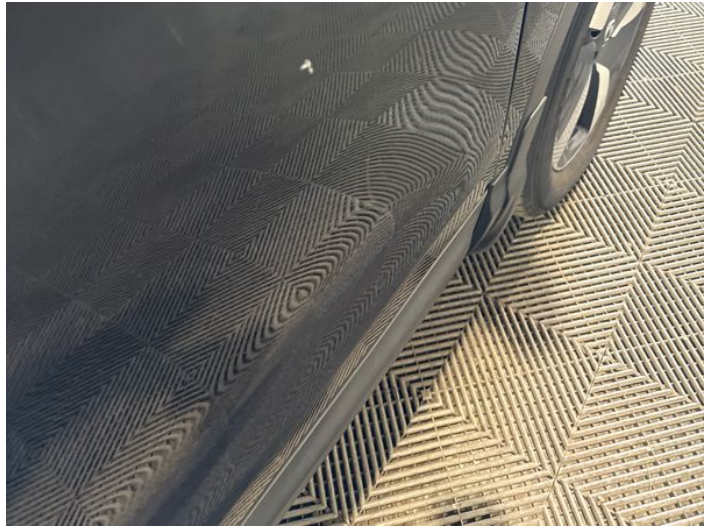
22: Door osf  
Dented  
2 Or Less UpTo 10mm

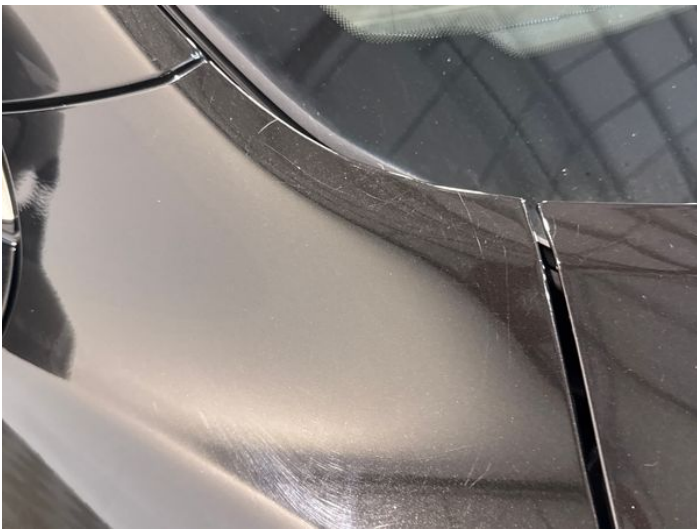
23: Wing osf  
Scratched  
UpTo 25mm Thru Paint

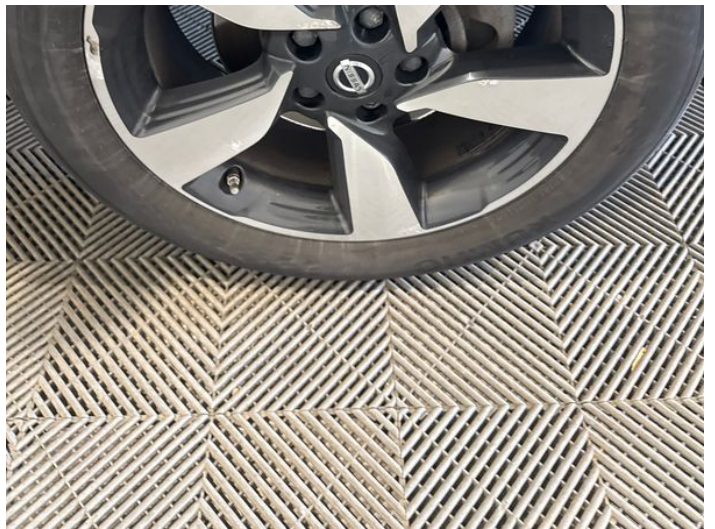
24: Wheel osf  
Scratched  
Over 50mm

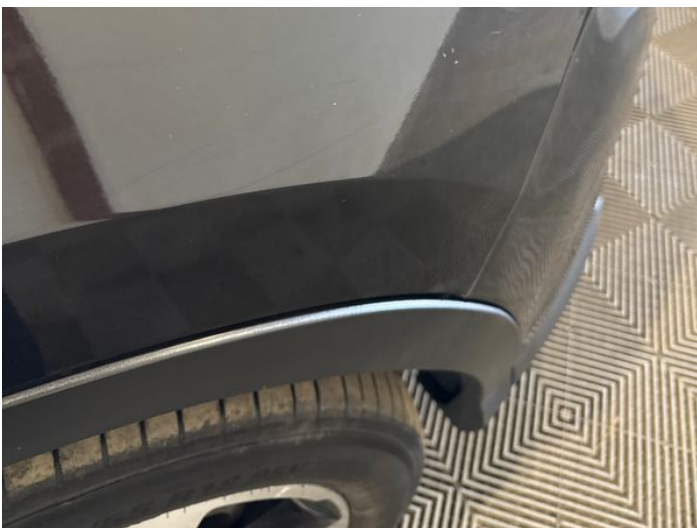
25: Wing osf  
Chipped  
1 To 5

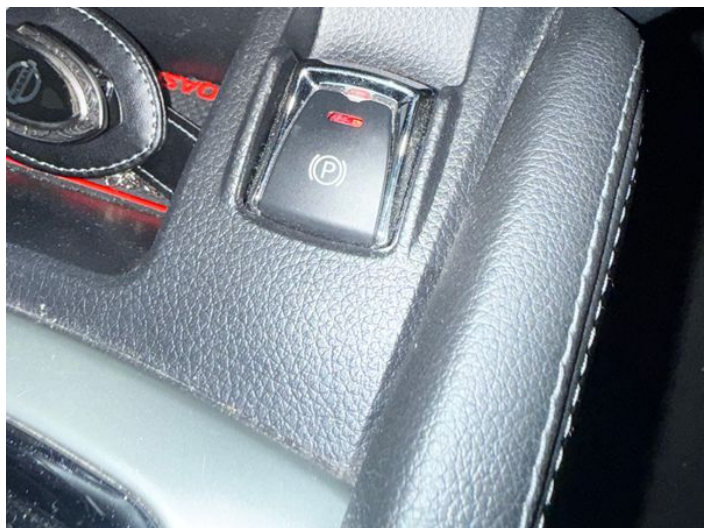
26: Switches And Controls  
Broken  
Replace
