## VEHICLE INSPECTION REPORT

**HN60XBU**

### Volkswagen Tiguan 2.0 TDi Match 5dr DSG

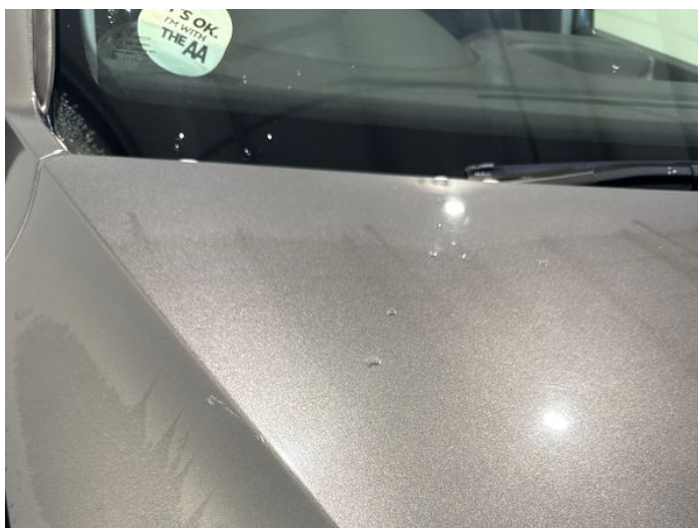
1: Bonnet  
Scratched  
Over 25mm Thru Paint

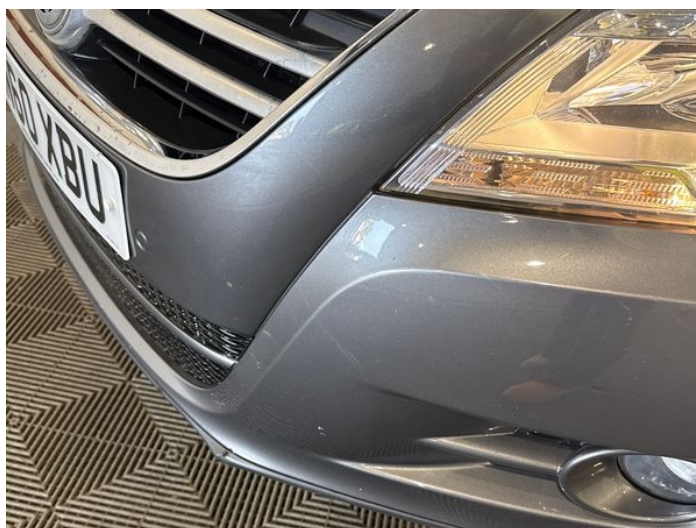
2: Bumper Front  
Scratched  
25 to 100mm Thru Paint

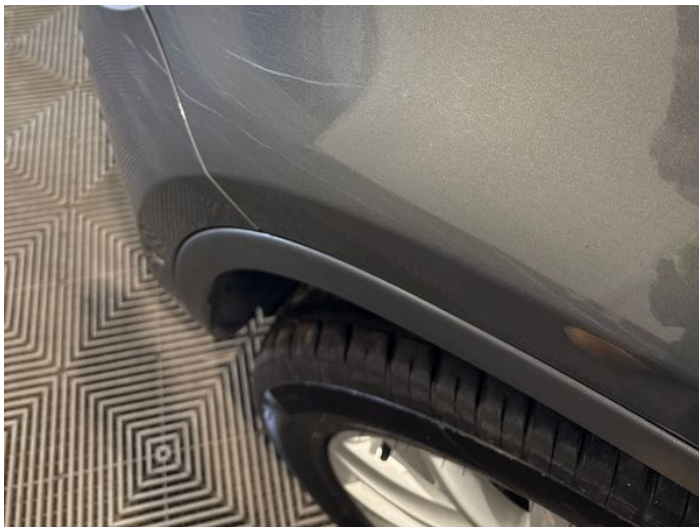
3: Wing nsf  
Scratched  
Over 25mm Thru Paint

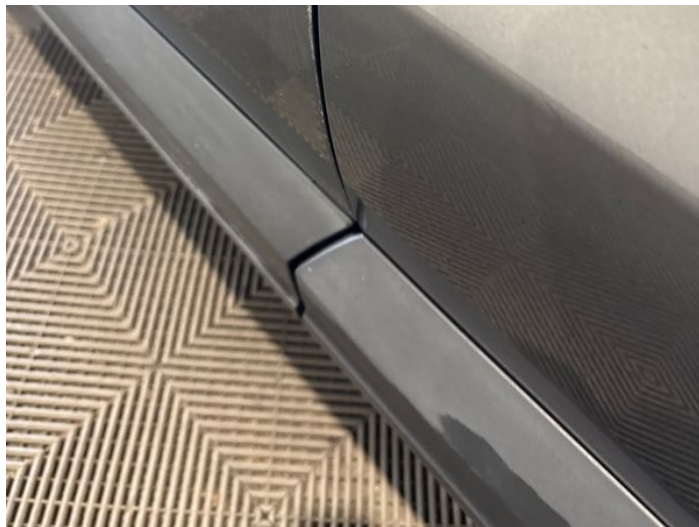
4: Door nsf  
Chipped  
Edge Chip

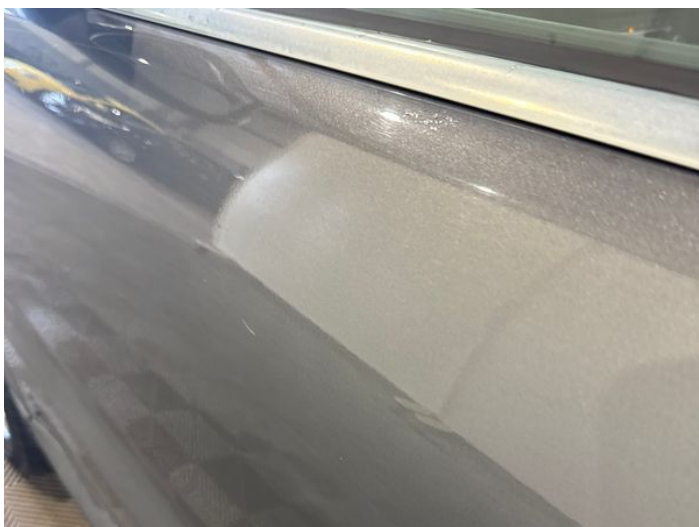
5: Door nsr  
Scratched  
UpTo 25mm Thru Paint

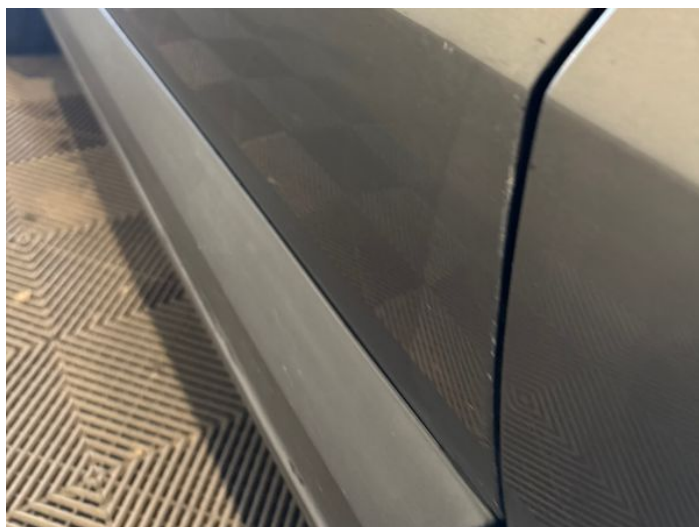
6: Door nsf  
Dented  
Between 10mm + 30mm

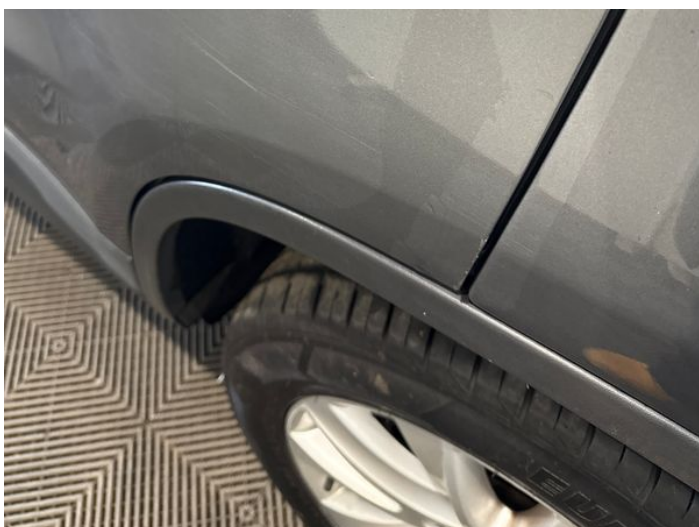
7: Door nsr  
Chipped  
1 To 5

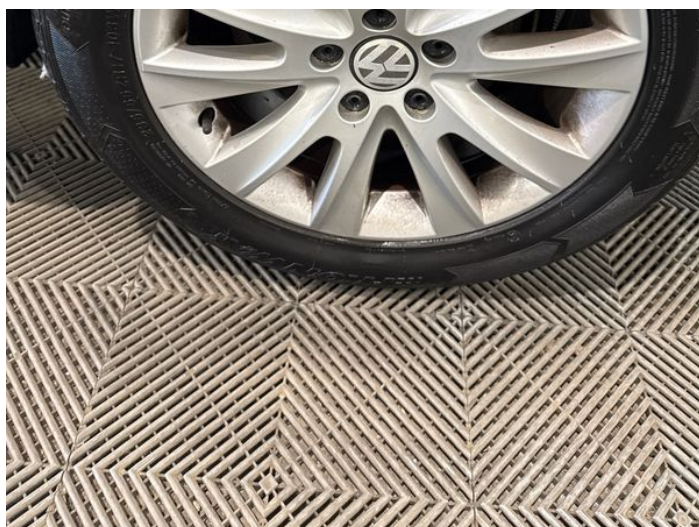
8: Wheel nsr  
Scratched  
Over 50mm

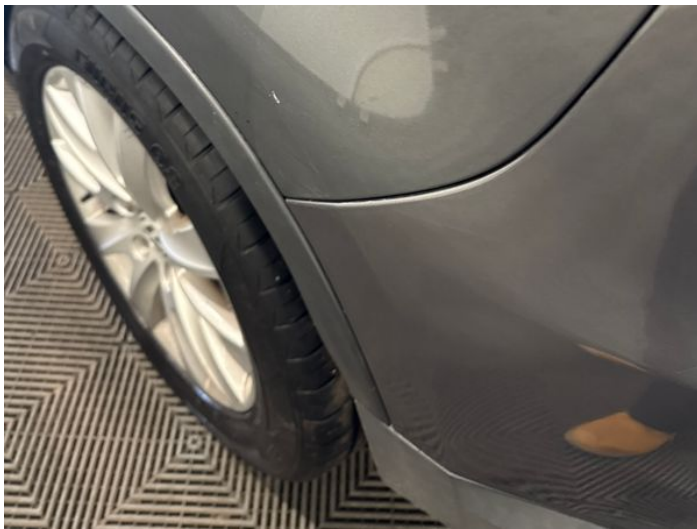
9: Qtr Panel nsr  
Chipped  
Over 5mm

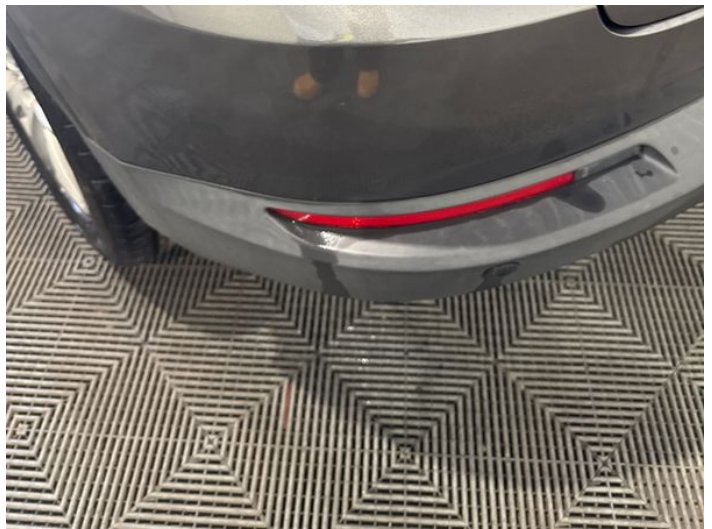
10: Bumper Rear  
Scratched  
25 to 100mm Thru Paint

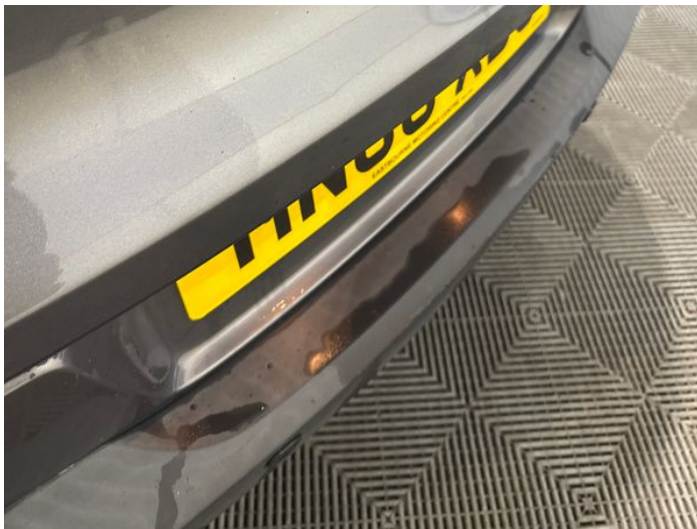
11: Tailgate  
Dented  
Over 30mm

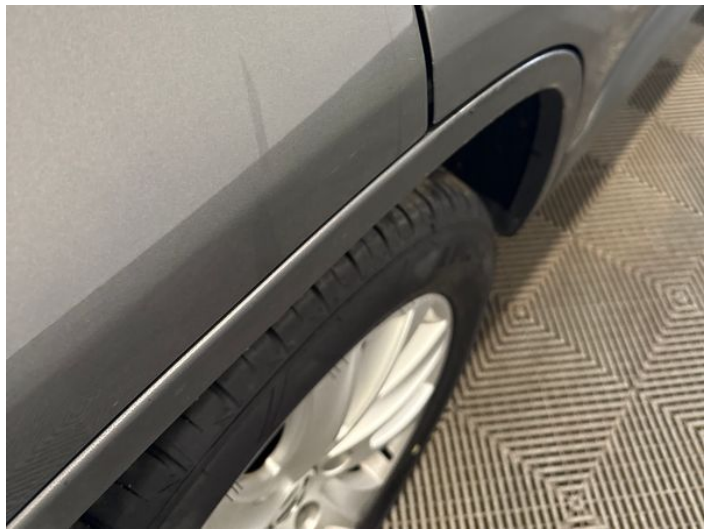
12: Qtr Panel osr  
Dented  
Between 10mm + 30mm

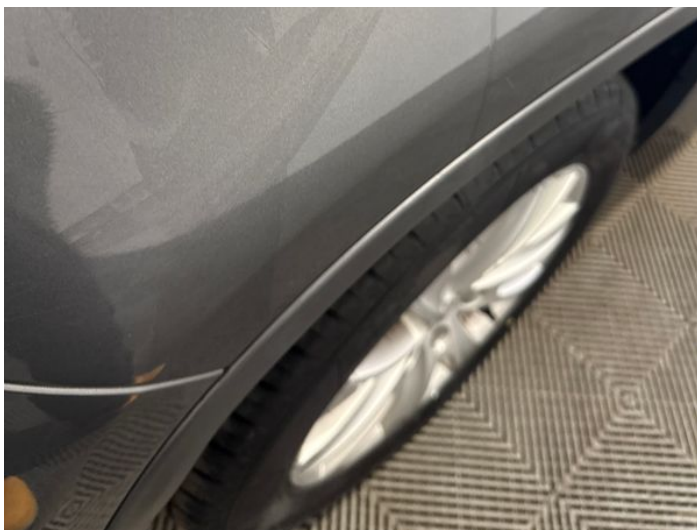
13: Qtr Panel osr  
Scratched  
Up To 25mm Thru Paint

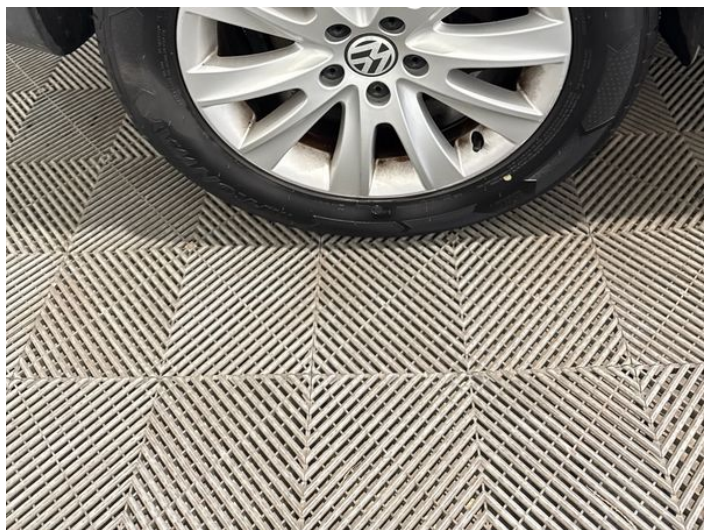
14: Wheel osr  
Scratched  
Up To 50mm

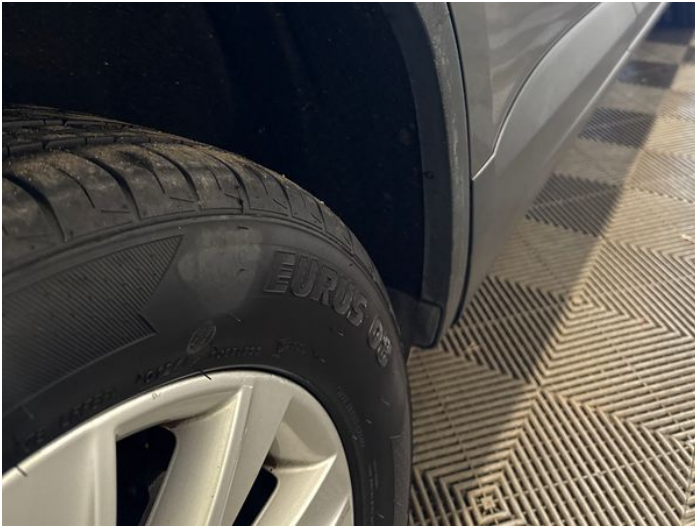
15: Qtr Panel Arch Extension os  
Scuffed (Unpainted)  
Over 100mm

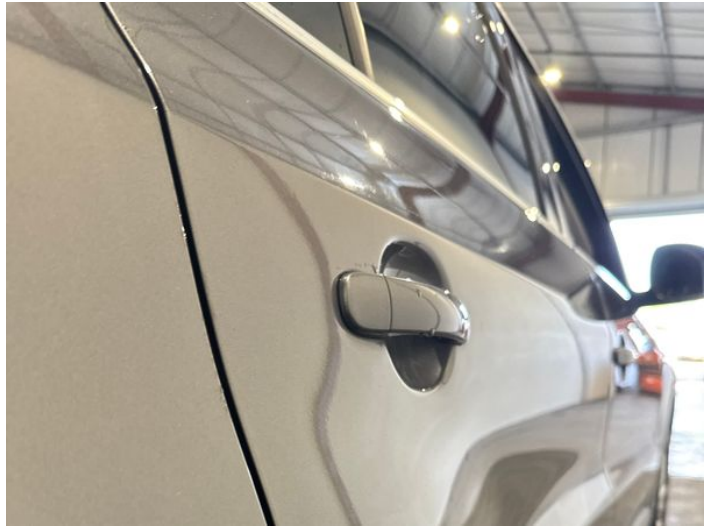
16: Door osr  
Chipped  
Edge Chip

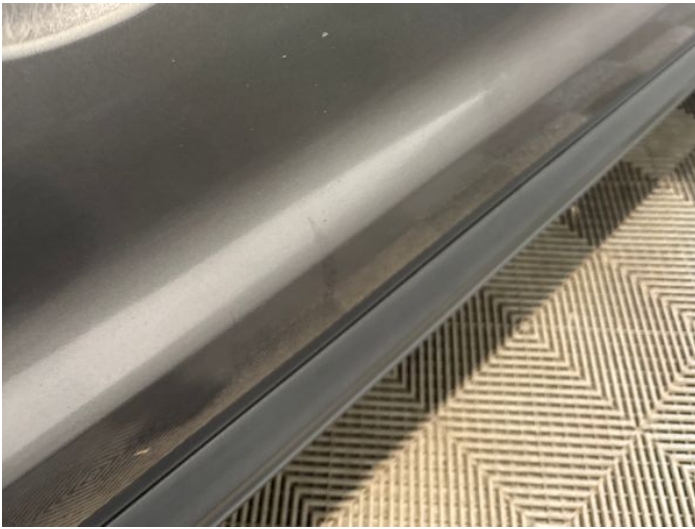
17: Door osf  
Chipped  
1 To 5

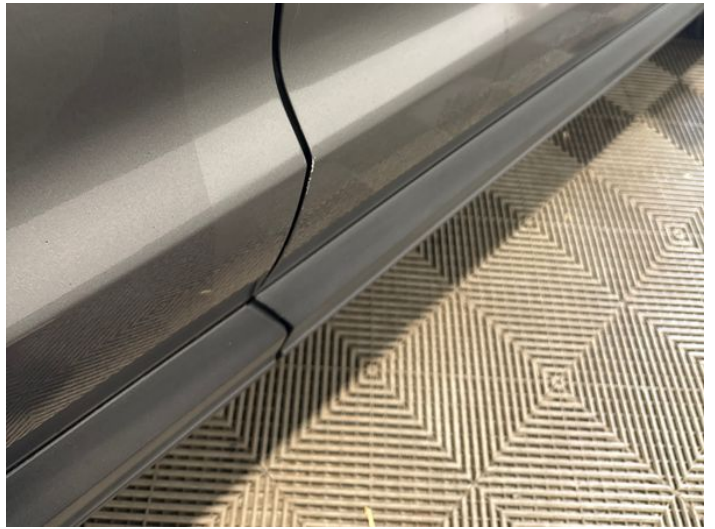
18: Door osf  
Chipped  
Edge Chip

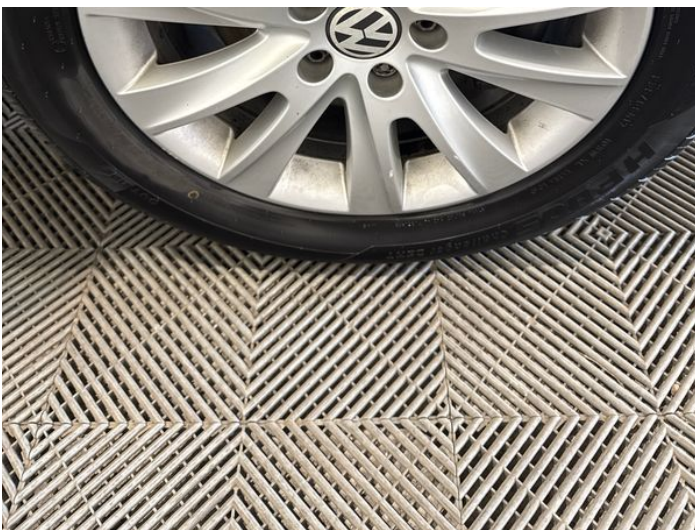
19: Wheel osf  
Scratched  
Over 50mm

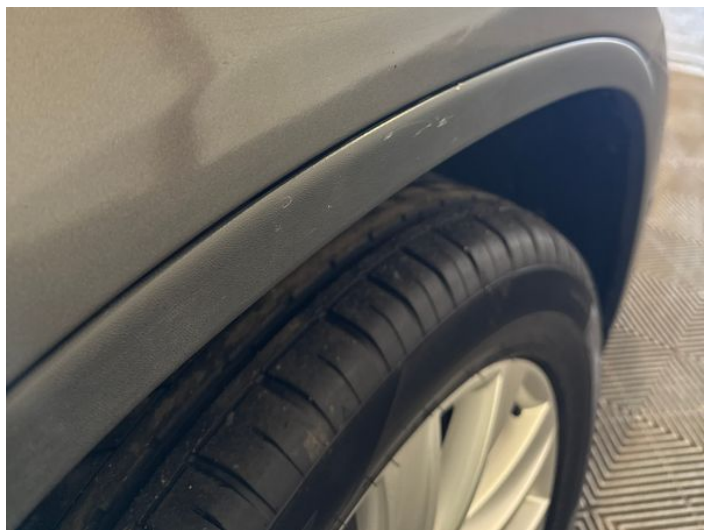
20: Wing osf  
Poor Previous Repair  
Rippled UpTo 30%
