# VEHICLE INSPECTION REPORT

**GU17EKB**

## Toyota Auris 1.8 Hybrid Excel TSS 5dr CVT

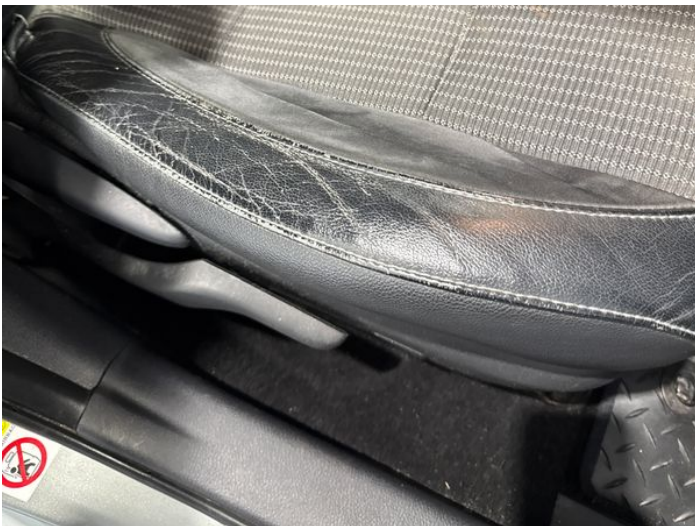
1: Seat Base Cover osf  
Scuffed  
Over 25mm

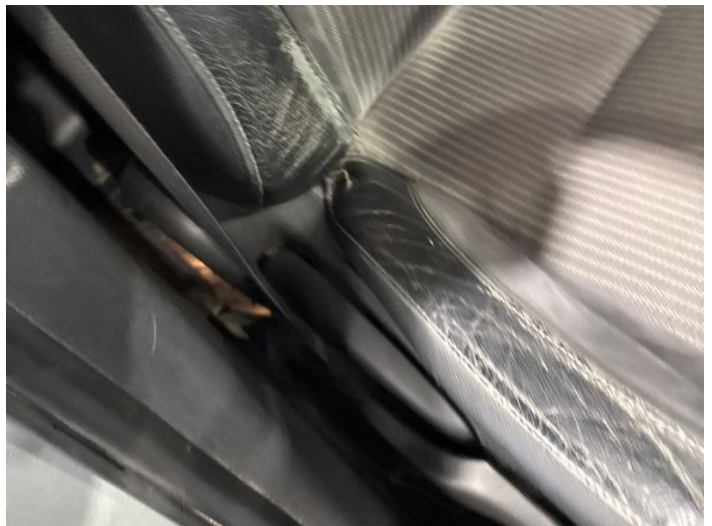
2: Seat Back Cover osf  
Torn  
Over 3mm

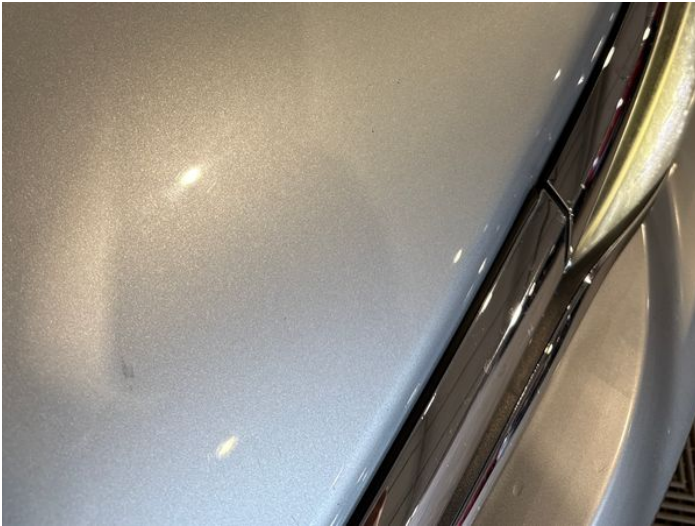
3: Bonnet  
Scratched  
Over 25mm Thru Paint

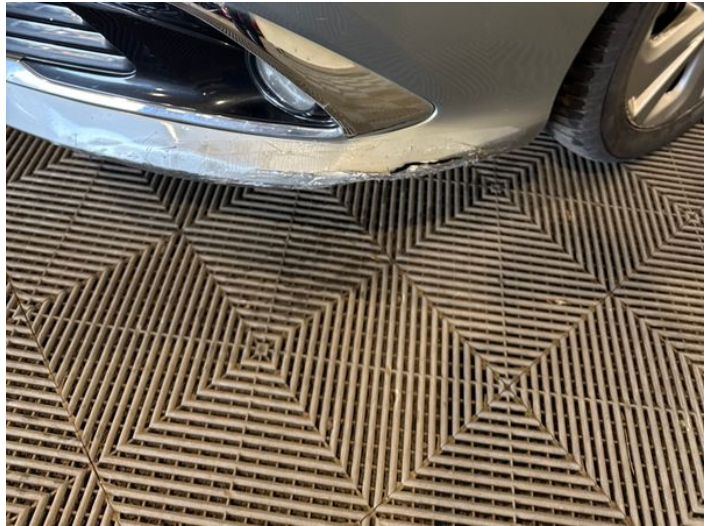
4: Bumper Front  
Cracked  
Over 25mm

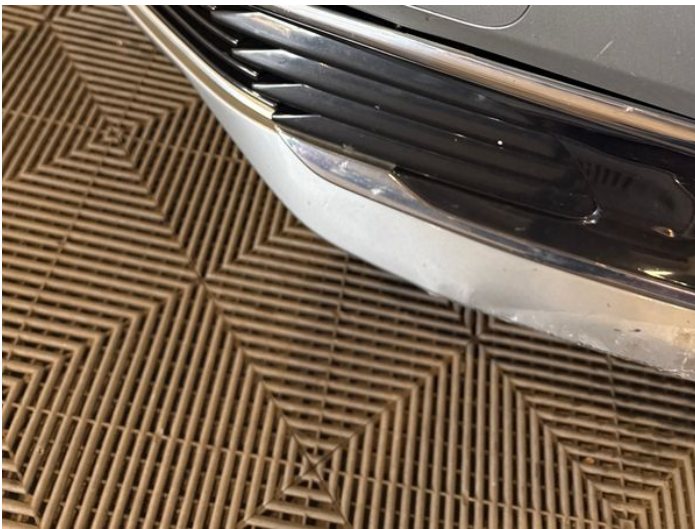
5: Bumper Front Moulding  
Broken  
Replace

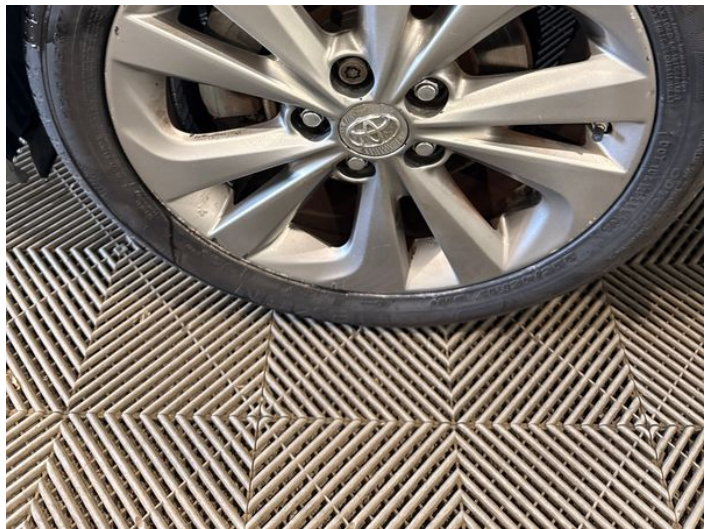
6: Wheel nsf  
Scratched  
Over 50mm

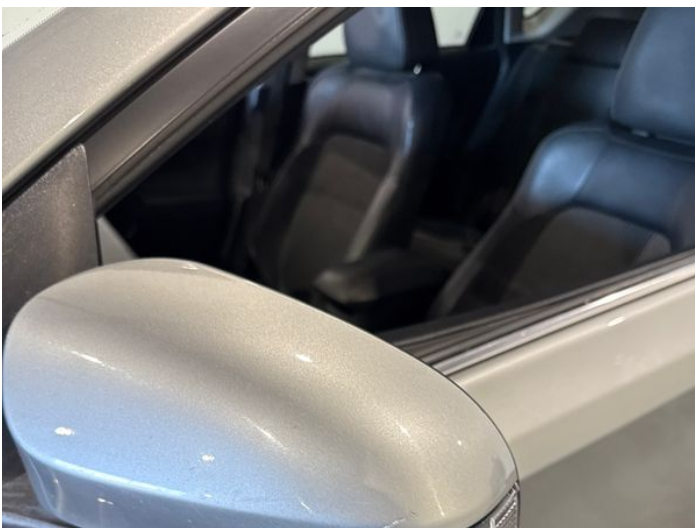
7: Door Mirror Assy nsf  
Scratched (Painted)  
UpTo 25mm Thru Paint

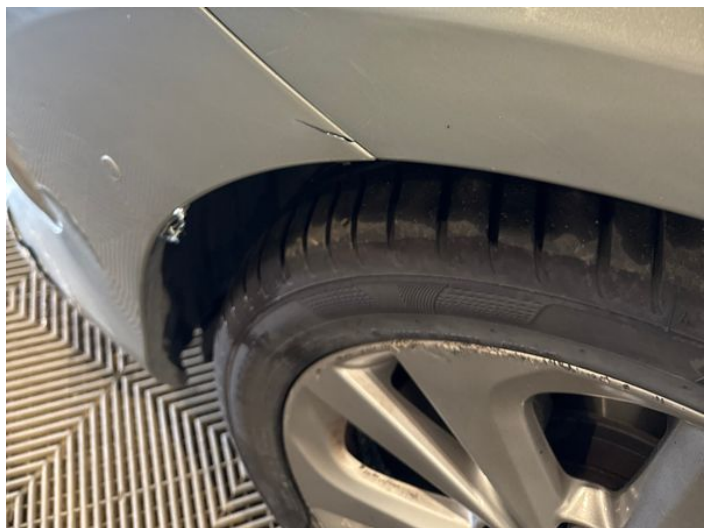
8: Wing nsf  
Scratched  
UpTo 25mm Thru Paint

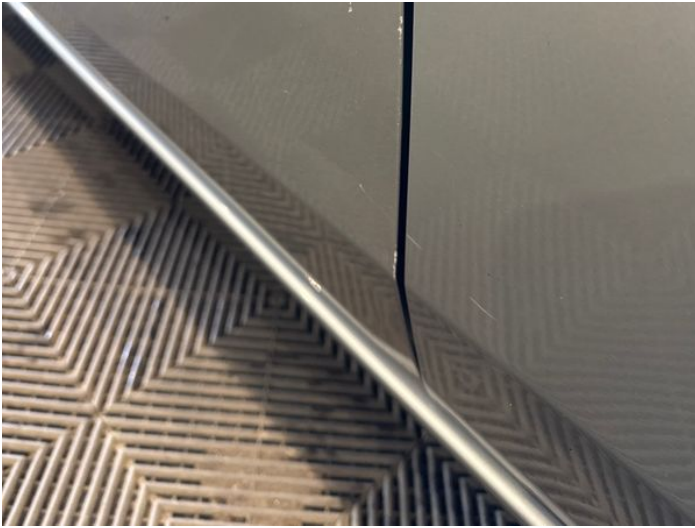
9: Door nsf  
Scratched  
Over 25mm Thru Paint

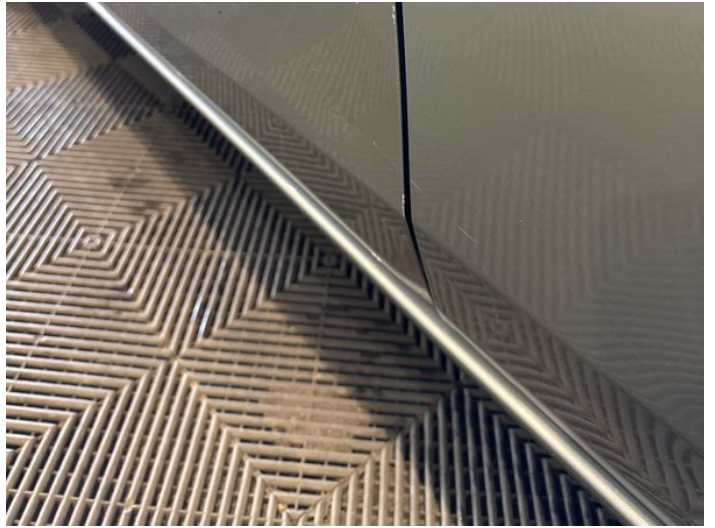
10: Door nsf  
Dented  
Between 10mm + 30mm

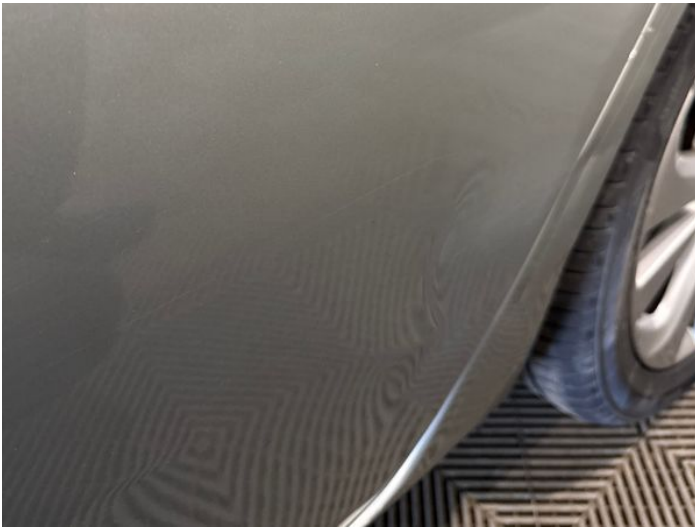
11: Door nsr  
Dented  
Over 30mm

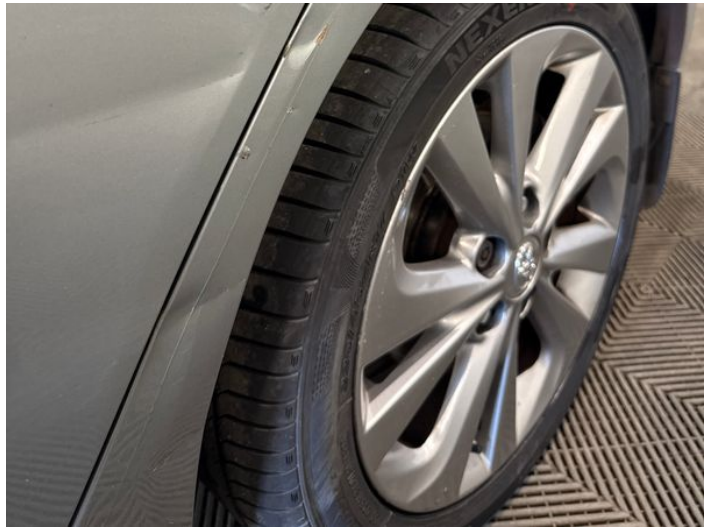
12: Qtr Panel nsr  
Dented  
With Paint Damage

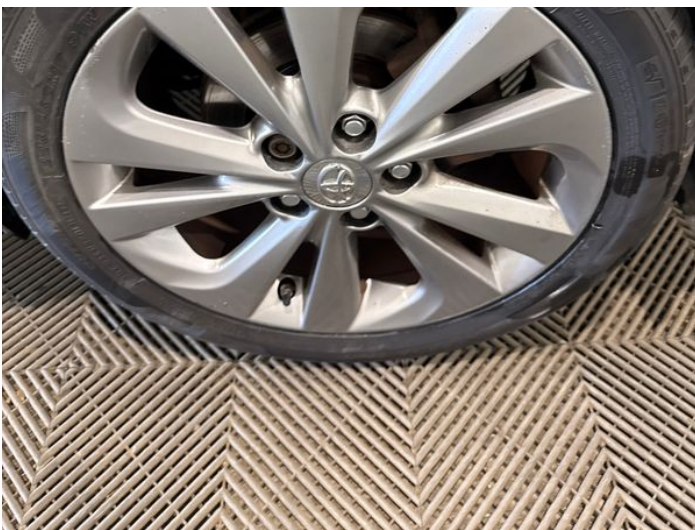
13: Wheel nsr  
Scratched  
Over 50mm

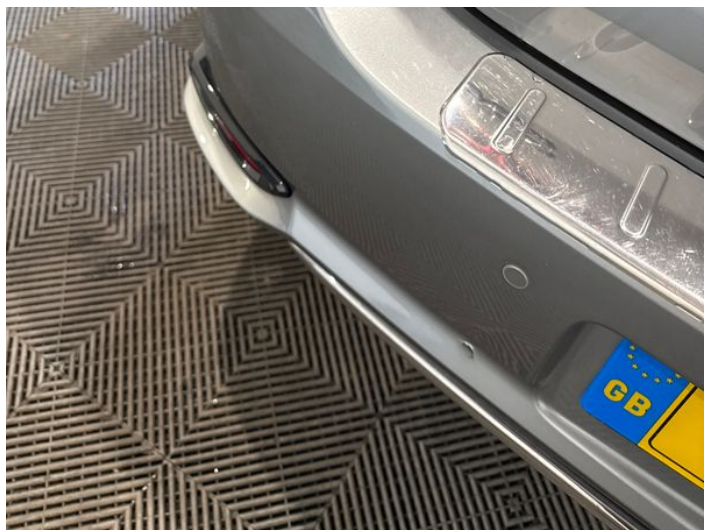
14: Bumper Rear  
Dented  
With Paint Damage

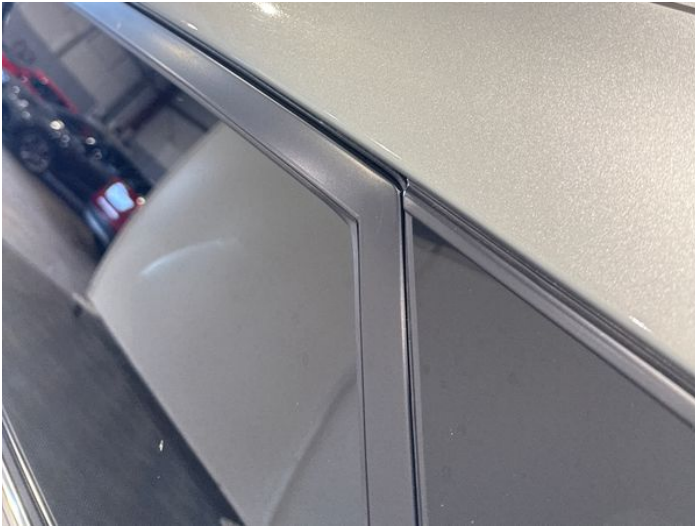
15: B Post ns  
Poor Previous Repair  
Poor Paint

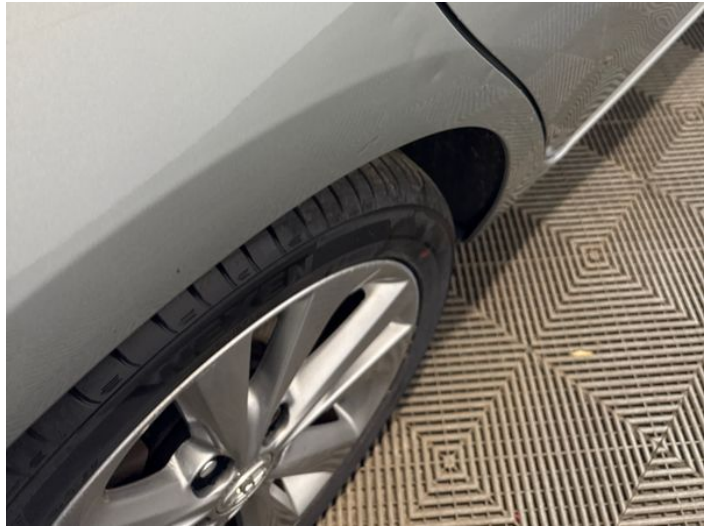
16: Qtr Panel osr  
Dented  
Over 30mm

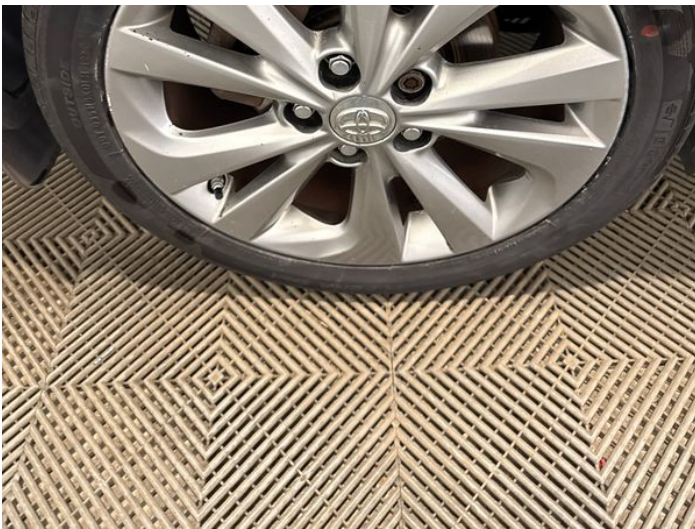
17: Wheel osr  
Scratched  
Over 50mm

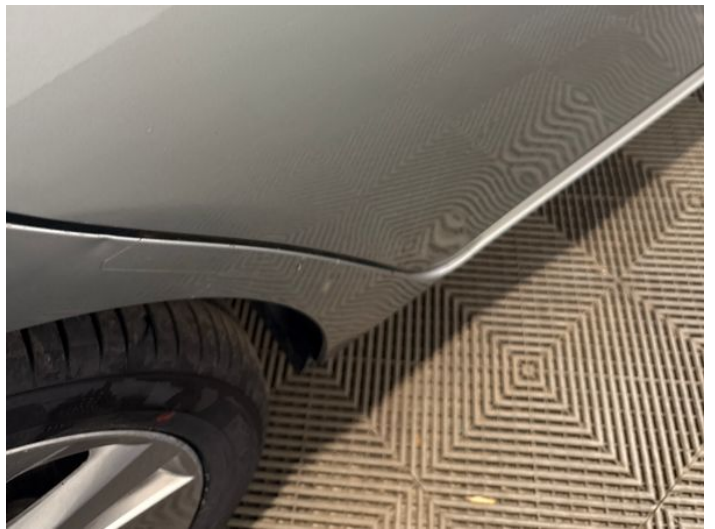
18: Door osr  
Scratched  
Over 25mm Thru Paint

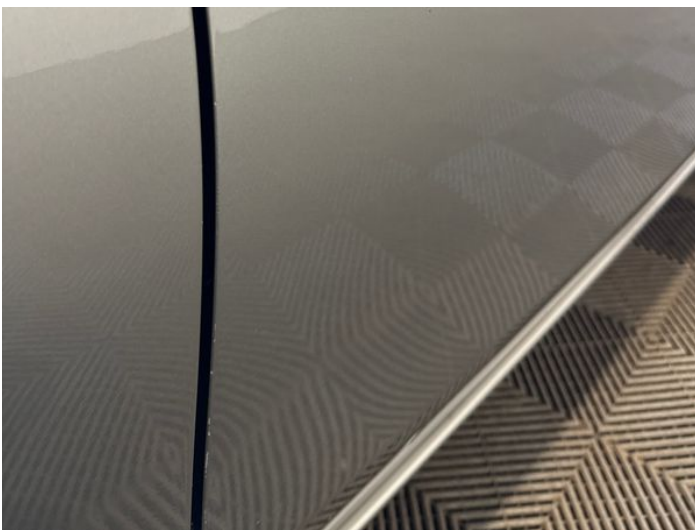
19: Door osf  
Dented  
Between 10mm + 30mm

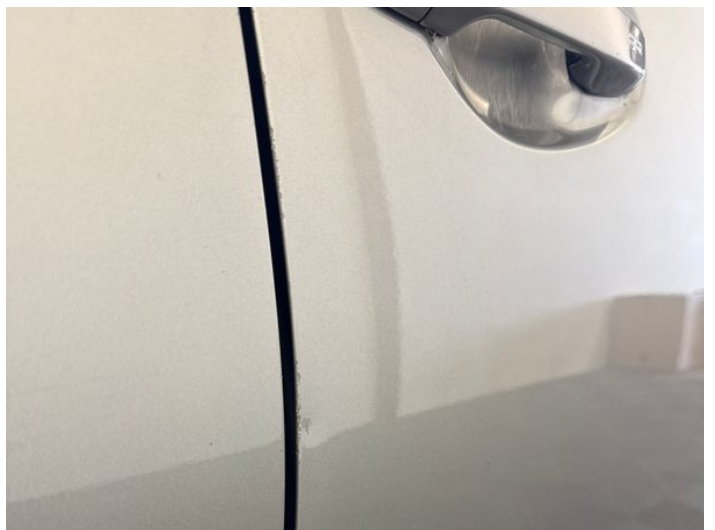
20: Door osf  
Chipped  
Edge Chip

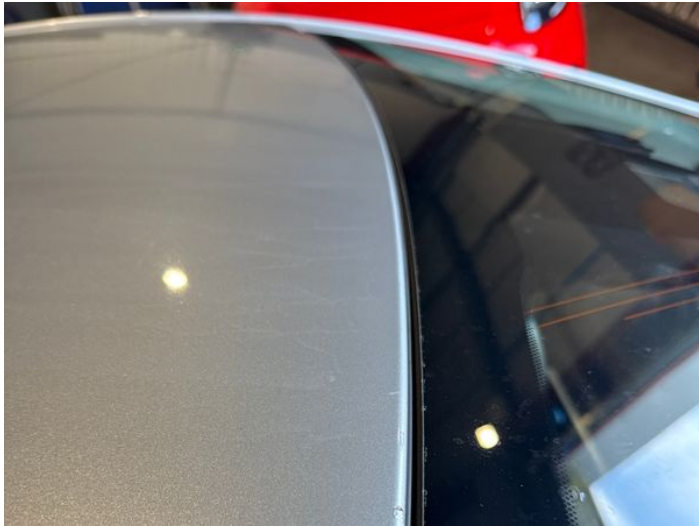
21: Roof  
Chipped  
Edge Chip
