# VEHICLE INSPECTION REPORT

**LE69GCY**

## MG Mg Hs EXCLUSIVE DCT

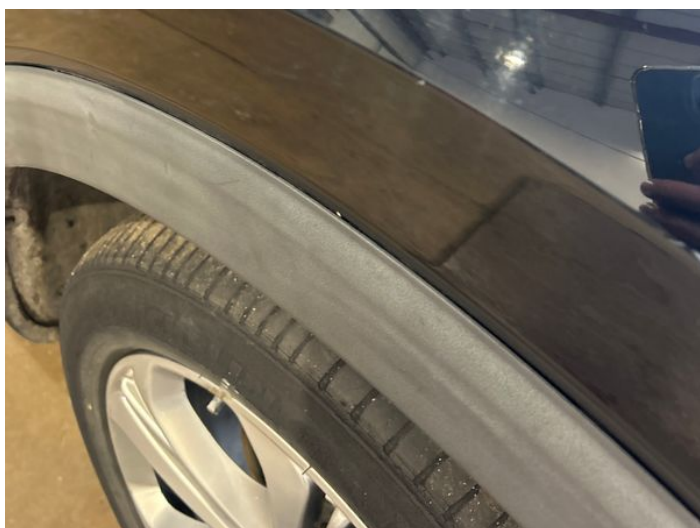
1: Wing osf  
Chipped  
1 To 5

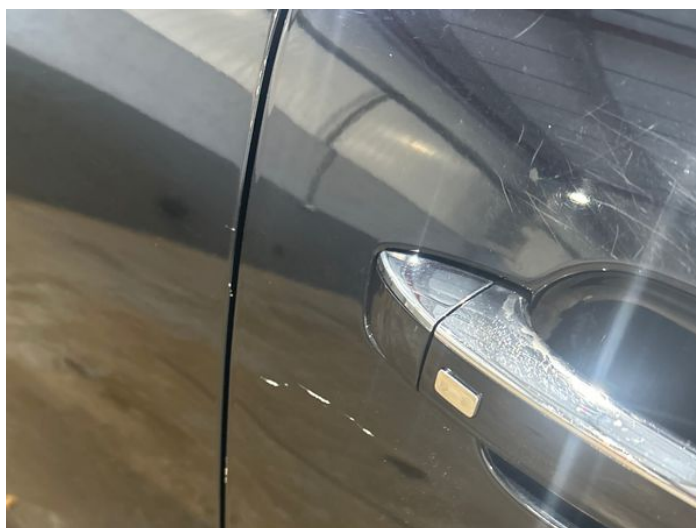
2: Door osf  
Scratched  
Over 25mm Thru Paint

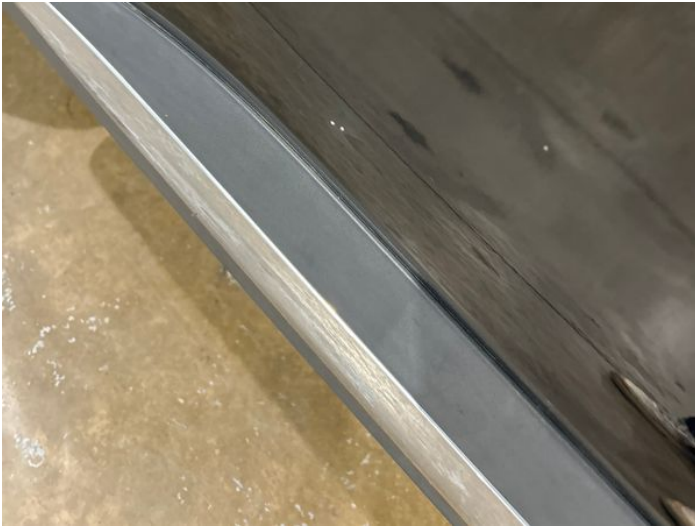
3: Door osr  
Chipped  
1 To 5

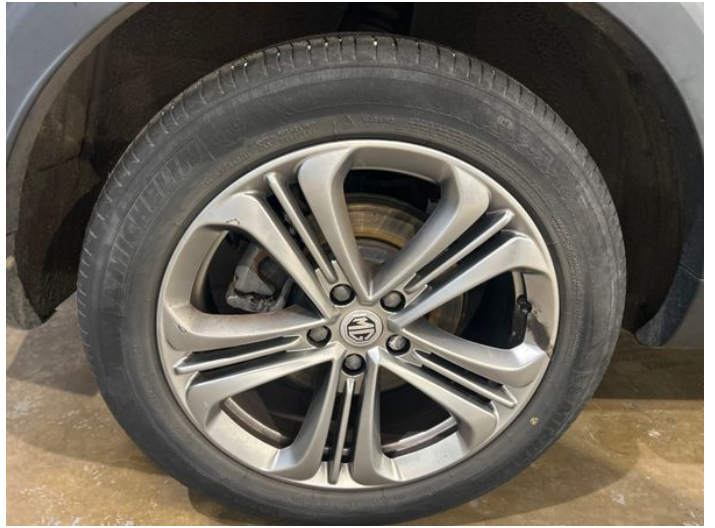
4: Wheel osr  
Scratched  
Over 50mm

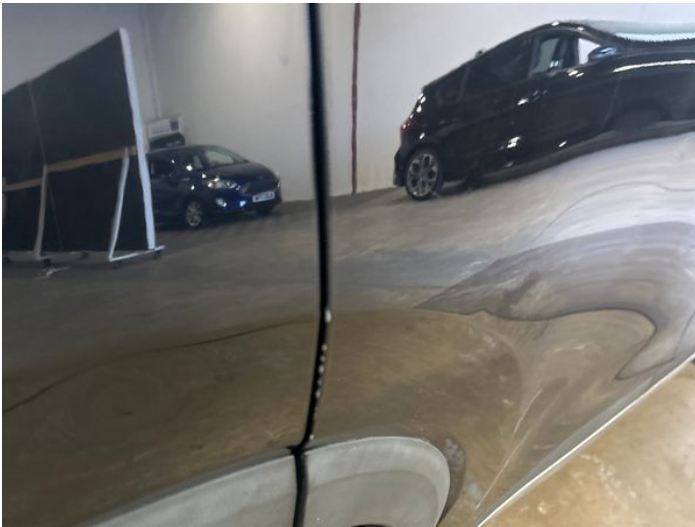
5: Door osr  
Chipped  
Edge Chip

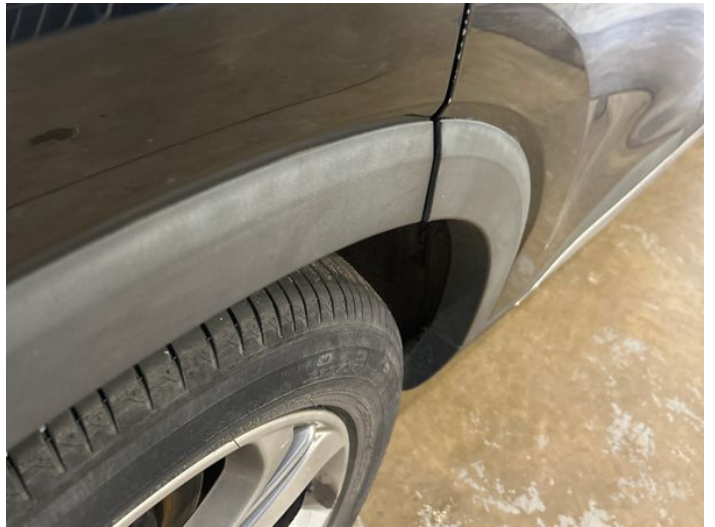
6: Qtr Panel osr  
Dented  
Between 10mm + 30mm

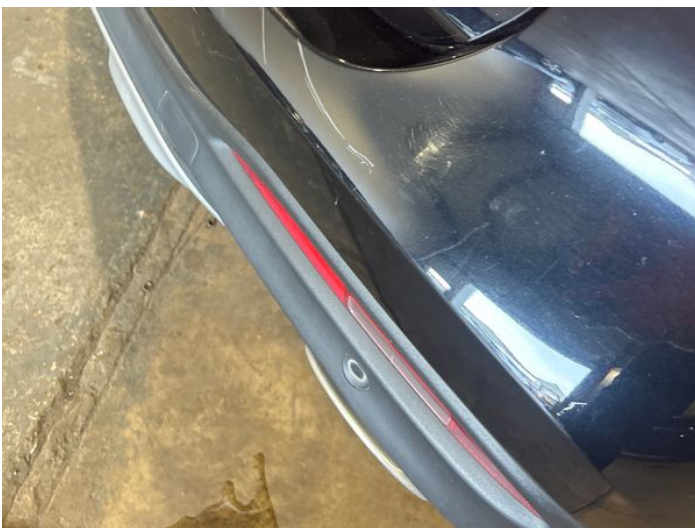
7: Bumper Rear  
Scratched  
25 to 100mm Thru Paint

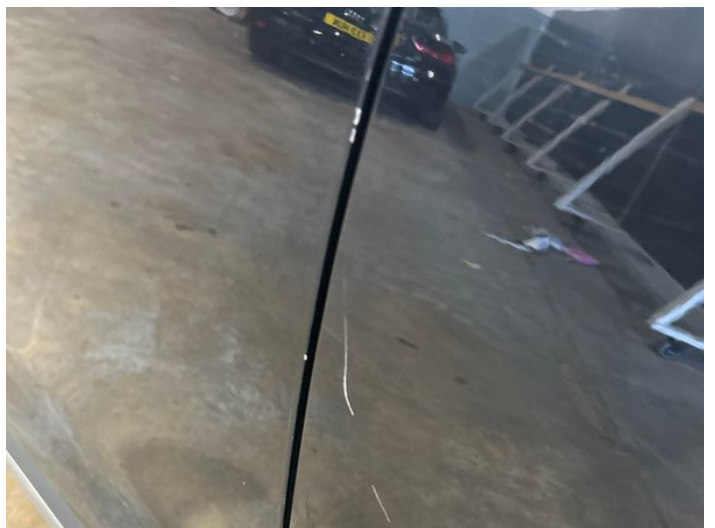
8: Door nsr  
Scratched  
Over 25mm Thru Paint

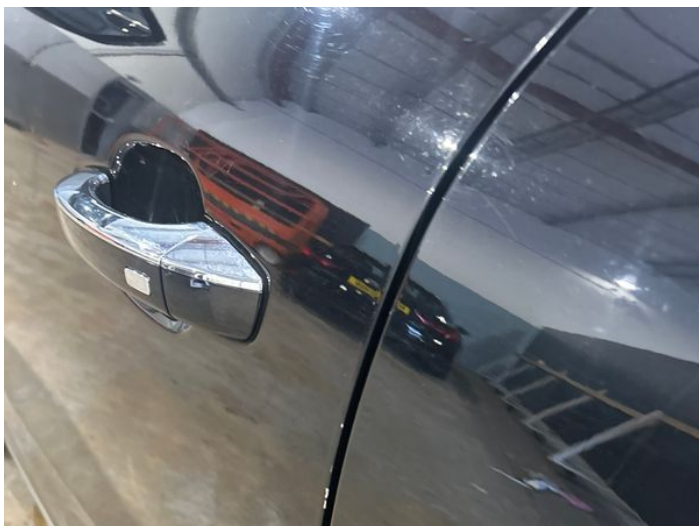
9: Door nsf  
Chipped  
Edge Chip

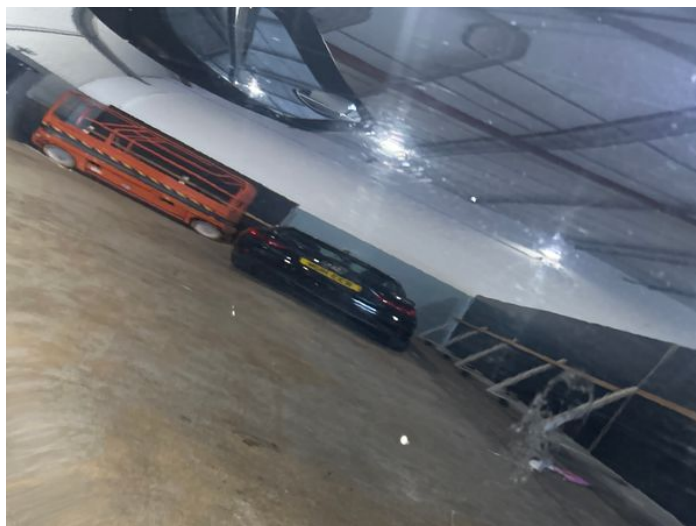
10: Door nsf  
Chipped  
1 To 5

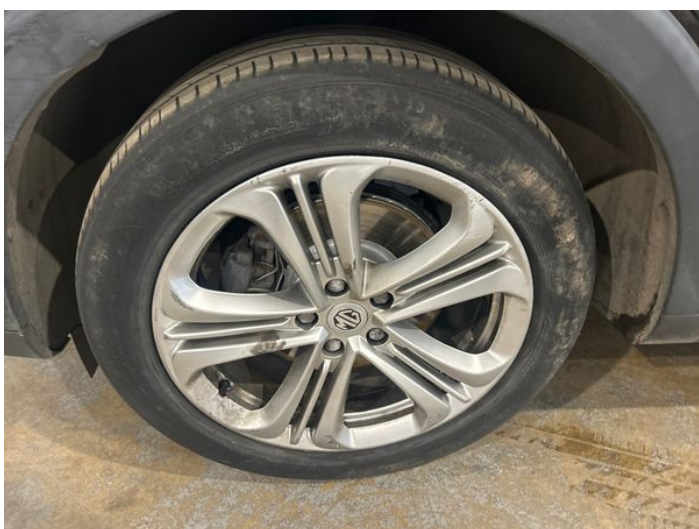
11: Wheel nsf  
Scratched  
Over 50mm

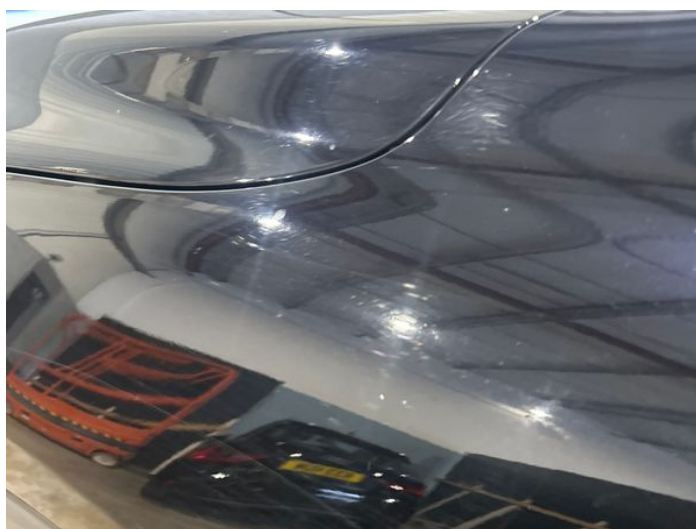
12: Wing nsf  
Chipped  
1 To 5

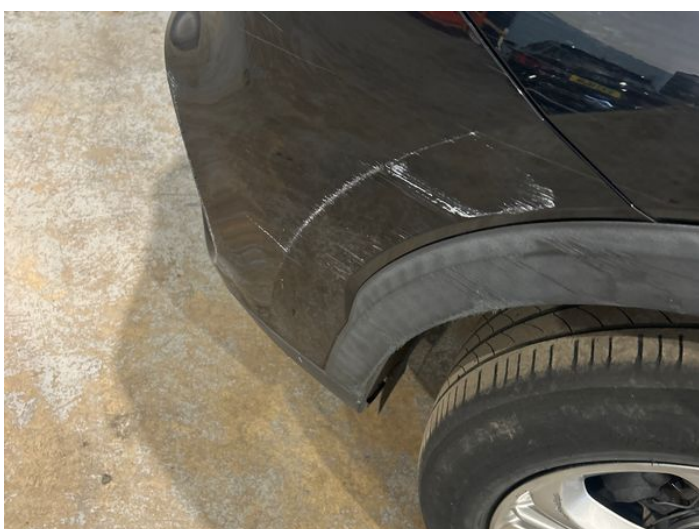
13: Bumper Front  
Scratched  
25 to 100mm Thru Paint

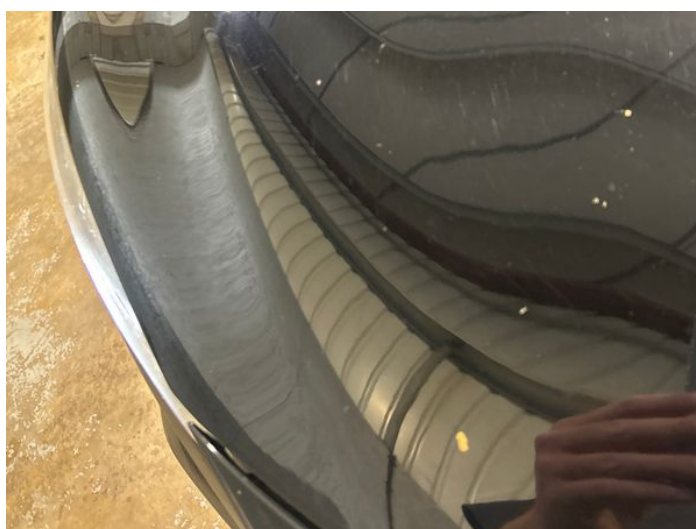
14: Bonnet  
Chipped  
1 To 5

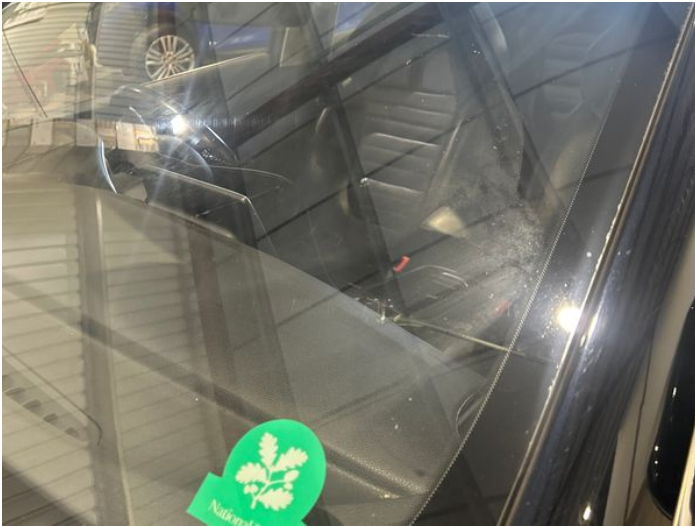
15: Screen Front  
Cracked  
Replace

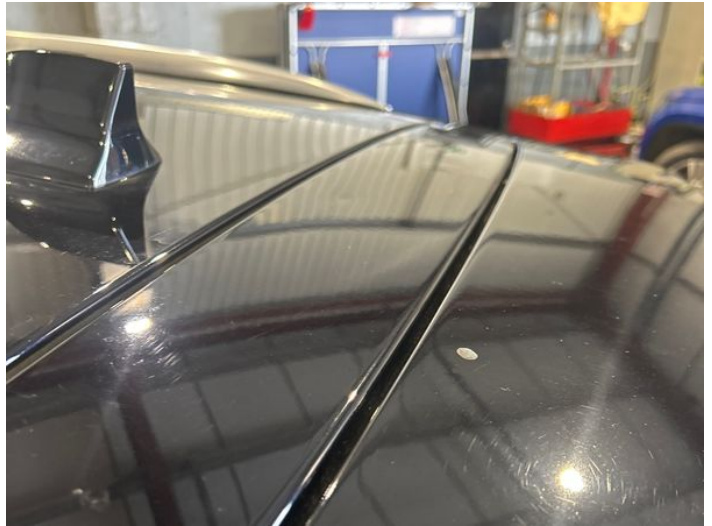
16: Boot Lid  
Dented  
2 Or Less Up To 10mm

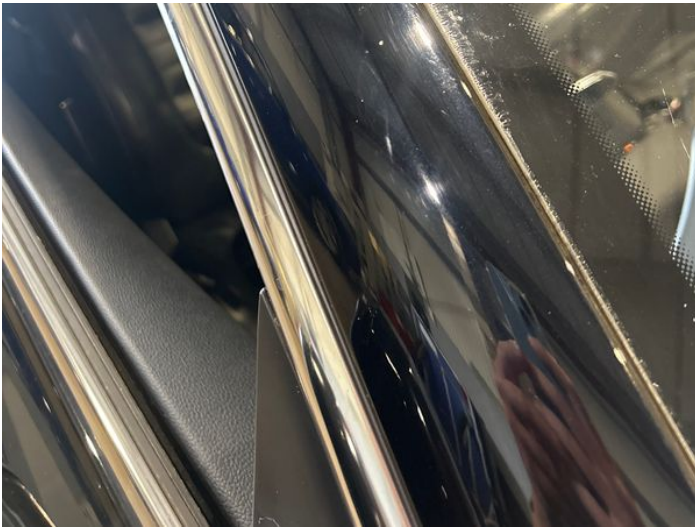
17: A Post os  
Chipped  
1 To 5

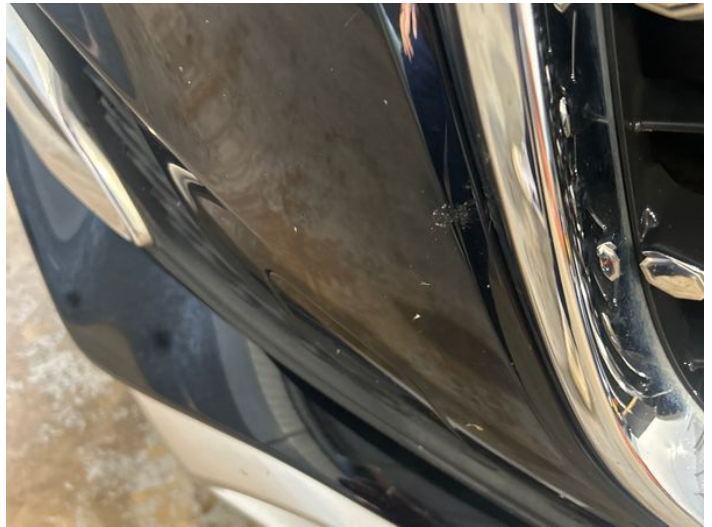
18: Bumper Front  
Chipped  
Multiple Chips

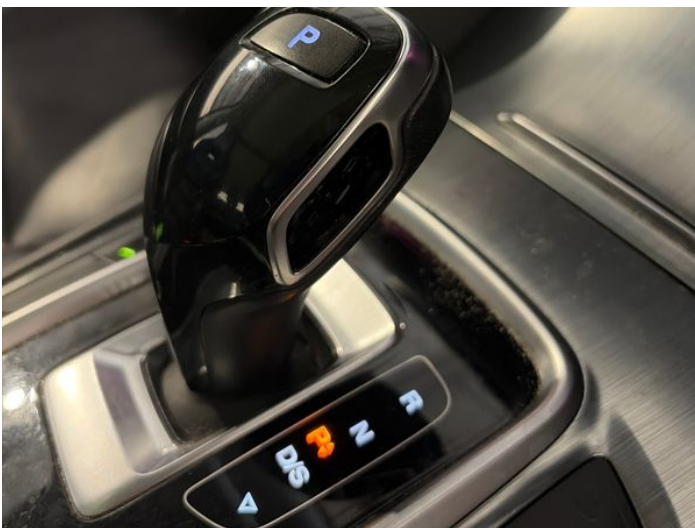
19: Switches And Controls  
Broken  
Replace

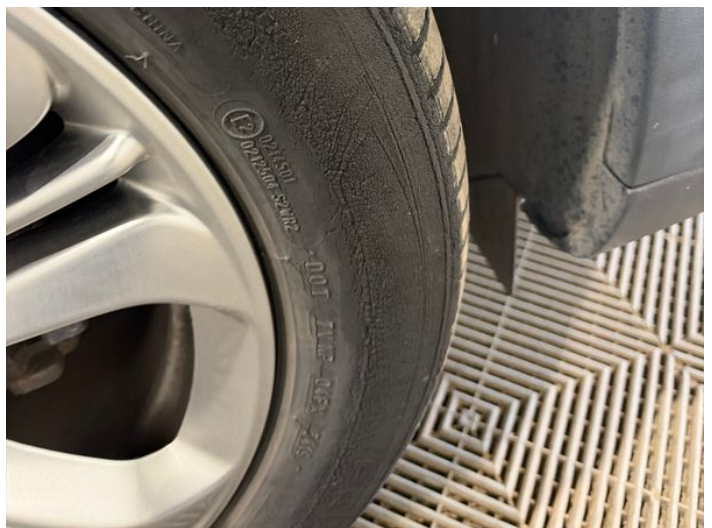
| Tyres | | |
|---|---|---|
| OSF | MICHELIN | Damaged |

20: Tyre osf  
Damaged  
Replace

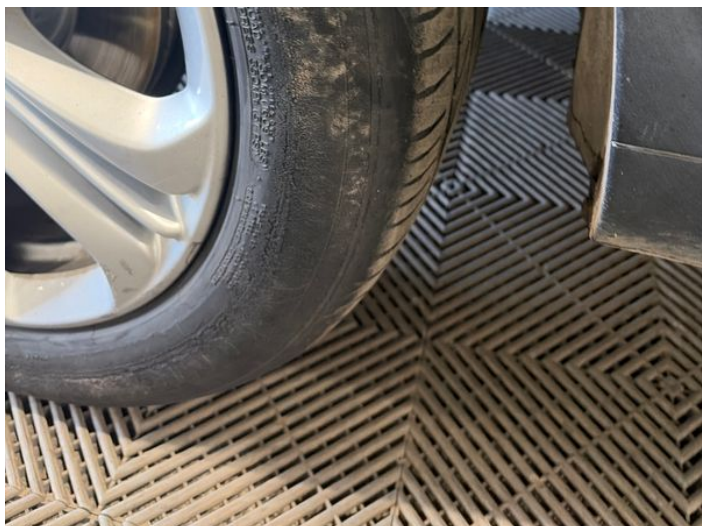
| Tyres | | |
|---|---|---|
| NSF | MICHELIN | Damaged |

21: Tyre nsf  
 Damaged  
 Replace
