# VEHICLE INSPECTION REPORT

**RX66OBE**

## Peugeot 2008 1.2 PureTech Allure 5dr

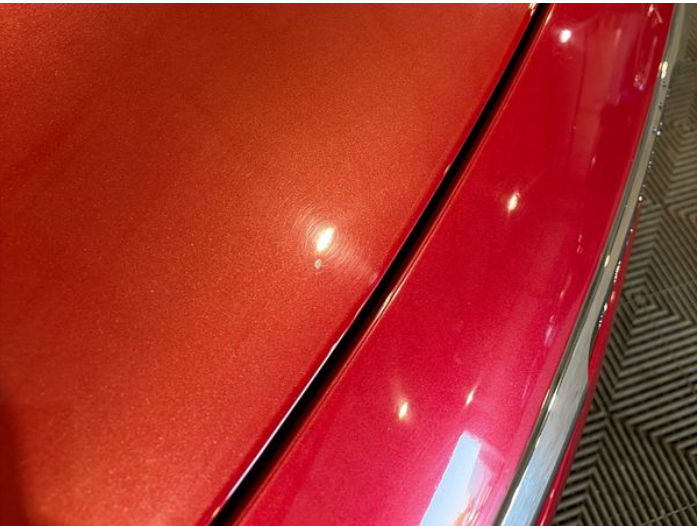
1: Bonnet  
Chipped  
1 To 5

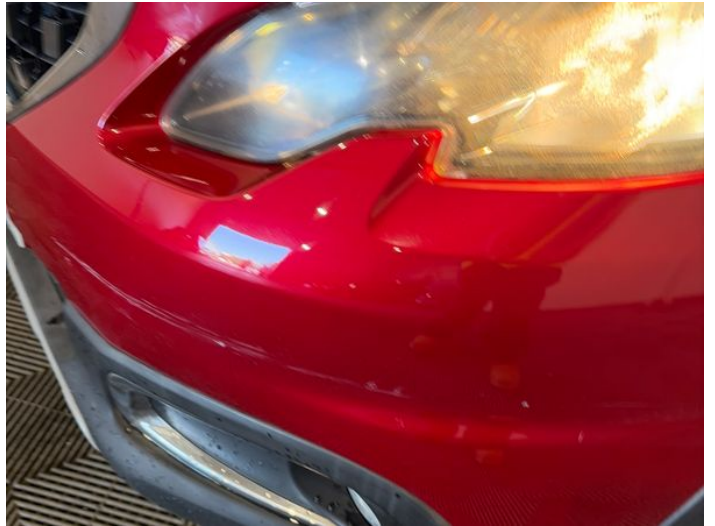
4: Bumper Front  
Scratched  
Over 100mm Thru Paint

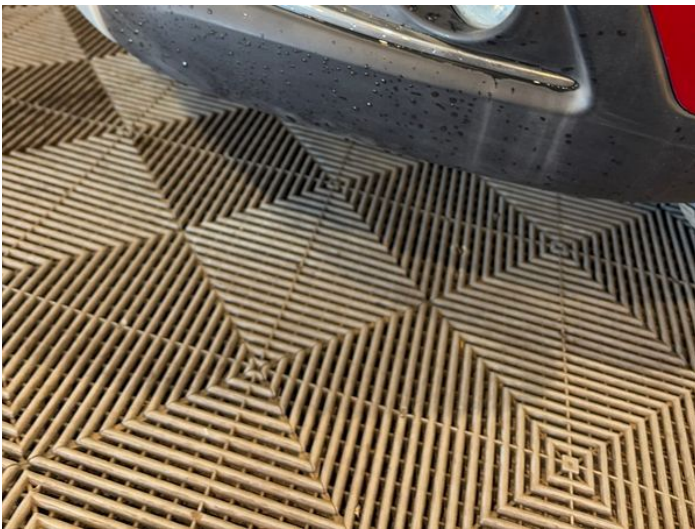
5: Bumper Front Moulding  
Scuffed (Unpainted)  
Over 100mm

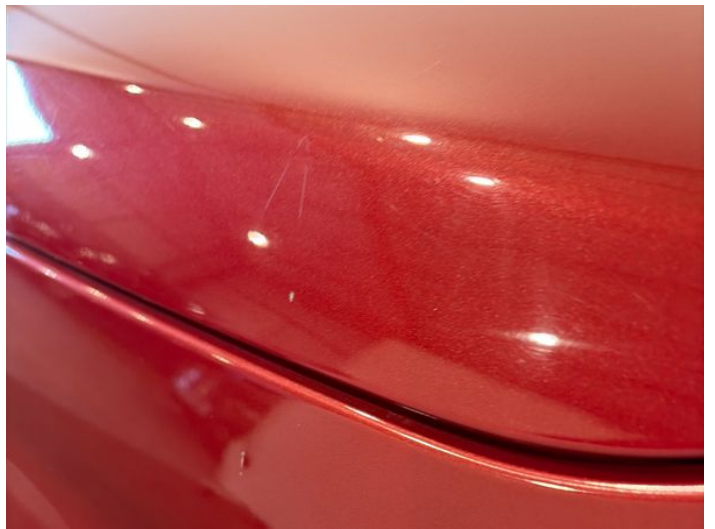
6: Wing nsf  
Dented  
Between 10mm + 30mm

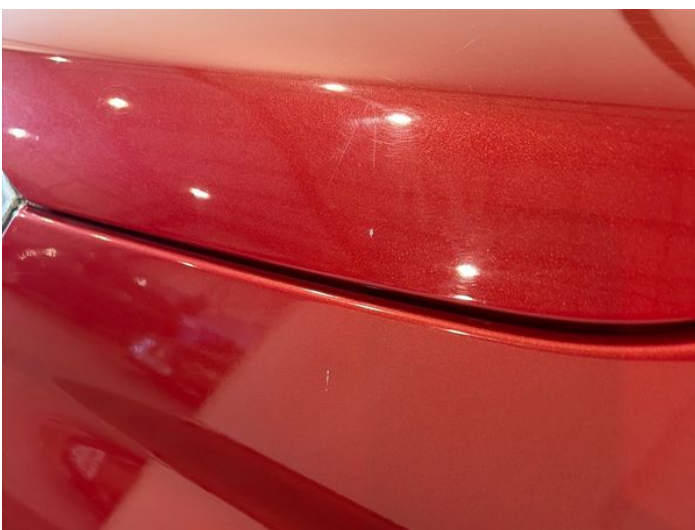
7: Wing nsf  
Scratched  
UpTo 25mm Thru Paint

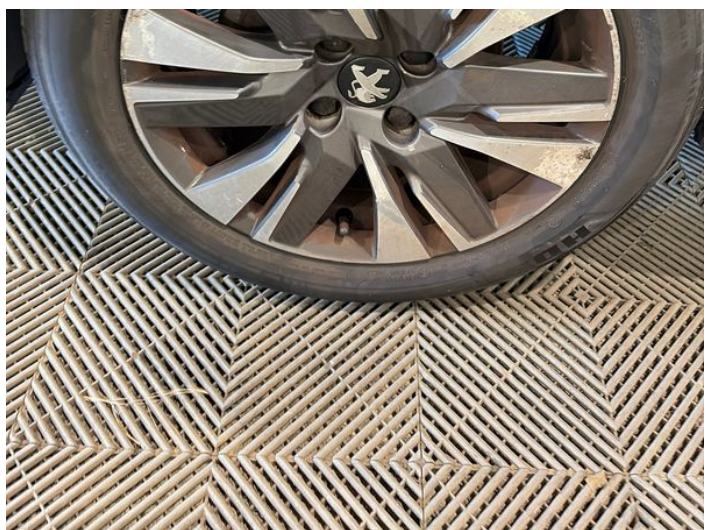
8: Wheel nsf  
Scratched  
Over 50mm

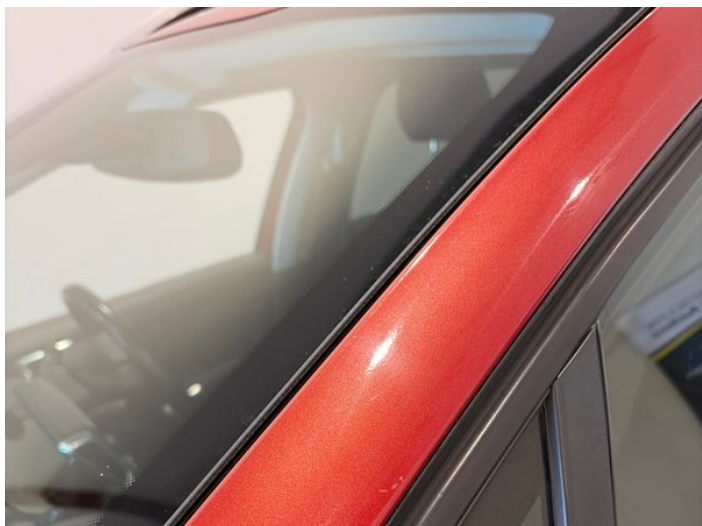
9: A Post ns  
Chipped  
1 To 5

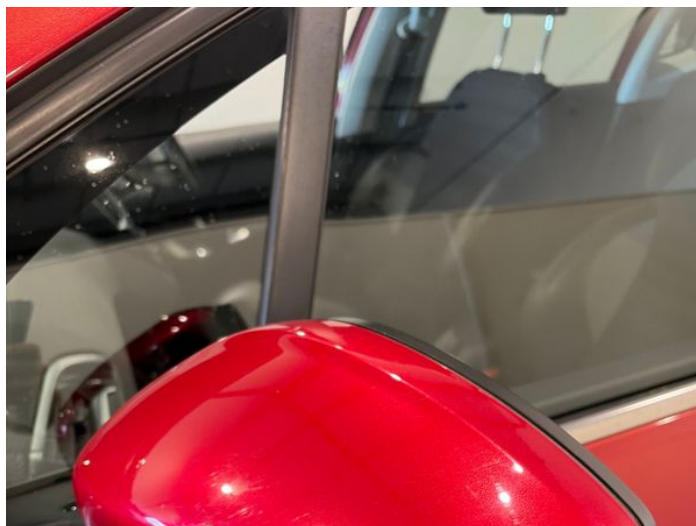
10: Door Mirror Assy nsf  
Scratched (Painted)  
UpTo 25mm Thru Paint

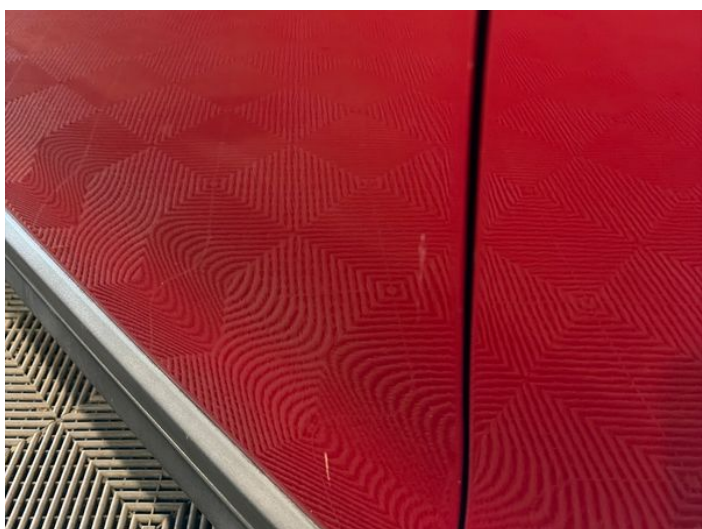
11: Door nsf  
Scratched  
Over 25mm Thru Paint

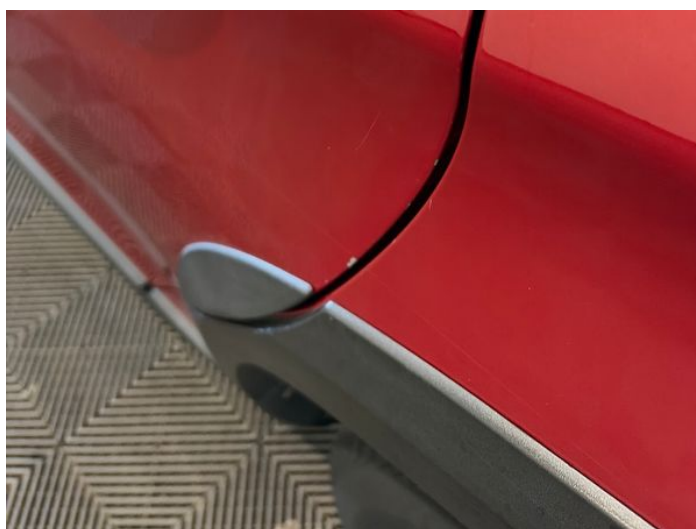
12: Door nsr  
Chipped  
Edge Chip

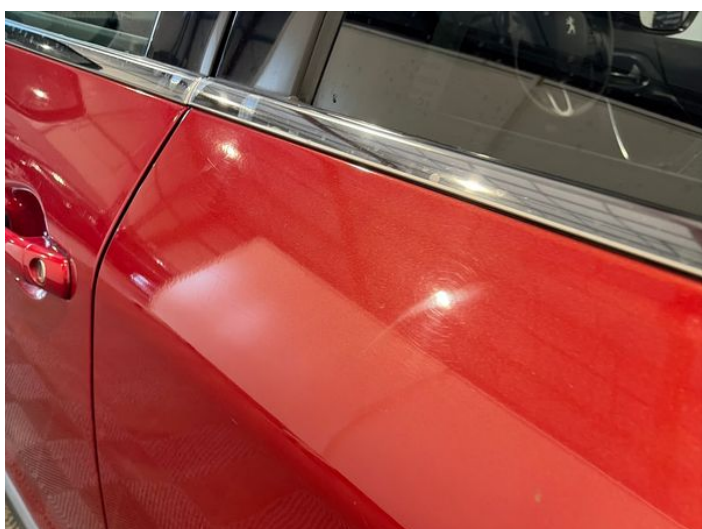
13: Door nsr  
Dented  
Between 10mm + 30mm

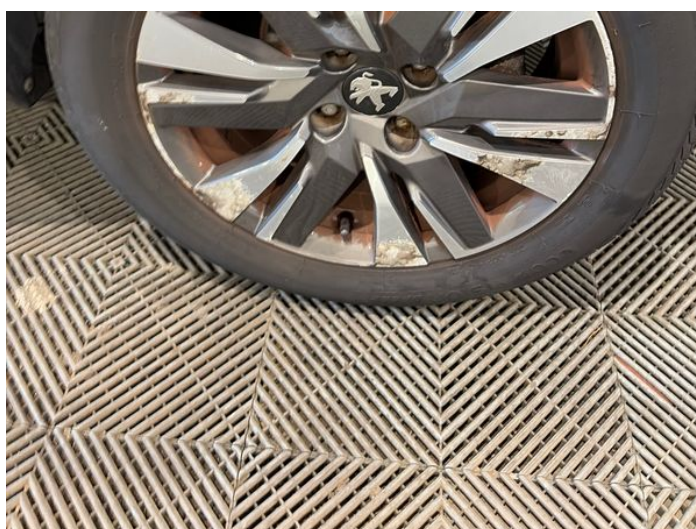
14: Wheel nsr  
Scratched  
Over 50mm

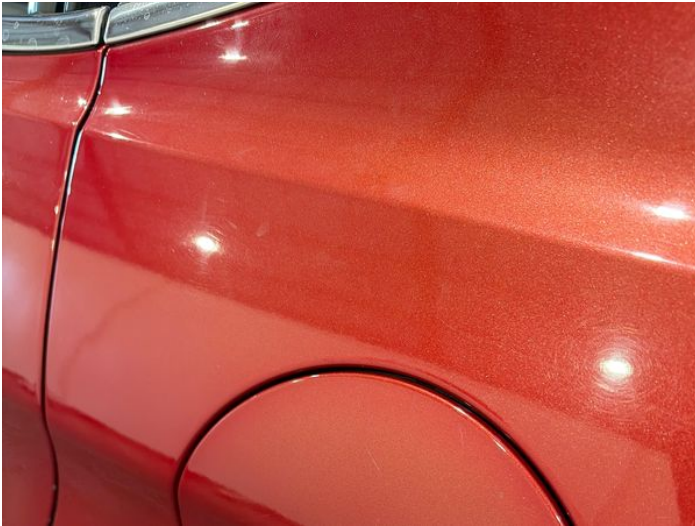
15: Qtr Panel nsr  
Scratched  
UpTo 25mm Thru Paint

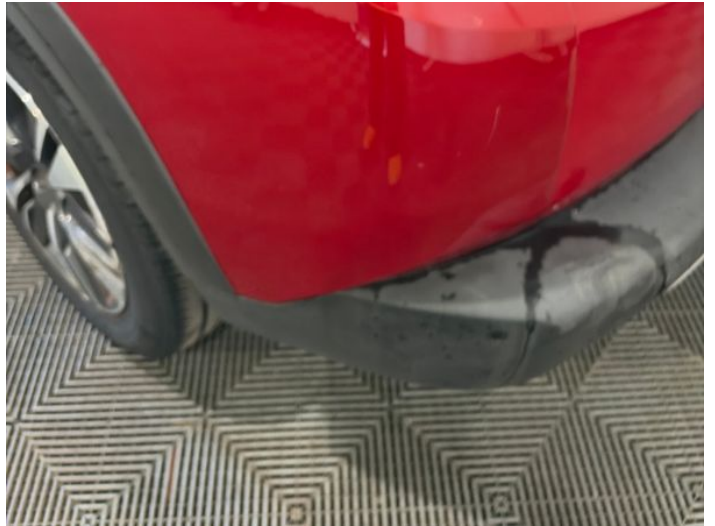
16: Bumper Rear  
Scratched  
Over 100mm Thru Paint

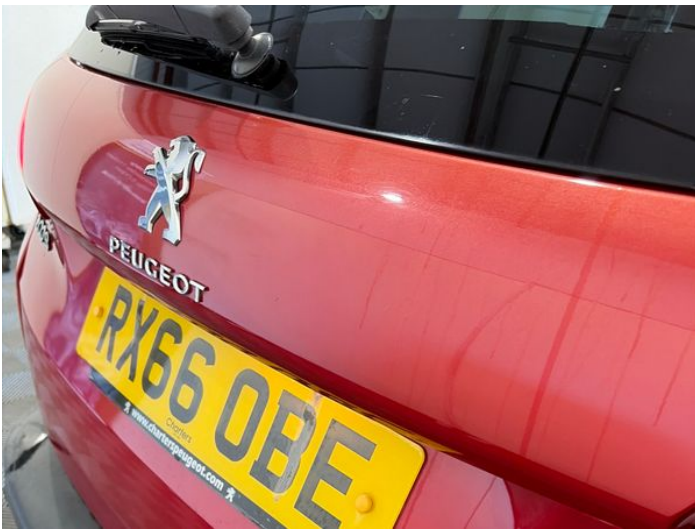
17: Tailgate  
Scratched  
Over 25mm Thru Paint

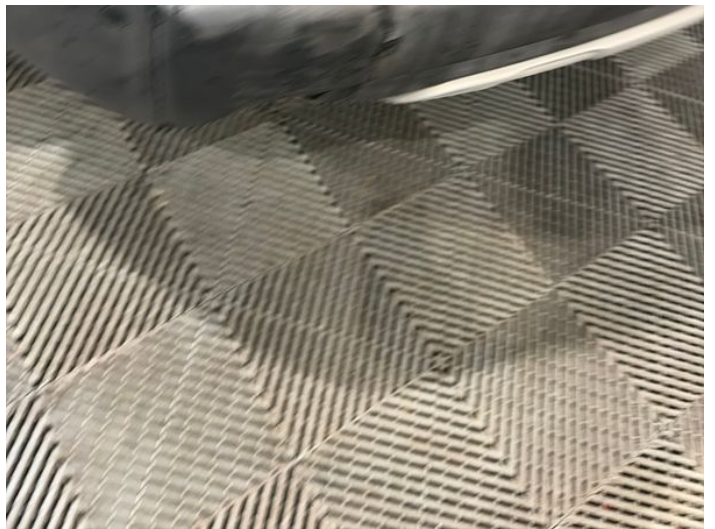
18: Bumper Rear Moulding  
Scuffed (Unpainted)  
Over 100mm

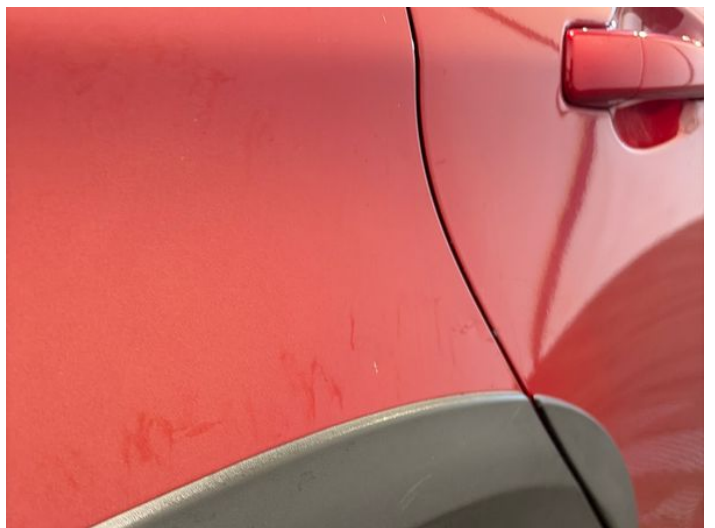
20: Qtr Panel osr  
Dented  
Between 10mm + 30mm

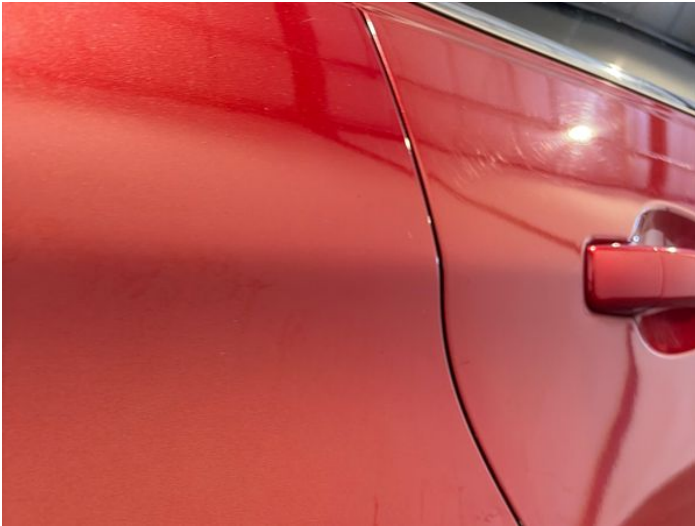
21: Qtr Panel osr  
Chipped  
1 To 5

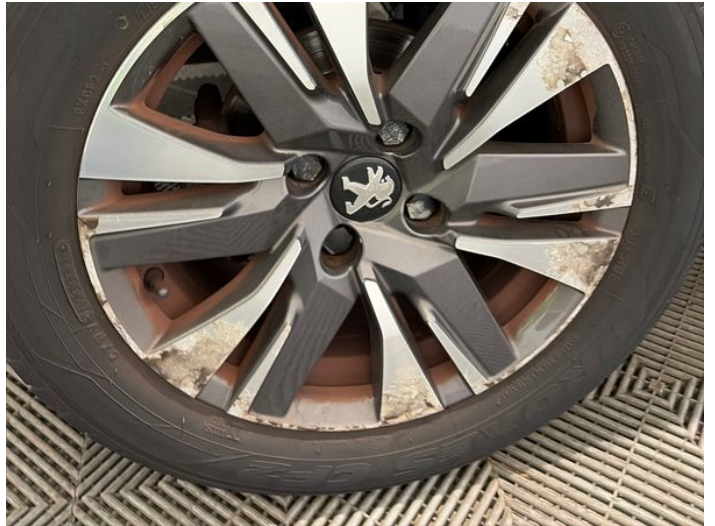
22: Wheel osr  
Scratched  
Over 50mm

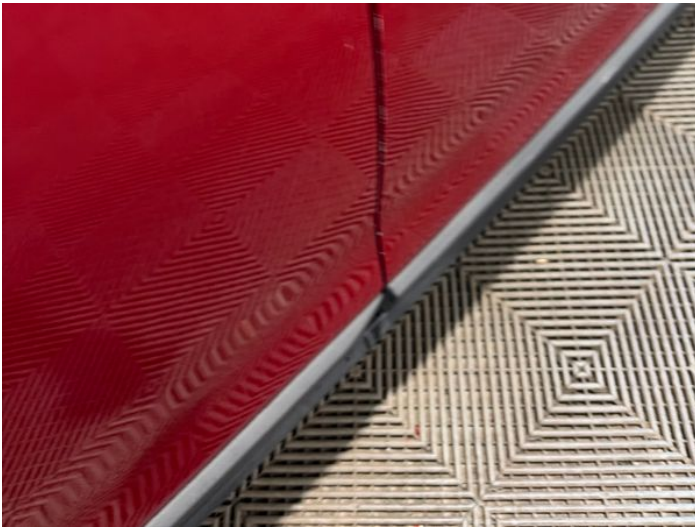
23: Door osr  
Chipped  
1 To 5

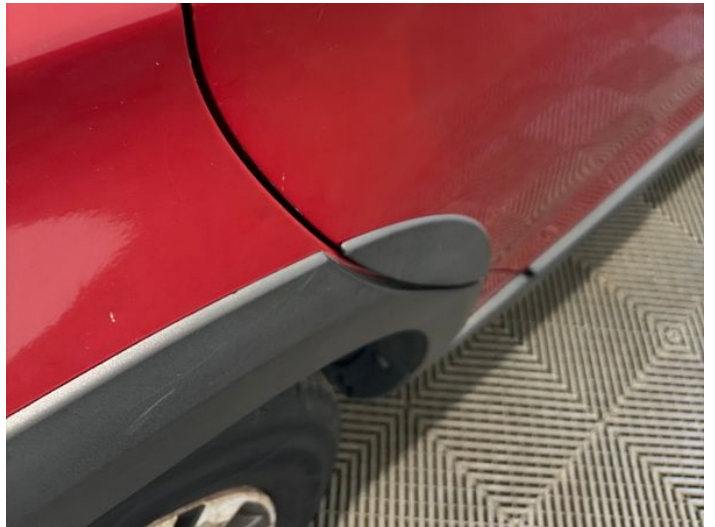
24: Door osr  
Chipped  
Edge Chip

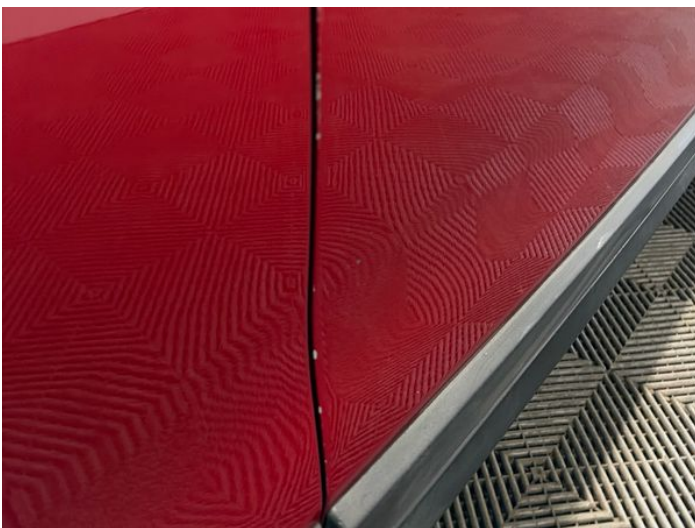
25: Door osf  
Chipped  
Edge Chip

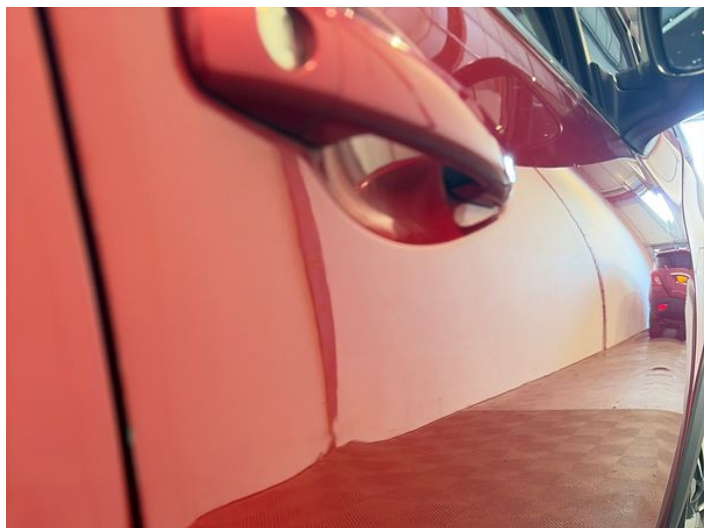
26: Door osf  
Dented  
Between 10mm + 30mm

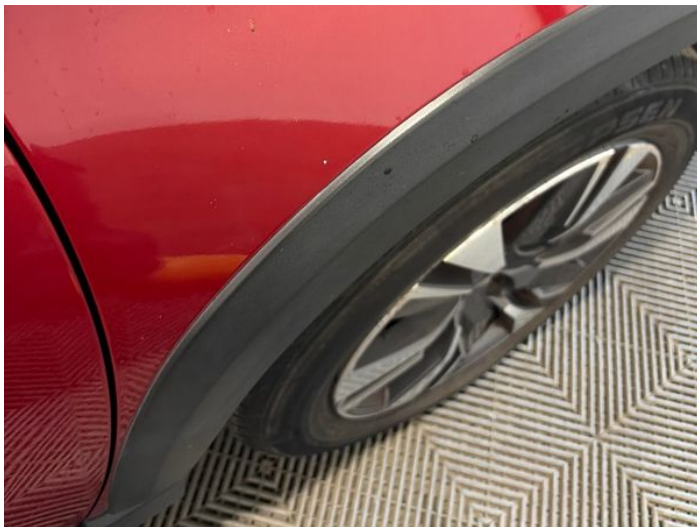
27: Wing osf  
Chipped  
1 To 5

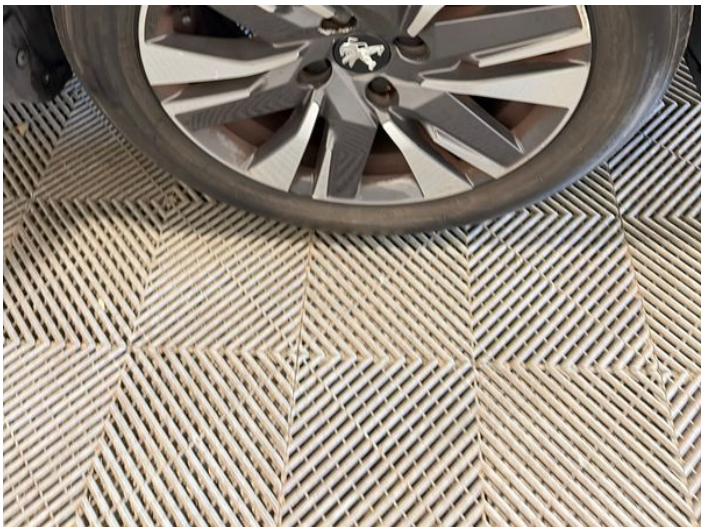
28: Wheel osf  
Scratched  
Over 50mm
