# VEHICLE INSPECTION REPORT

**GU11XME**

## Hyundai I30 1.6 CRDi Comfort 5dr

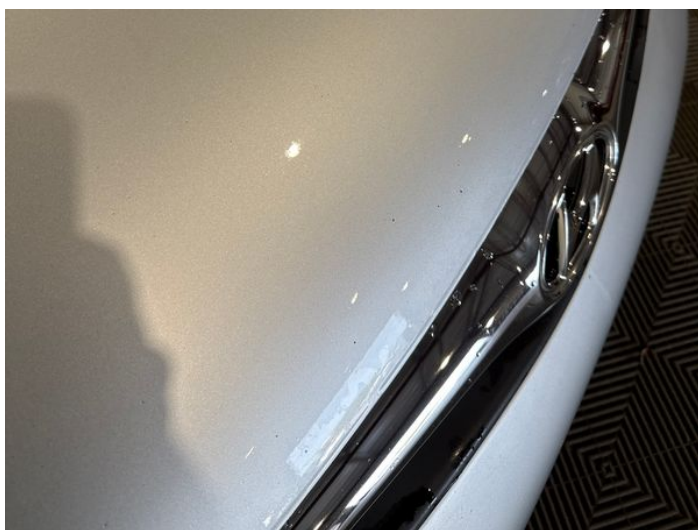
1: Bonnet  
Chipped  
Multiple Chips

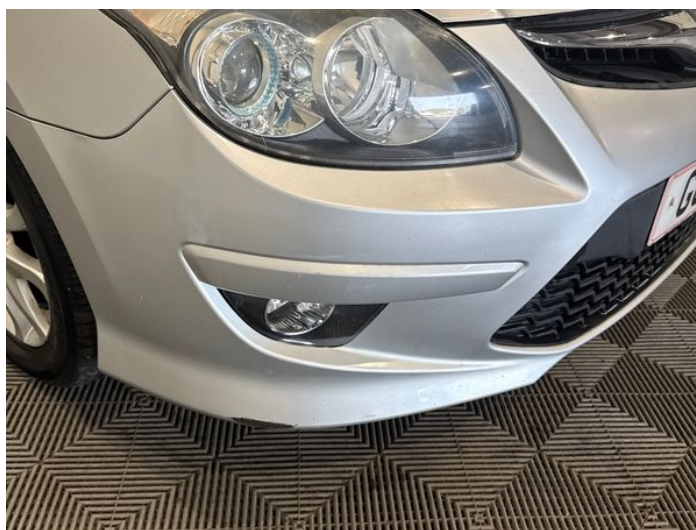
2: Bumper Front  
Scratched  
Over 100mm Thru Paint

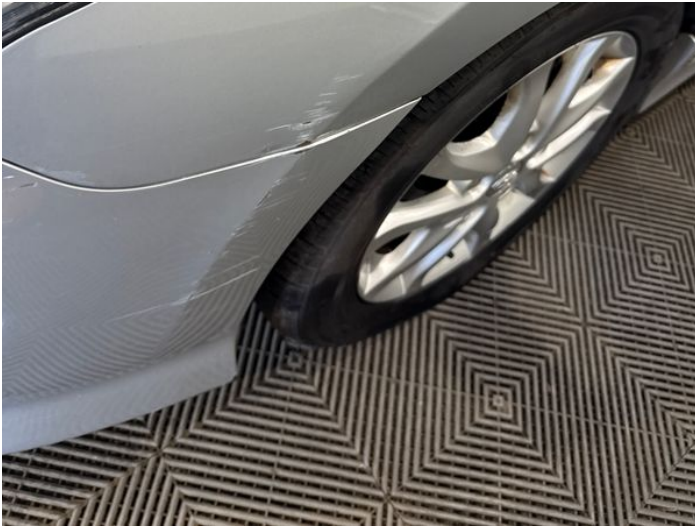
3: Wing nsf  
Dented  
With Paint Damage

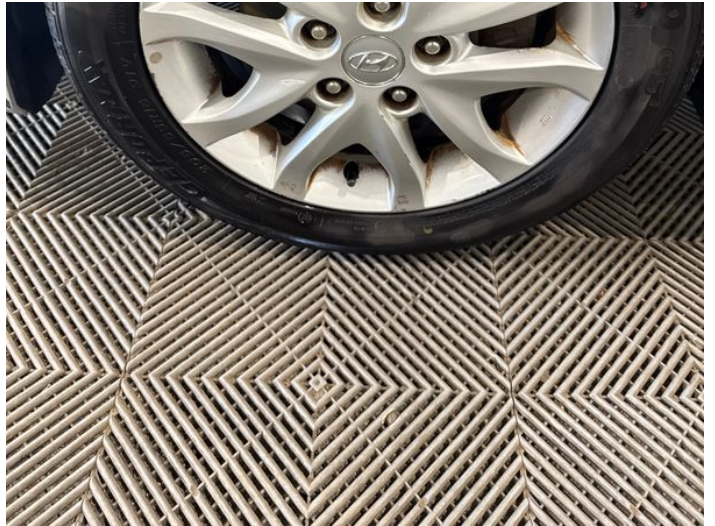
4: Wheel nsf  
Scratched  
Over 50mm

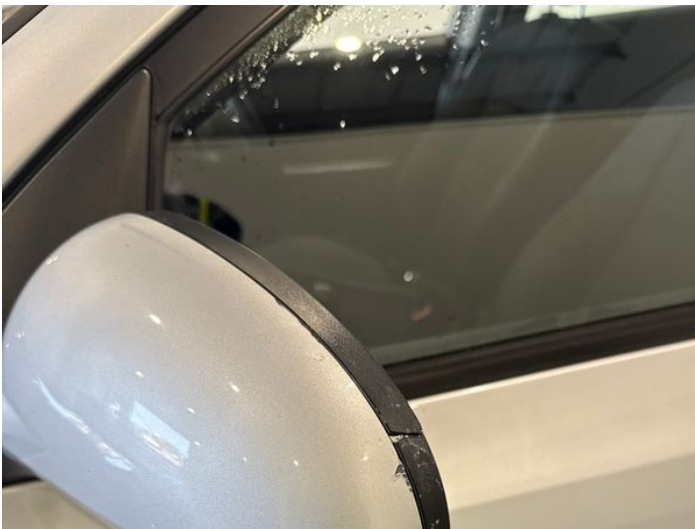
5: Door Mirror Assy nsf  
Scratched (Painted)  
Over 25mm Thru Paint

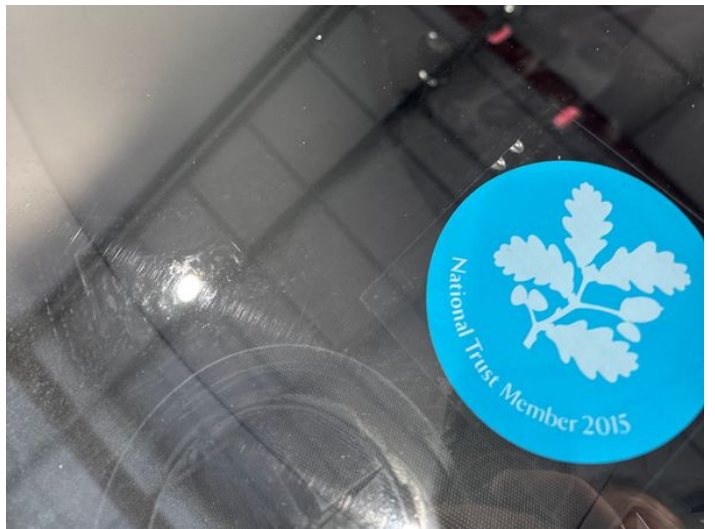
6: Screen Front  
Chipped  
UpTo 10mm

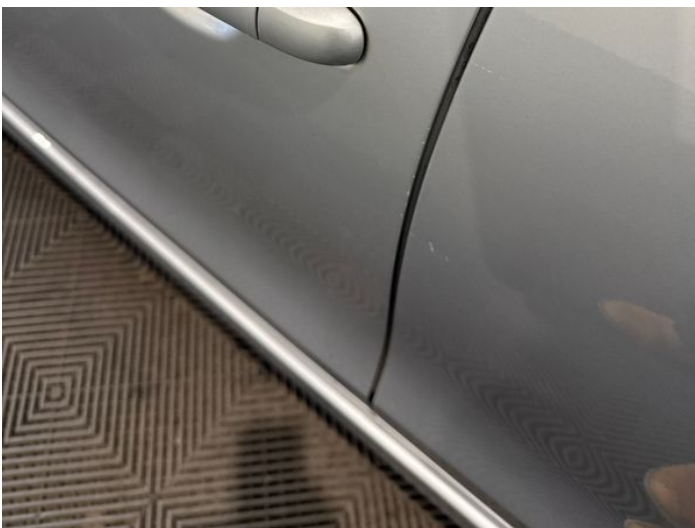
7: Door nsf  
Chipped  
Edge Chip

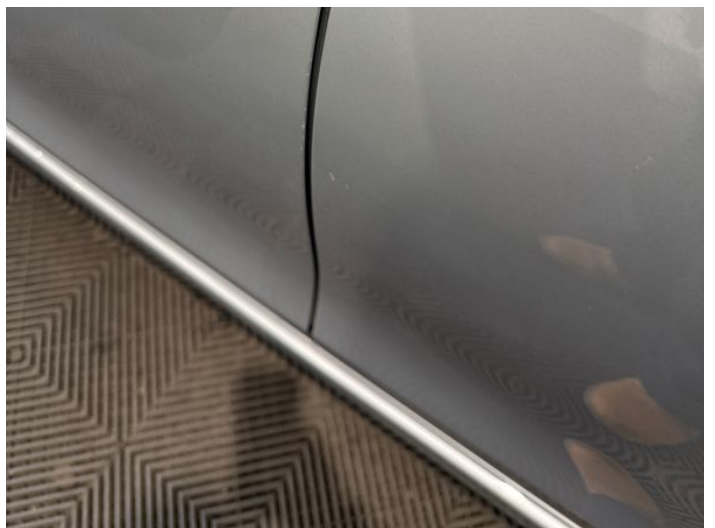
8: Door nsr  
Scratched  
Over 25mm Thru Paint

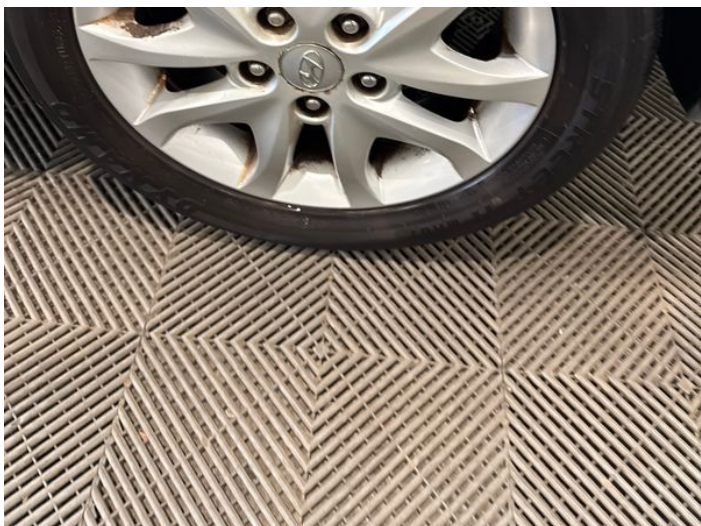
9: Wheel nsr  
Scratched  
Over 50mm

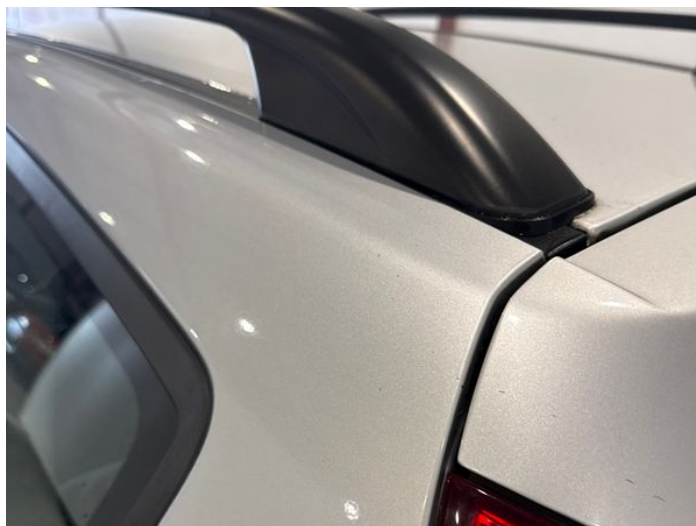
10: Qtr Panel nsr  
Chipped  
1 To 5

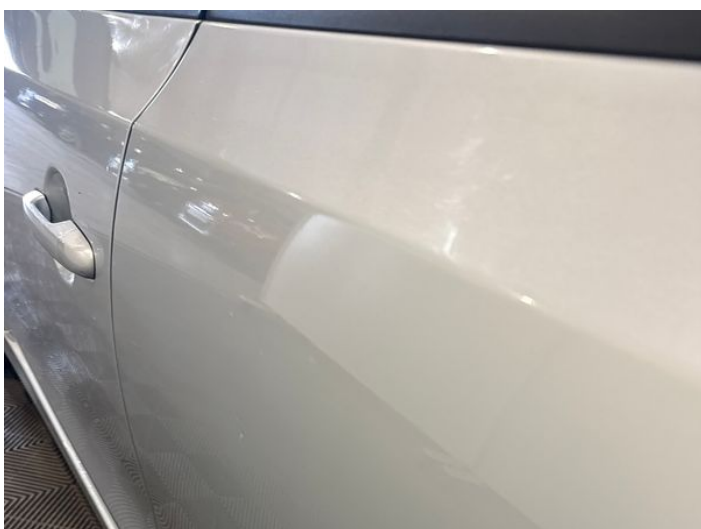
11: Door nsr  
Dented  
Between 10mm + 30mm

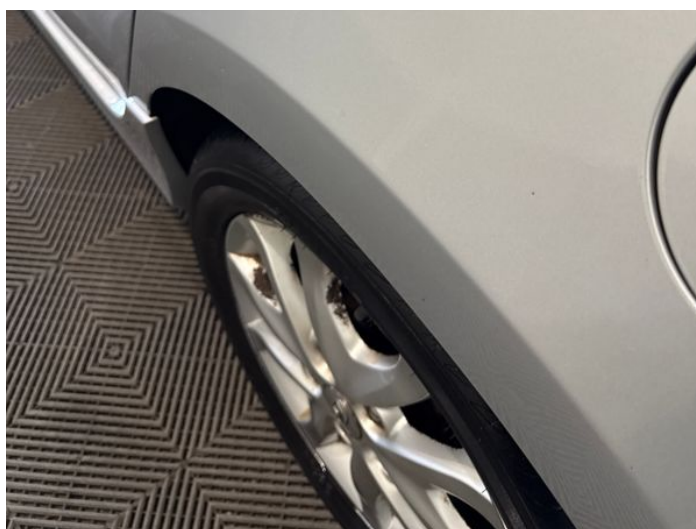
12: Qtr Panel nsr  
Dented  
Between 10mm + 30mm

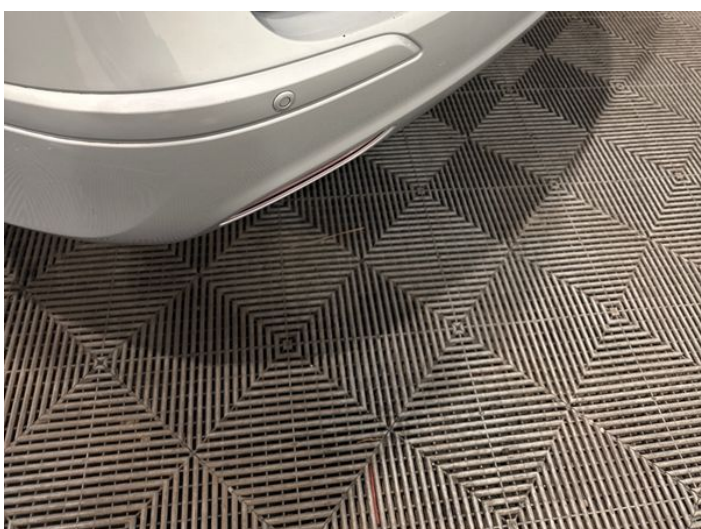
13: Bumper Rear  
Scratched  
Over 100mm Thru Paint

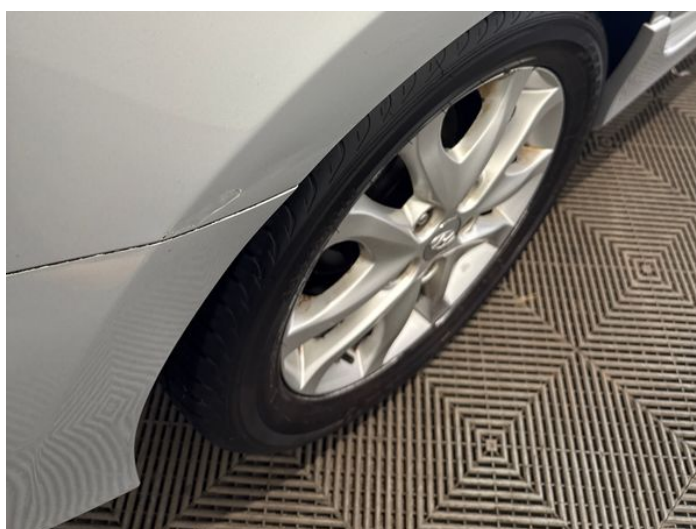
14: Qtr Panel osr  
Dented  
With Paint Damage

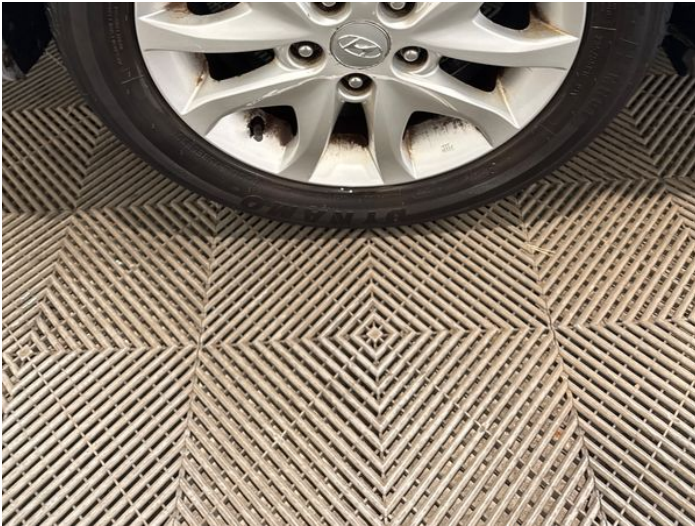
15: Wheel osr  
Scratched  
Over 50mm

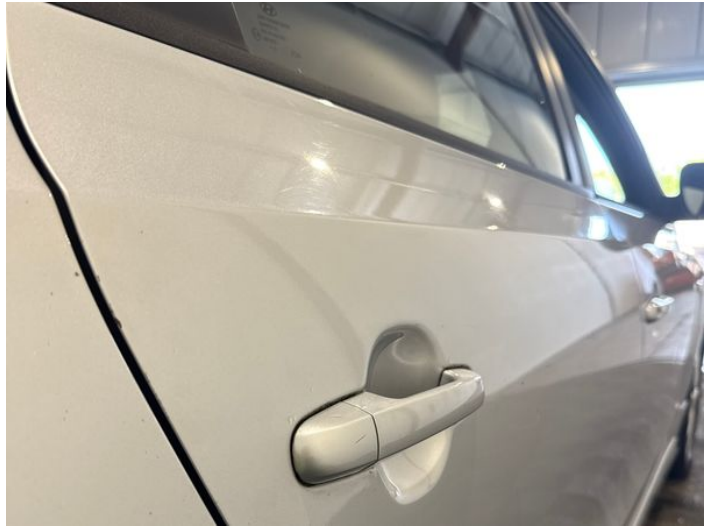
16: Door osr  
Poor Previous Repair  
Rippled UpTo 30%

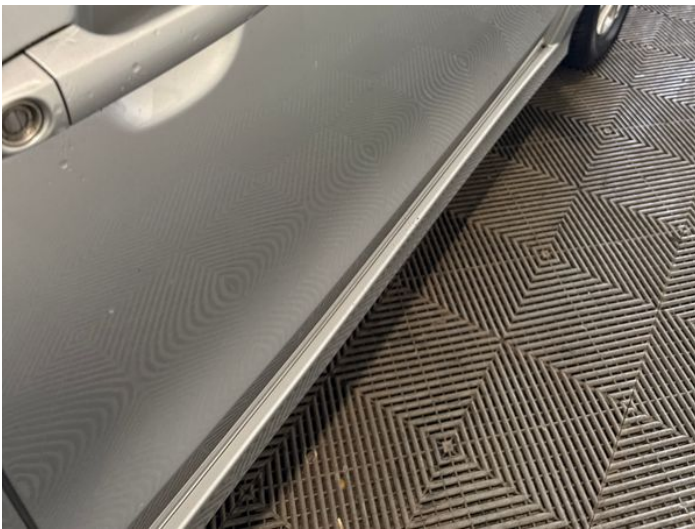
17: Door osf  
Dented  
With Paint Damage

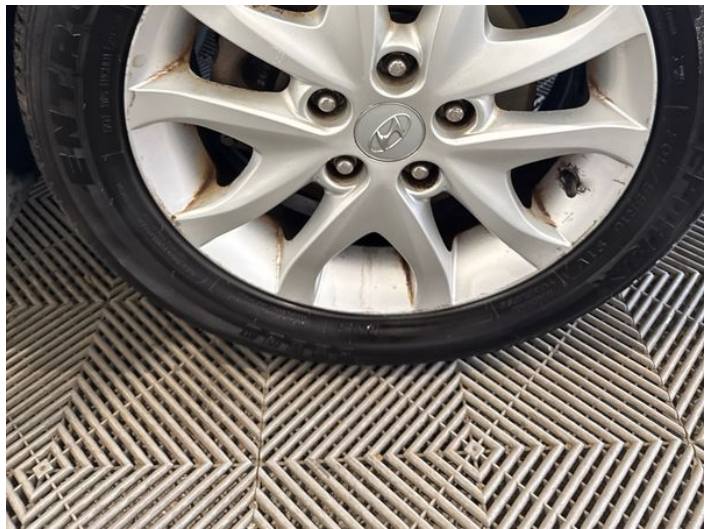
18: Wheel osf  
Scratched  
Over 50mm

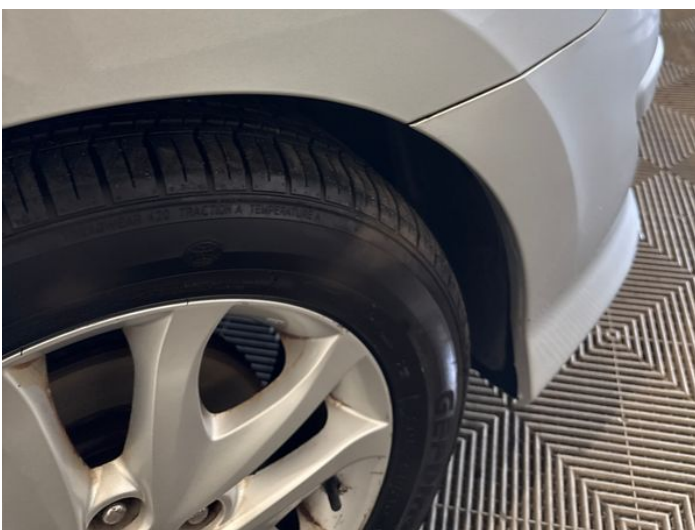
19: Wing osf  
Chipped  
1 To 5

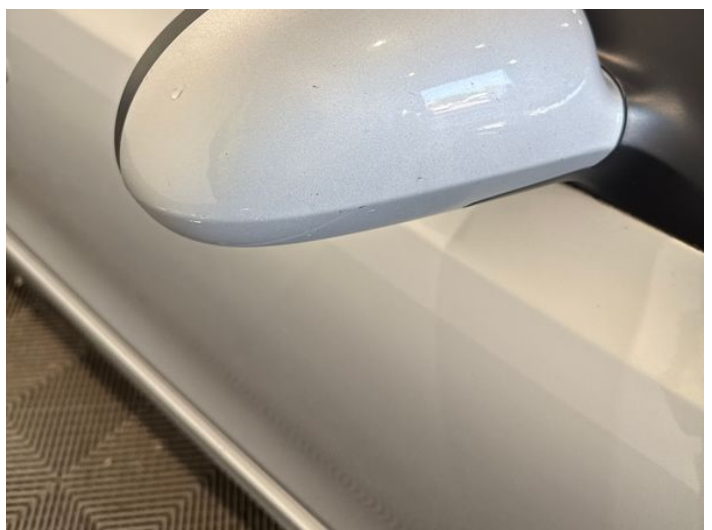
20: Door Mirror Assy osf  
Scratched (Painted)  
UpTo 25mm Thru Paint

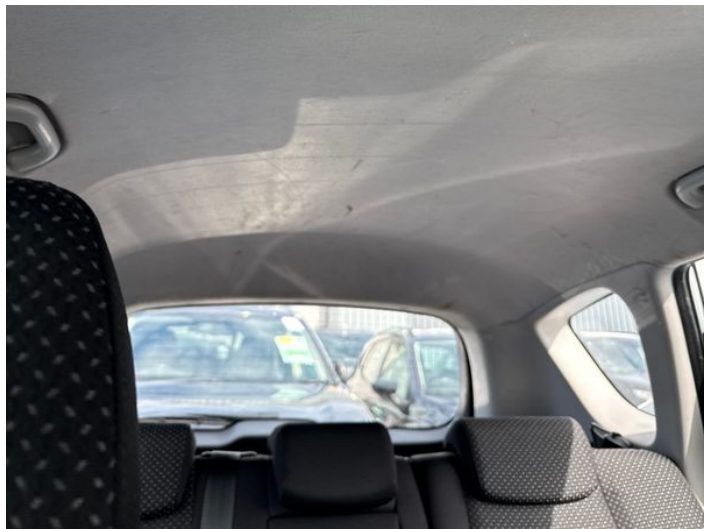
22: Roof Lining  
Scuffed  
Over 25mm
