## VEHICLE INSPECTION REPORT

**GP24FSK**

### Kia Sportage 1.6T GDi 157 48V ISG 3 5dr DCT

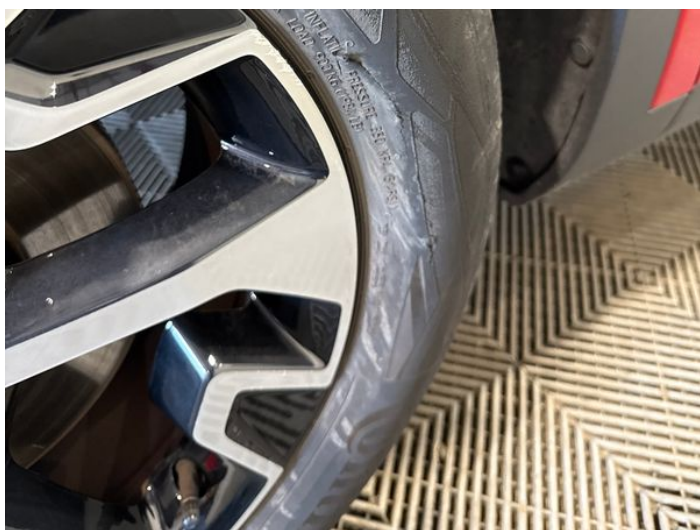
| NSF | CONTINENTAL | Damaged |

1: Tyre nsf  
Damaged  
Replace

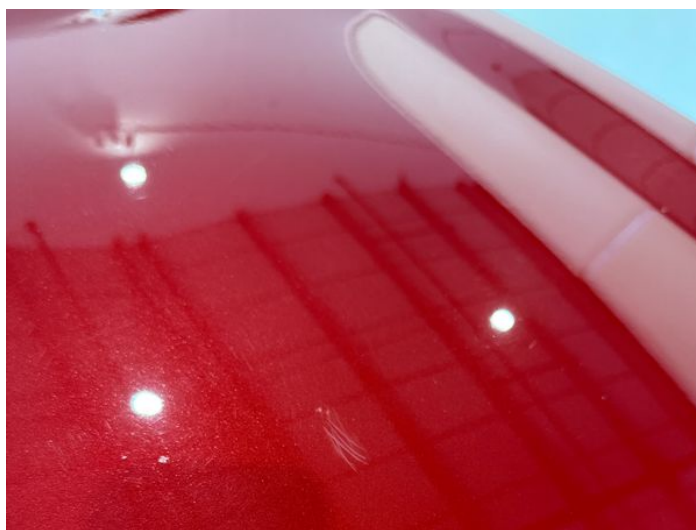
2: Bonnet  
Scratched  
Over 25mm Thru Paint

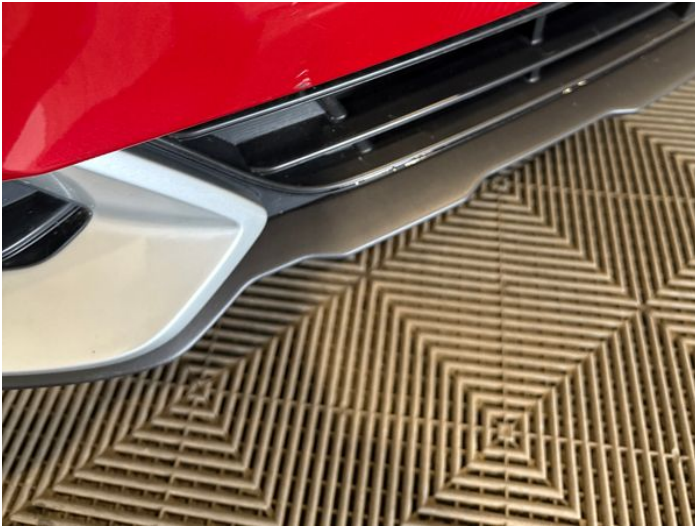
3: Bumper Front  
Scratched  
UpTo 25mm Thru Paint

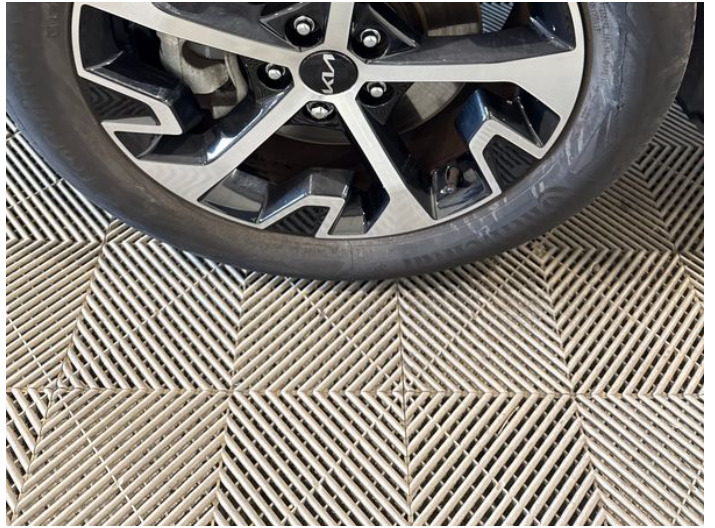
4: Wheel nsf  
Scratched  
Over 50mm

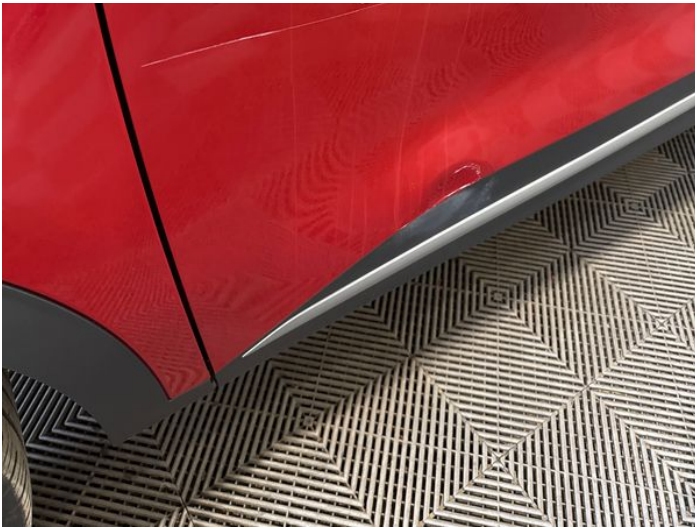
5: Door nsf  
Dented  
With Paint Damage

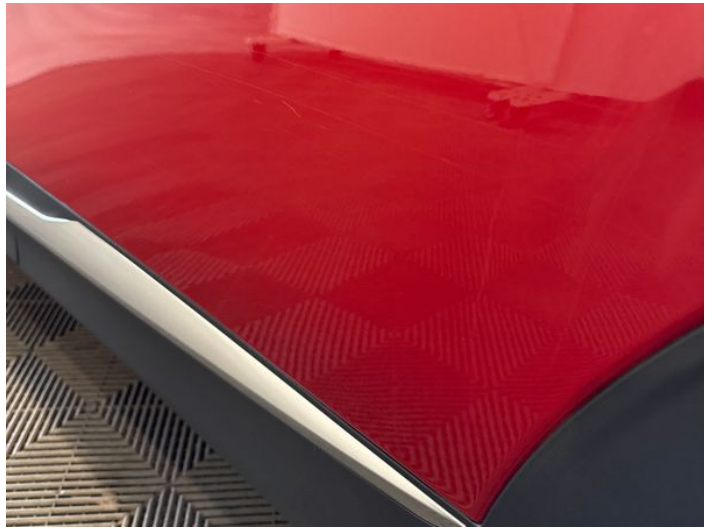
6: Door nsr  
Scratched  
UpTo 25mm Thru Paint

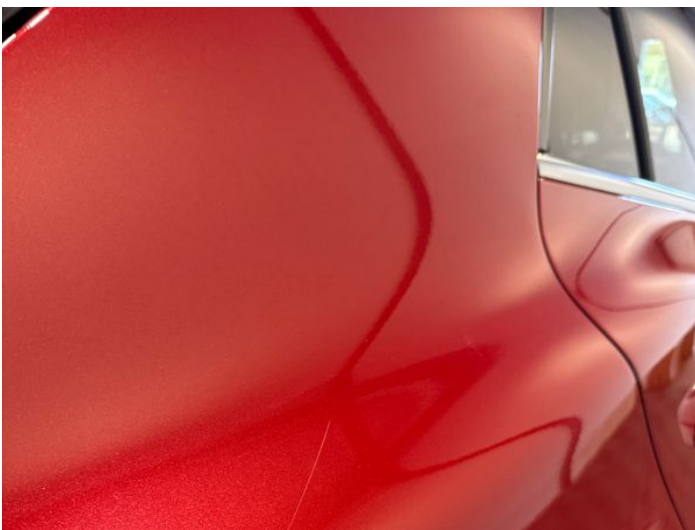
7: Qtr Panel osr  
Scratched  
Over 25mm Thru Paint

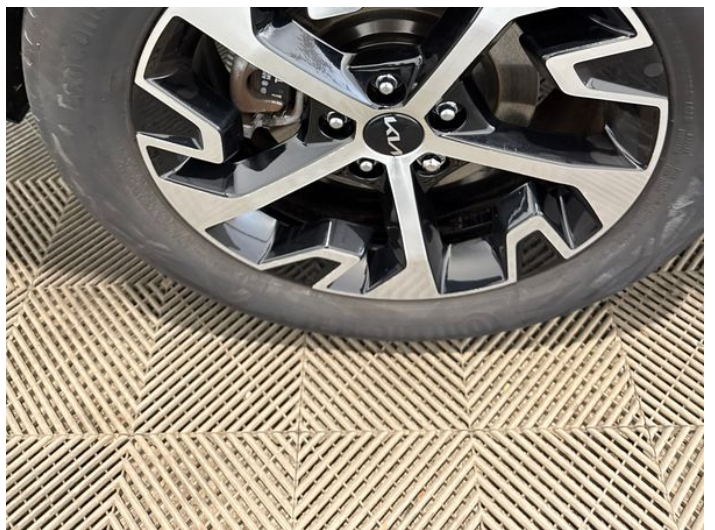
8: Wheel osr  
Scratched  
Up To 50mm

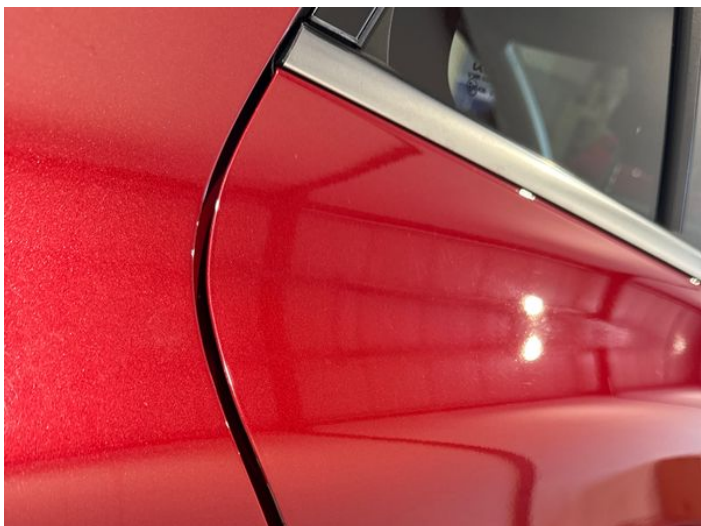
9: Door osr  
Chipped  
Edge Chip

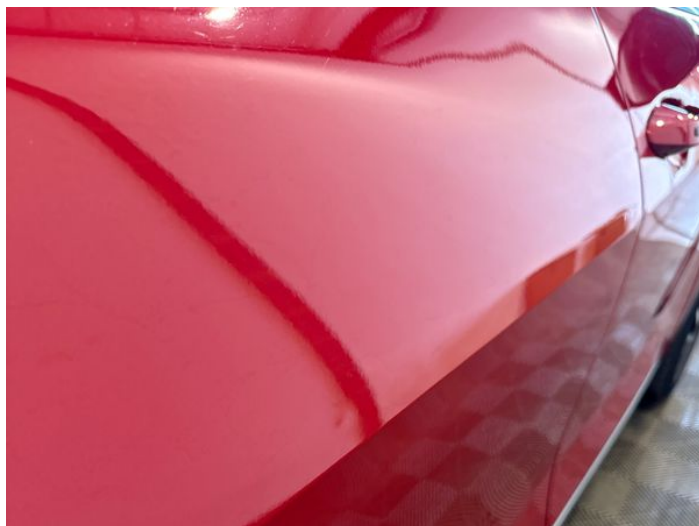
10: Door osr  
Dented  
Between 10mm + 30mm

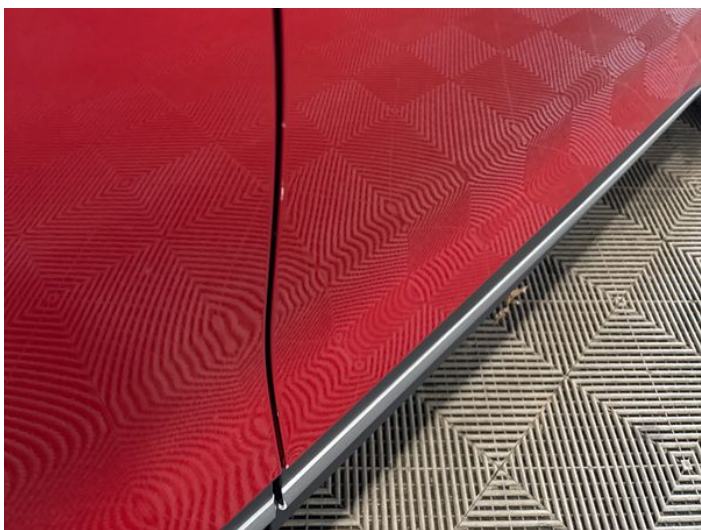
11: Door osf  
Chipped  
Edge Chip

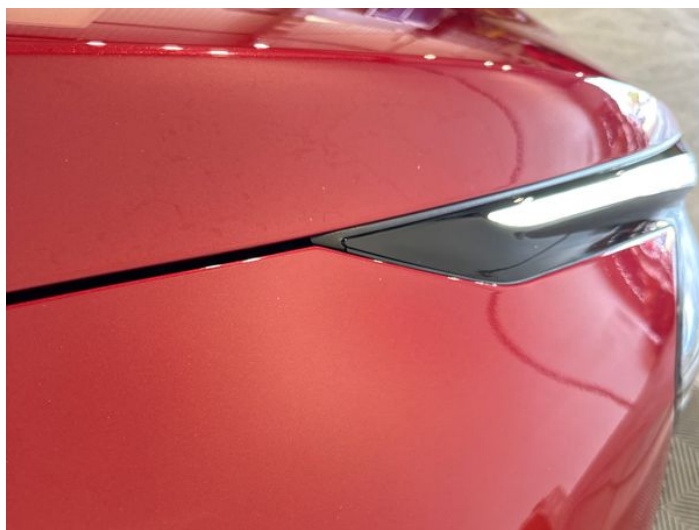
12: Wing osf  
Chipped  
1 To 5

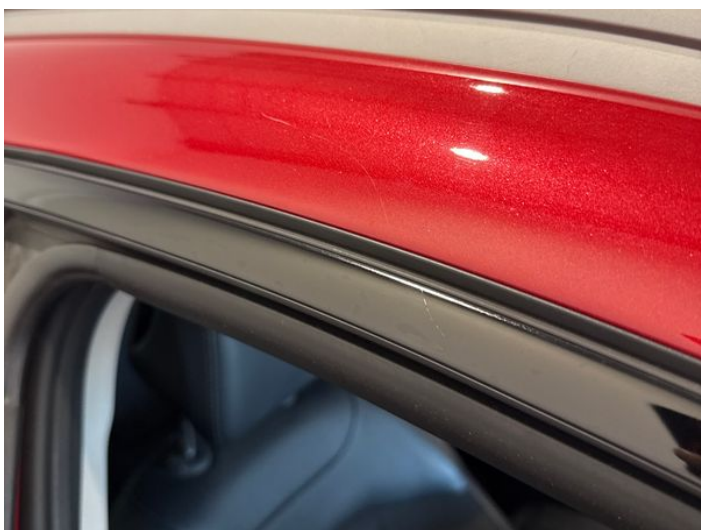
13: A Post os  
Scratched  
Over 25mm Thru Paint

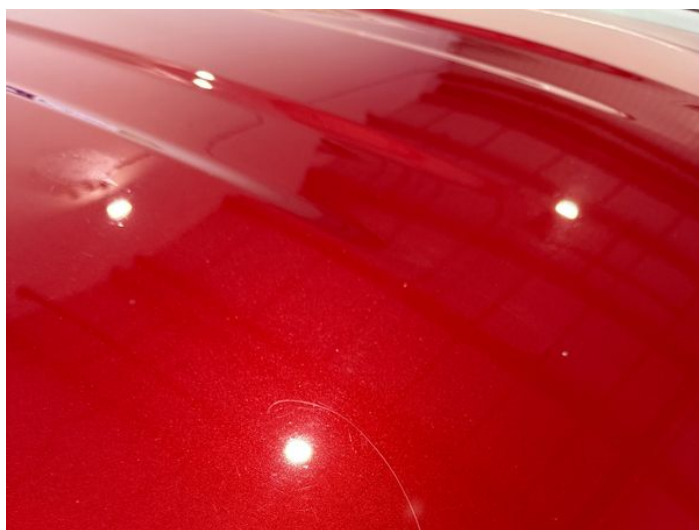
14: Roof  
Scratched  
Over 25mm Thru Paint
