## VEHICLE INSPECTION REPORT

**SG18TOV**

### Renault Kadjar 1.2 TCE Signature S Nav 5dr EDC

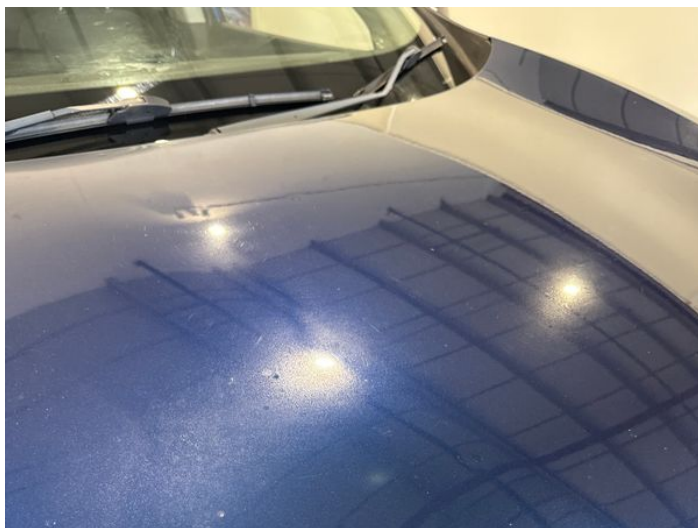
1: Bonnet  
Scratched  
Over 25mm Thru Paint

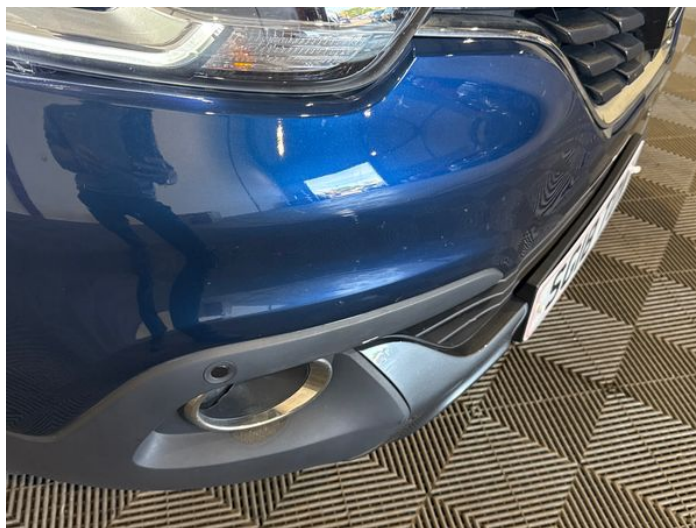
2: Bumper Front  
Scratched  
25 to 100mm Thru Paint

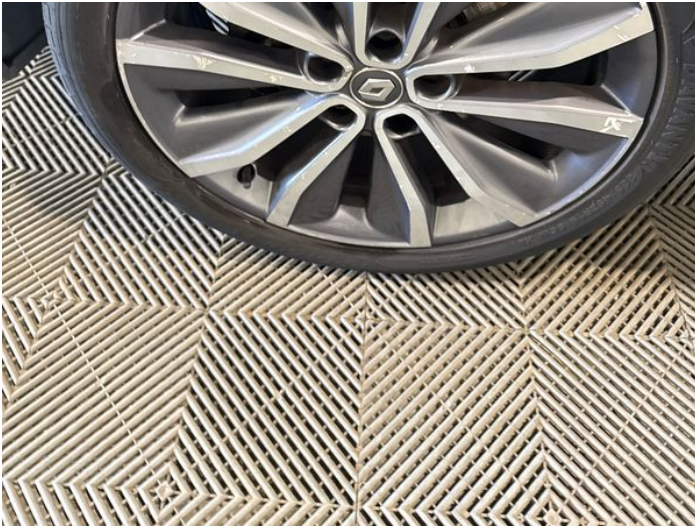
3: Wheel nsf  
Scratched  
Over 50mm

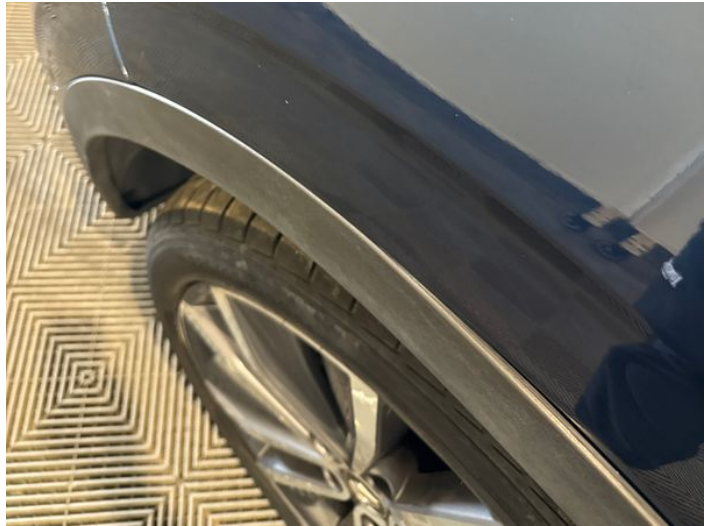
4: Wing nsf  
Chipped  
1 To 5

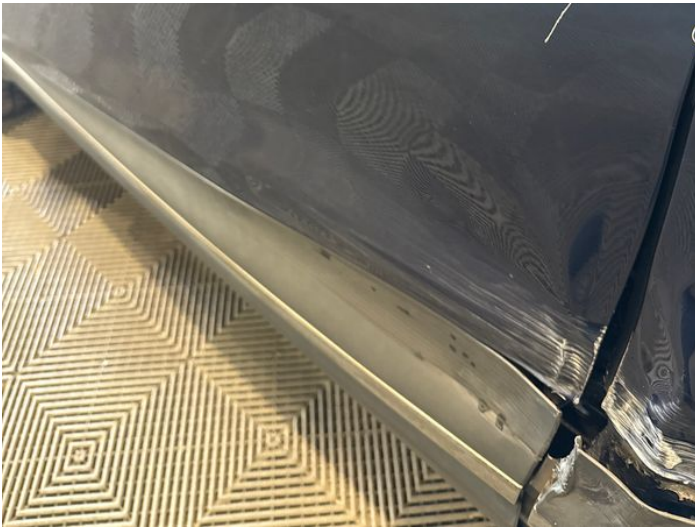
5: Door nsf  
Dented  
With Paint Damage

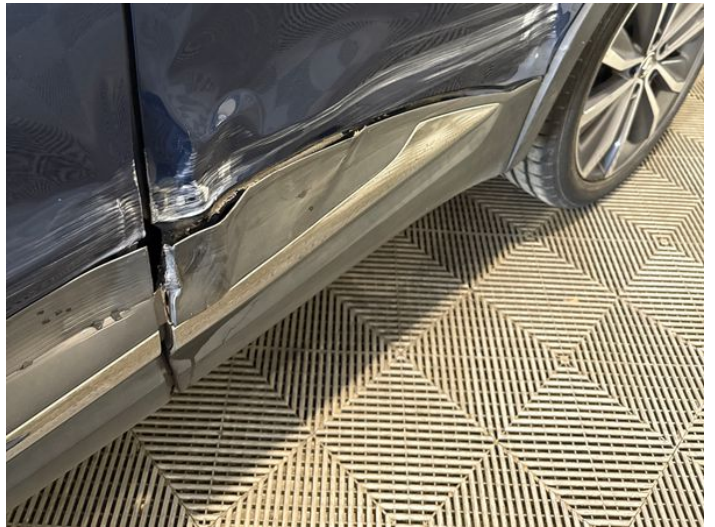
6: Door nsr  
Dented  
With Paint Damage

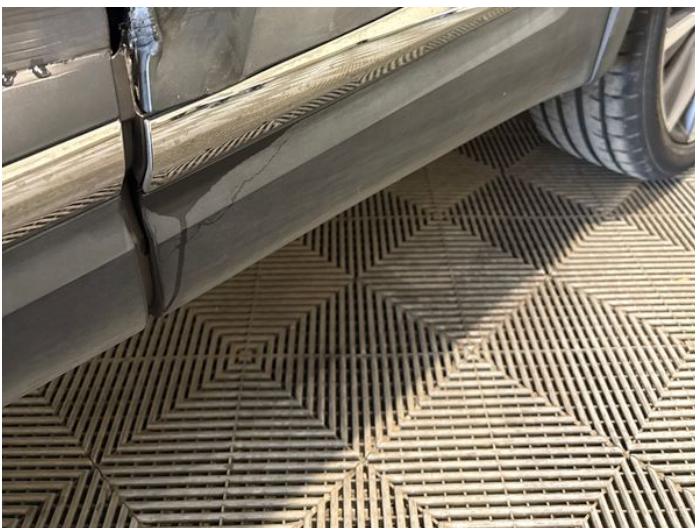
7: Door Moulding nsr  
Broken  
Replace

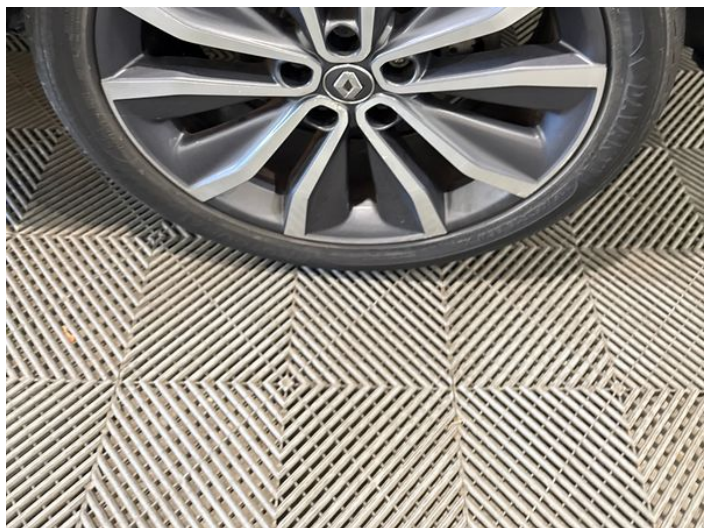
8: Wheel nsr  
Scratched  
Up To 50mm

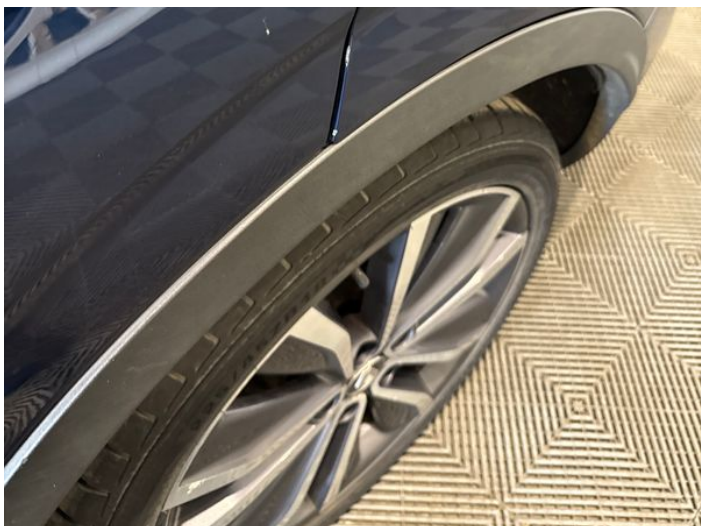
9: Qtr Panel nsr  
Chipped  
Edge Chip

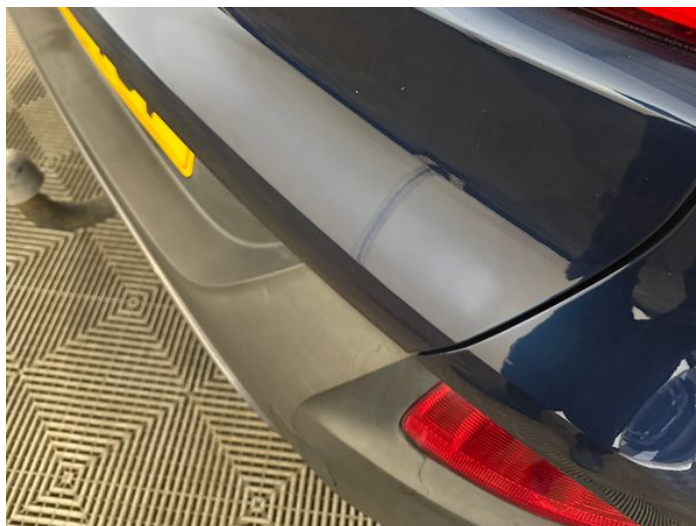
10: Tailgate  
Chipped  
1 To 5

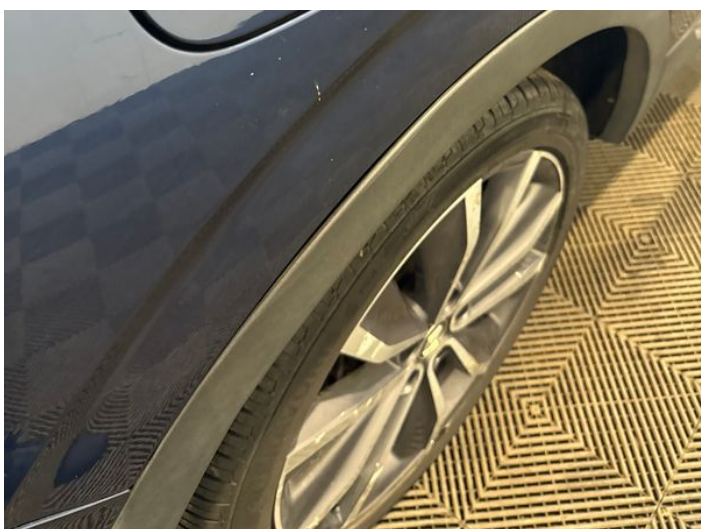
11: Qtr Panel osr  
Chipped  
1 To 5

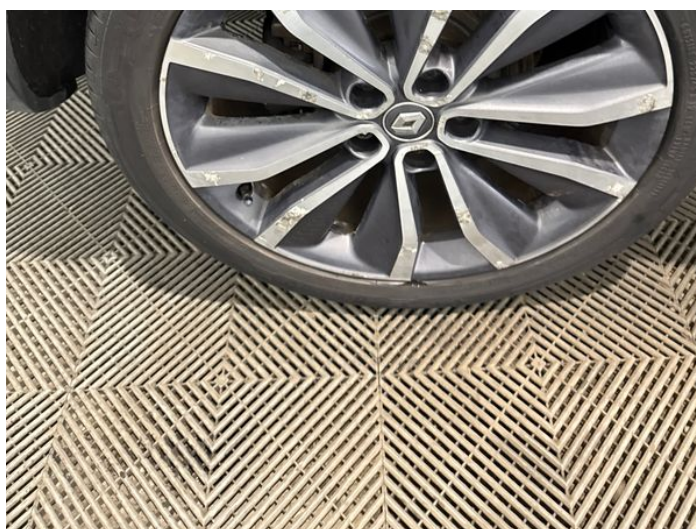
12: Wheel osr  
Scratched  
Over 50mm

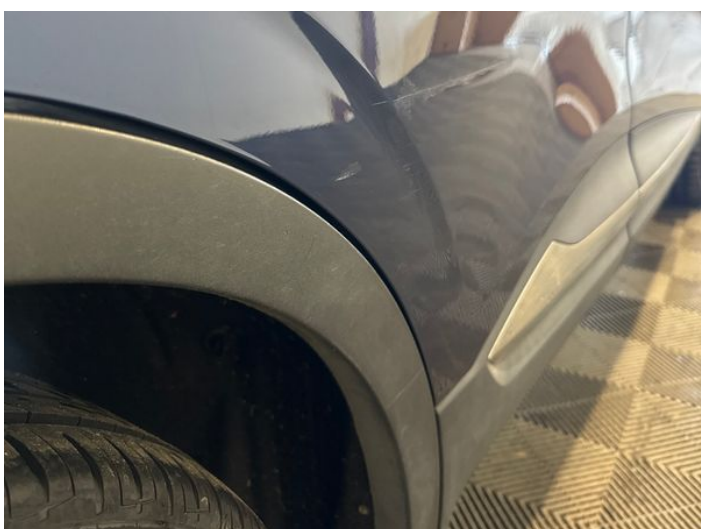
13: Door nsr  
Dented  
With Paint Damage

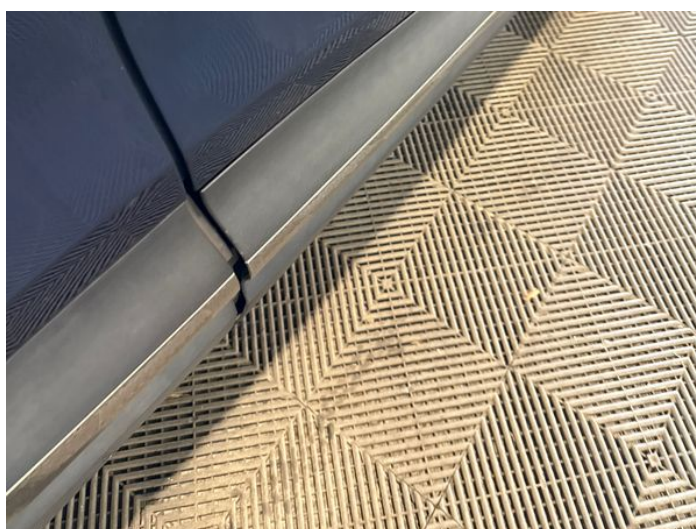
14: Door osf  
Dented  
Between 10mm + 30mm

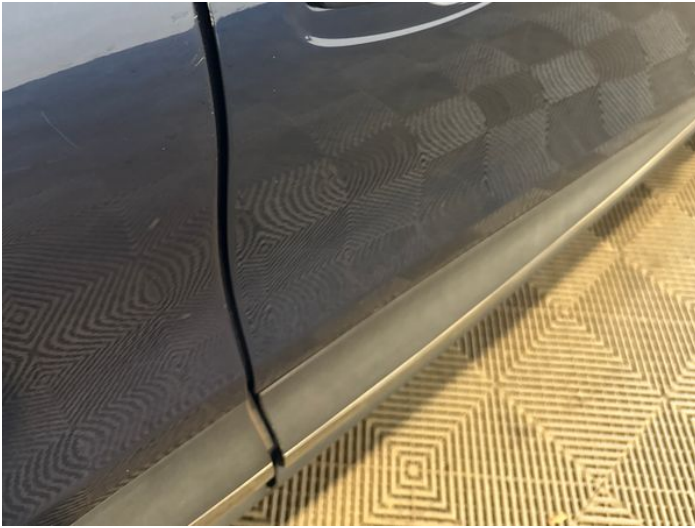
15: Door osf  
Chipped  
Edge Chip

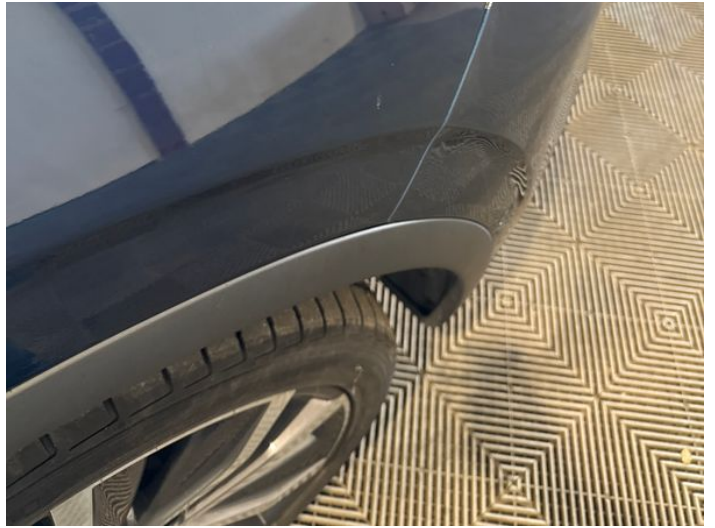
16: Wing osf  
Chipped  
1 To 5

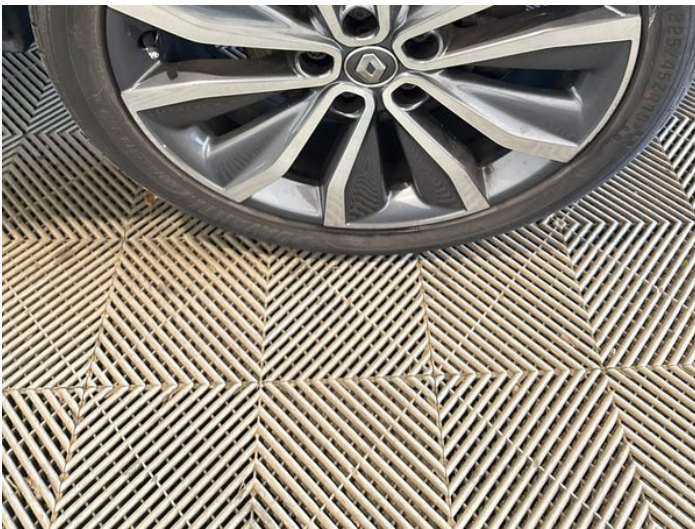
17: Wheel osf  
Scratched  
Up To 50mm

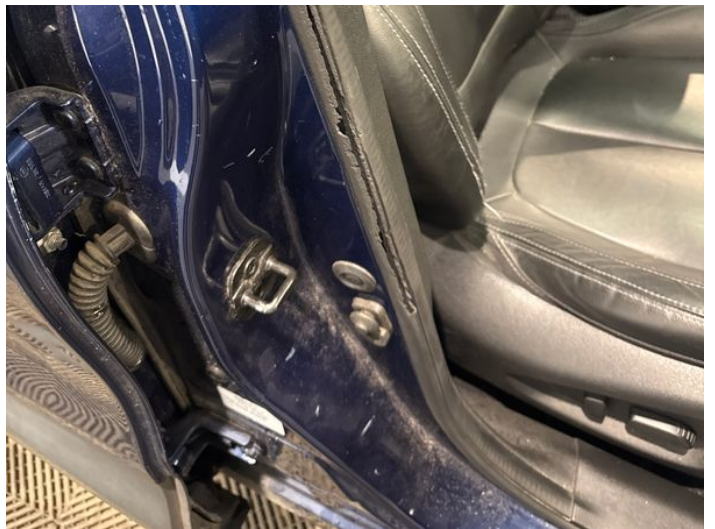
18: Aperture Seal osf  
Broken  
Replace

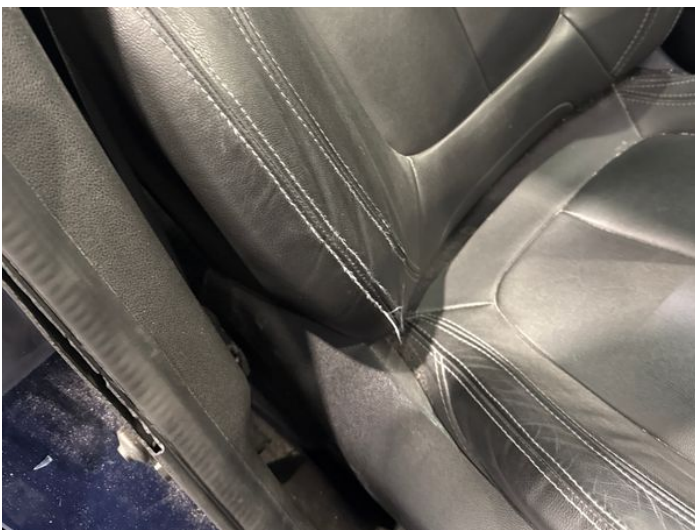
19: Seat Back Cover osf  
Scuffed  
Over 25mm

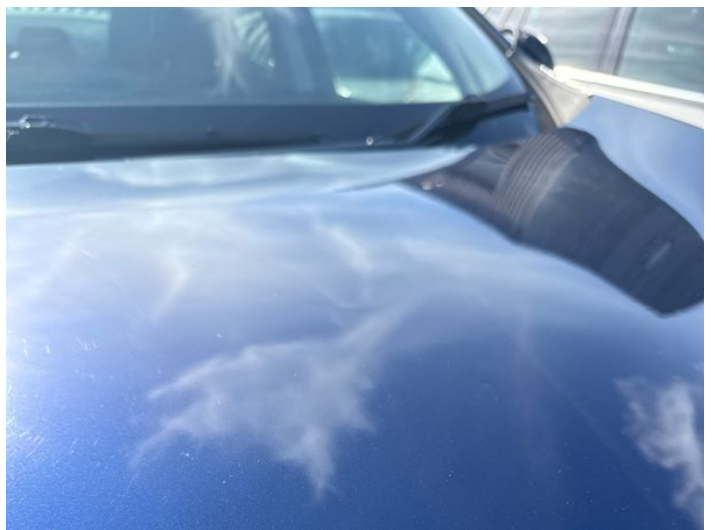
20: Bonnet  
Dented  
Hail - Moderate
