# VEHICLE INSPECTION REPORT

**GV10NFC**

## Ford Fiesta 1.25 Zetec 3dr [82]

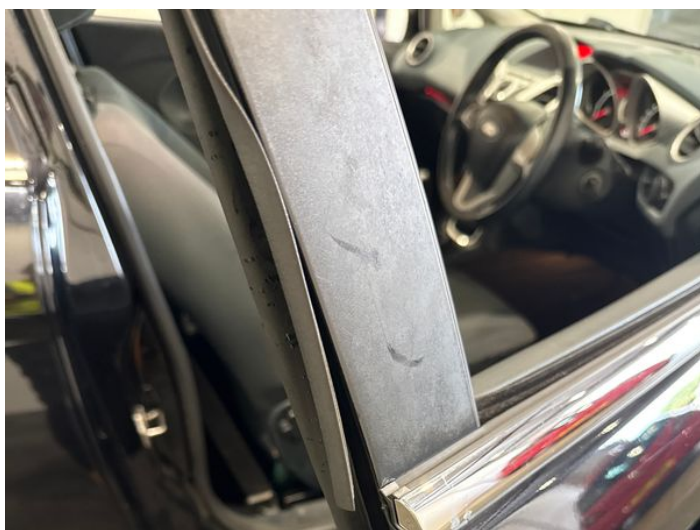
1: Aperture Seal of  
Broken  
Replace

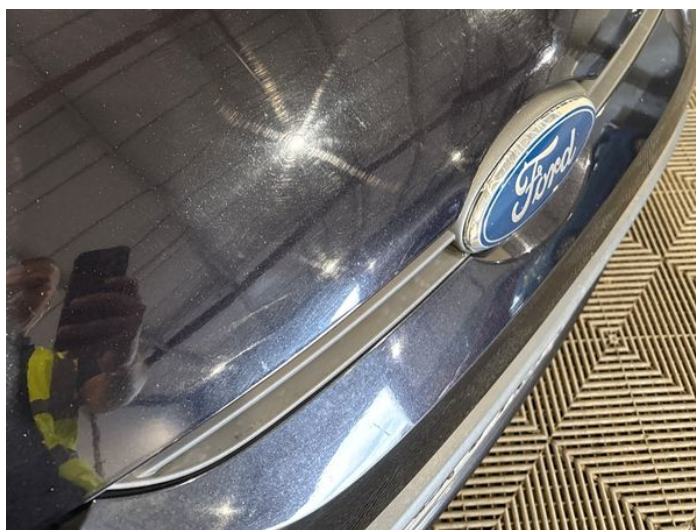
2: Bonnet  
Scratched  
Over 25mm Thru Paint

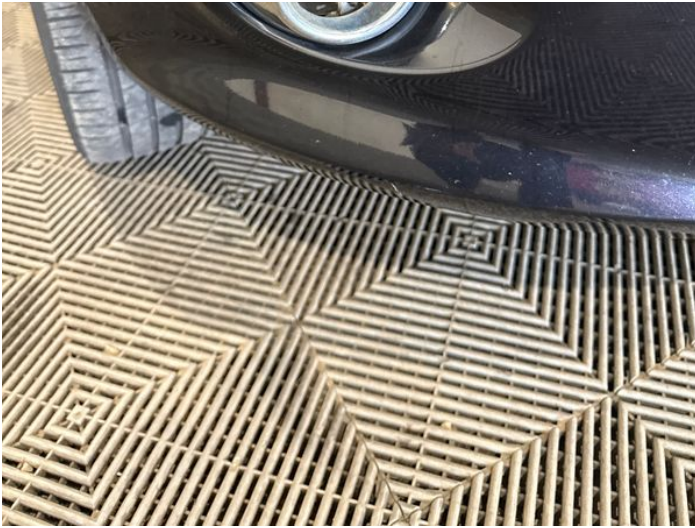
3: Fogdriving Lamp osf  
Broken  
Replace

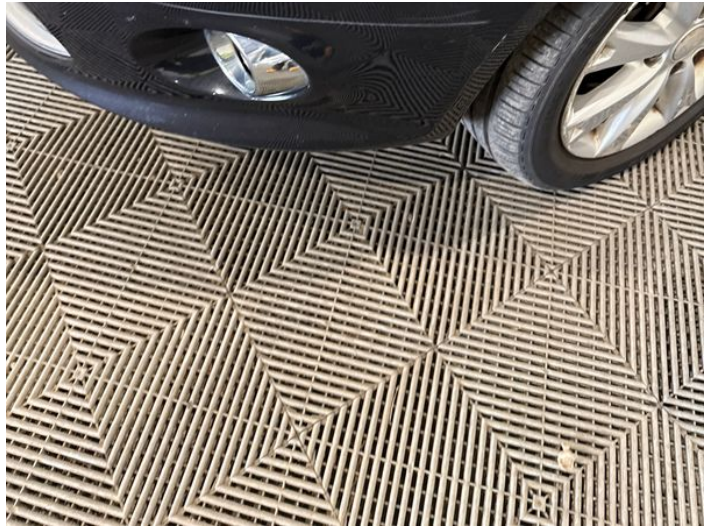
4: Bumper Front  
Scratched  
Over 100mm Thru Paint

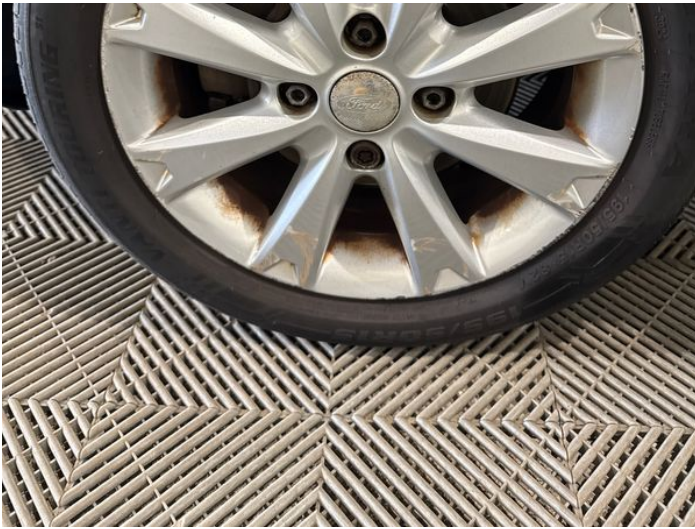
5: Wheel nsf  
Scratched  
Over 50mm

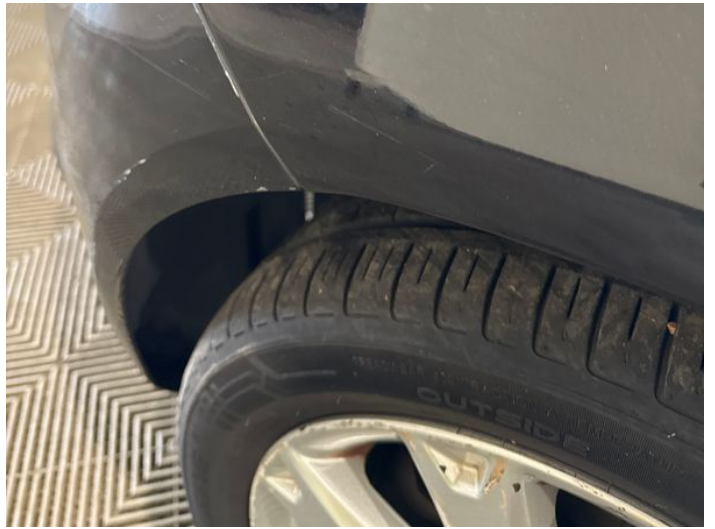
6: Wing nsf  
Scratched  
UpTo 25mm Thru Paint

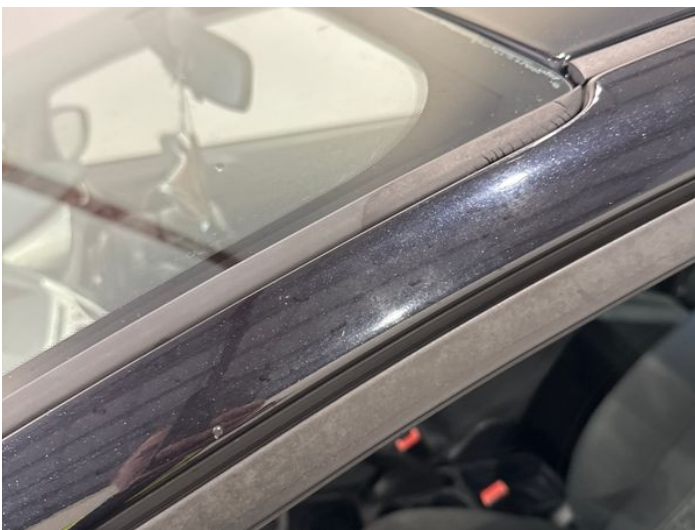
7: A Post ns  
Chipped  
1 To 5

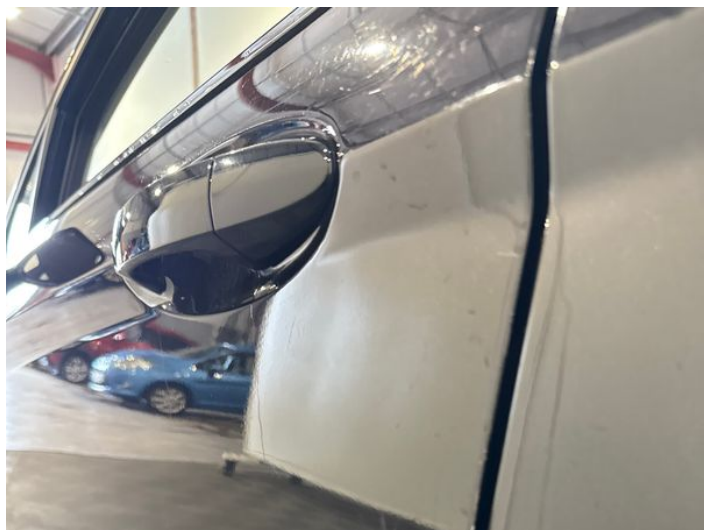
8: Door nsf  
Scratched  
Over 25mm Thru Paint

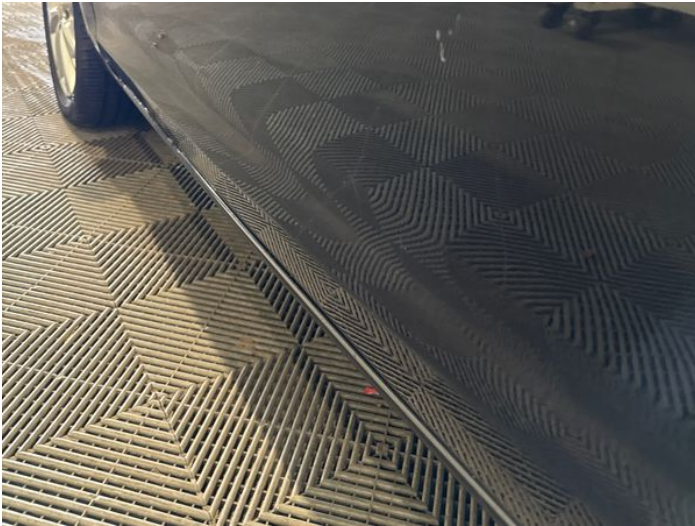
9: Door nsf  
Dented  
Between 10mm + 30mm

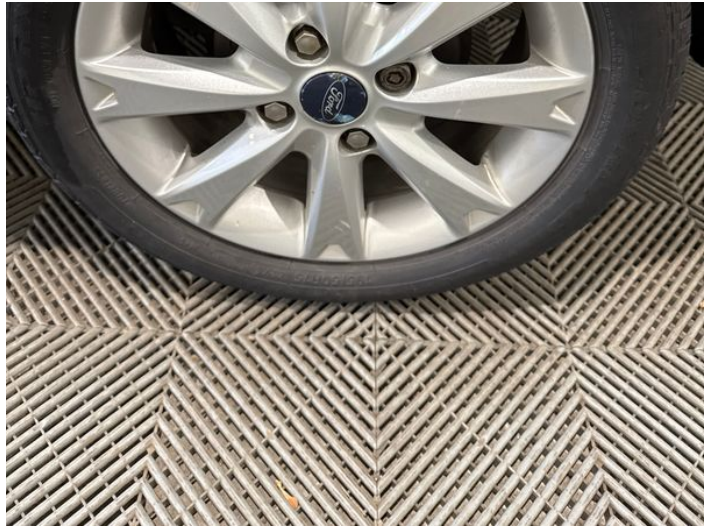
10: Wheel nsr  
Scratched  
Over 50mm

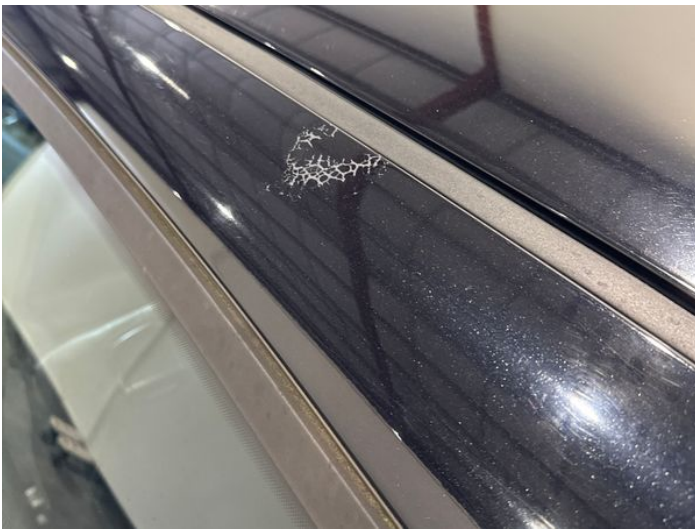
11: B Post ns  
Scratched  
Over 25mm Thru Paint

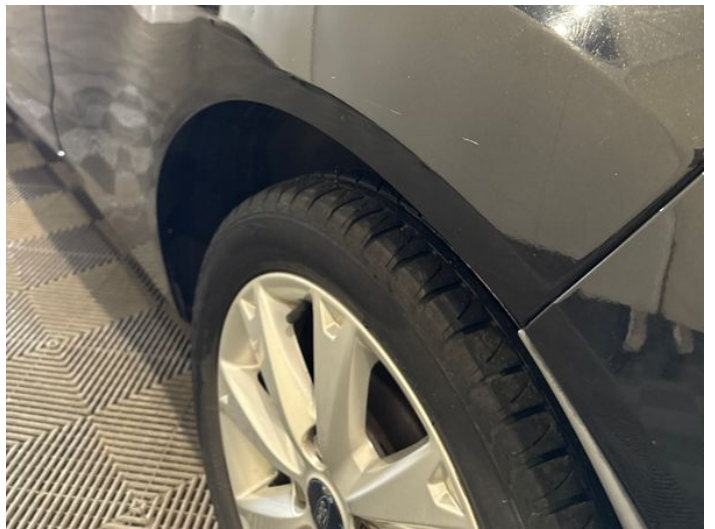
12: Qtr Panel nsr  
Dented  
With Paint Damage

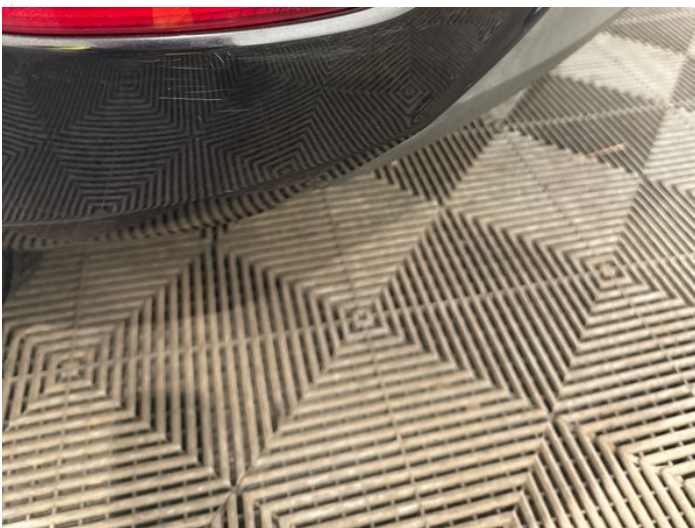
13: Bumper Reflector nsr  
Broken  
Replace

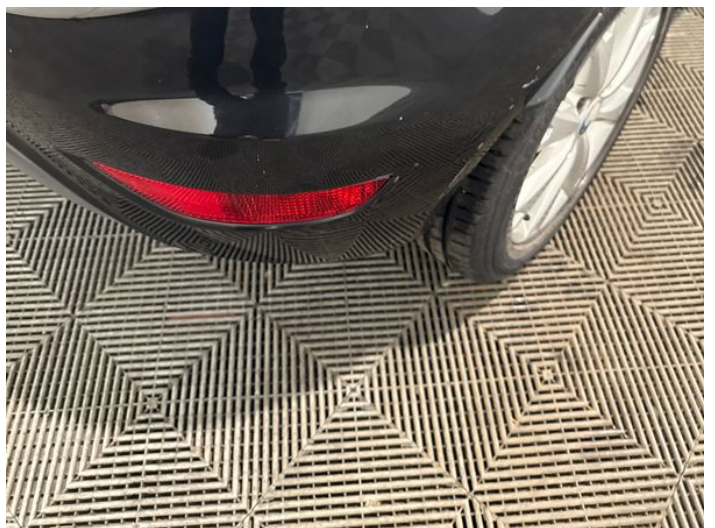
14: Bumper Rear  
Scratched  
Over 100mm Thru Paint

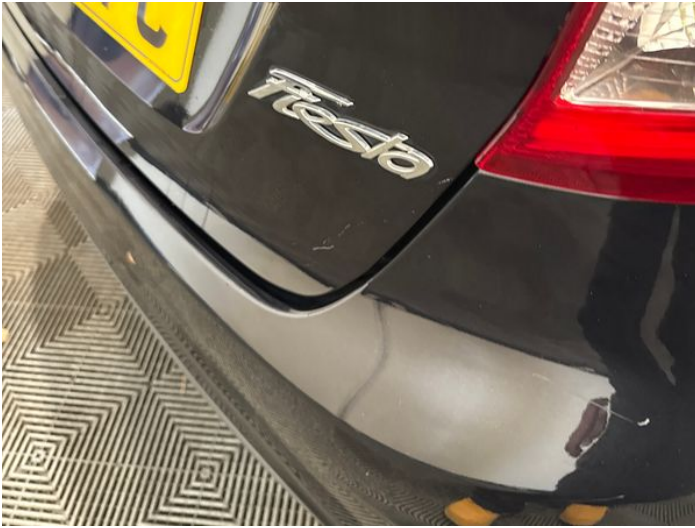
15: Tailgate  
Scratched  
Over 25mm Thru Paint

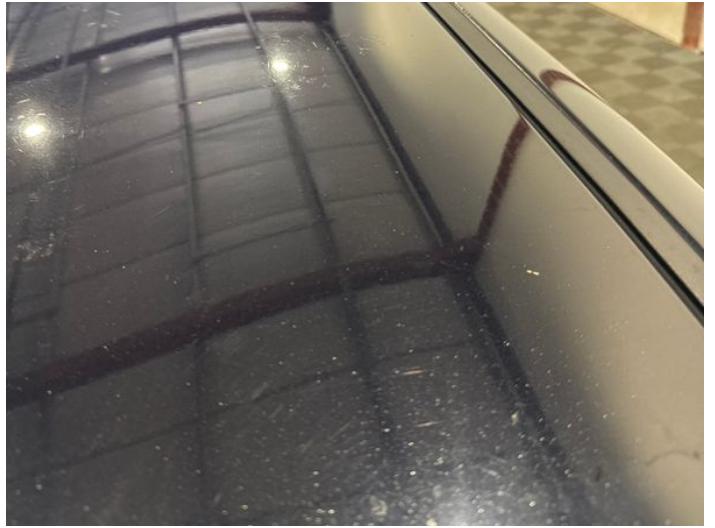
16: Roof  
Dented  
Over 30mm

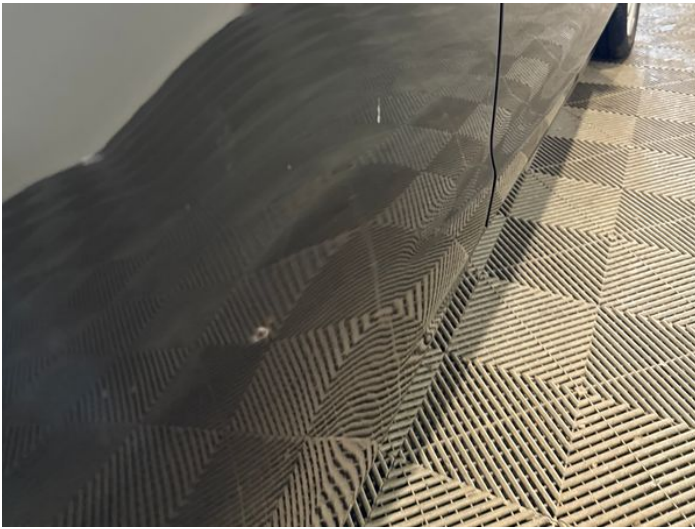
17: Qtr Panel osr  
Dented  
Between 10mm + 30mm

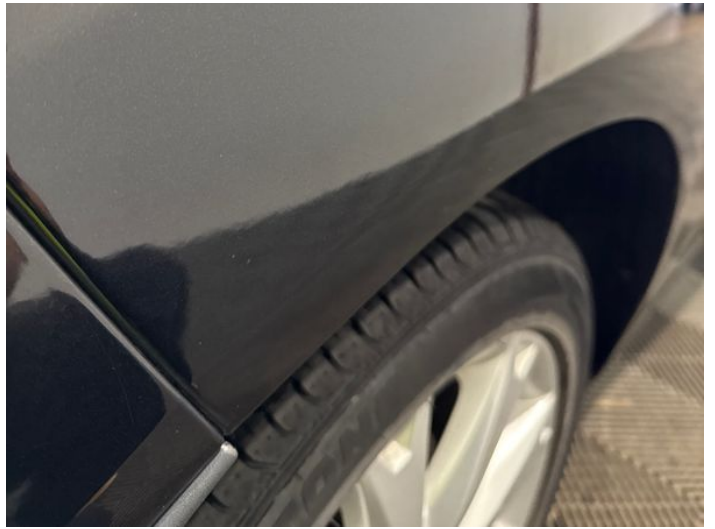
18: Qtr Panel osr  
Poor Previous Repair  
Poor Paint

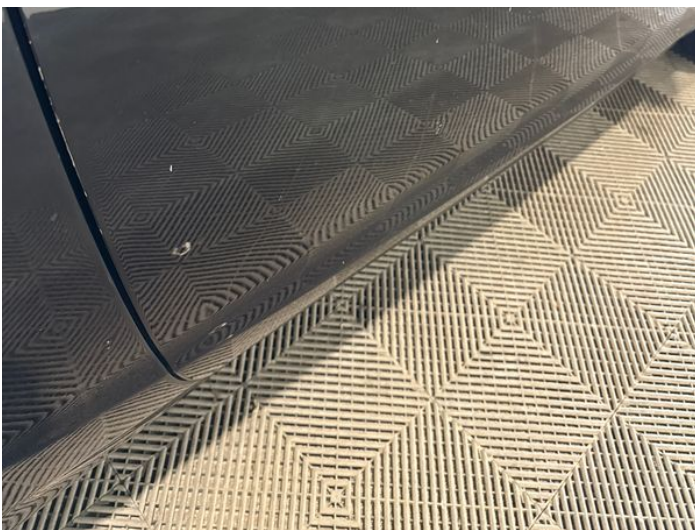
19: Door osf  
Scratched  
Over 25mm Thru Paint

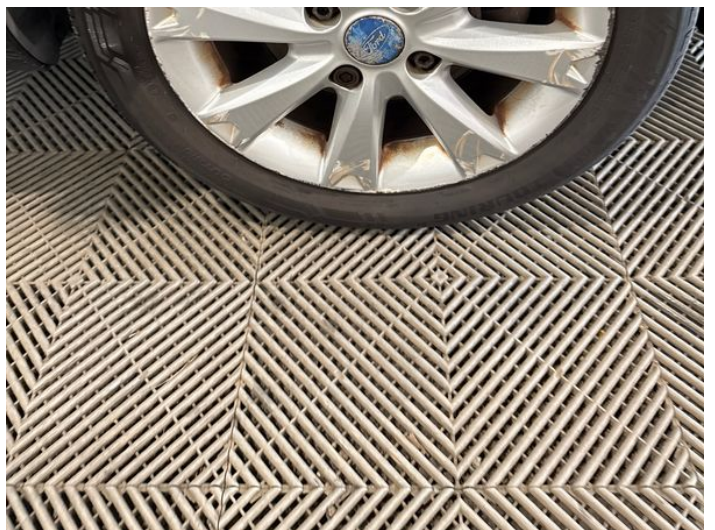
20: Wheel osf  
Scratched  
Over 50mm

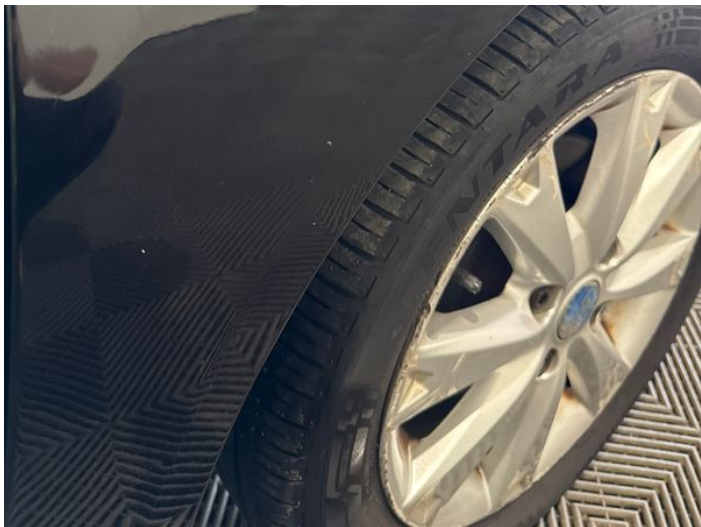
21: Wing osf  
Scratched  
UpTo 25mm Thru Paint
