VEHICLE INSPECTION REPORT

GV20JYW

Renault ZOE 100kW i GT Line R135 50kWh Rapid Charge 5dr Auto

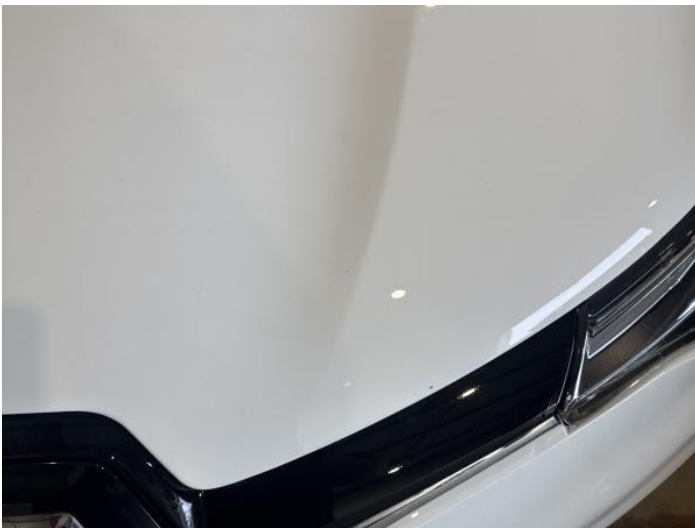
1: Bonnet
Chipped
1 To 5

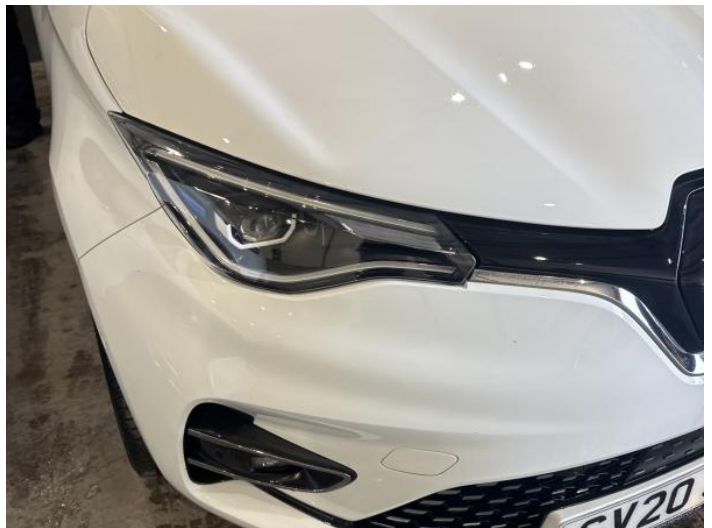
2: Bumper Front
Chipped
Multiple Chips

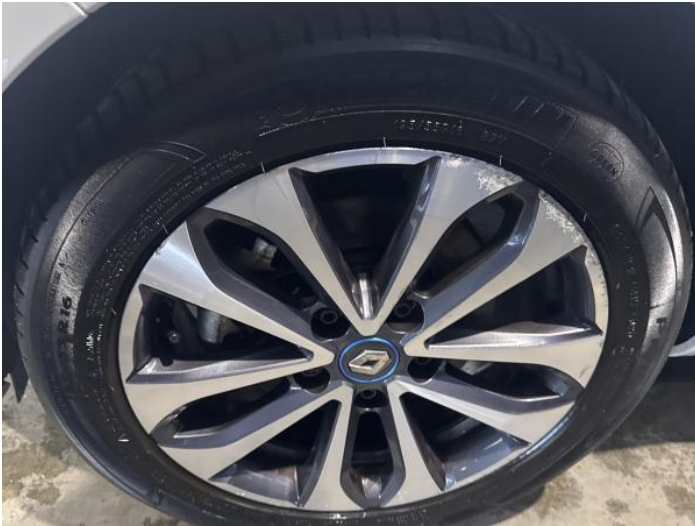
3: Wheel nsf
Scratched
Over 50mm

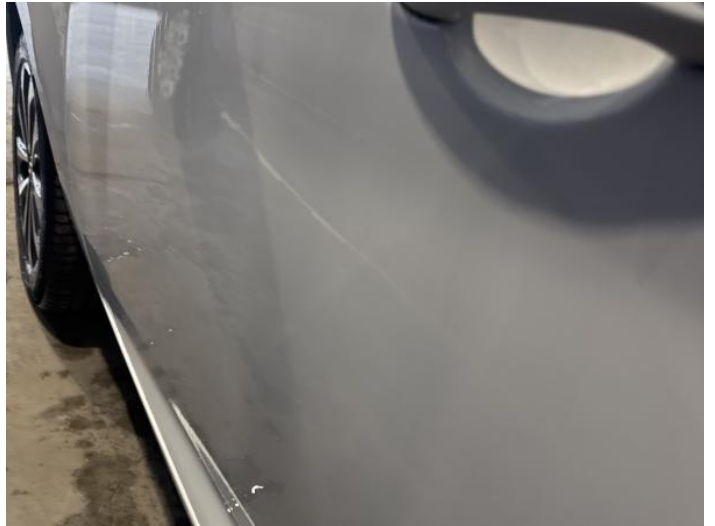
4: Door nsf
Chipped
1 To 5

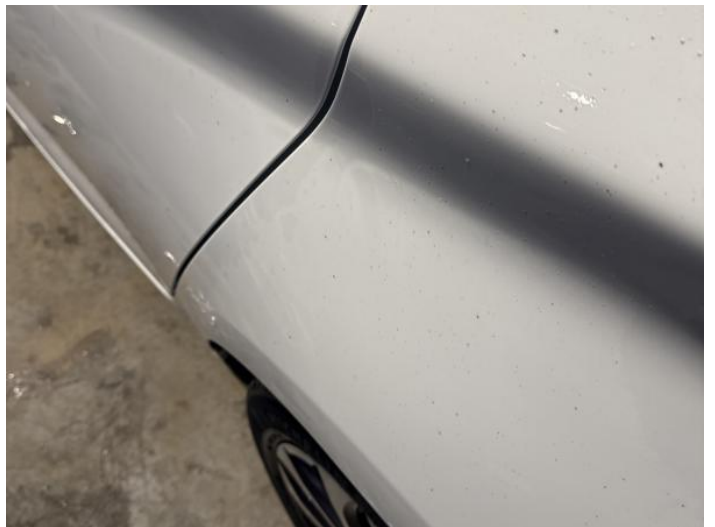
6: Qtr Panel nsr
Dented
2 Or Less UpTo 10mm

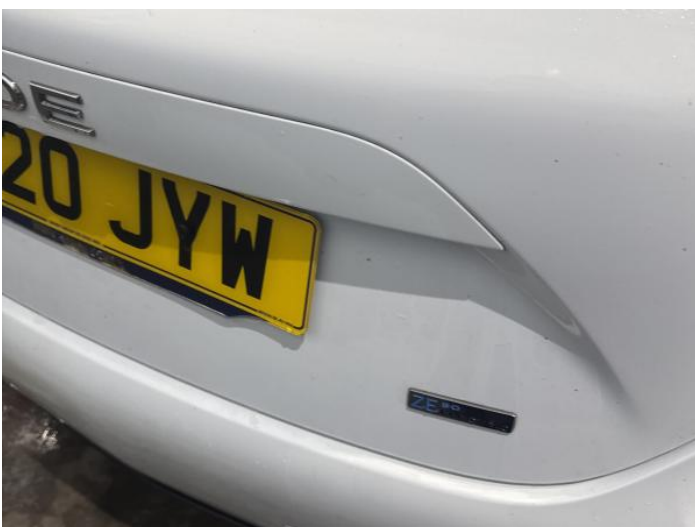
7: Bumper Rear
Chipped
Multiple Chips

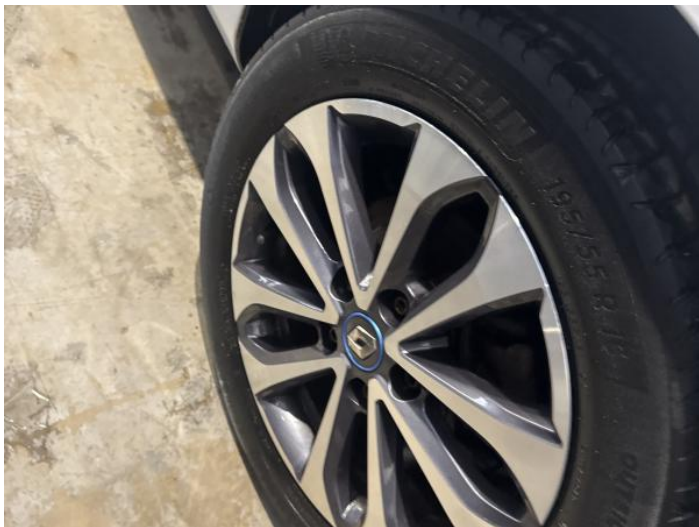
9: Wheel nsr
Scratched
Up To 50mm

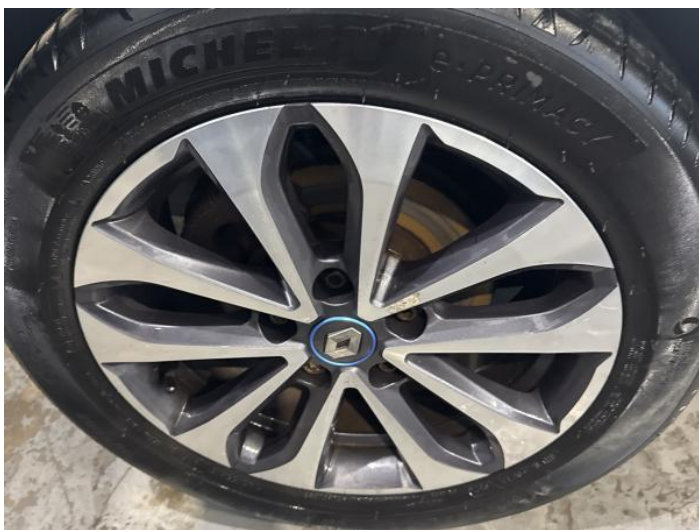
11: Wheel osr
Scratched
Over 50mm

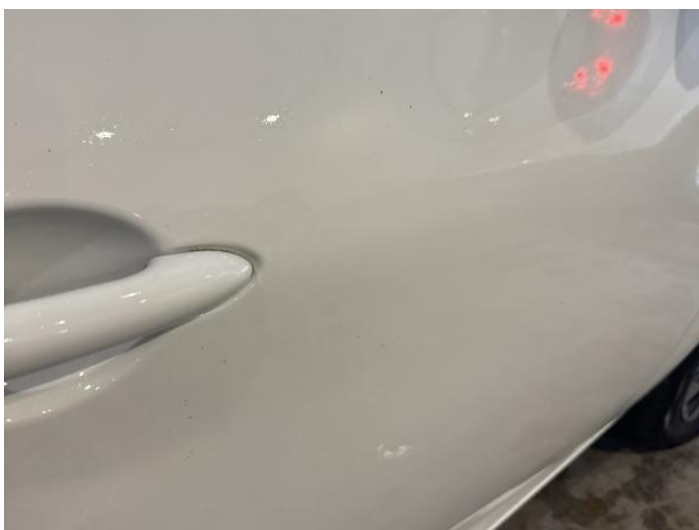
13: Door osf
Dented
2 Or Less UpTo 10mm

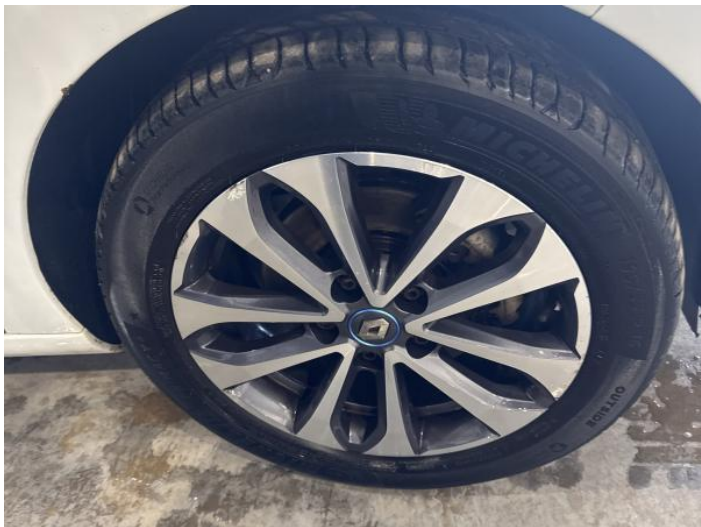
15: Wheel osf
Scratched
Over 50mm
