## VEHICLE INSPECTION REPORT

**KT15HAO**

### Peugeot 3008 1.6 BlueHDi 120 Allure 5dr EAT6

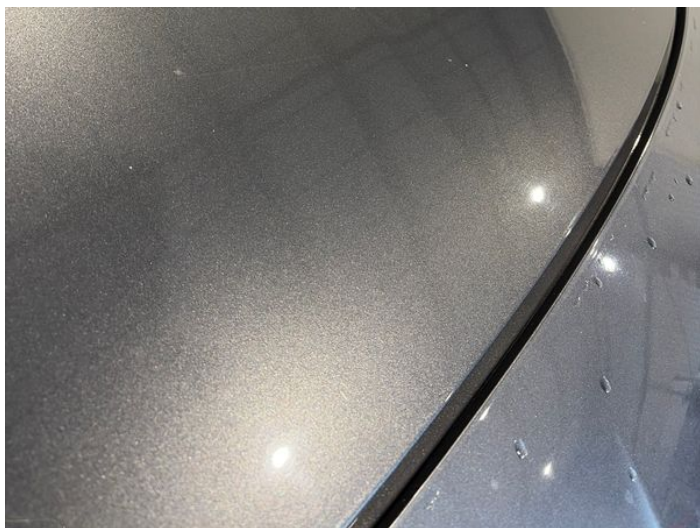
1: Bonnet  
Chipped  
Multiple Chips

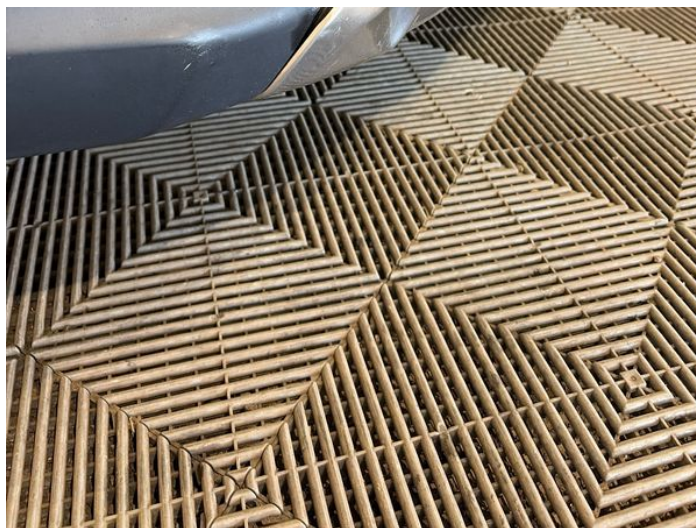
2: Bumper Front Moulding  
Broken  
Replace

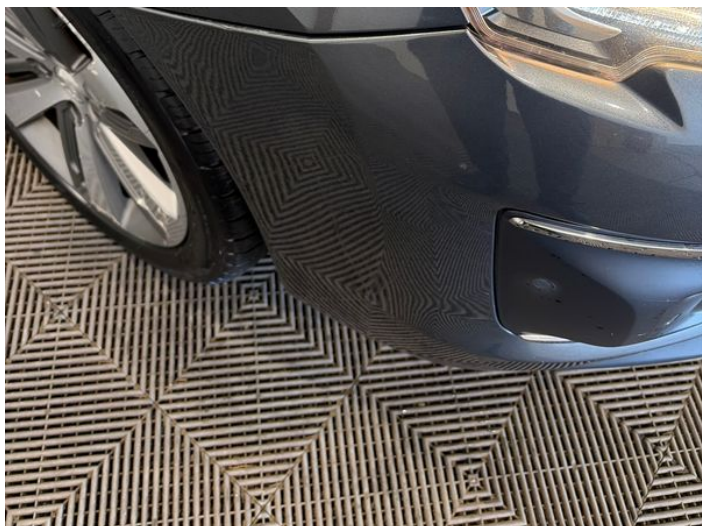
3: Bumper Front  
Insecure  
Action Required

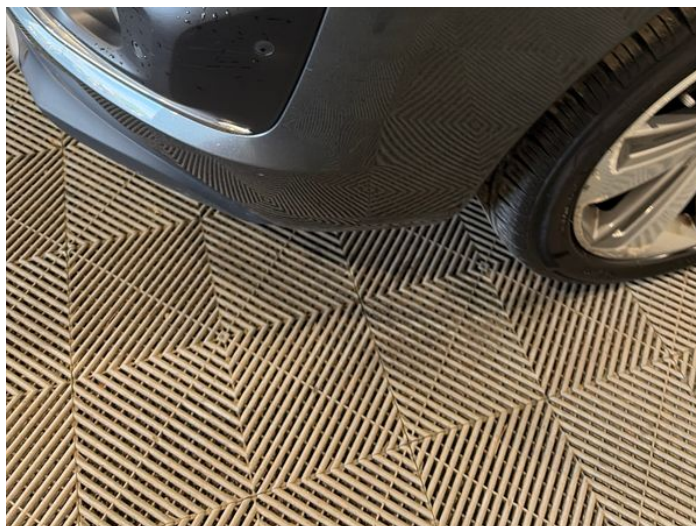
4: Bumper Front  
Scratched  
25 to 100mm Thru Paint

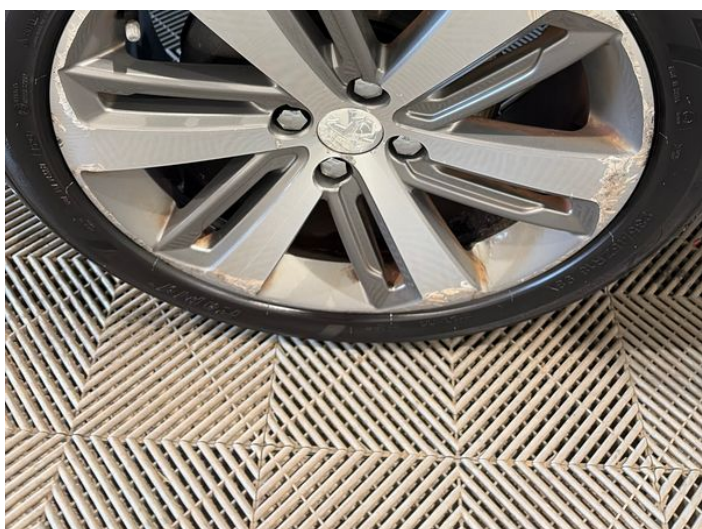
5: Wheel nsf  
Scratched  
Over 50mm

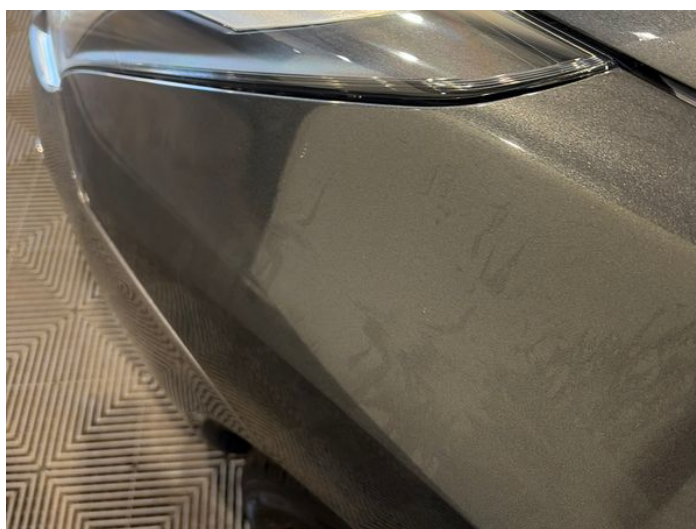
6: Wing nsf  
Chipped  
1 To 5

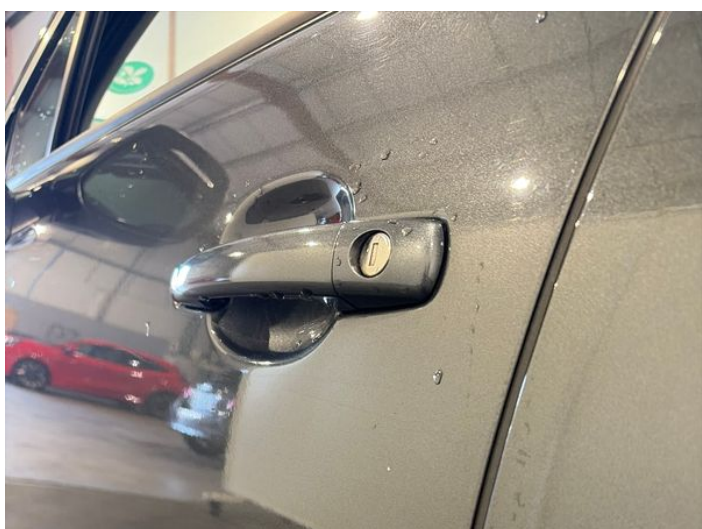
7: Door nsf  
Chipped  
1 To 5

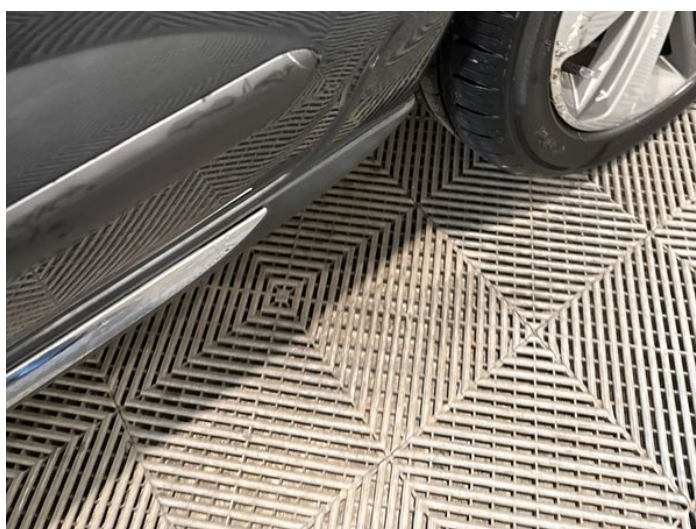
8: Door nsr  
Scratched  
Over 25mm Thru Paint

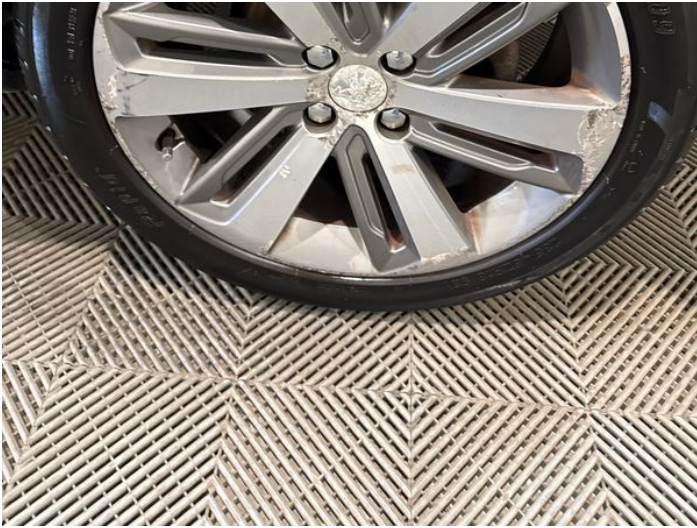
9: Wheel nsr  
Scratched  
Over 50mm

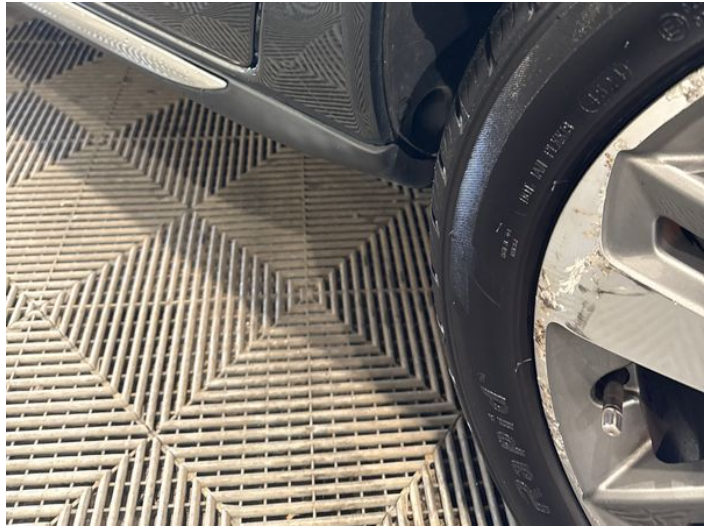
10: Qtr Panel nsr  
Dented  
With Paint Damage

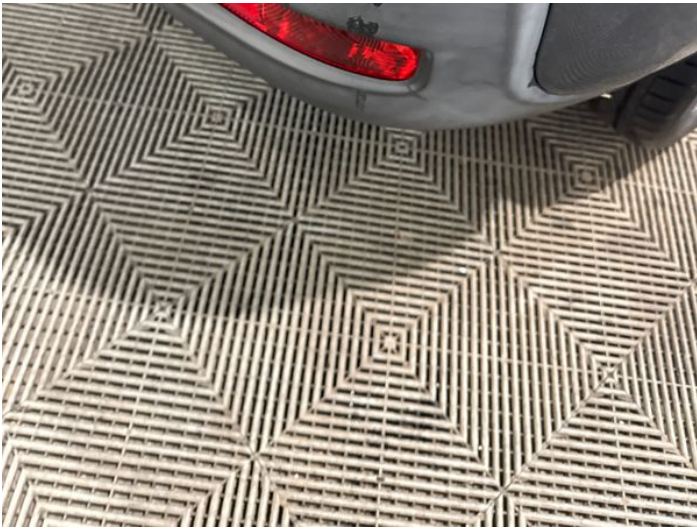
11: Bumper Rear Moulding  
Scuffed (Unpainted)  
Over 100mm

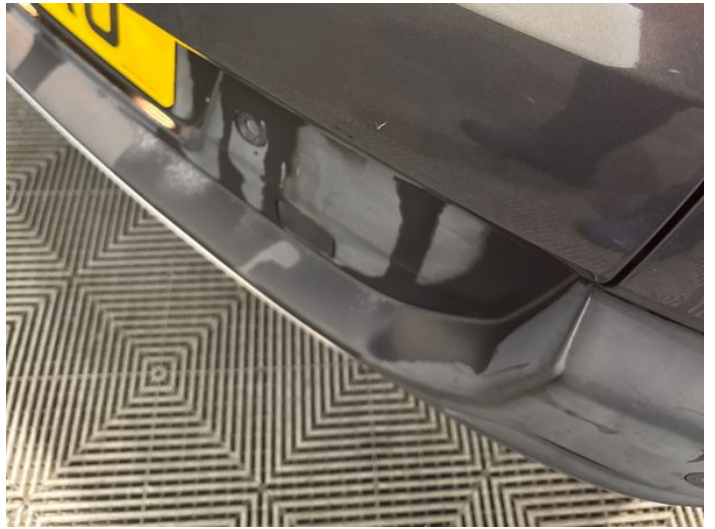
12: Tailgate  
Scratched  
UpTo 25mm Thru Paint

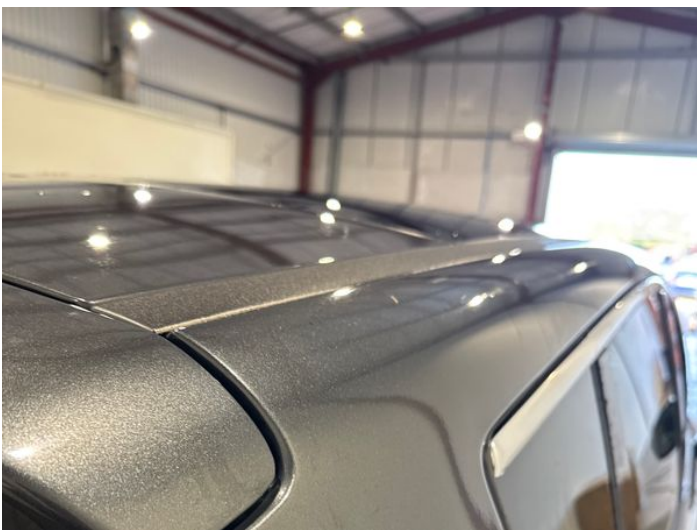
13: C Post os  
Dented  
Over 30mm

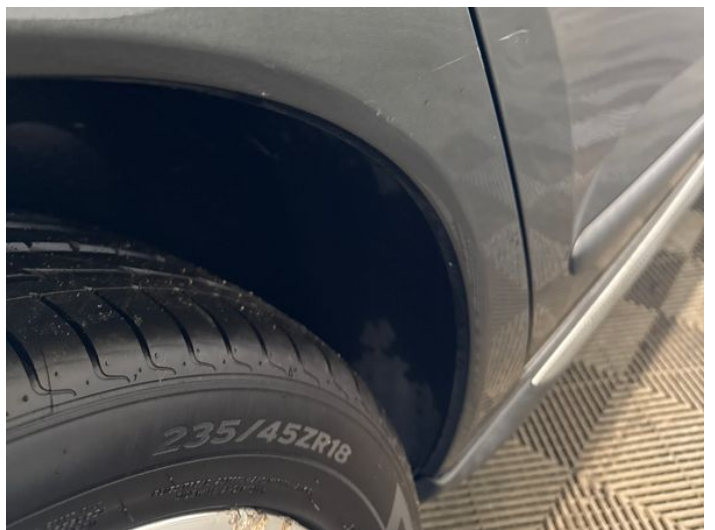
14: Qtr Panel osr  
Dented  
With Paint Damage

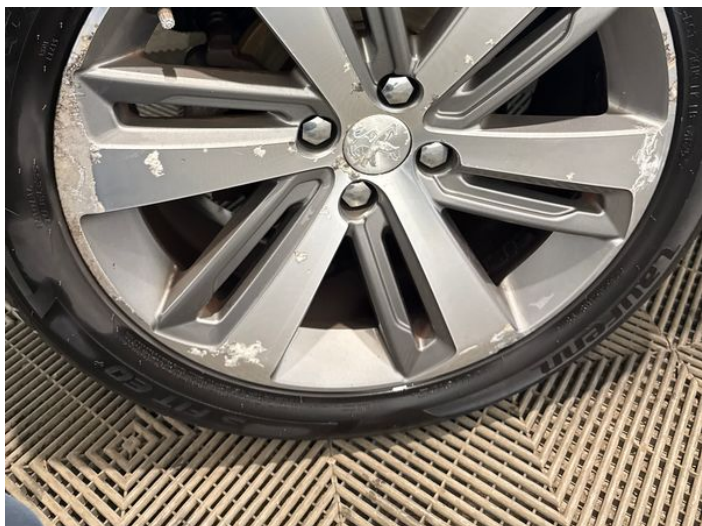
15: Wheel osr  
Scratched  
Over 50mm

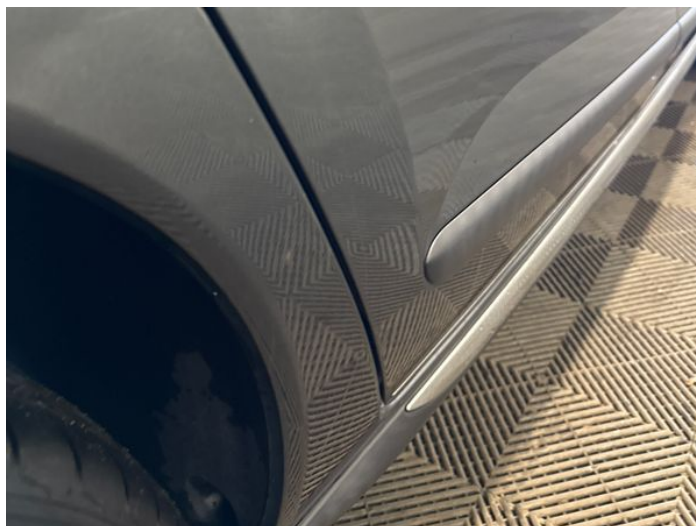
16: Door osr  
Dented  
With Paint Damage

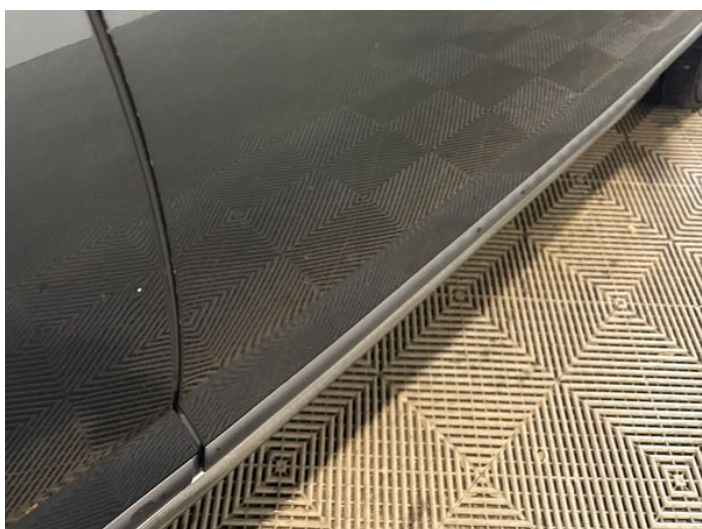
17: Door osf  
Chipped  
Edge Chip

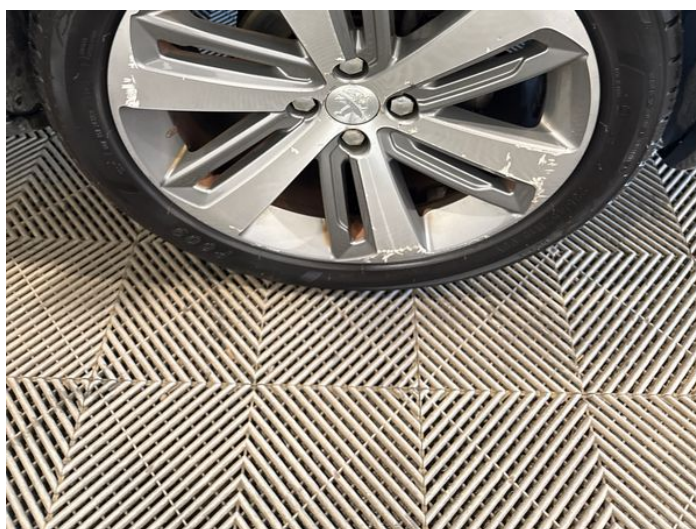
18: Wheel osf  
Scratched  
Over 50mm

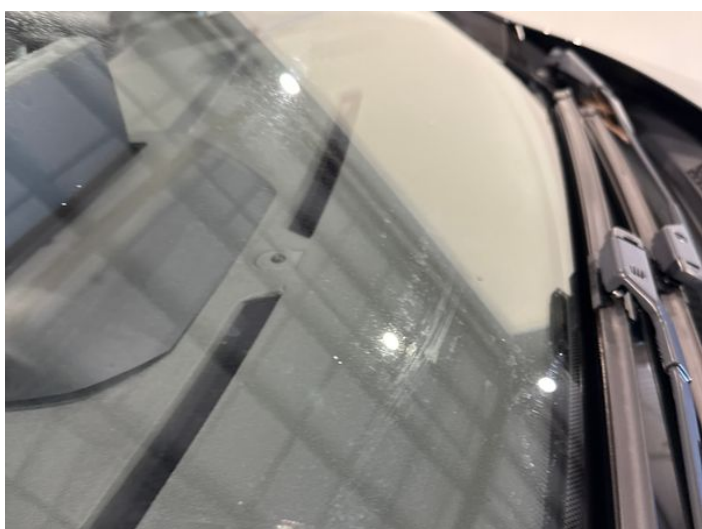
19: Screen Front  
Chipped  
UpTo 10mm
