# VEHICLE INSPECTION REPORT

**GU62KCA**

## BMW 1 Series 118d Sport 5dr Step Auto

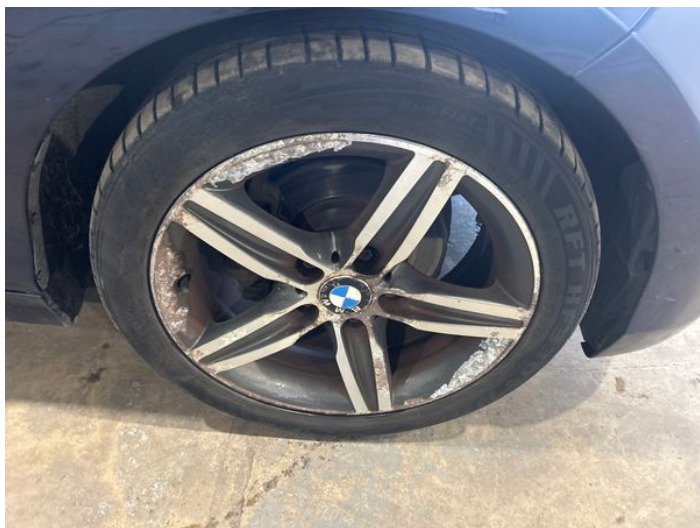
1: Wheel osf  
Corroded  
Light

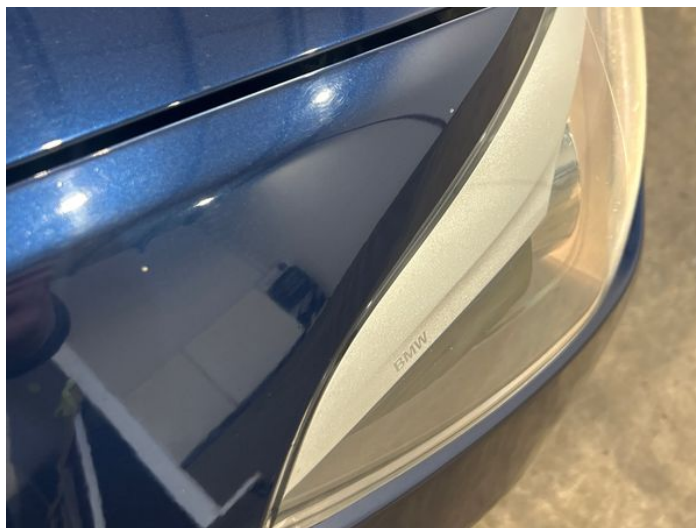
2: Wing osf  
Chipped  
1 To 5

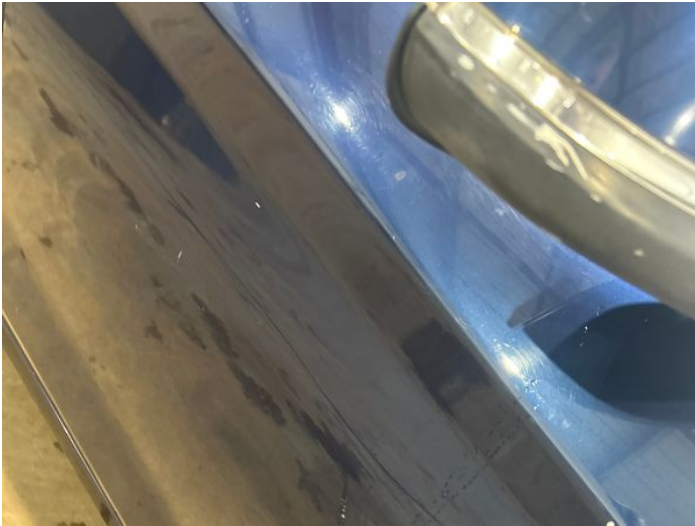
3: Door osf  
Chipped  
1 To 5

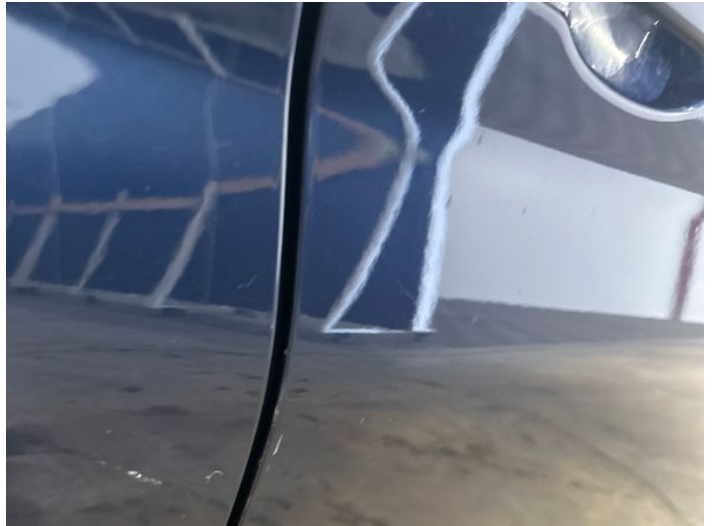
4: Door osf  
Chipped  
Edge Chip

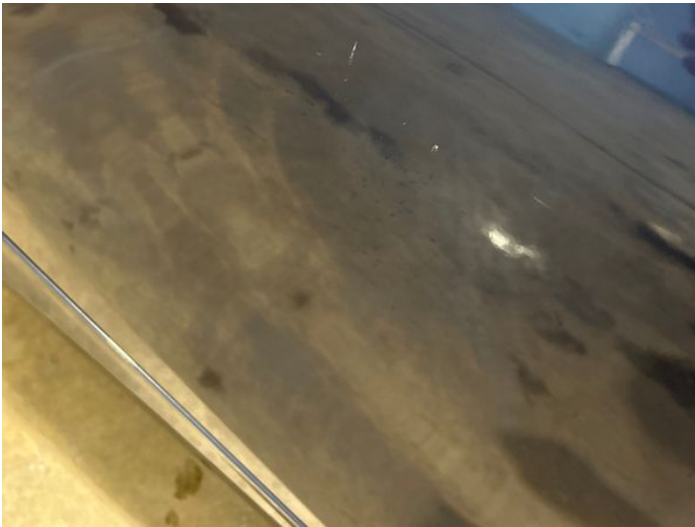
5: Door osr  
Chipped  
1 To 5

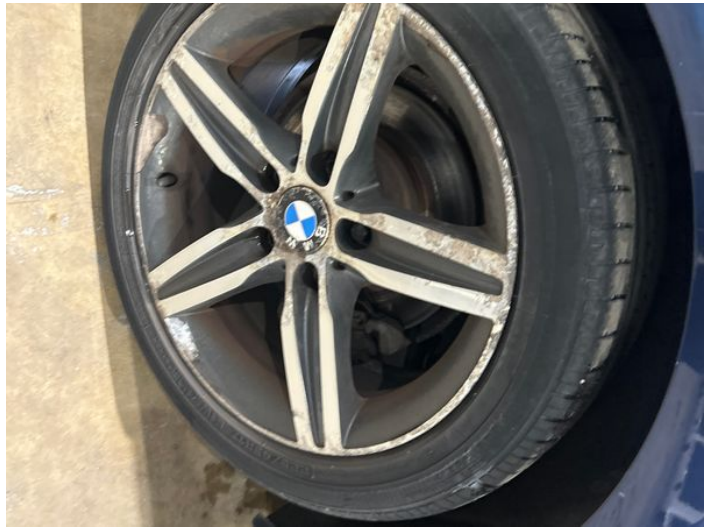
6: Wheel osr  
Corroded  
Light

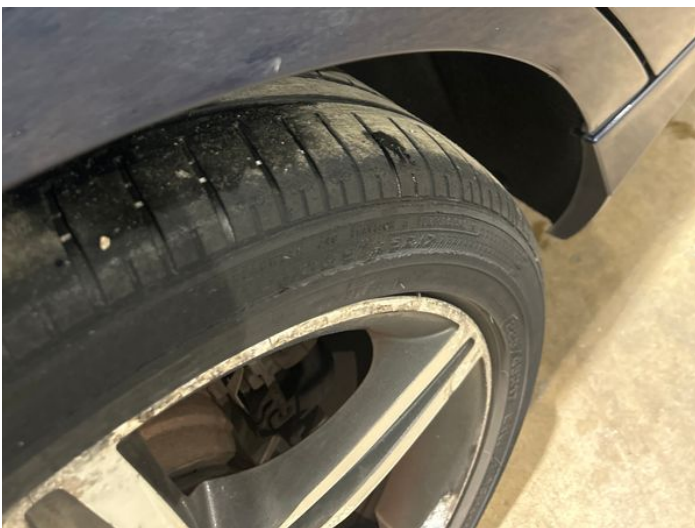
7: Qtr Panel osr  
Dented  
Between 10mm + 30mm

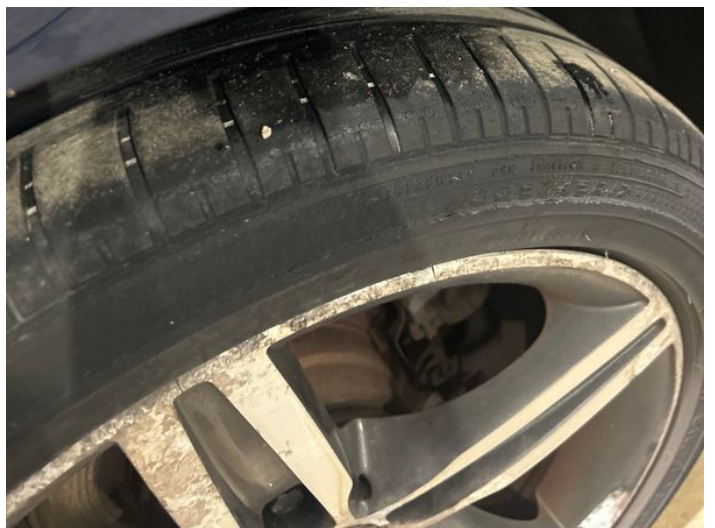
8: Qtr Panel osr  
Chipped  
1 To 5

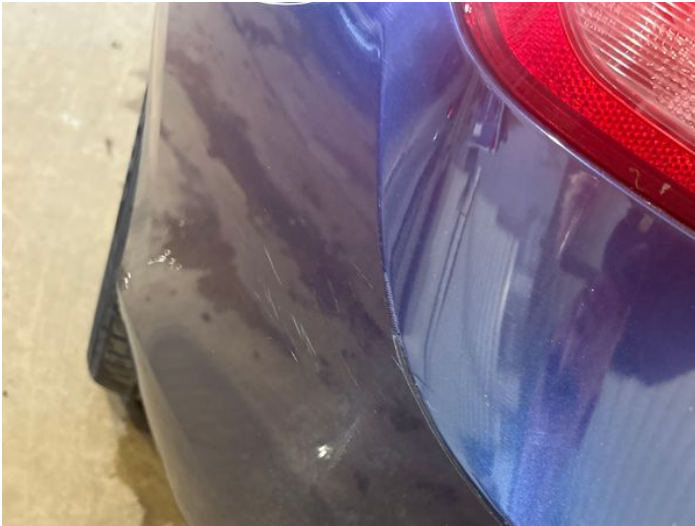
9: Bumper Rear  
Scratched  
Over 100mm Thru Paint

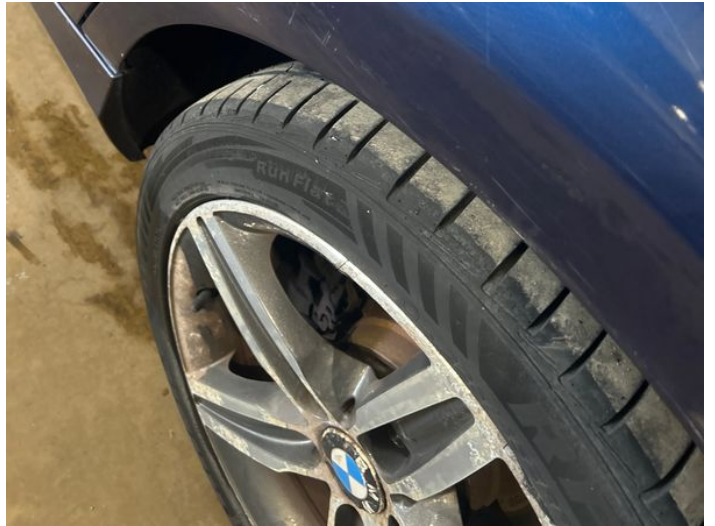
10: Qtr Panel nsr  
Dented  
With Paint Damage

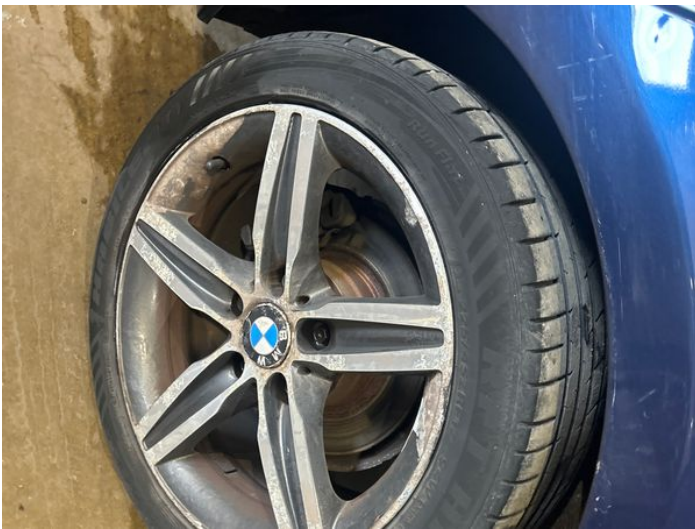
11: Wheel nsr  
Corroded  
Light

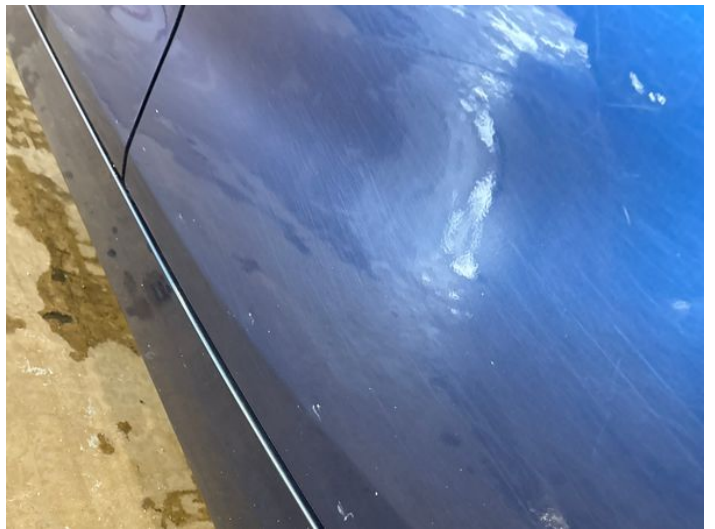
12: Door nsr  
Dented  
With Paint Damage

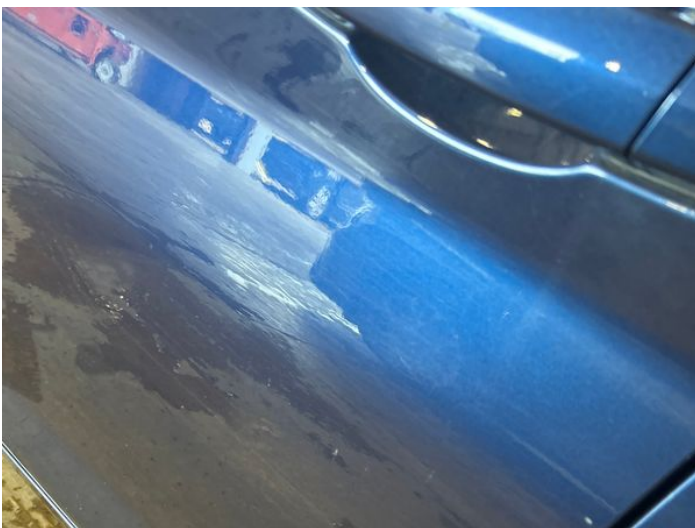
13: Door nsf  
Chipped  
1 To 5

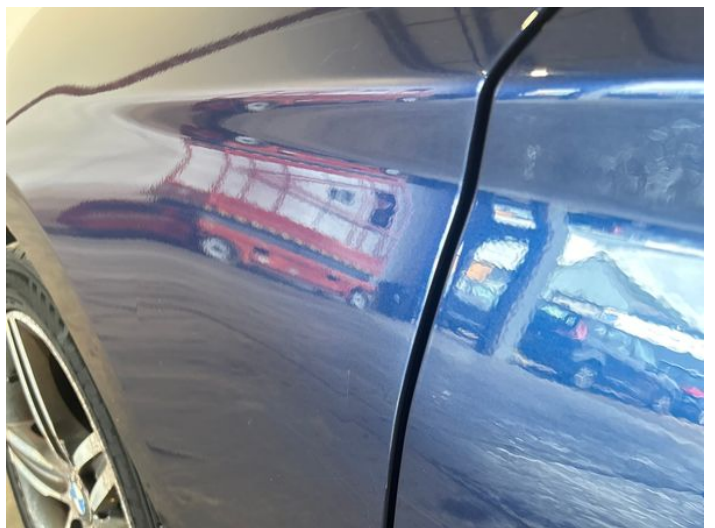
14: Wing nsf  
Dented  
Between 10mm + 30mm

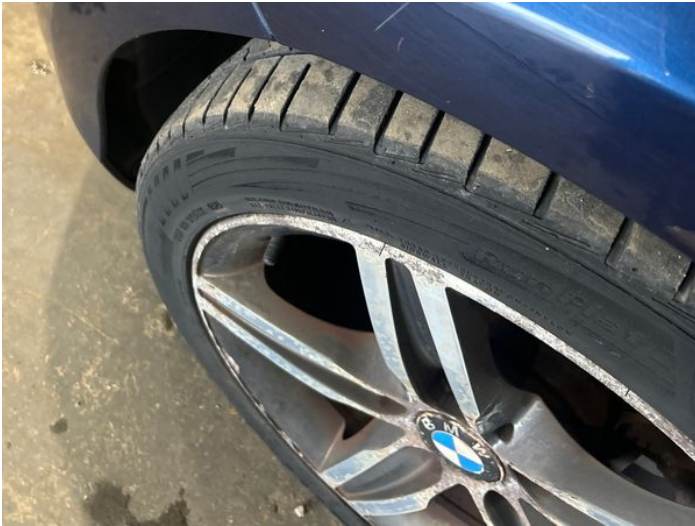
15: Wing nsf  
Scratched  
UpTo 25mm Thru Paint

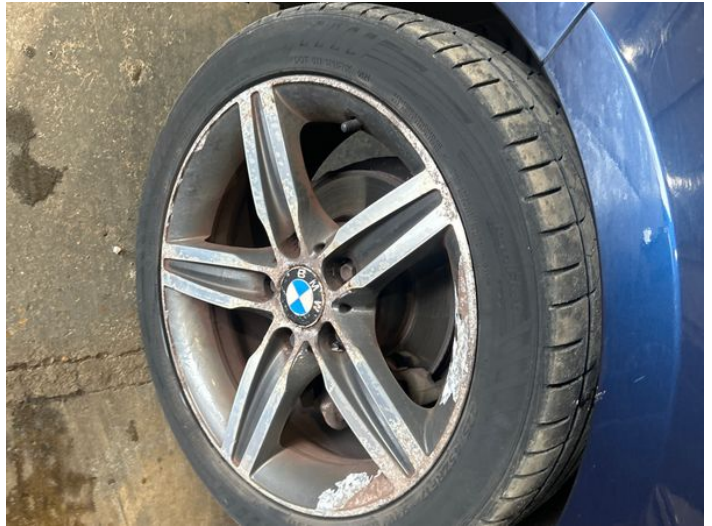
16: Wheel nsf  
Corroded  
Light

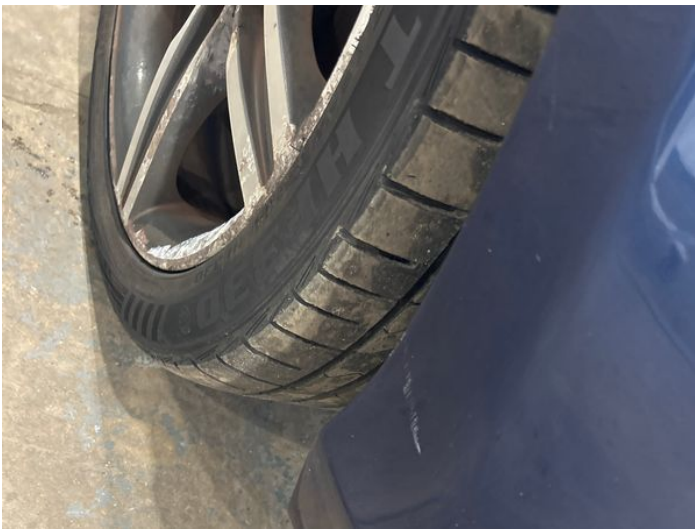
17: Bumper Front  
Scratched  
UpTo 25mm Thru Paint

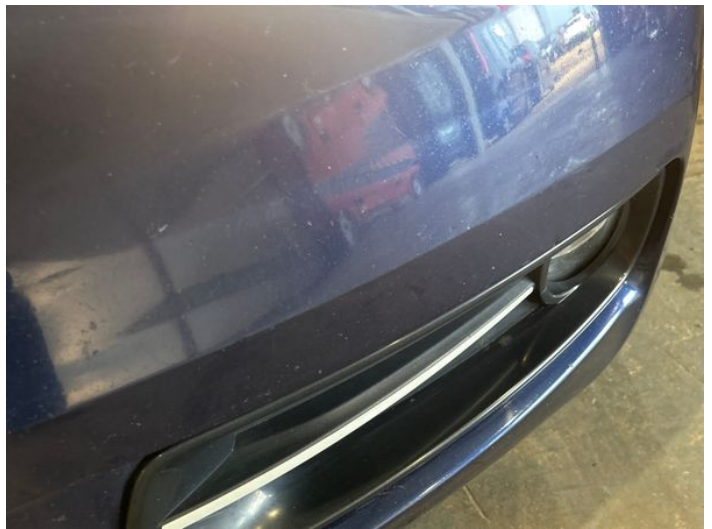
18: Bumper Front  
Chipped  
Multiple Chips

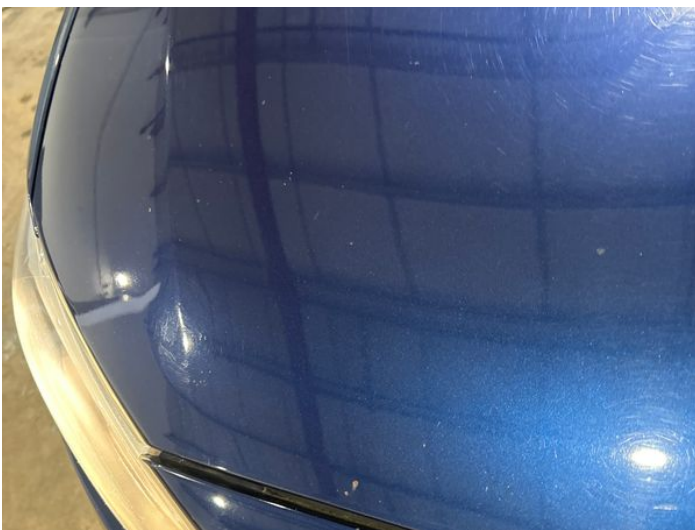
19: Bonnet  
Chipped  
1 To 5

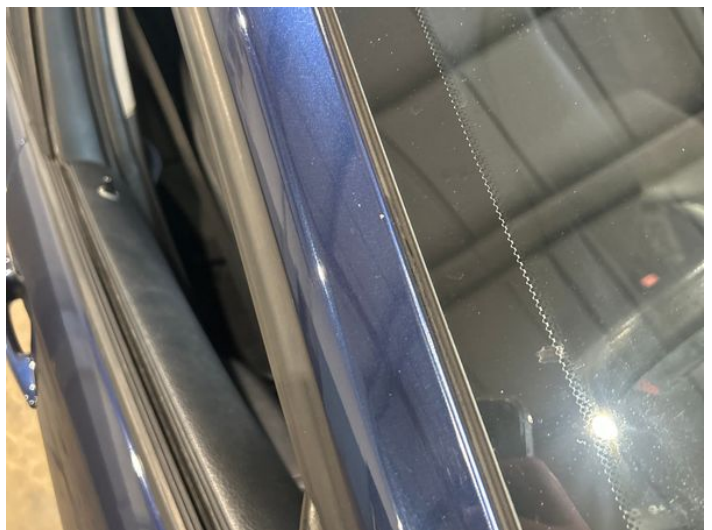
20: A Post os  
Chipped  
1 To 5

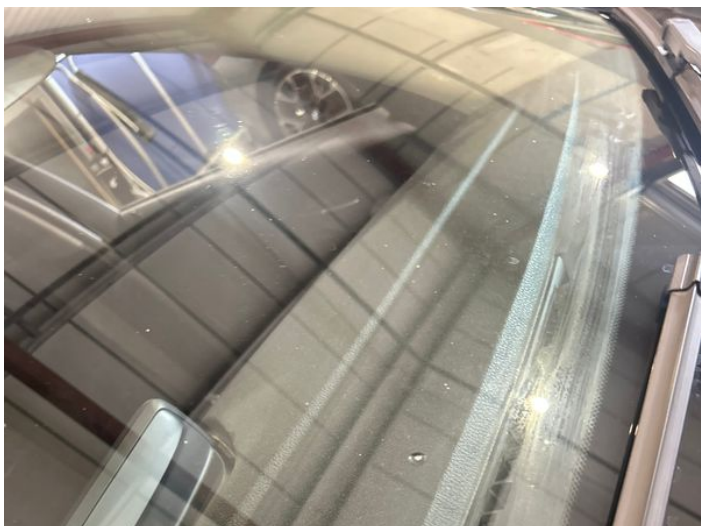
21: Screen Front  
Chipped  
UpTo 10mm

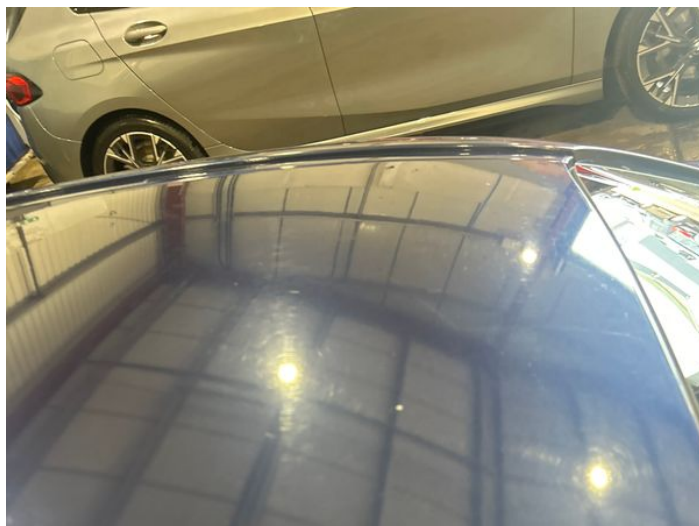
22: Roof  
Chipped  
1 To 5
