# VEHICLE INSPECTION REPORT

**DL64HDA**

## Vauxhall Corsa 1.4 SE 5dr

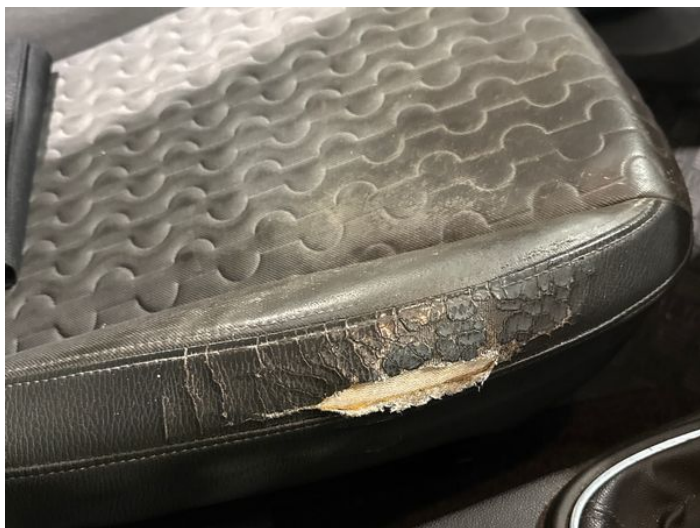
1: Seat Base Cover nsf  
Torn  
Over 3mm

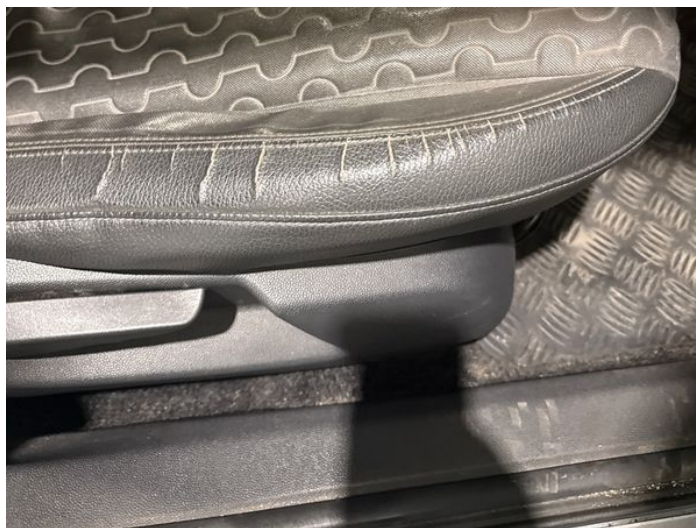
2: Seat Back Cover osf  
Scuffed  
Over 25mm

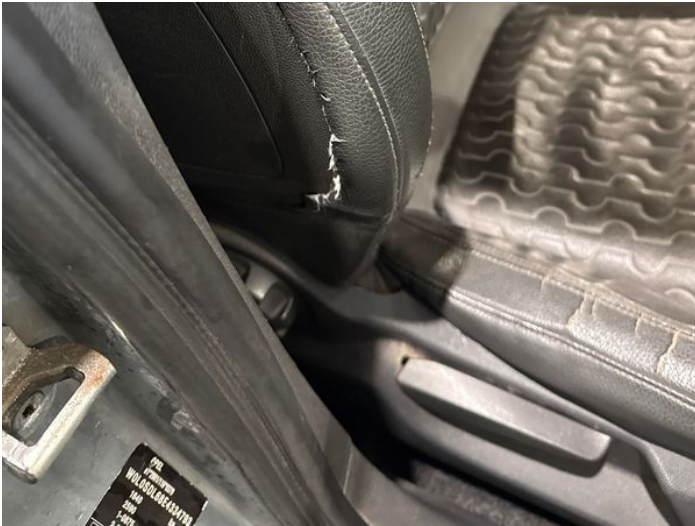
3: Seat Back Cover osf  
Torn  
Over 3mm

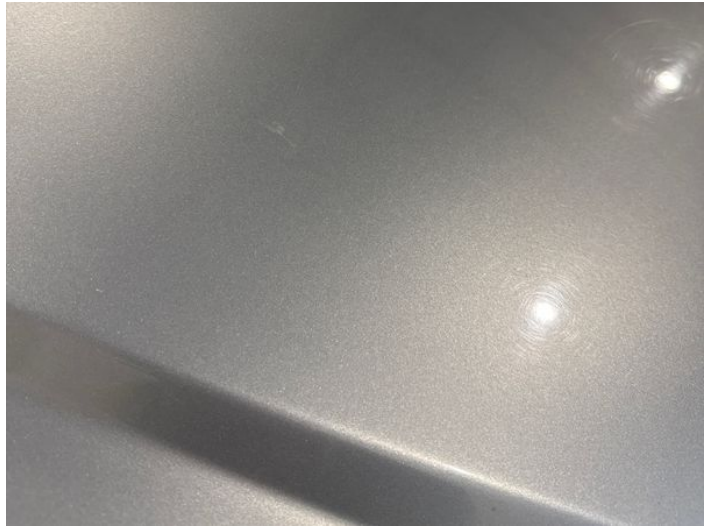
4: Bonnet  
Dented  
Between 10mm + 30mm

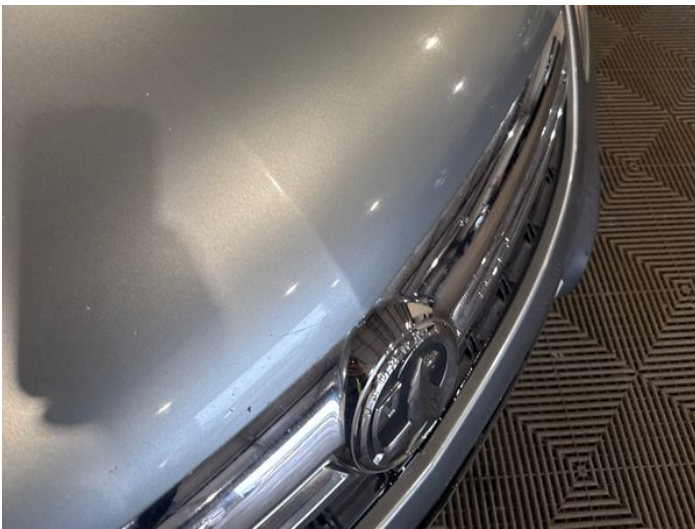
5: Bonnet  
Chipped  
Multiple Chips

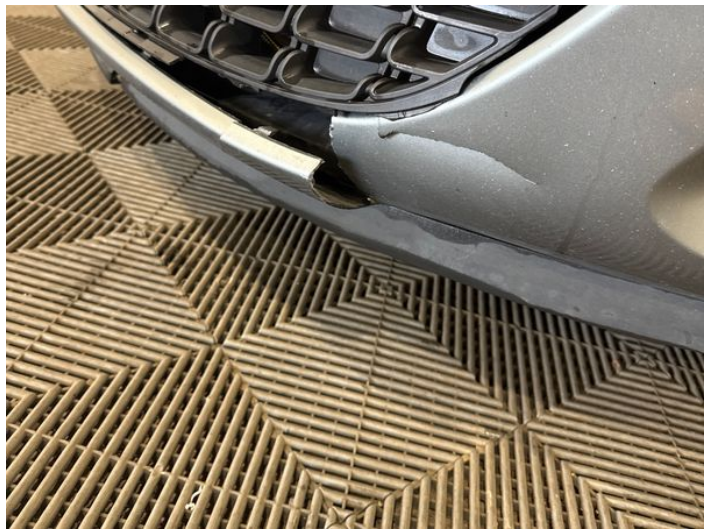
6: Bumper Front  
Cracked  
Over 25mm

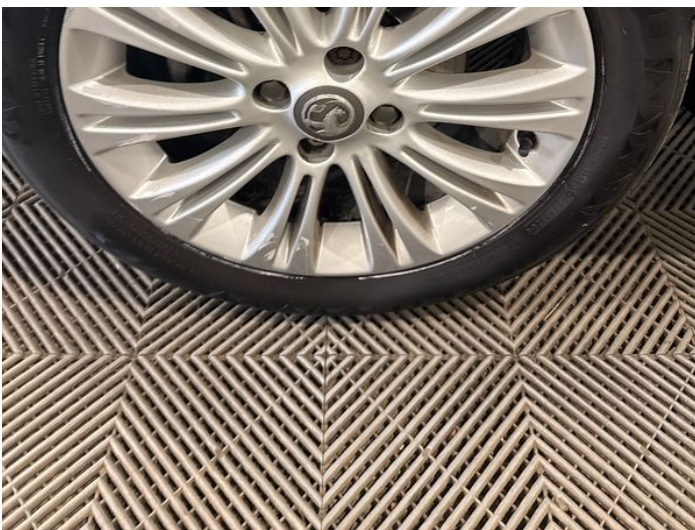
7: Wheel nsf  
Scratched  
Over 50mm

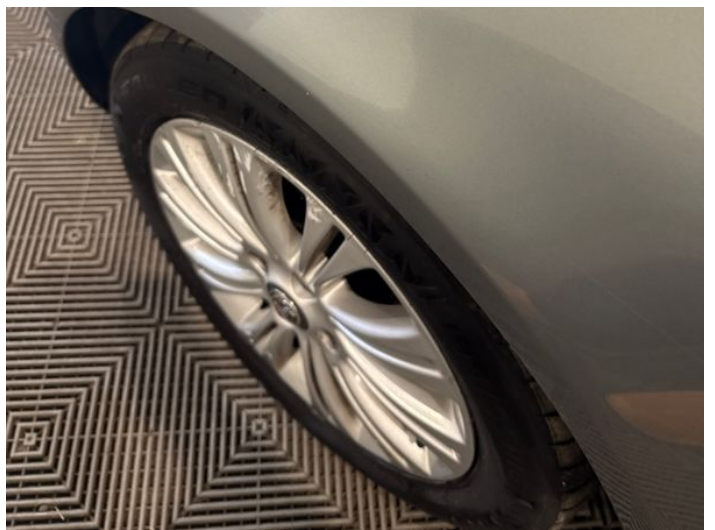
8: Wing nsf  
Chipped  
1 To 5

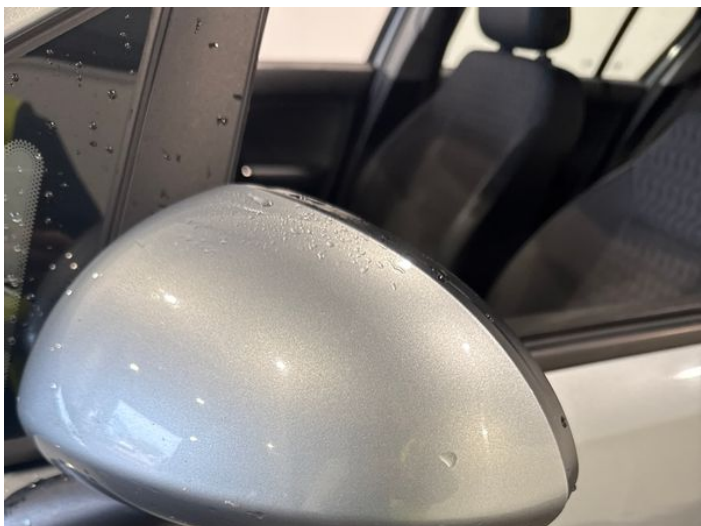
9: Door Mirror Assy nsf  
Scratched (Painted)  
UpTo 25mm Thru Paint

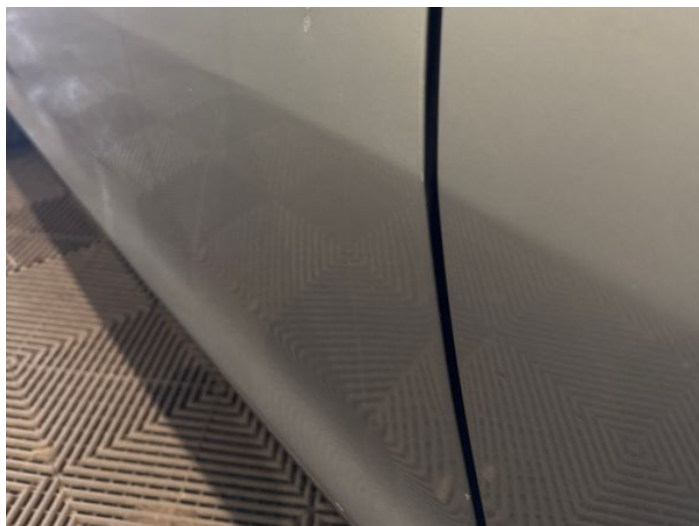
10: Door nsf  
Dented  
Between 10mm + 30mm

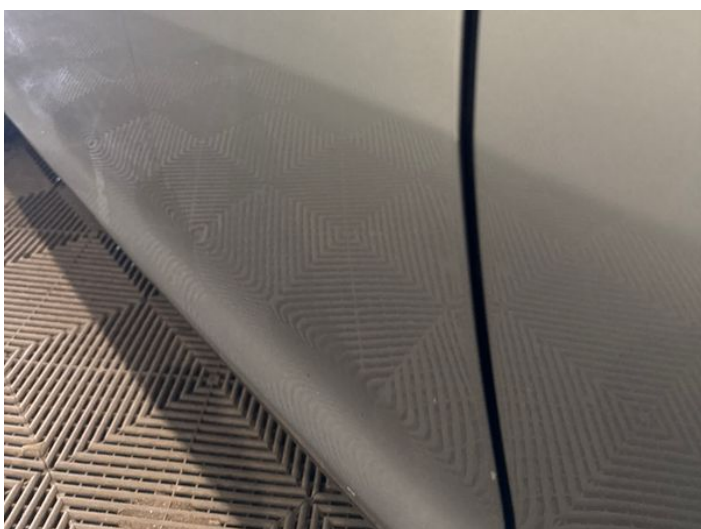
11: Door nsf  
Scratched  
UpTo 25mm Thru Paint

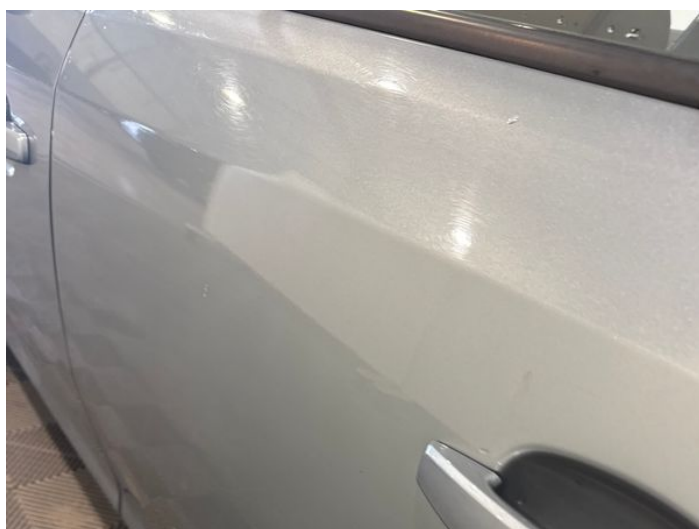
12: Door nsr  
Chipped  
Multiple Chips

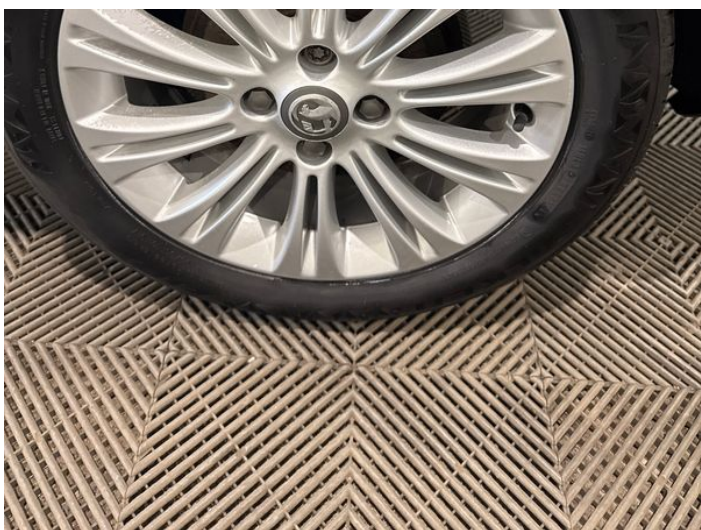
13: Wheel nsr  
Scratched  
Over 50mm

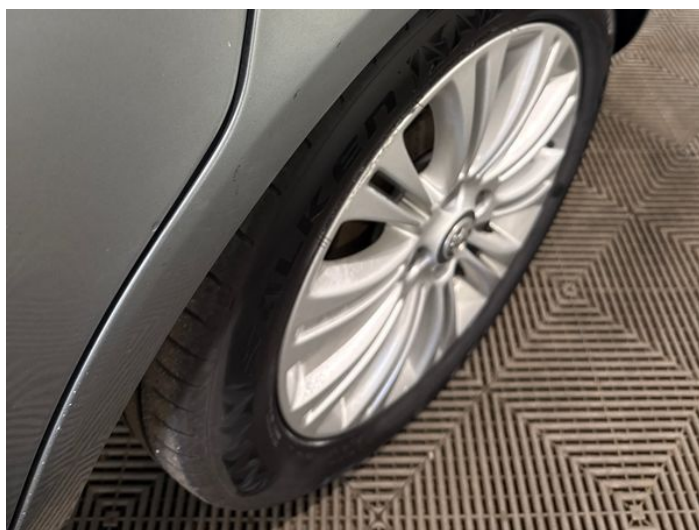
14: Qtr Panel nsr  
Scratched  
Over 25mm Thru Paint

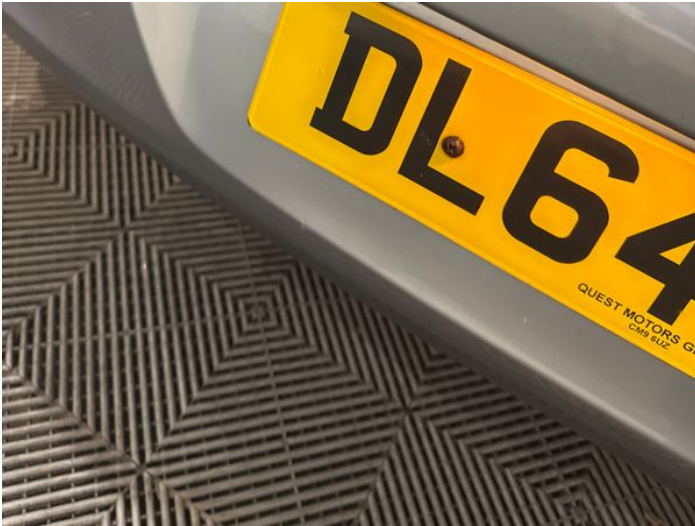
15: Bumper Rear  
Scratched  
25 to 100mm Thru Paint

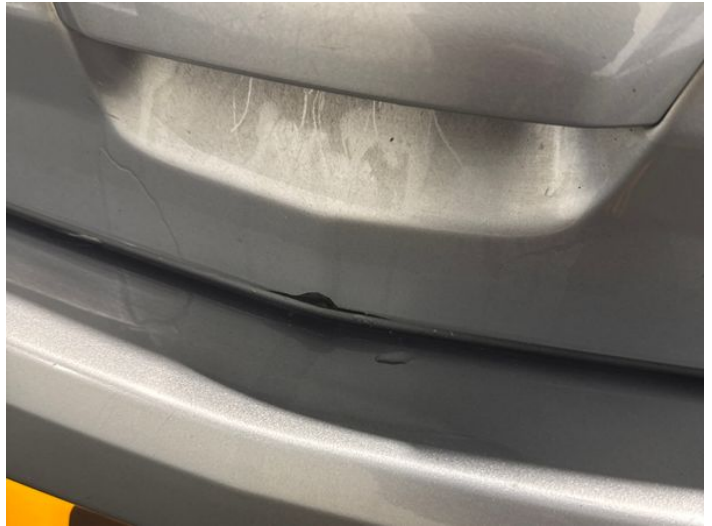
16: Tailgate  
Scratched  
Over 25mm Thru Paint

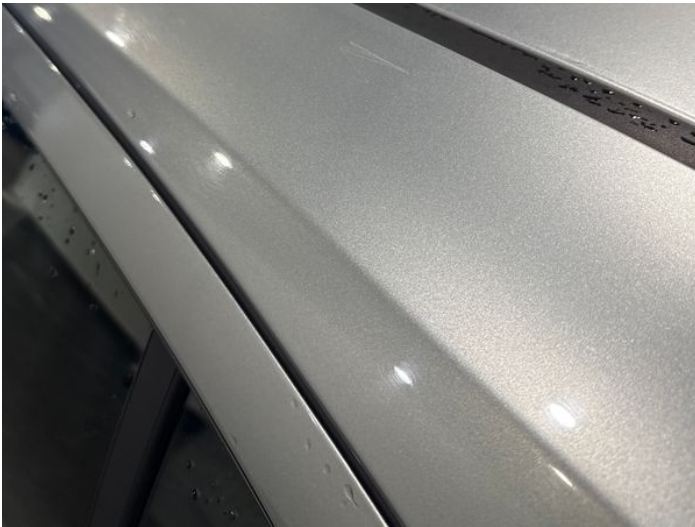
17: B Post ns  
Scratched  
Over 25mm Thru Paint

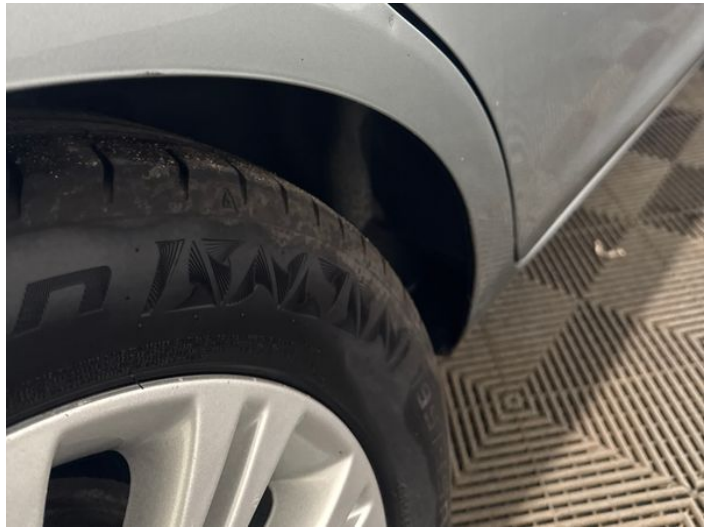
18: Qtr Panel osr  
Dented  
Between 10mm + 30mm

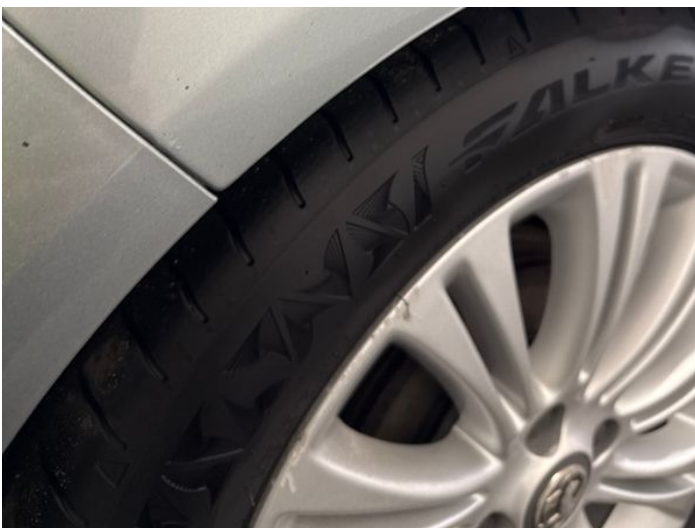
19: Qtr Panel osr  
Chipped  
1 To 5

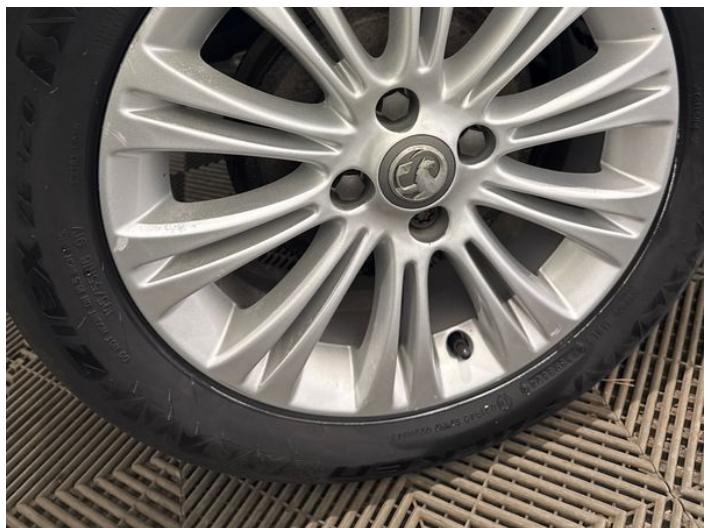
20: Wheel osr  
Scratched  
Over 50mm

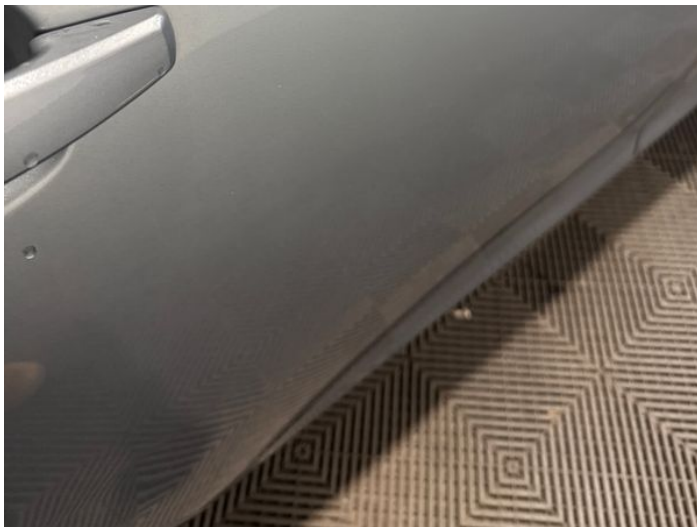
21: Door osr  
Scratched  
Over 25mm Thru Paint

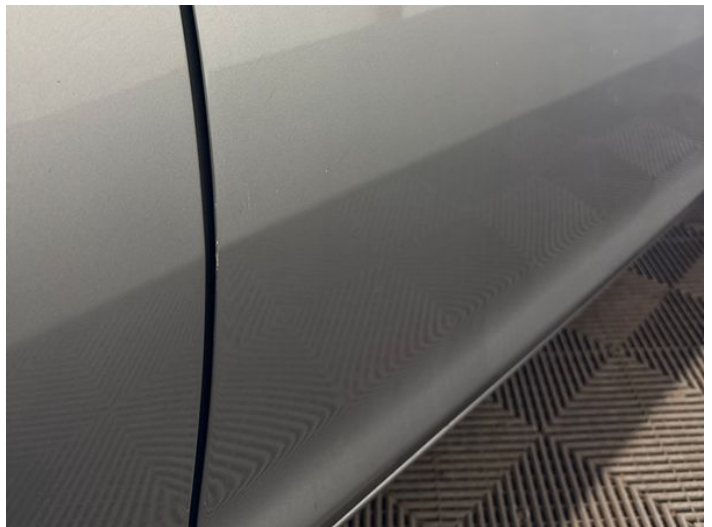
22: Door osf  
Scratched  
Over 25mm Thru Paint

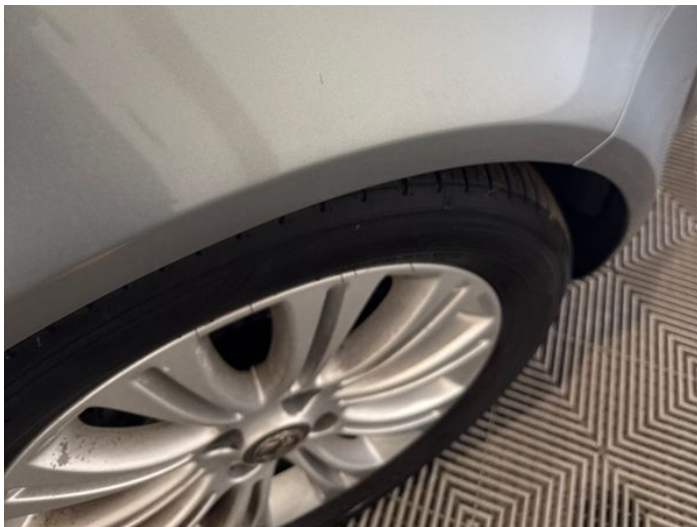
23: Wing osf  
Chipped  
1 To 5

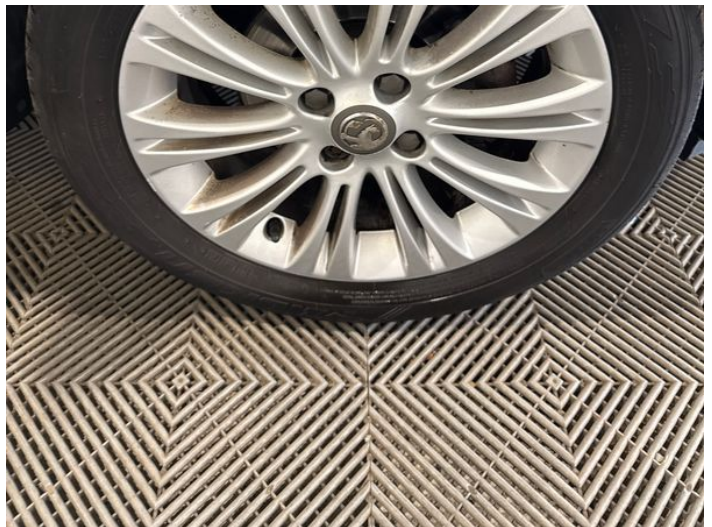
24: Wheel osf  
Scratched  
Over 50mm

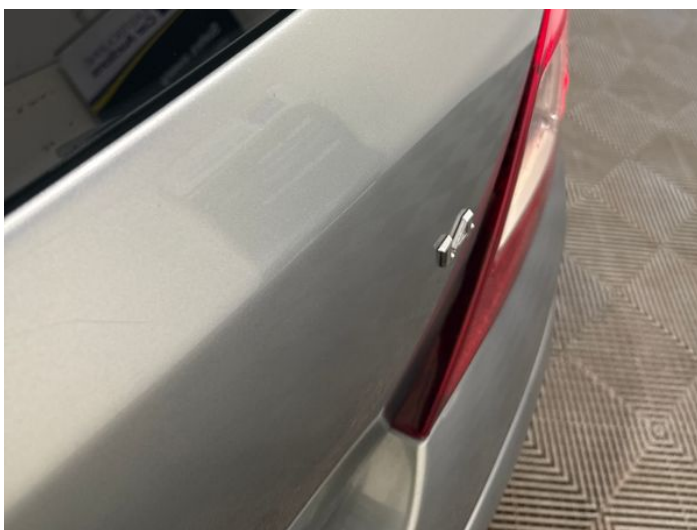
25: Tailgate  
Dented  
Between 10mm + 30mm
