# VEHICLE INSPECTION REPORT

**GX16XWE**

## Volkswagen Polo 1.2 TSI SE 5dr

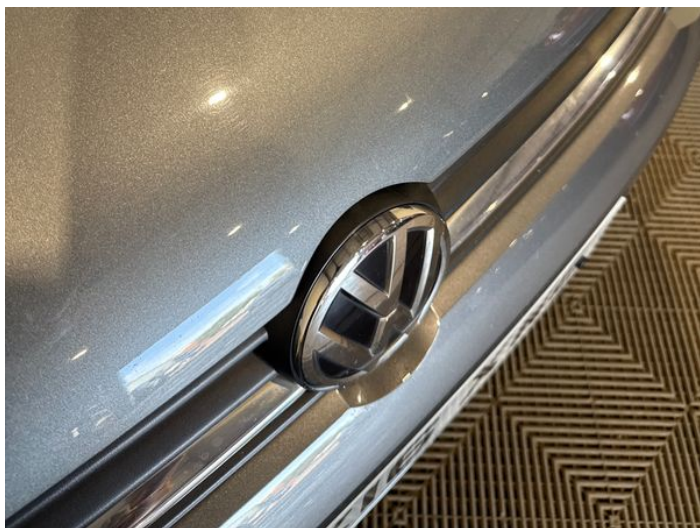
1: Bonnet  
Chipped  
1 To 5

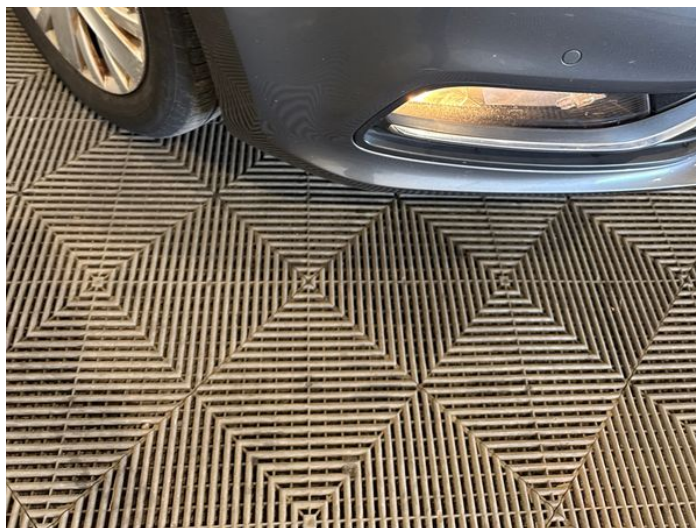
2: Bumper Front  
Scratched  
Over 100mm Thru Paint

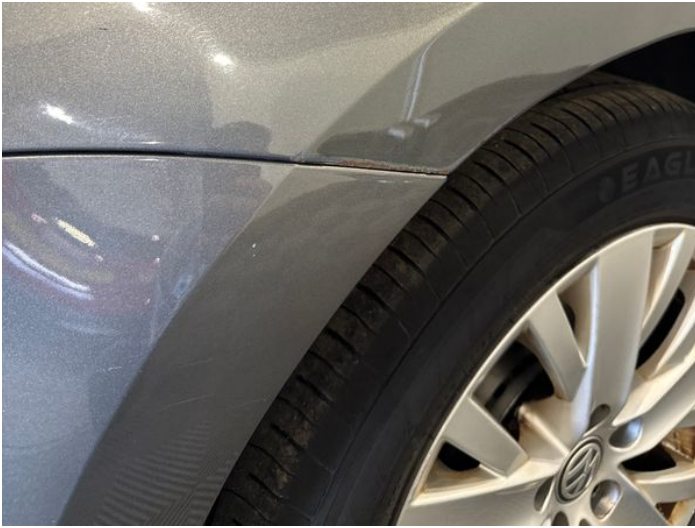
3: Wing nsf  
Rusted  
Over 5mm

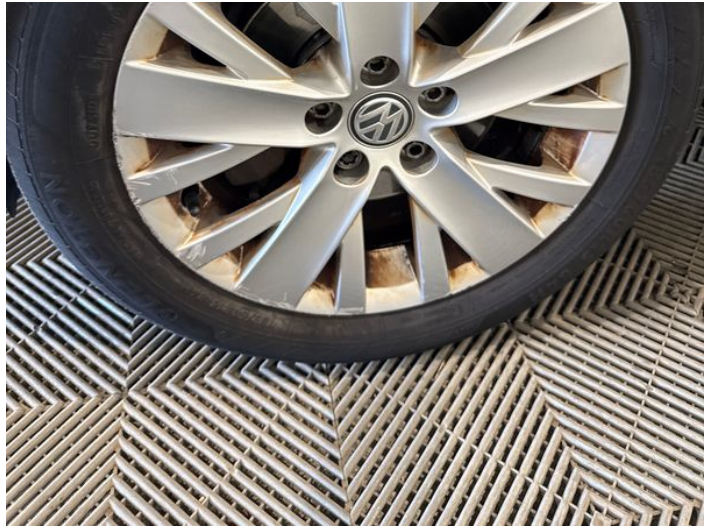
4: Wheel nsf  
Scratched  
Over 50mm

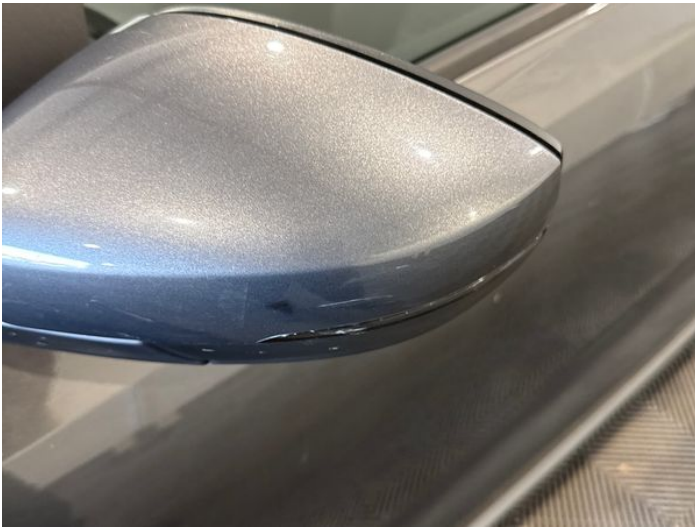
5: Door Mirror Assy nsf  
Scratched (Painted)  
UpTo 25mm Thru Paint

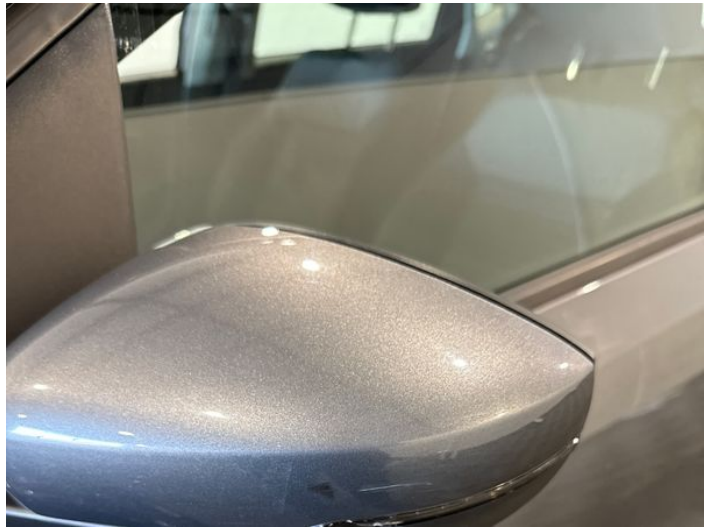
6: Flasher Side Repeater ns  
Broken  
Replace

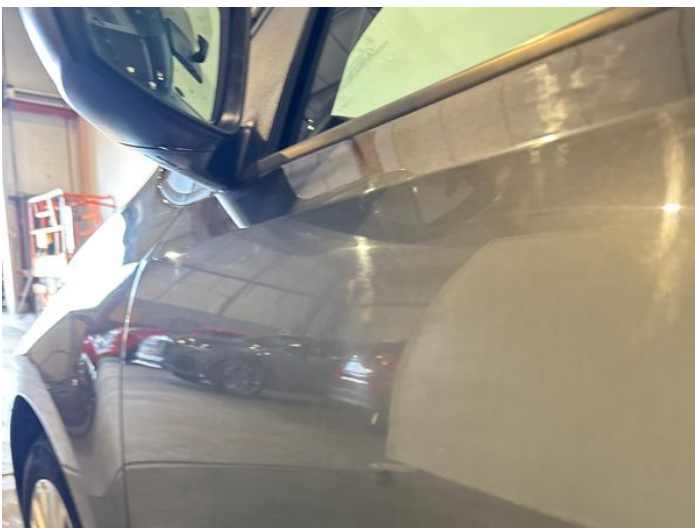
7: Door nsf  
Dented  
Over 30mm

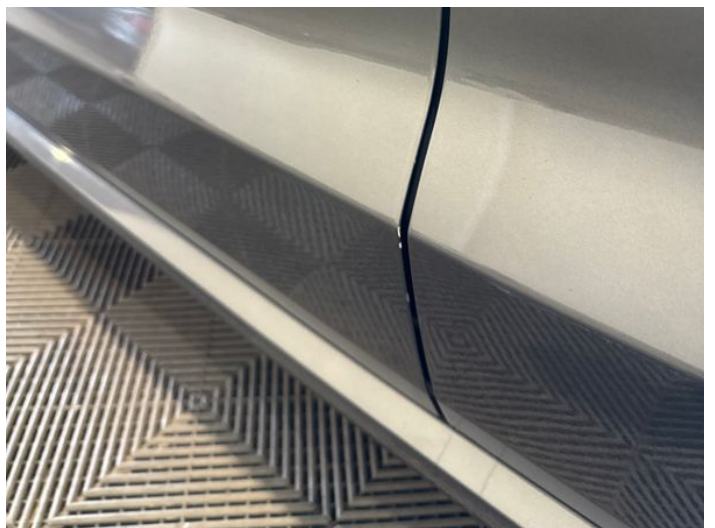
8: Door nsf  
Chipped  
Edge Chip

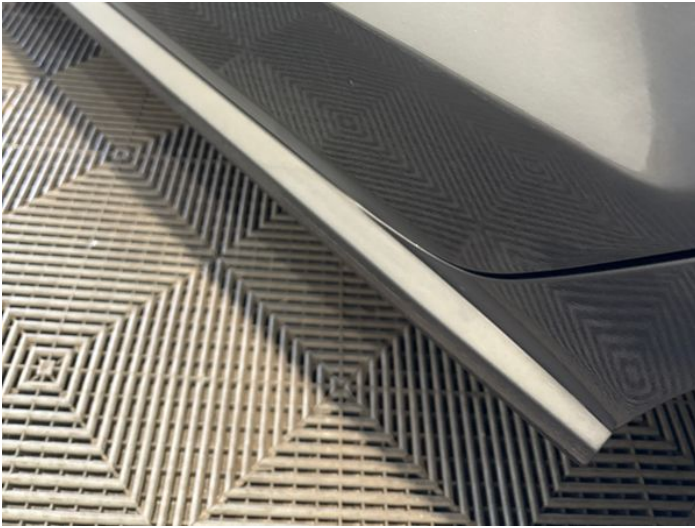
9: Door nsr  
Scratched  
Over 25mm Thru Paint

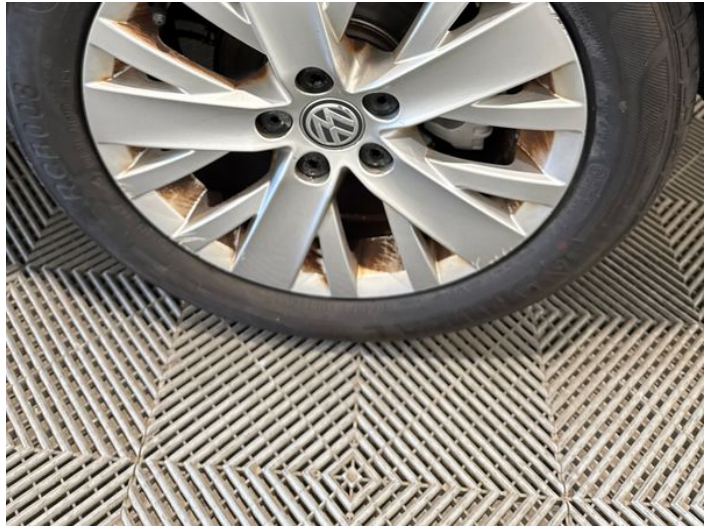
10: Wheel nsr  
Scratched  
Over 50mm

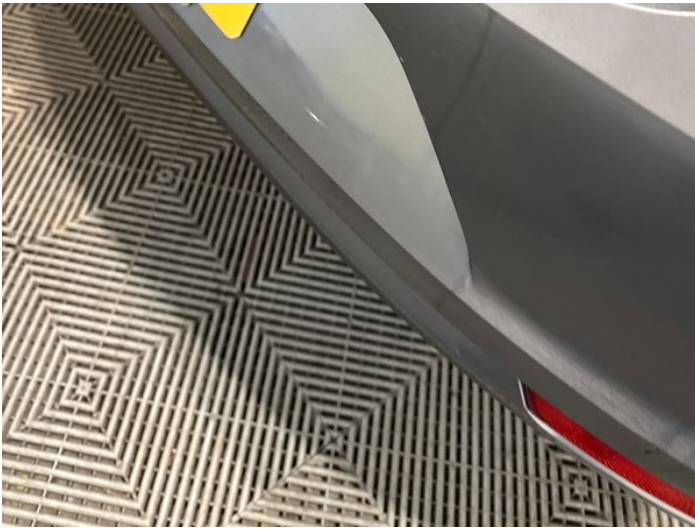
11: Bumper Rear  
Dented  
With Paint Damage

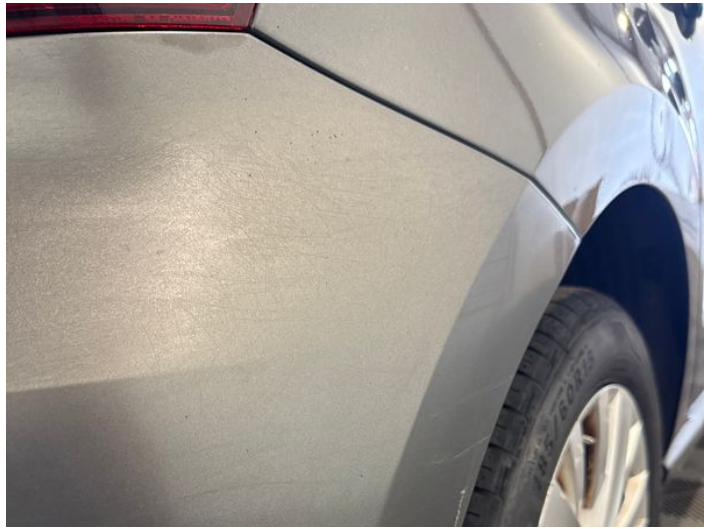
12: Bumper Rear  
Poor Previous Repair  
Poor Paint

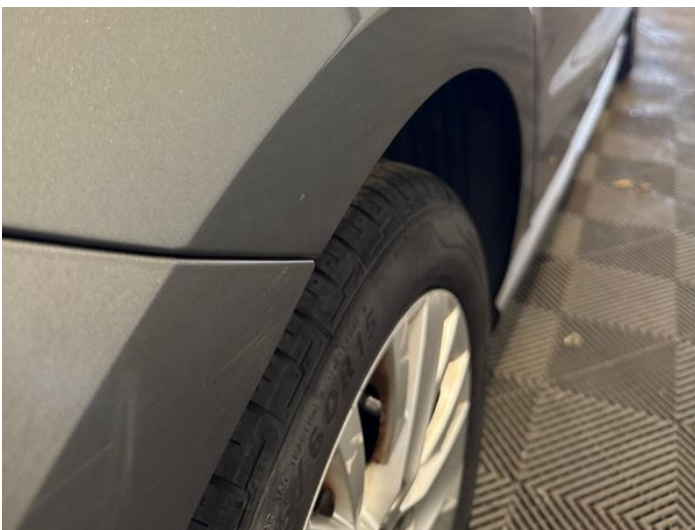
13: Qtr Panel osr  
Dented  
Over 30mm

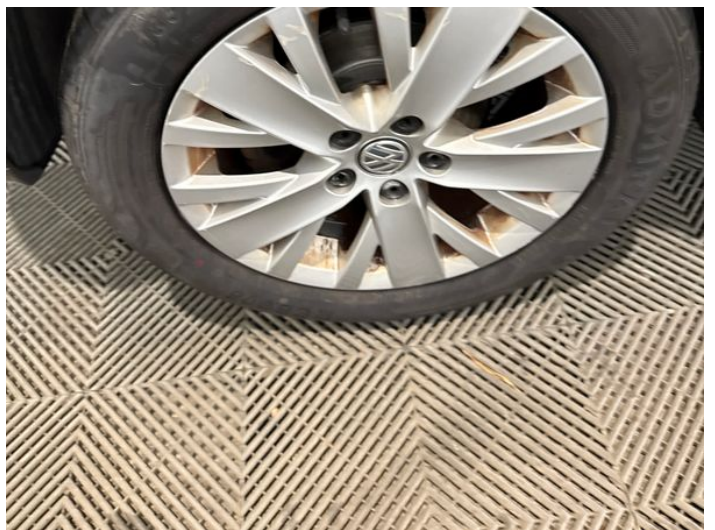
14: Wheel osr  
Scratched  
Over 50mm

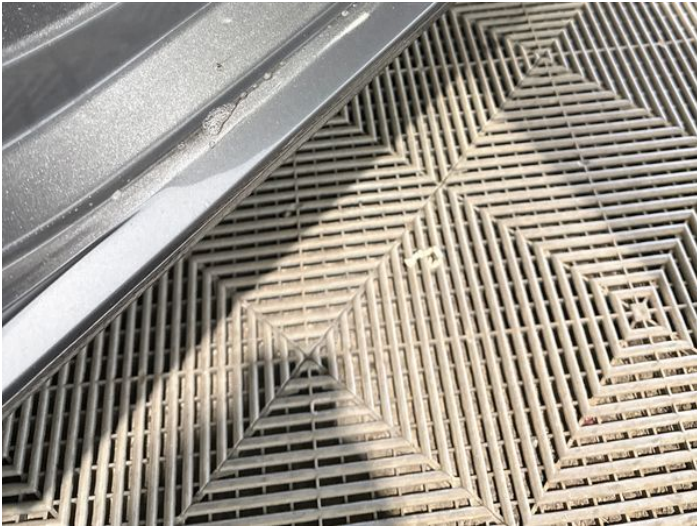
15: Sill os  
Scratched  
Over 25mm Thru Paint

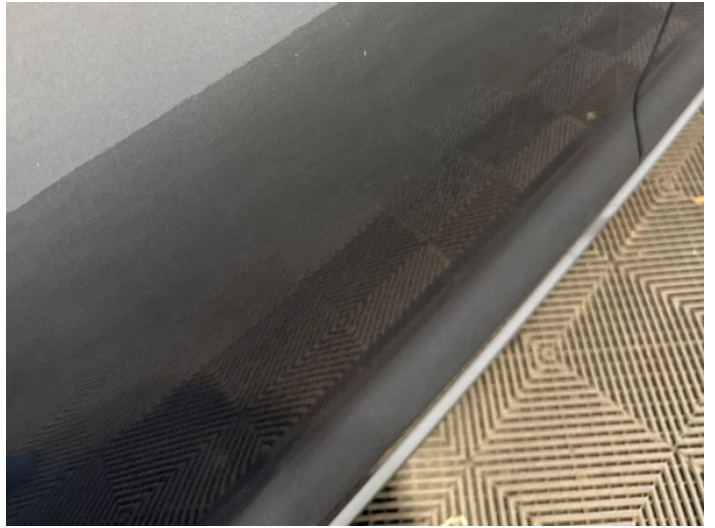
16: Door osr  
Chipped  
1 To 5

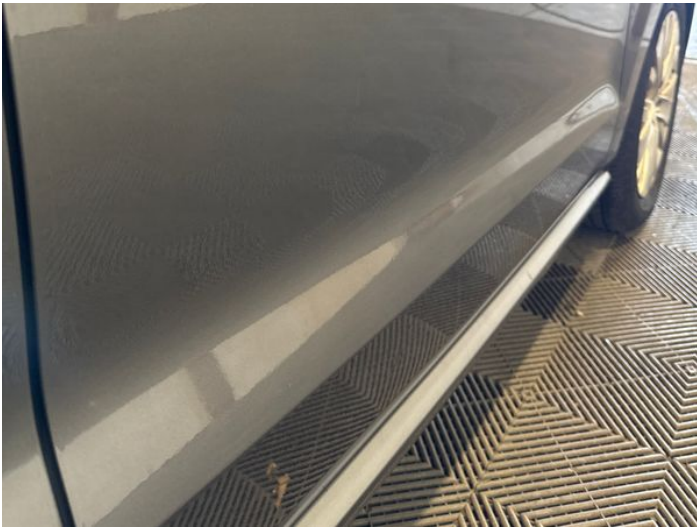
17: Door osf  
Poor Previous Repair  
Poor Paint

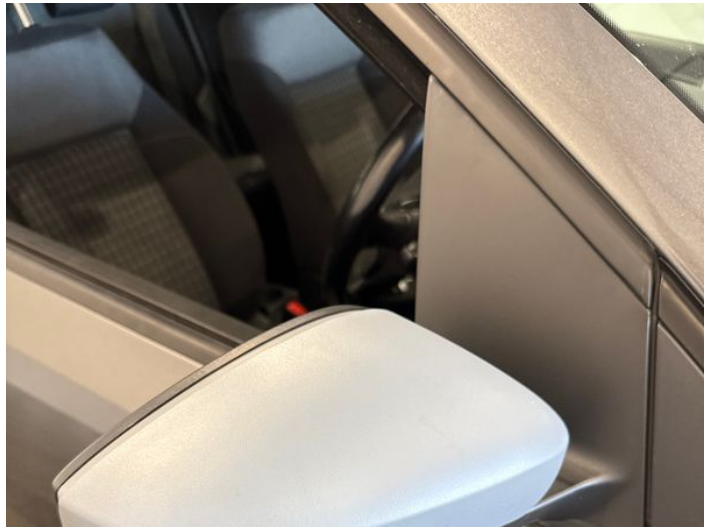
18: Door Mirror Assy osf  
Broken  
Replace

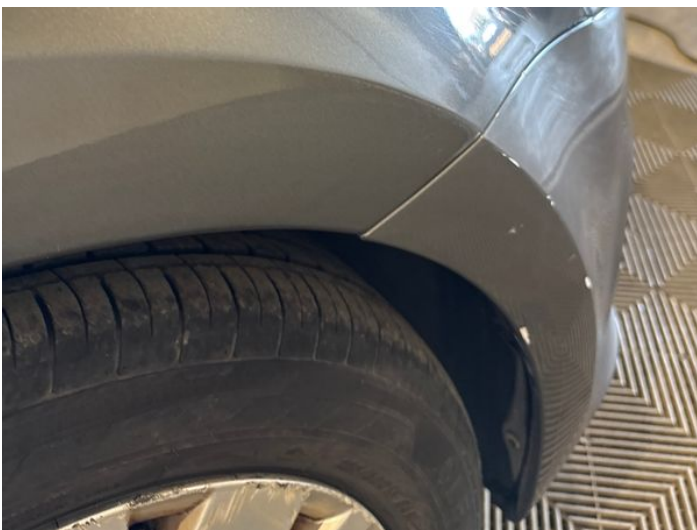
19: Wing osf  
Scratched  
Over 25mm Thru Paint

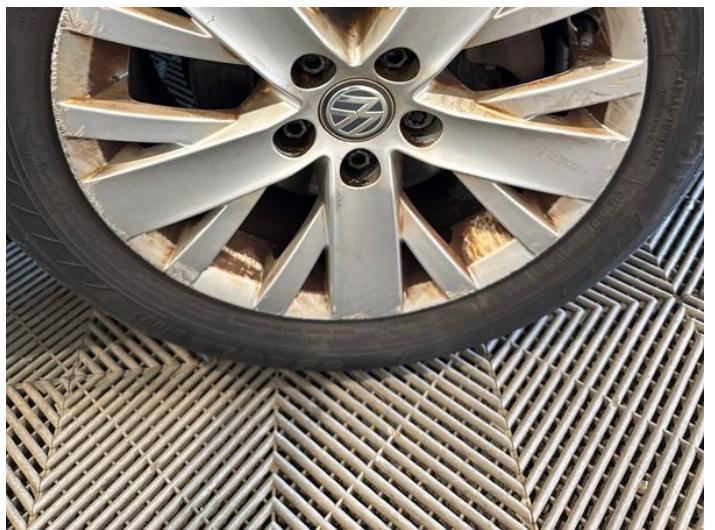
20: Wheel osf  
Scratched  
Over 50mm
