## VEHICLE INSPECTION REPORT

**GU14YYS**

### Citroen DS4 1.6 e-HDi 115 DStyle 5dr

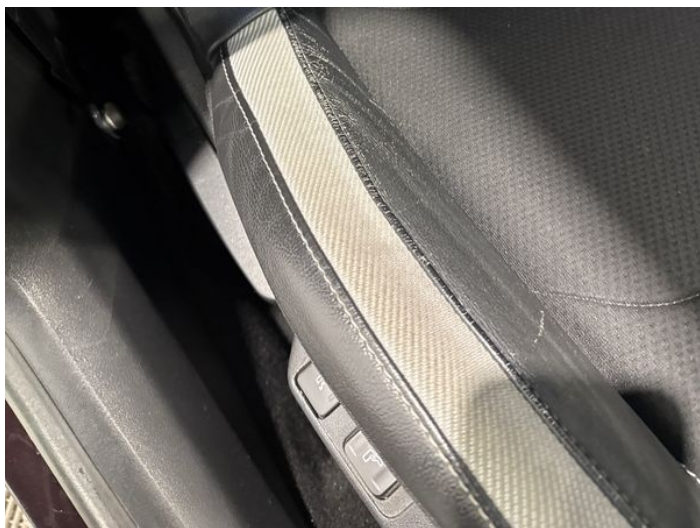
1: Seat Base Cover of  
Scuffed  
Over 25mm

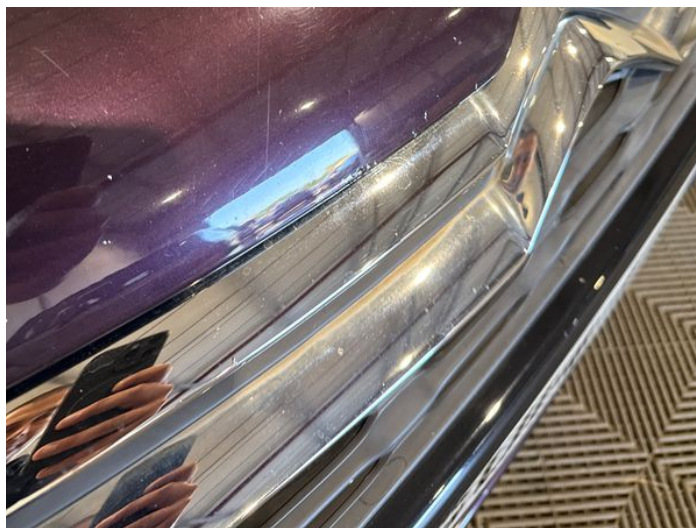
2: Bonnet  
Rusted  
Over 5mm

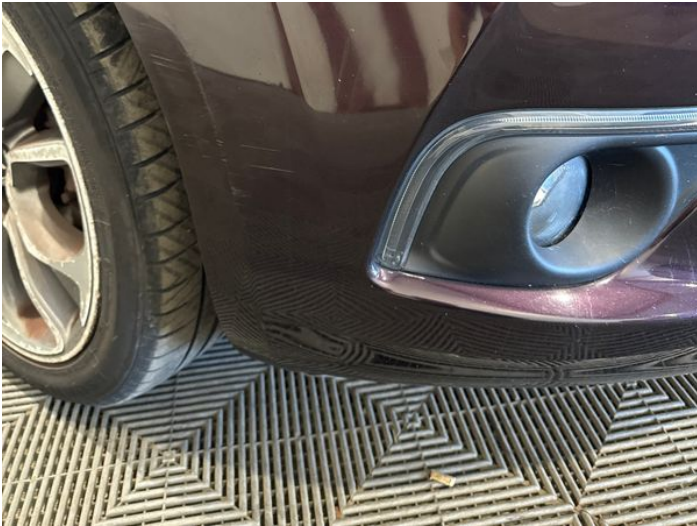
3: Bumper Front  
Scratched  
Over 100mm Thru Paint

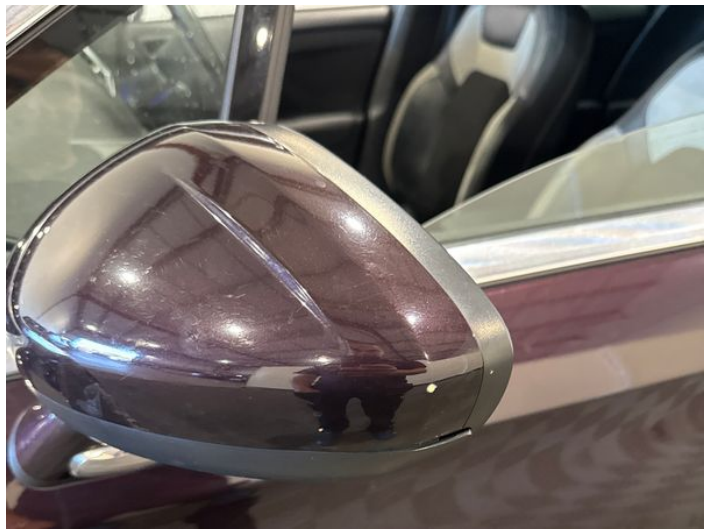
6: Door Mirror Assy nsf  
Scratched (Painted)  
UpTo 25mm Thru Paint

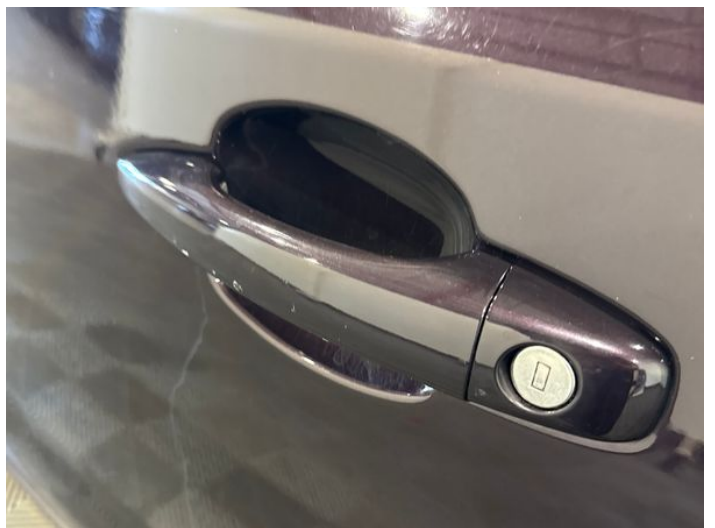
8: Handle Outer nsf  
Scratched (Painted)  
UpTo 25mm Thru Paint

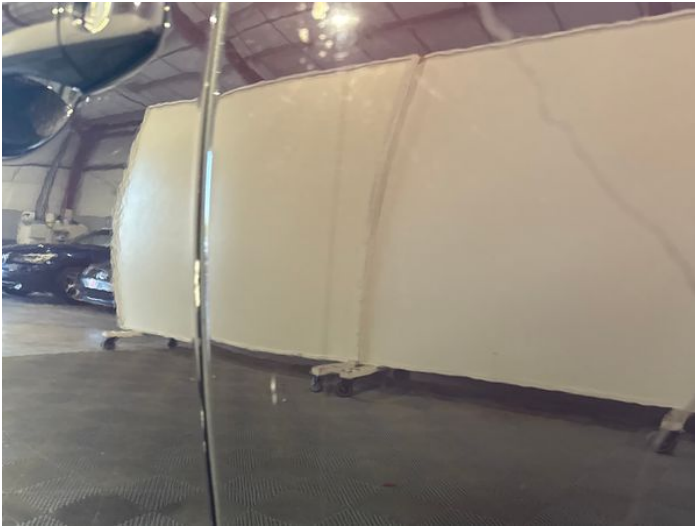
9: Door nsr  
Scratched  
UpTo 25mm Thru Paint

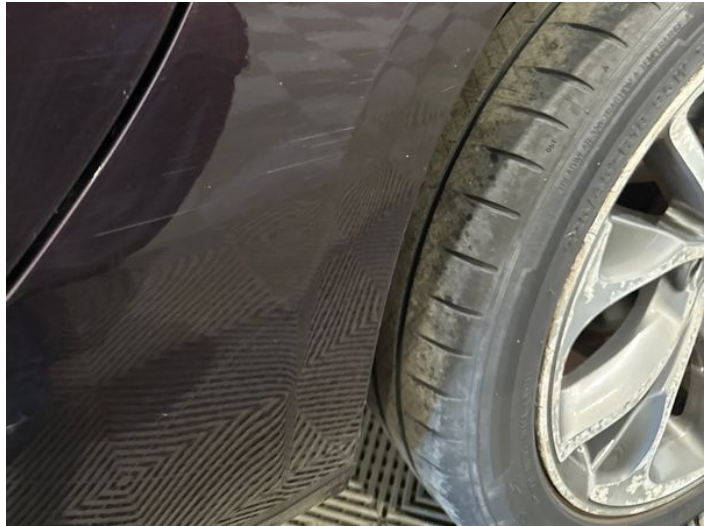
10: Qtr Panel nsr  
Scratched  
Over 25mm Thru Paint

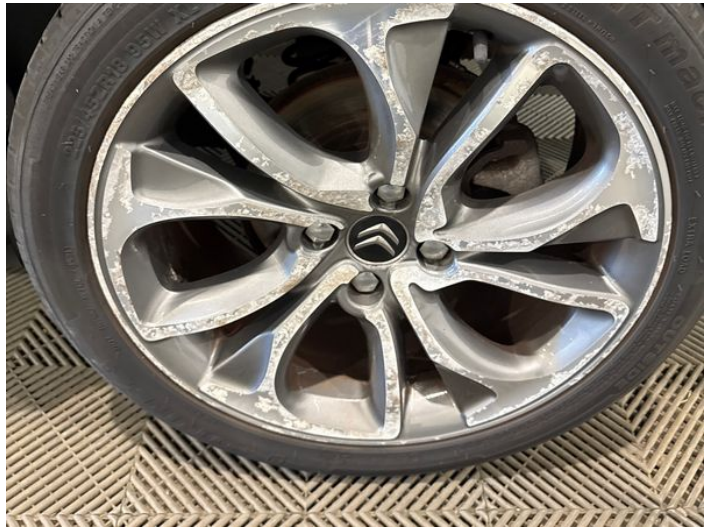
12: Wheel nsr  
Scratched  
Over 50mm

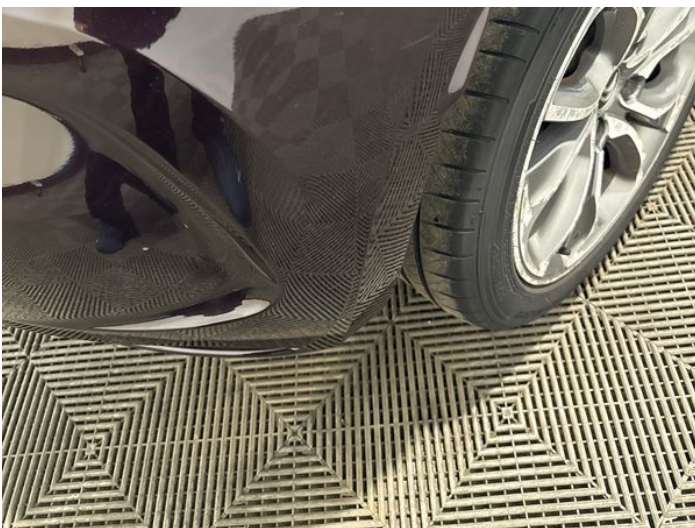
13: Bumper Rear  
Scratched  
Up To 25mm Thru Paint

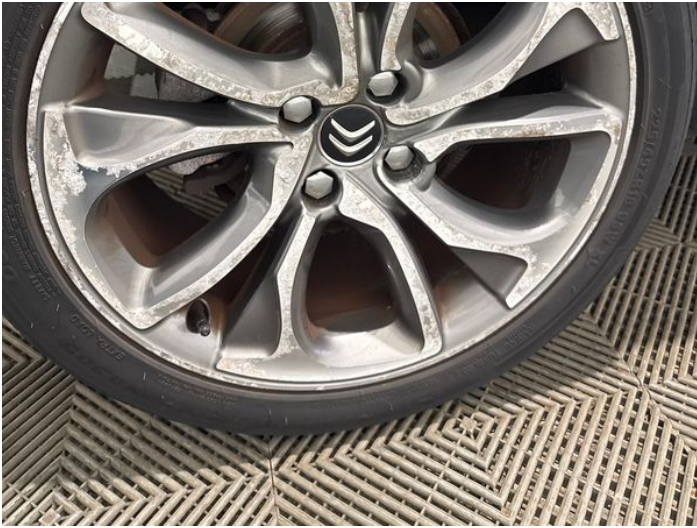
15: Wheel osr  
Scratched  
Over 50mm

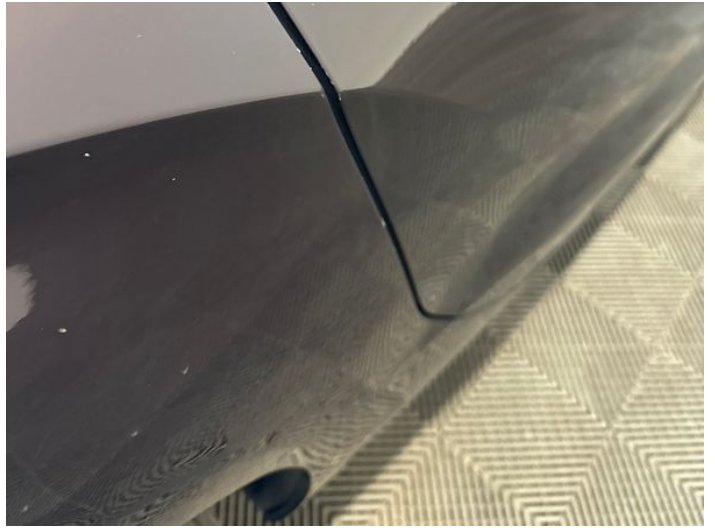
16: Door osr  
Chipped  
Edge Chip

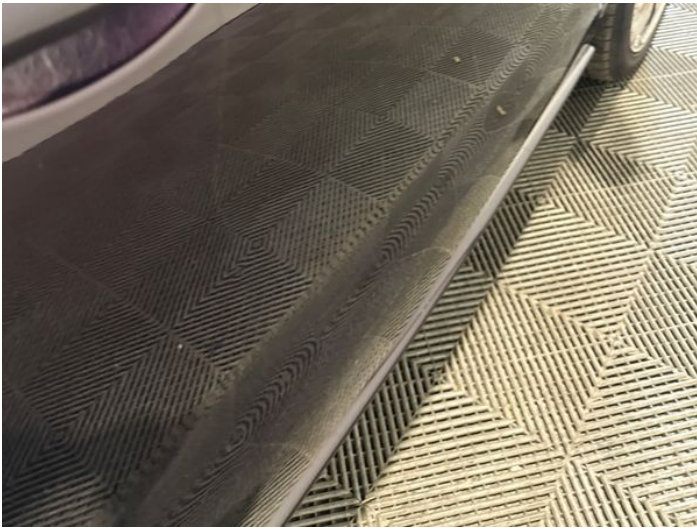
17: Door osf  
Dented  
Between 10mm + 30mm

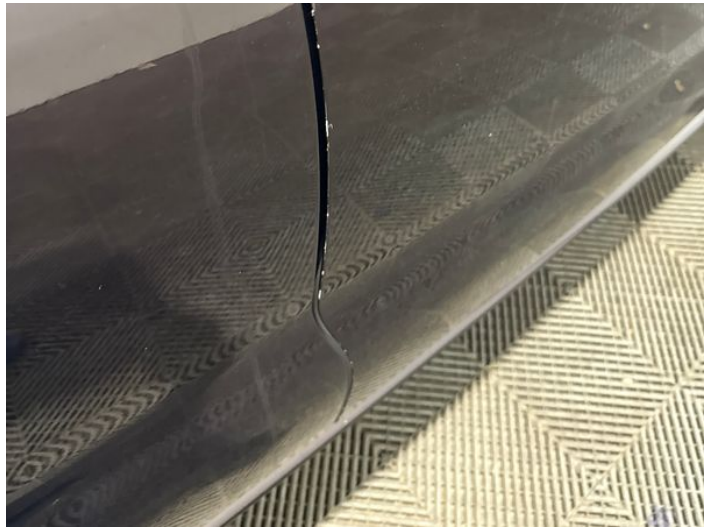
18: Door osf  
Chipped  
Edge Chip

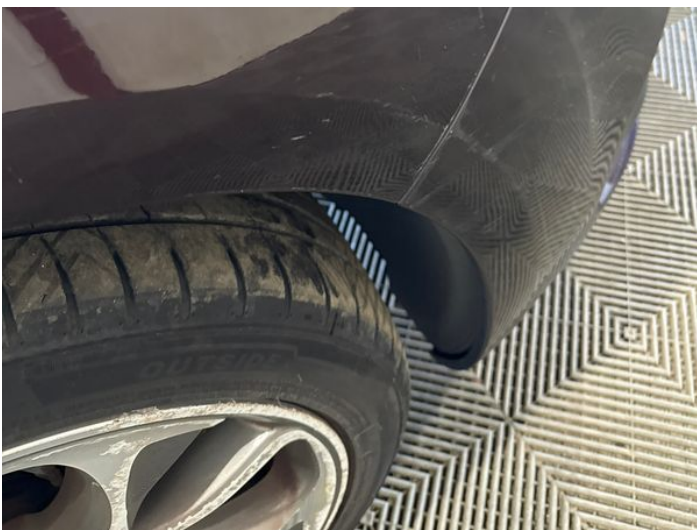
19: Wing osf  
Scratched  
Over 25mm Thru Paint

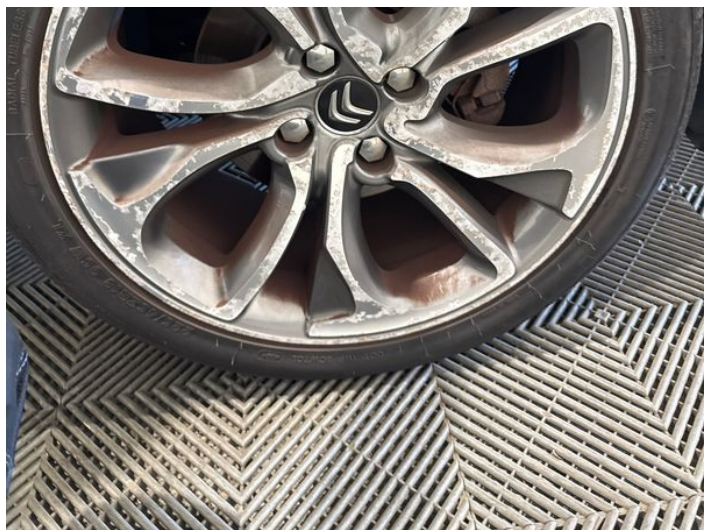
20: Wheel osf  
Scratched  
Over 50mm

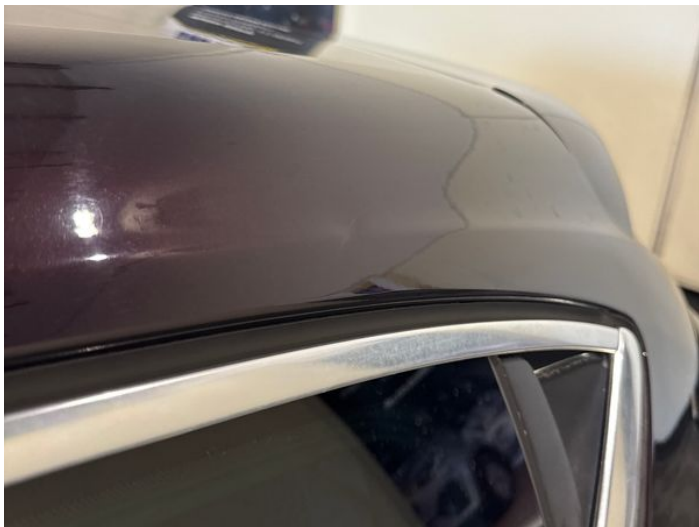
21: B Post ns  
Dented  
Between 10mm + 30mm
