# VEHICLE INSPECTION REPORT

**RJ16RKE**

## Kia Rio 1.4 CRDi 3 5dr

Non Runner  
Inspection

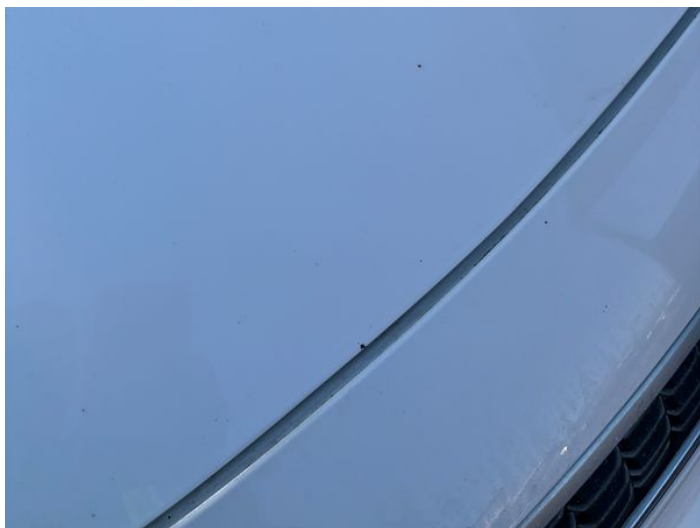
1: Bonnet  
Chipped  
1 To 5

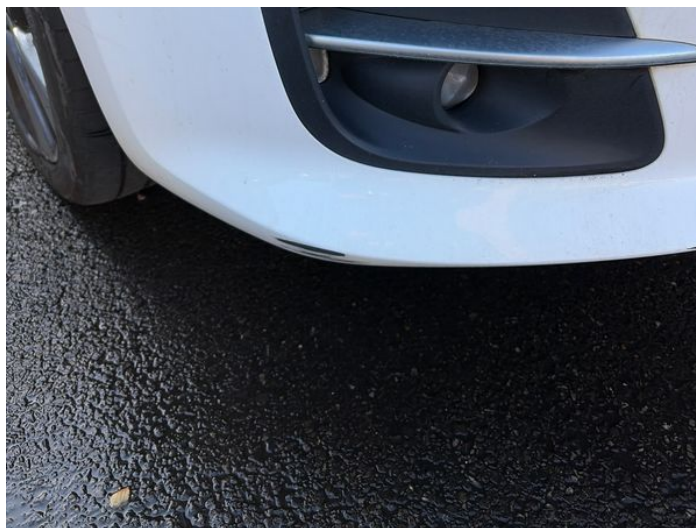
2: Bumper Front  
Scratched  
Over 100mm Thru Paint

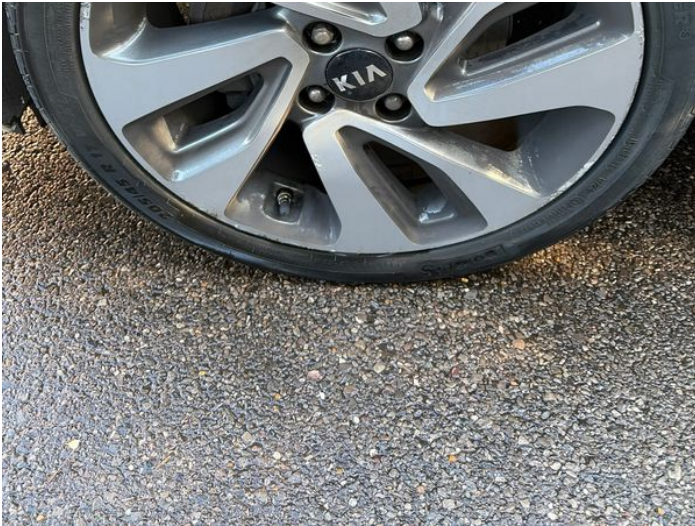
3: Wheel nsf  
Scratched  
Over 50mm

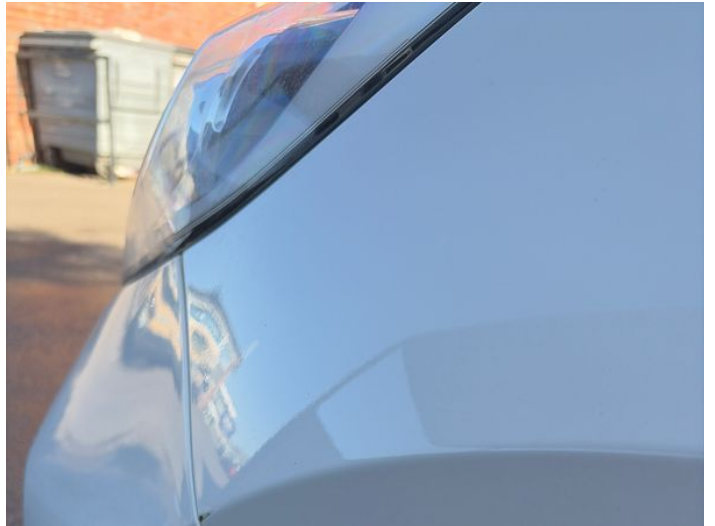
4: Wing nsf  
Scratched  
UpTo 25mm Thru Paint

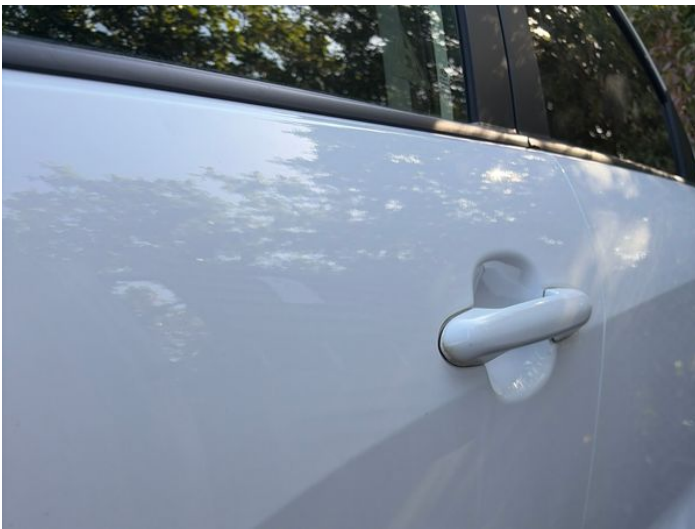
5: Door nsf  
Dented  
Between 10mm + 30mm

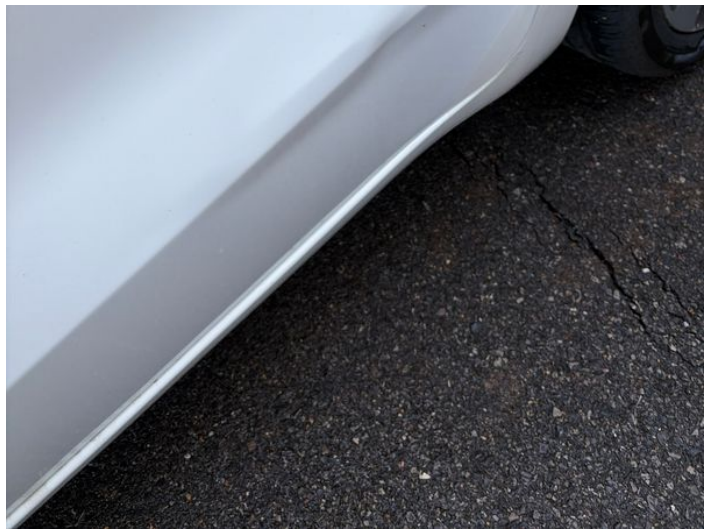
6: Door nsr  
Dented  
Over 30mm

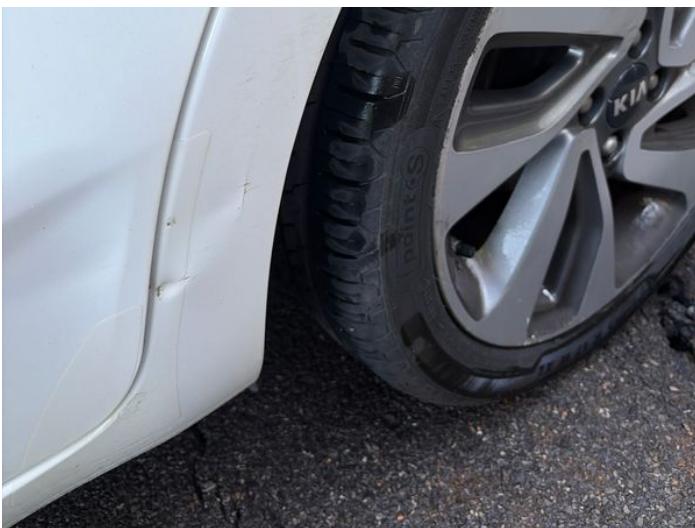
7: Qtr Panel nsr  
Dented  
With Paint Damage

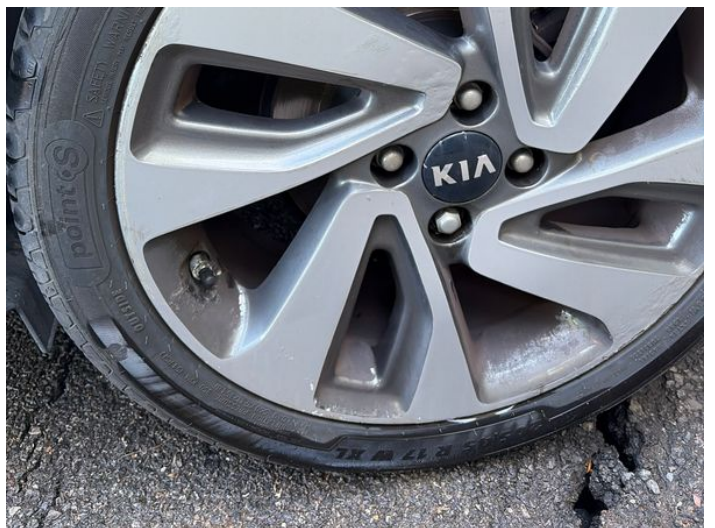
8: Wheel nsr  
Scratched  
Up To 50mm

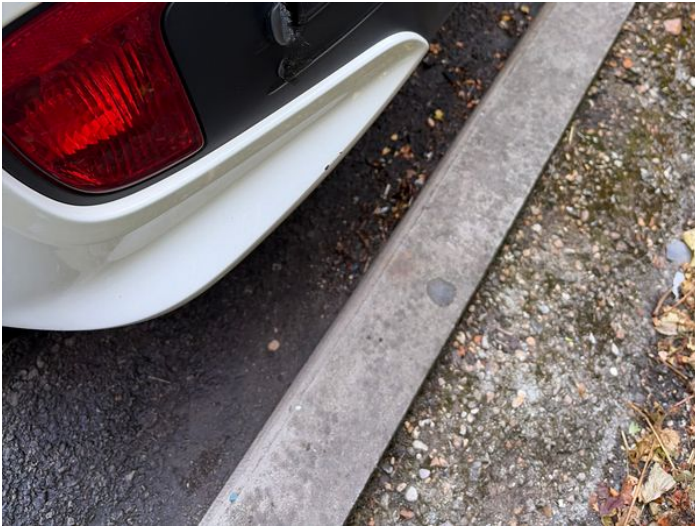
9: Bumper Rear Moulding  
Broken  
Replace

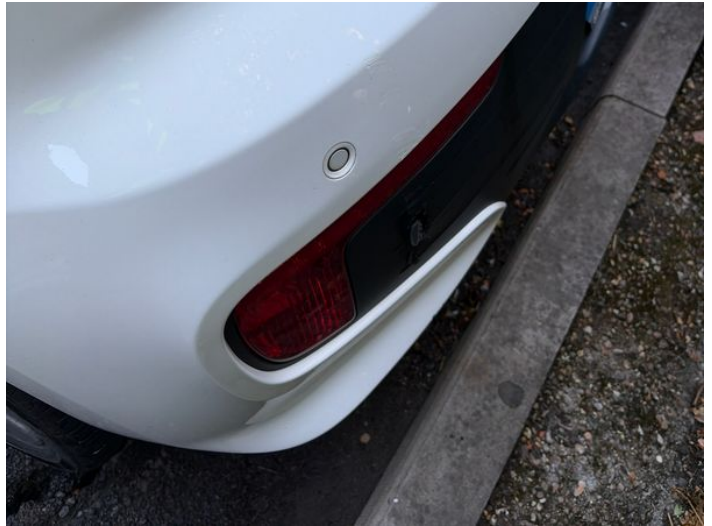
10: Bumper Rear  
Scratched  
25 to 100mm Thru Paint

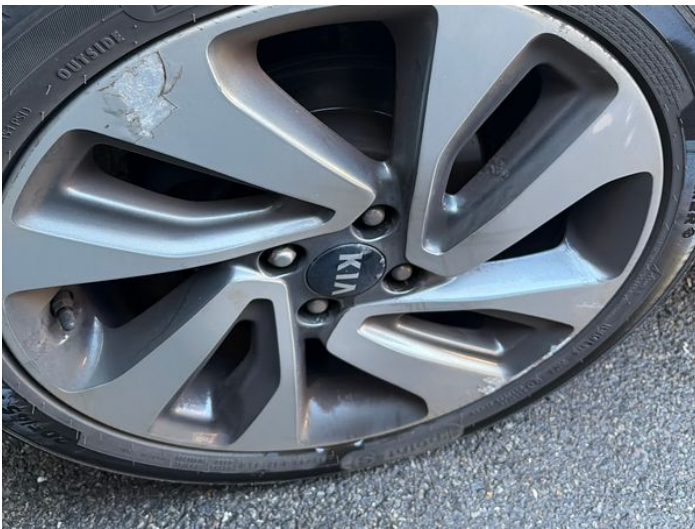
11: Wheel osr  
Scratched  
Over 50mm

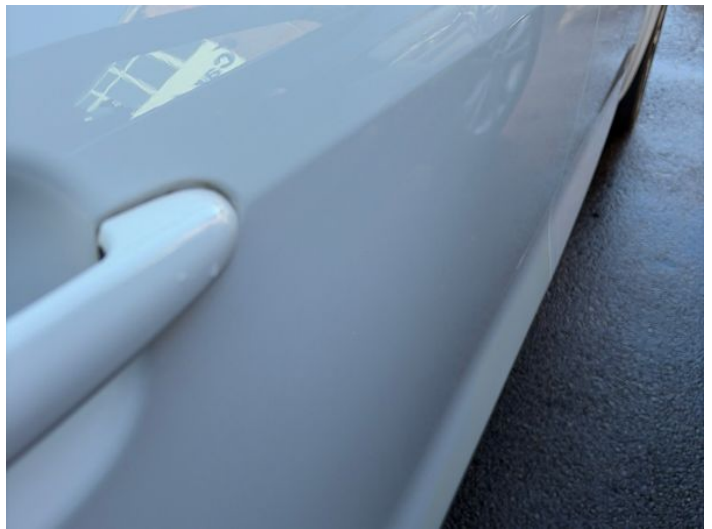
12: Door osr  
Dented  
Between 10mm + 30mm

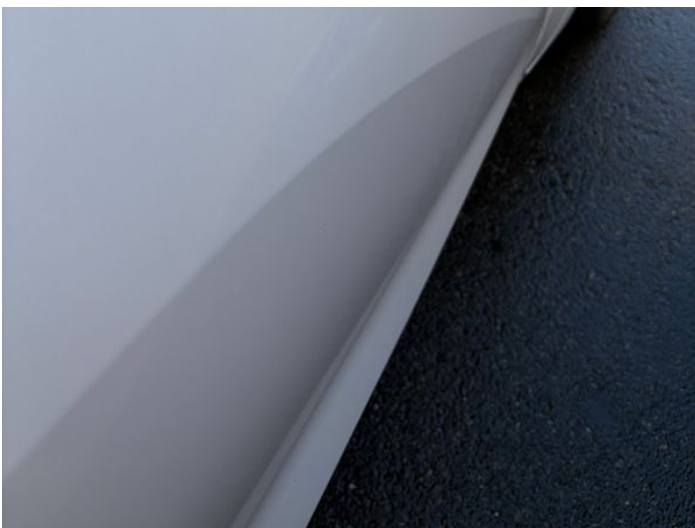
13: Door osf  
Dented  
Between 10mm + 30mm

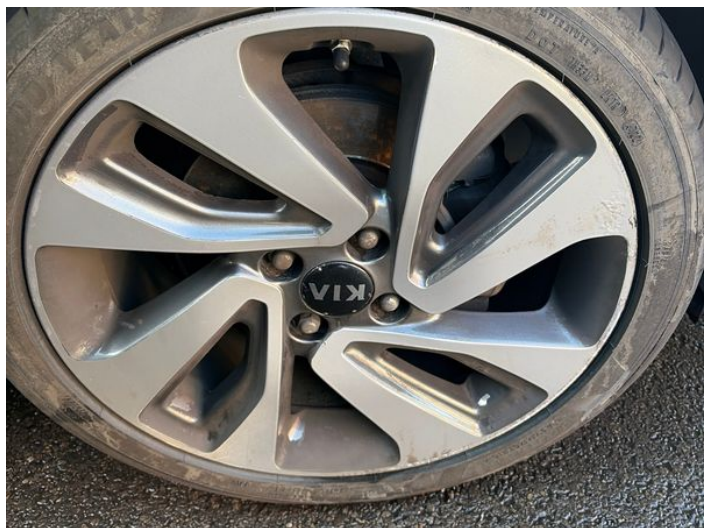
14: Wheel osf  
Scratched  
Over 50mm

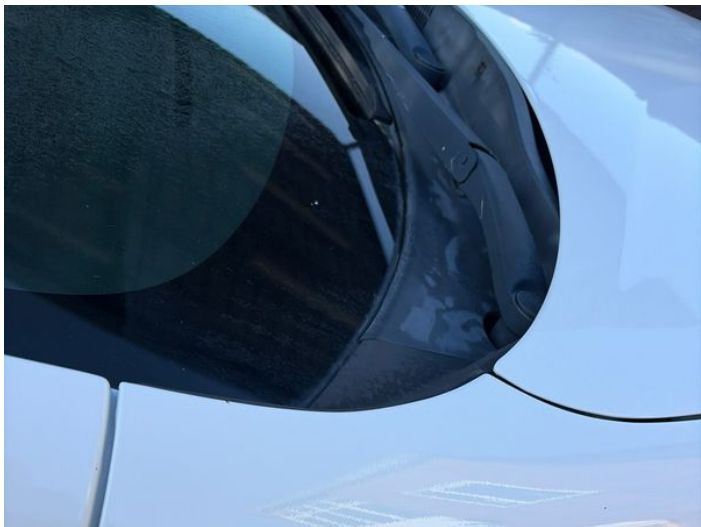
15: Wing of  
Chipped  
1 To 5
