VEHICLE INSPECTION REPORT

GY17NGO

Kia Sportage 2.0 CRDi KX-4 5dr Auto

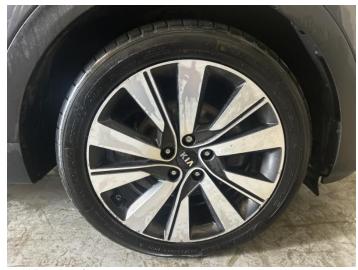
1: Wheel osf Scratched Over 50mm

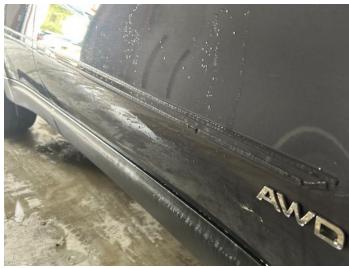
2: Door Moulding osf Missing Replace

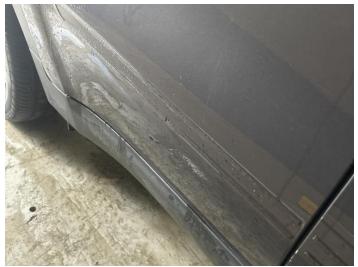
3: Door Moulding osr Missing Replace

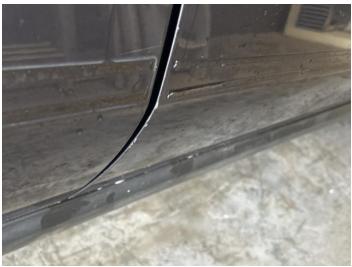
4: Door osf Chipped Edge Chip

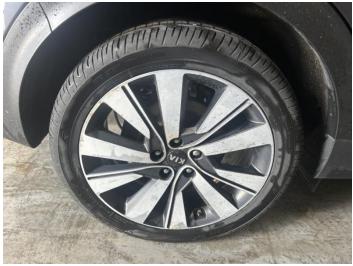
5: Wheel osr Corroded Light

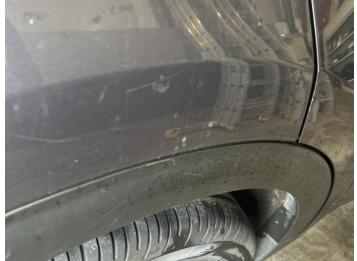
6: Qtr Panel osr Scratched Over 25mm Not Thru Paint

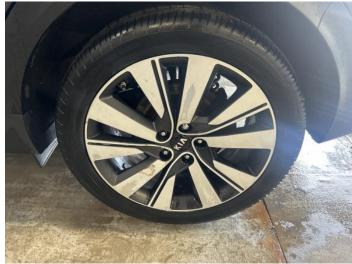
8: Wheel nsr Corroded Light

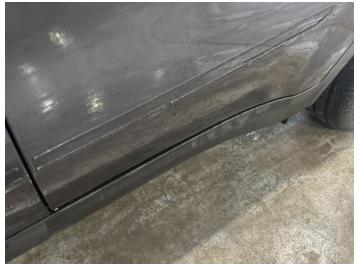
9: Door Moulding nsr Missing Replace

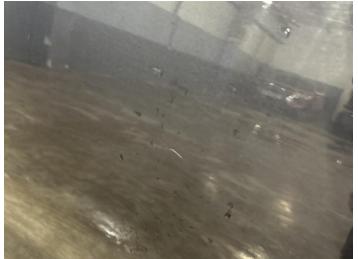
11: Door nsrChipped1 To 5

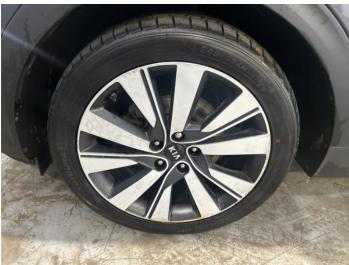
12: Wheel nsf Scratched Over 50mm
