# VEHICLE INSPECTION REPORT

**GX20HGC**

## Ford Puma 1.0 EcoBoost Hybrid mHEV 155 ST-Line X 1st Ed 5dr

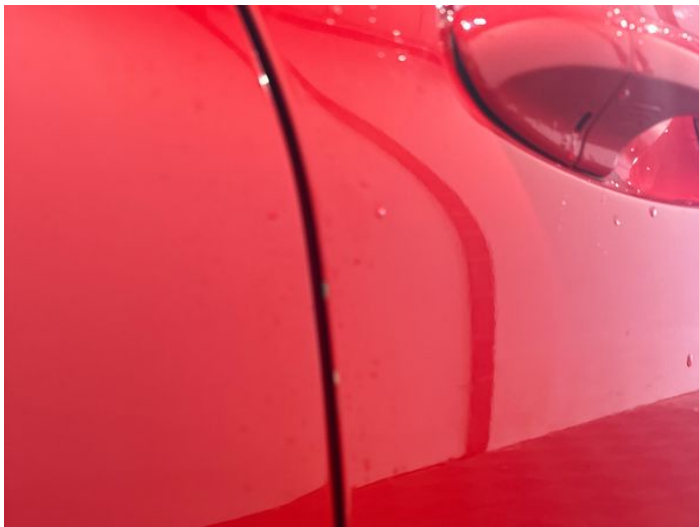
9: Door osf  
Chipped  
Edge Chip

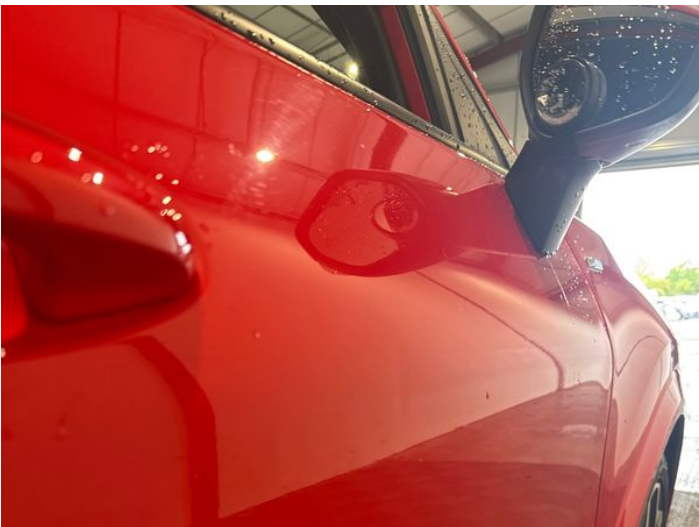
10: Door osf  
Dented  
Over 30mm

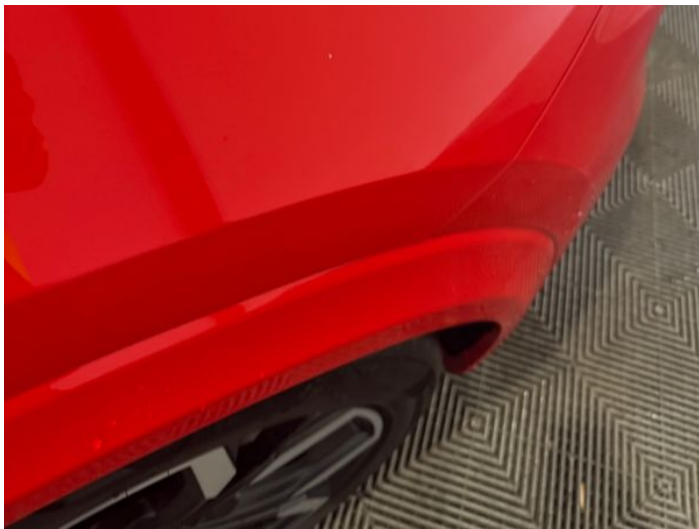
11: Wing osf  
Chipped  
1 To 5
