# VEHICLE INSPECTION REPORT

**TGZ3705**

## Vauxhall Grandland X 1.2 Turbo SRi Nav 5dr

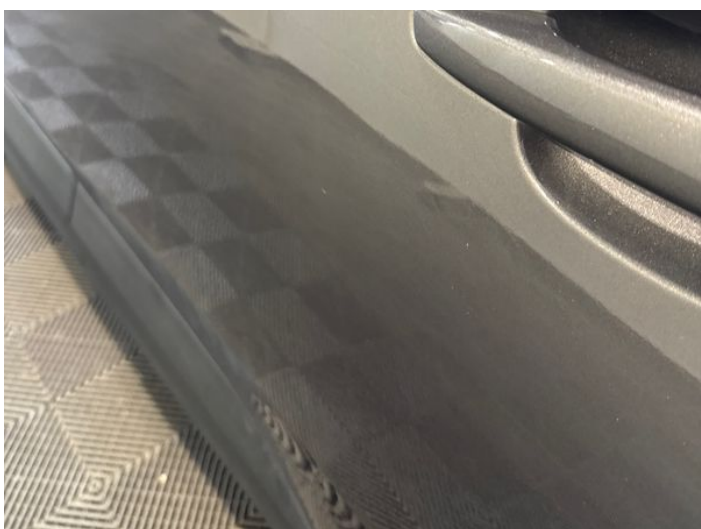
5: Door nsr  
Dented  
With Paint Damage

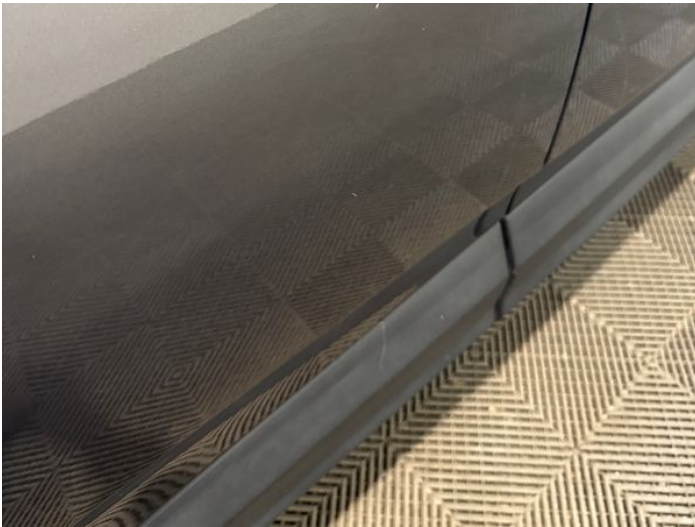
11: Door osr  
Chipped  
1 To 5

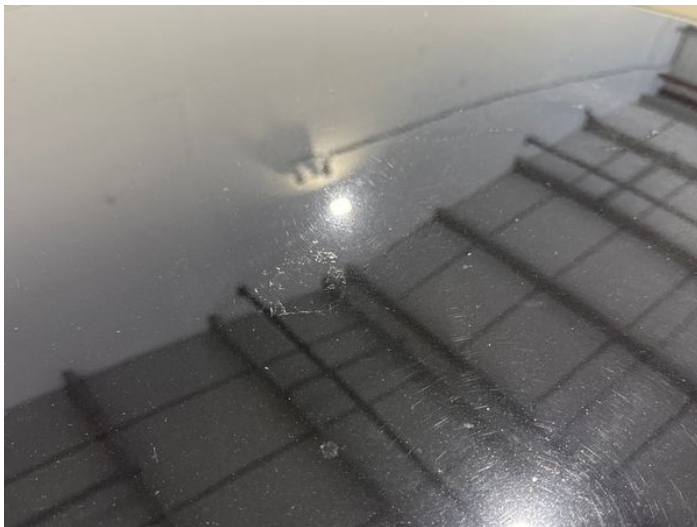
15: Roof  
Scratched  
Over 25mm Thru Paint
