## VEHICLE INSPECTION REPORT

**LX66HHL**

### Mitsubishi Outlander 2.2 DI-D 4 5dr Auto

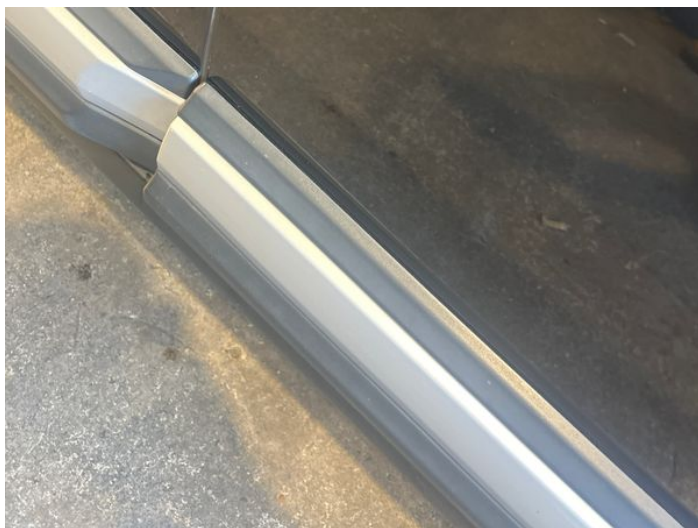
1: Door osf  
Chipped  
1 To 5

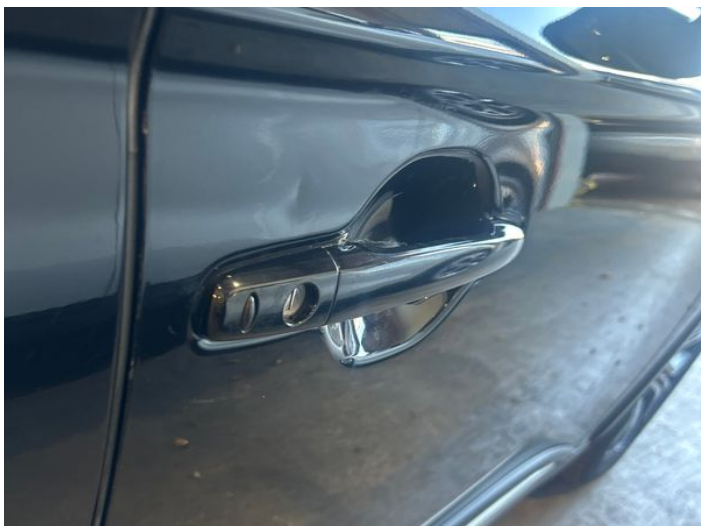
3: Door osf  
Dented  
Between 10mm + 30mm

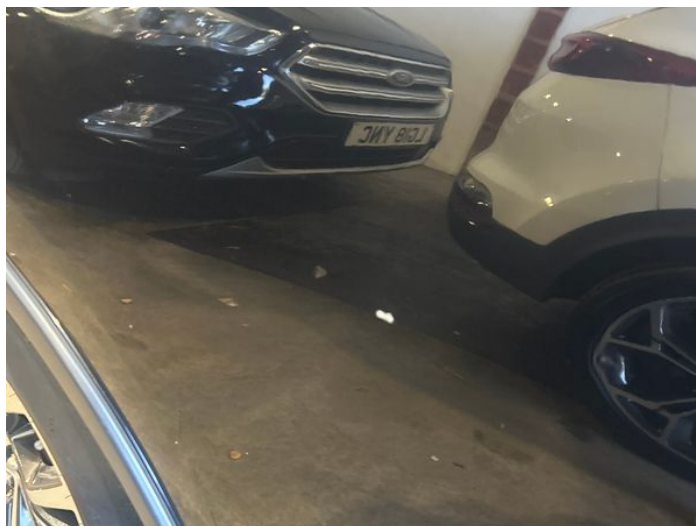
4: Door osr  
Chipped  
1 To 5

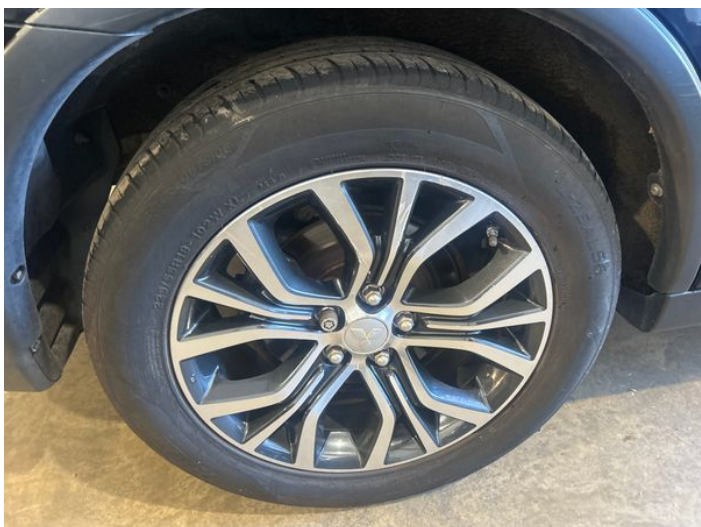
5: Wheel osr  
Scratched  
Over 50mm

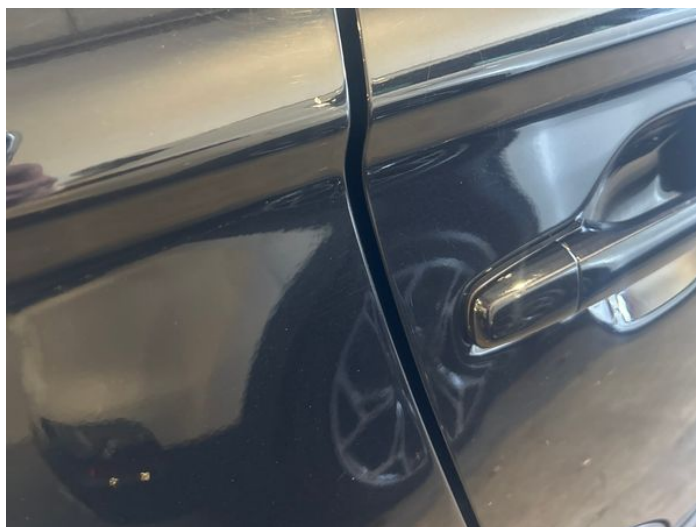
6: Qtr Panel osr  
Chipped  
1 To 5

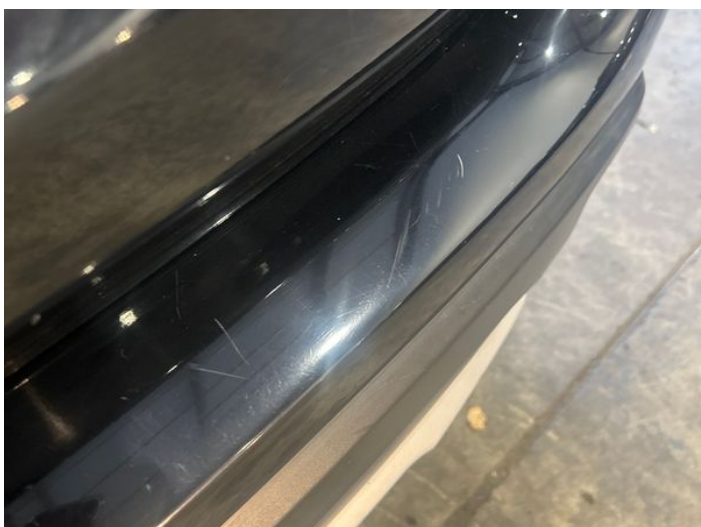
7: Bumper Rear  
Scratched  
25 to 100mm Thru Paint

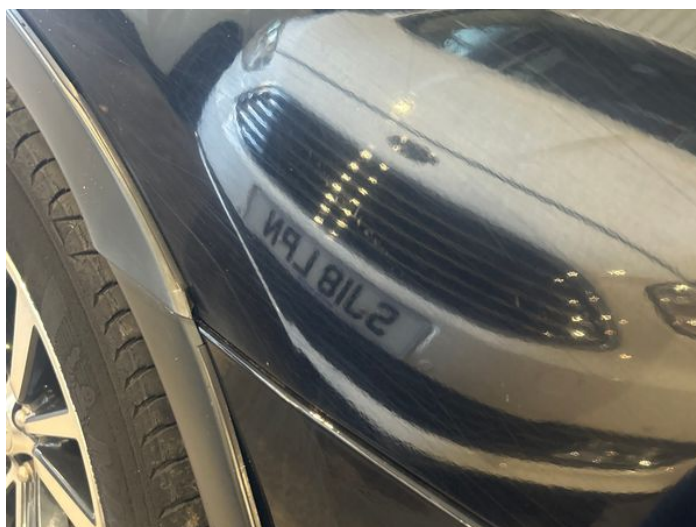
8: Qtr Panel nsr  
Chipped  
1 To 5

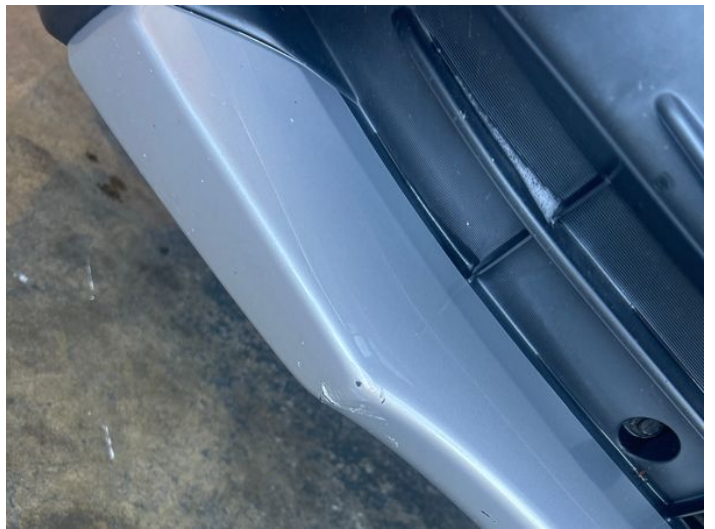
12: Bumper Front Moulding  
Scratched (Painted)  
UpTo 25mm Thru Paint

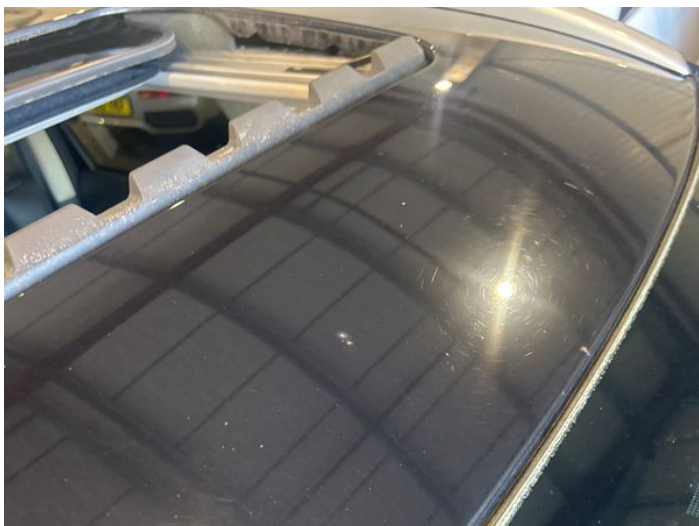
15: Roof  
Chipped  
1 To 5
