# VEHICLE INSPECTION REPORT

**WR15DWJ**

## Volvo V40 D2 ES 5dr Powershift

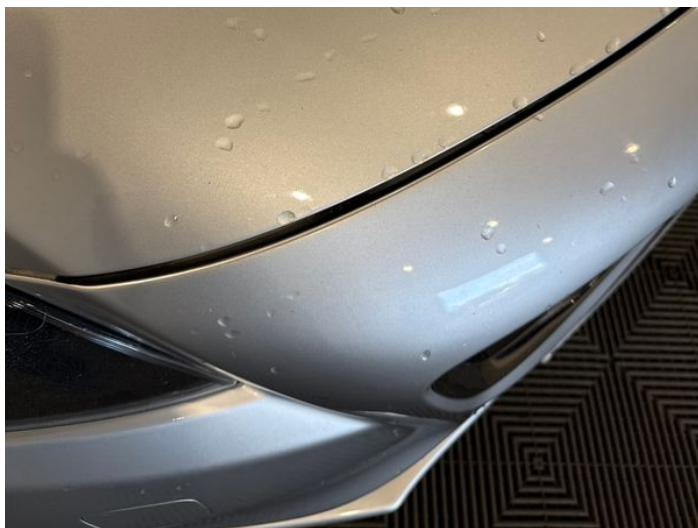
1: Bonnet  
Chipped  
1 To 5

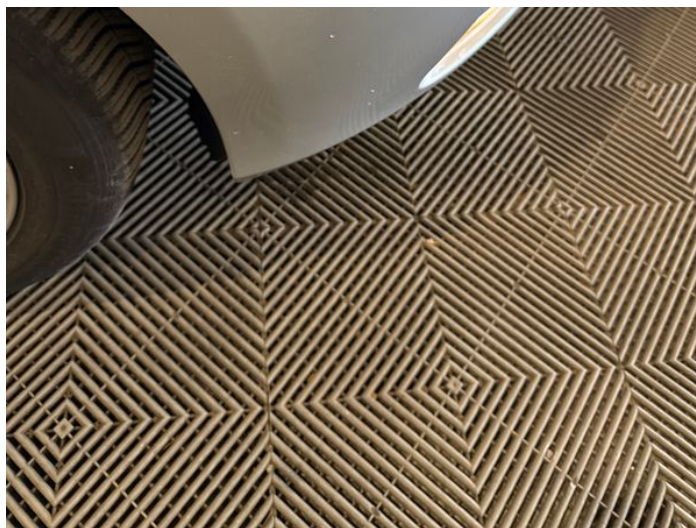
2: Bumper Front  
Poor Previous Repair  
Poor Paint

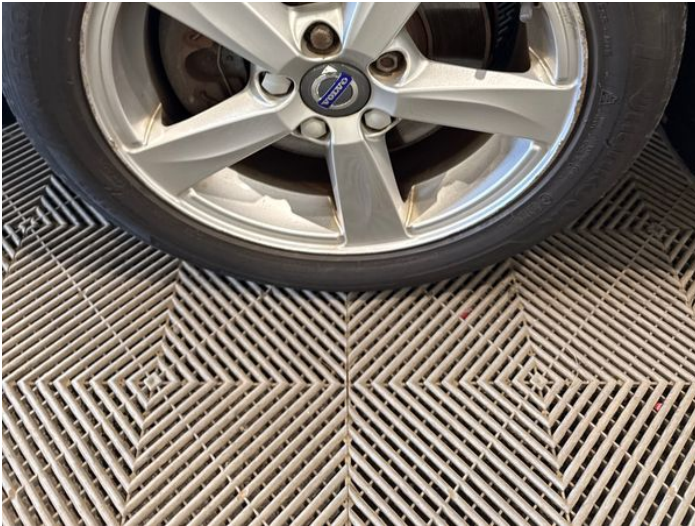
3: Wheel nsf  
Scratched  
Over 50mm

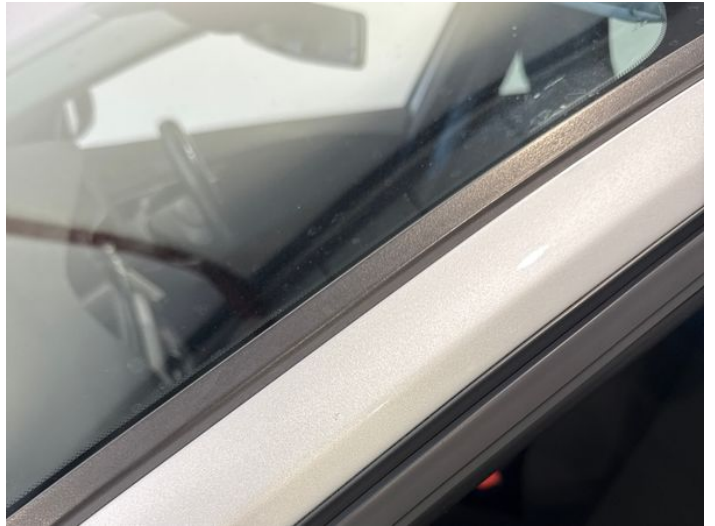
4: A Post ns  
Chipped  
1 To 5

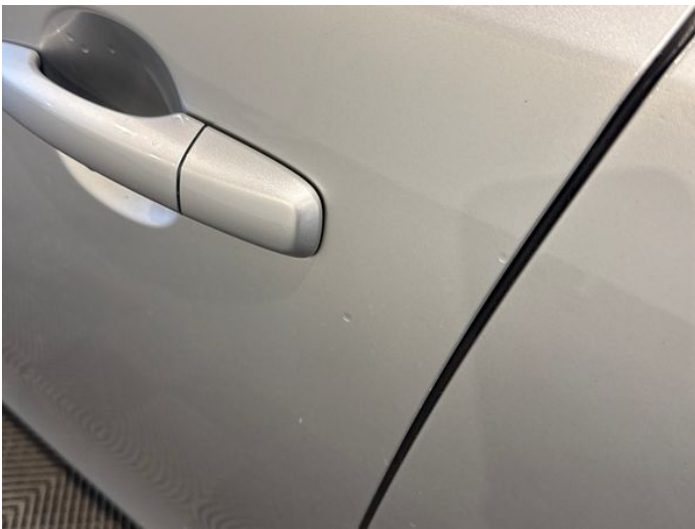
5: Door nsf  
Chipped  
1 To 5

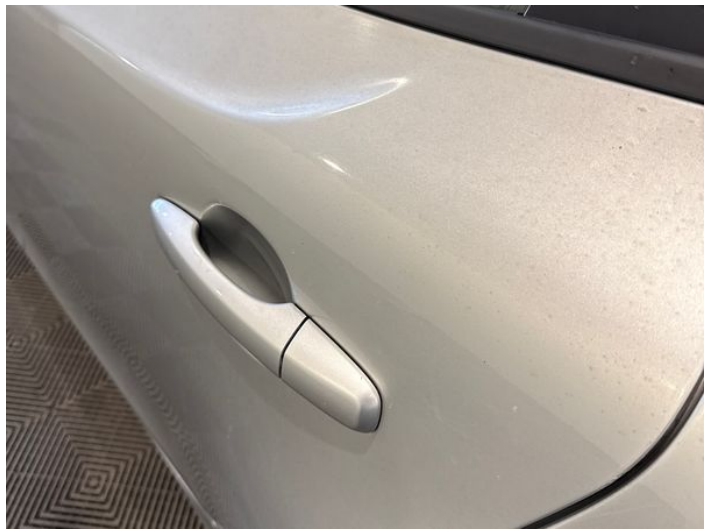
6: Door nsr  
Poor Previous Repair  
Poor Paint

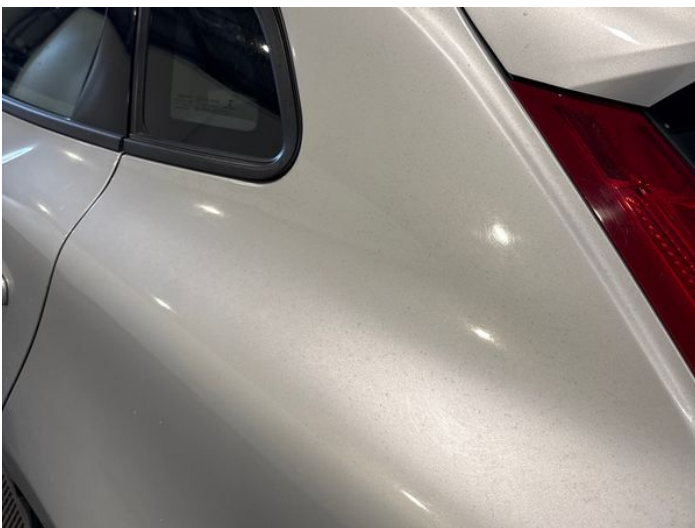
7: Qtr Panel nsr  
Poor Previous Repair  
Poor Paint

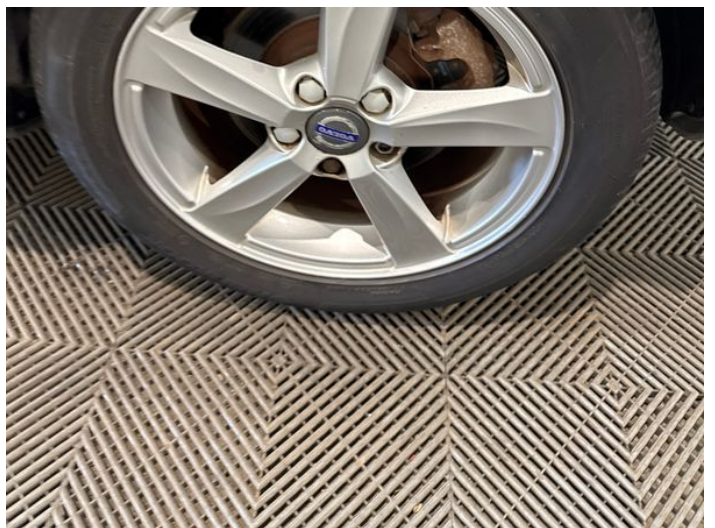
8: Wheel nsr  
Scratched  
Up To 50mm

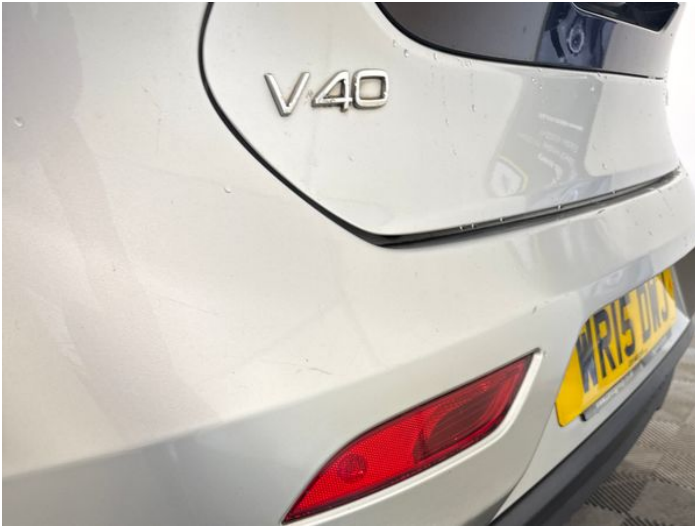
9: Bumper Rear  
Poor Previous Repair  
Poor Paint

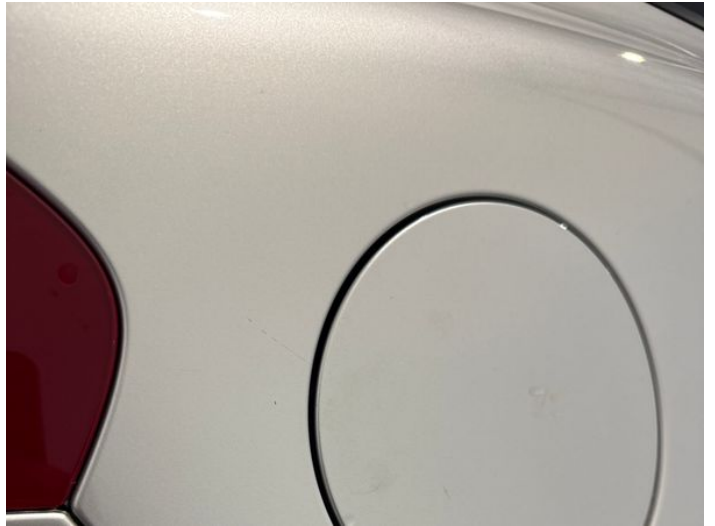
10: Qtr Panel osr  
Scratched  
UpTo 25mm Thru Paint

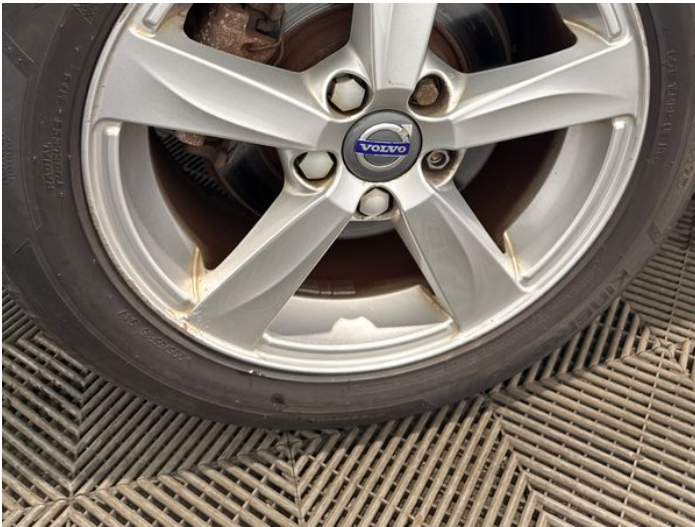
11: Wheel osr  
Scratched  
Over 50mm

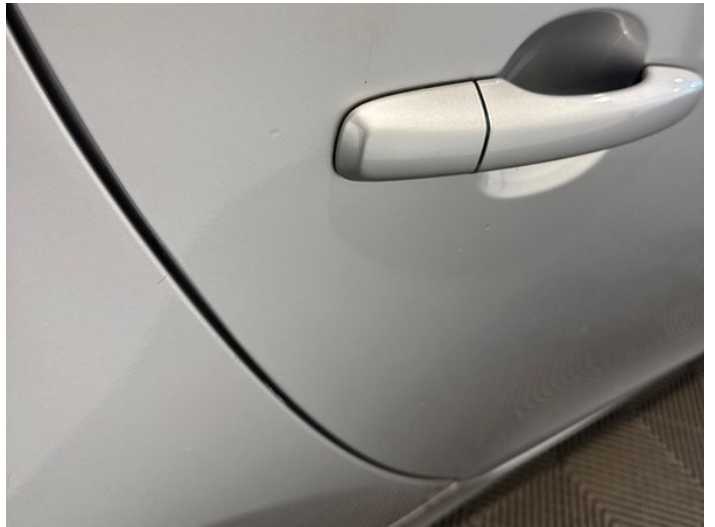
12: Door osr  
Chipped  
Edge Chip

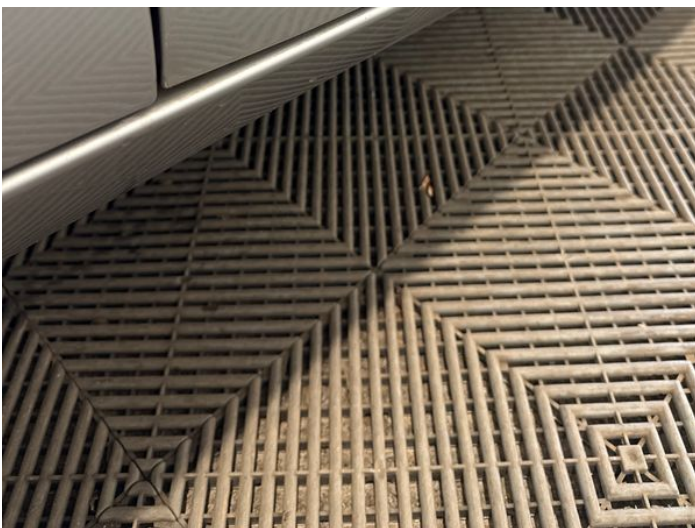
13: Door osf  
Dented  
Between 10mm + 30mm

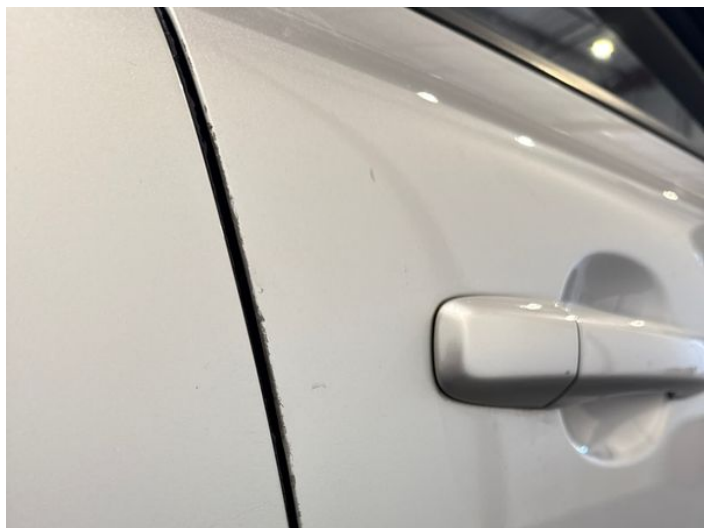
14: Door osf  
Chipped  
Edge Chip

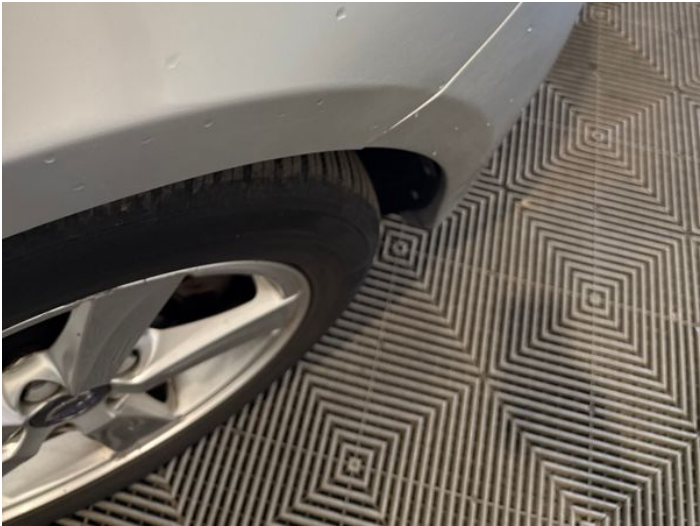
15: Wing osf  
Poor Previous Repair  
Poor Paint

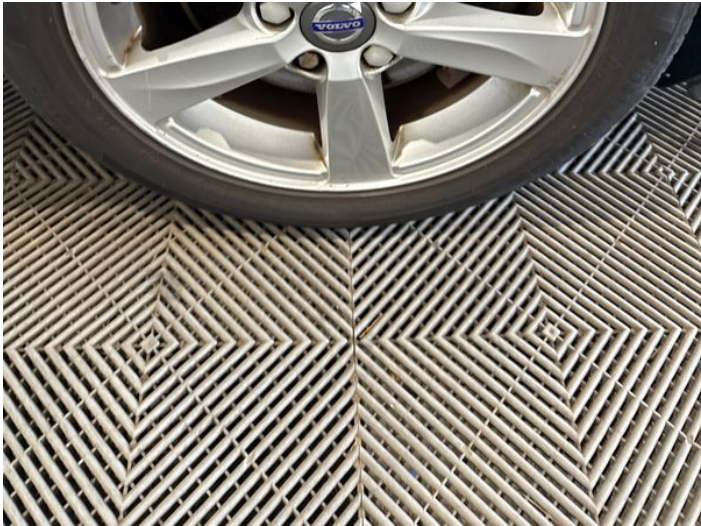
16: Wheel osf  
Scratched  
Over 50mm

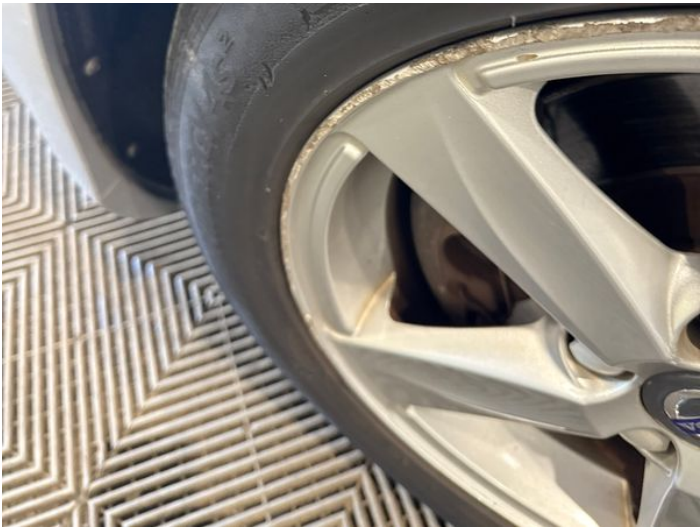
| NSF | HANKOOK | Damaged |

17: Tyre nsf  
Damaged  
Replace
