# VEHICLE INSPECTION REPORT

**HK15KWC**

## Hyundai Santa Fe 2.2 CRDi Premium 5dr [7 Seats]

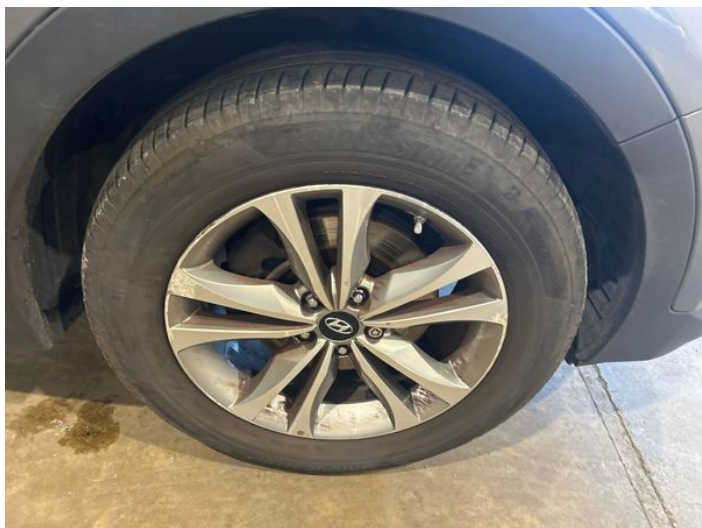
1: Wheel osf  
Corroded  
Light

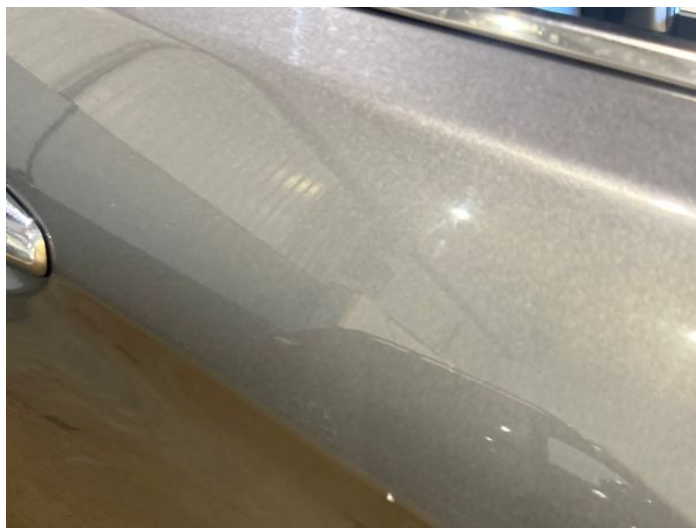
2: Door osf  
Chipped  
1 To 5

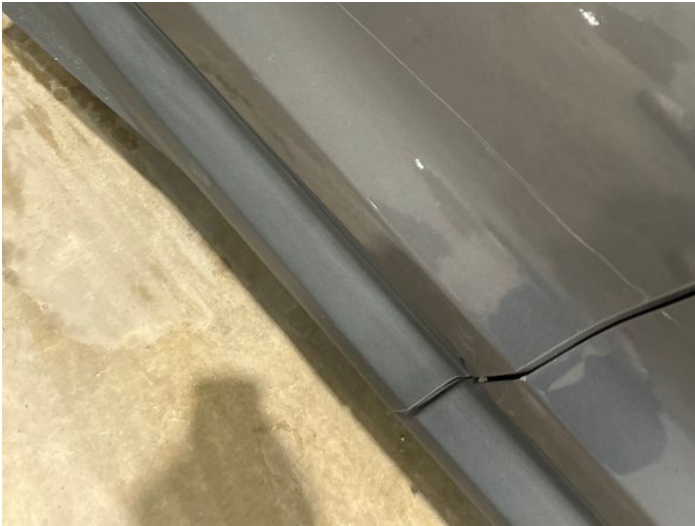
3: Door osr  
Scratched  
Over 25mm Thru Paint

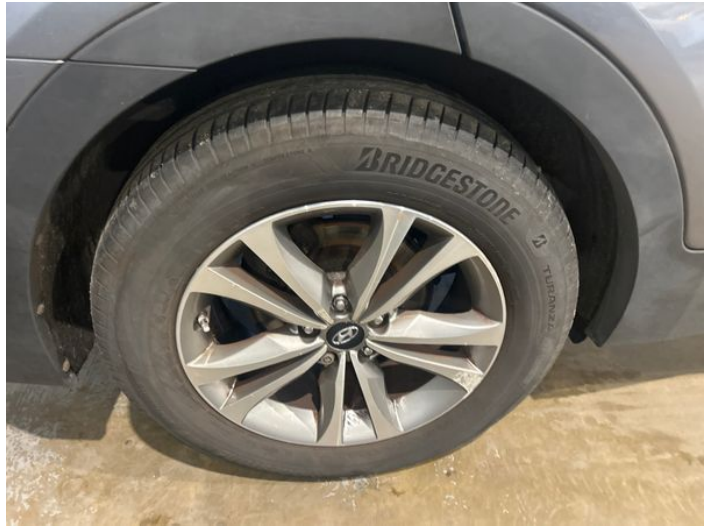
4: Wheel osr  
Corroded  
Light

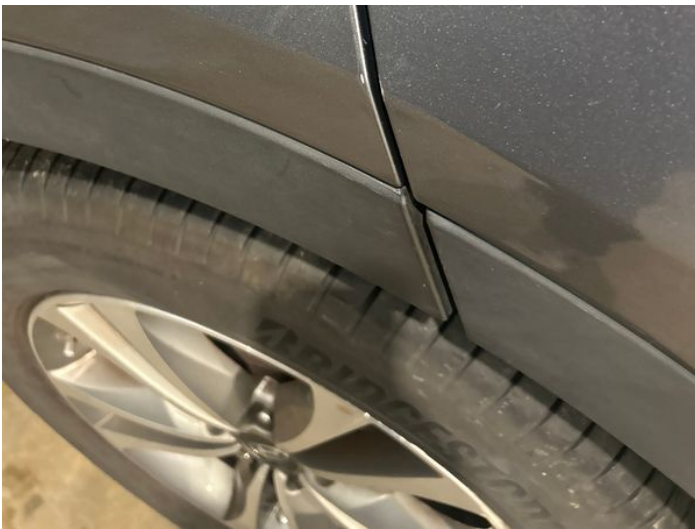
5: Qtr Panel osr  
Chipped  
1 To 5

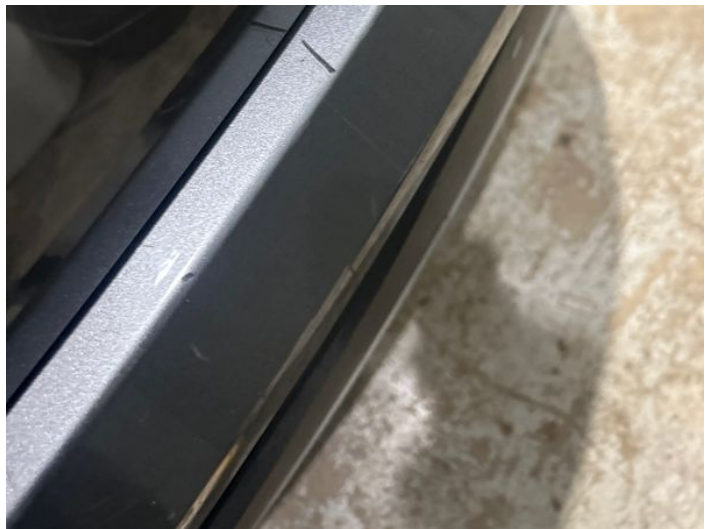
6: Bumper Rear  
Scratched  
Up To 25mm Thru Paint

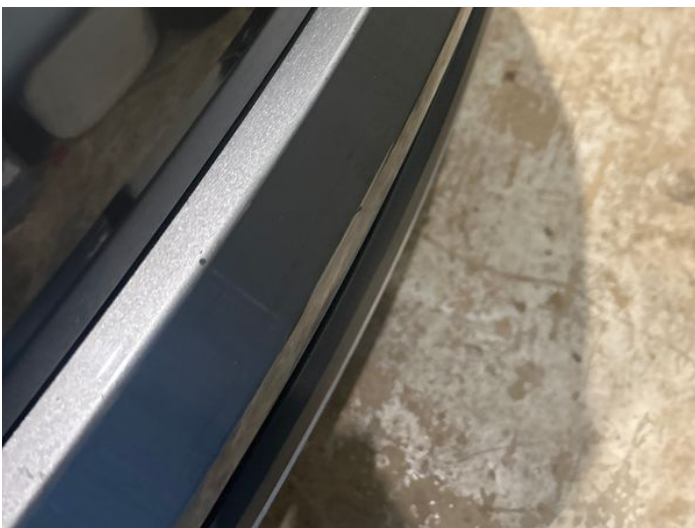
7: Bumper Rear  
Chipped  
Multiple Chips

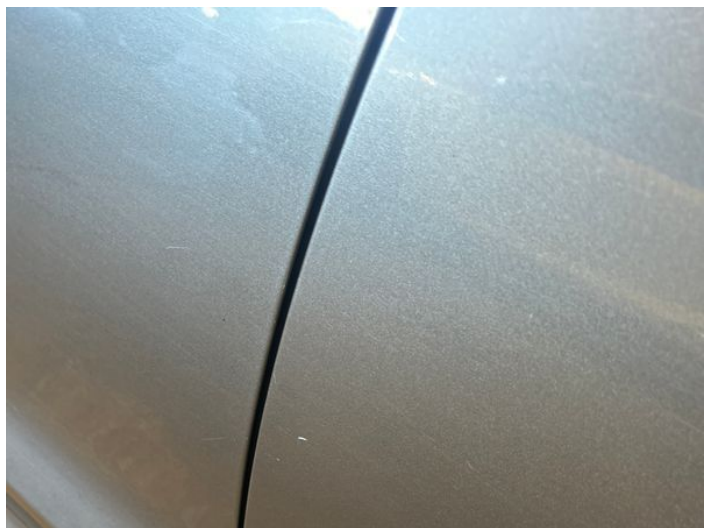
8: Door nsr  
Chipped  
1 To 5

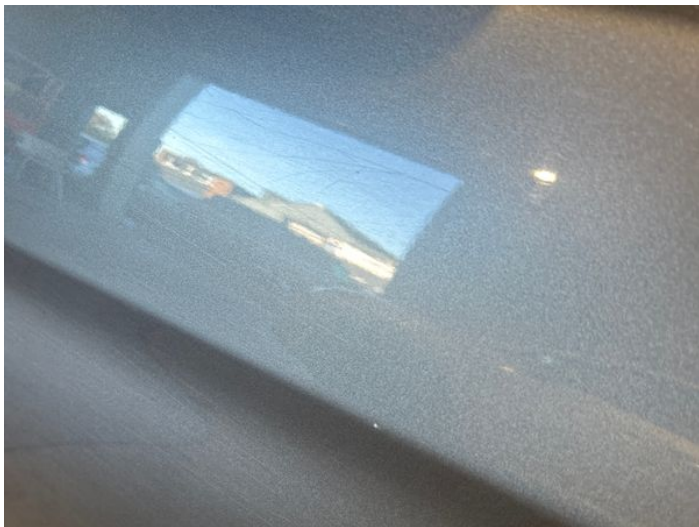
9: Door nsf  
Chipped  
1 To 5

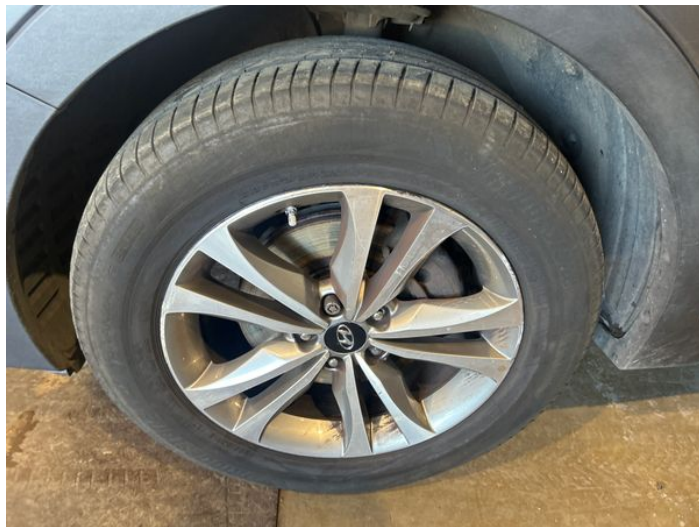
10: Wheel nsf  
Corroded  
Light

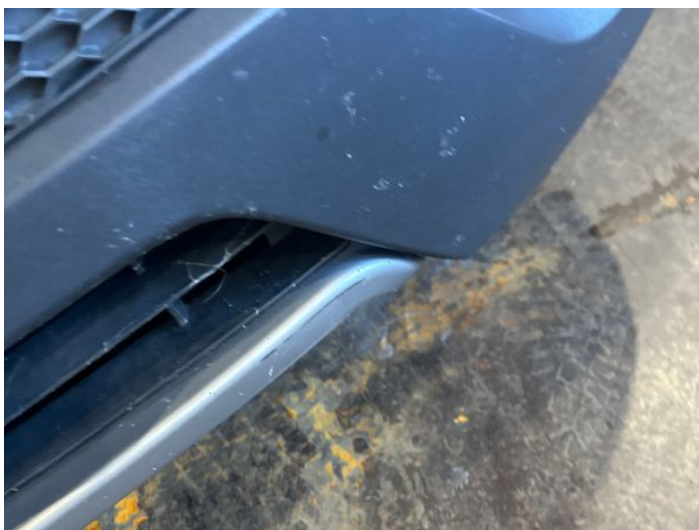
11: Bumper Front Moulding  
Scratched (Painted)  
Over 25mm Thru Paint

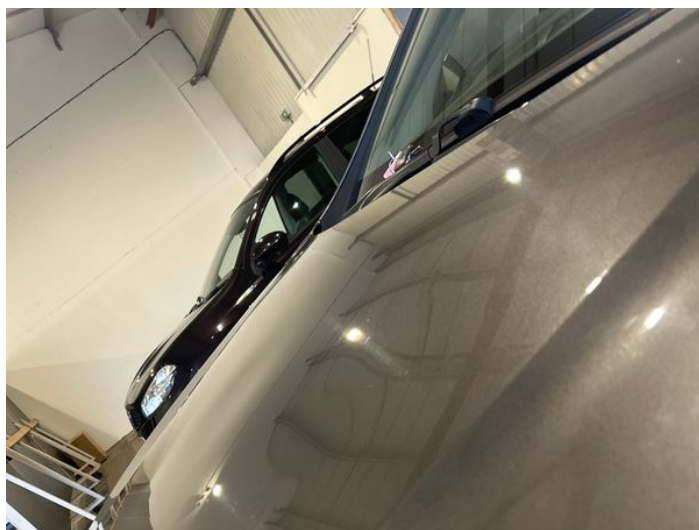
12: Bonnet  
Dented  
Over 30mm

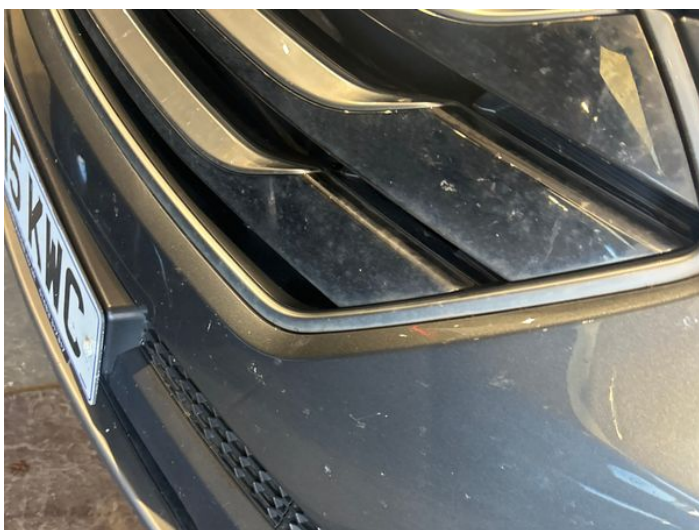
13: Bumper Front  
Chipped  
Multiple Chips

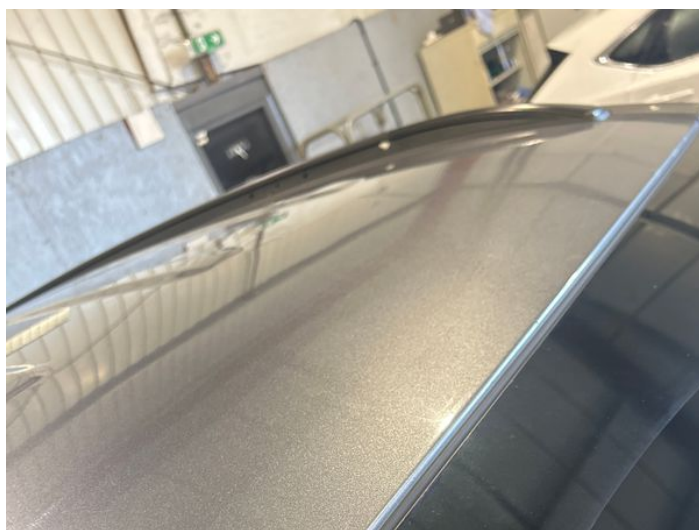
14: Roof  
Dented  
With Paint Damage

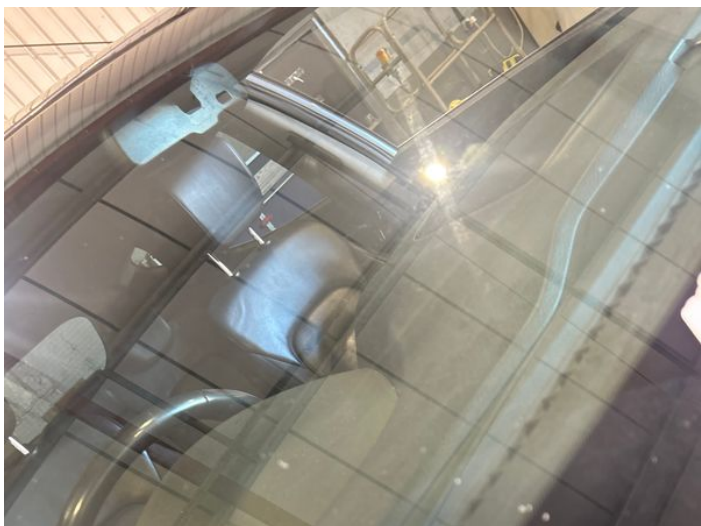
15: Screen Front  
Chipped  
UpTo 10mm
