# VEHICLE INSPECTION REPORT

**GN68XMF**

## Toyota Auris 1.2T Icon Tech TSS 5dr

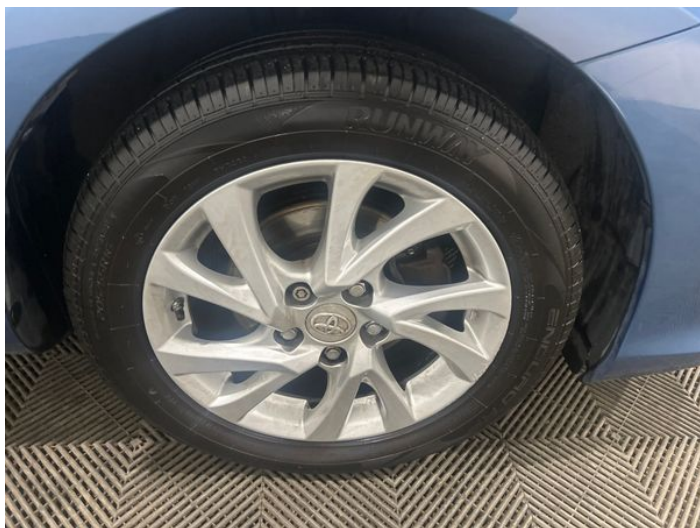
1: Wheel osf  
Scratched  
Over 50mm

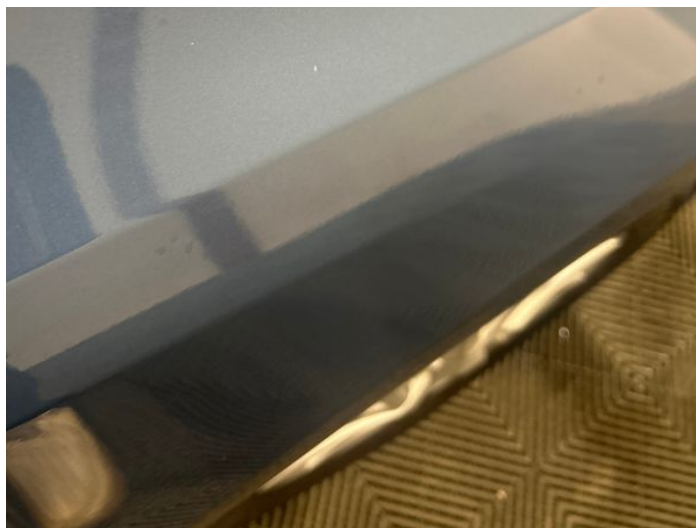
2: Wing osf  
Chipped  
1 To 5

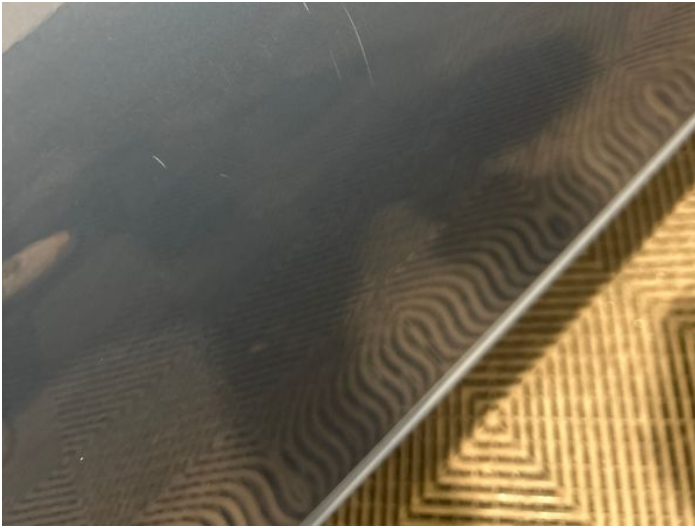
3: Door osf  
Scratched  
UpTo 25mm Thru Paint

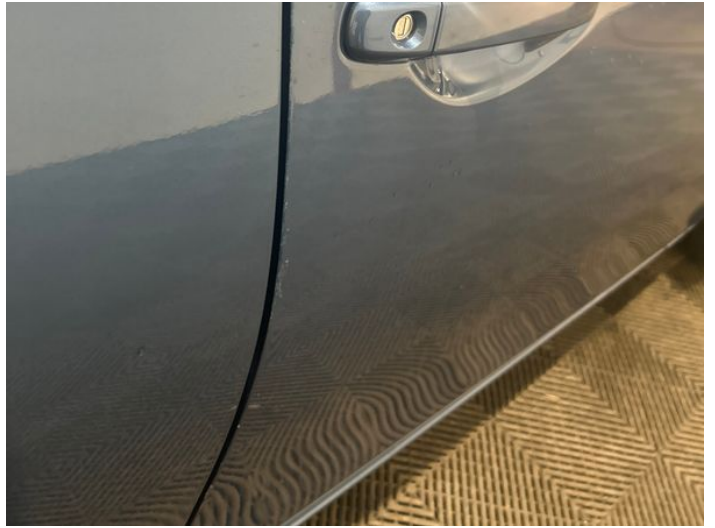
4: Door osf  
Chipped  
Edge Chip

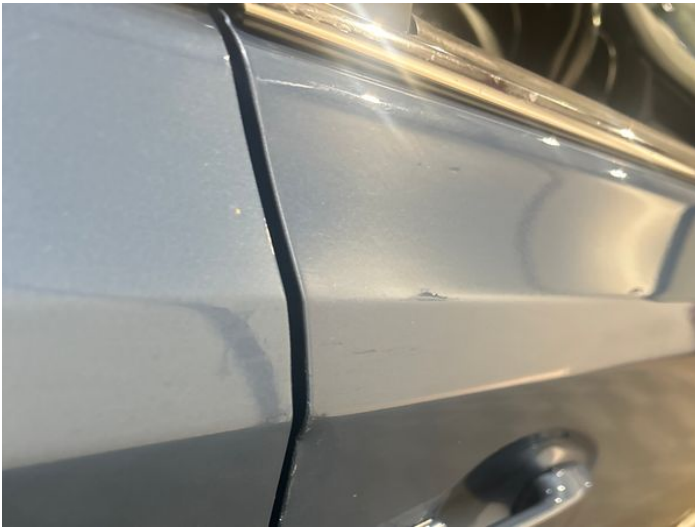
5: Door osf  
Dented  
Between 10mm + 30mm

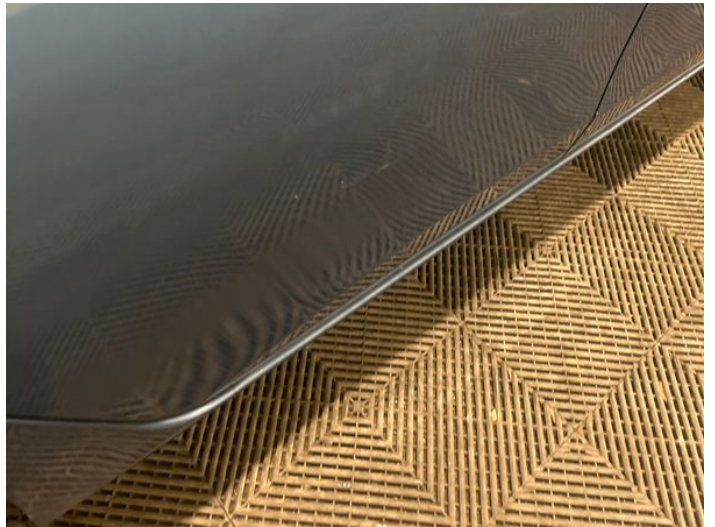
6: Door osr  
Poor Previous Repair  
Poor Paint

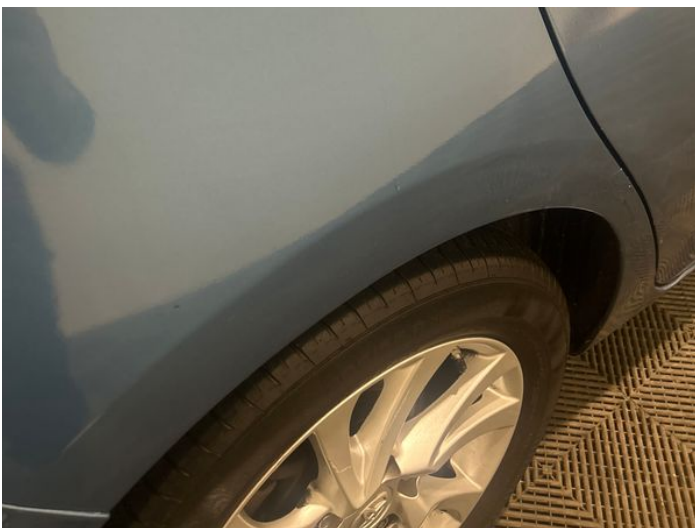
7: Qtr Panel osr  
Poor Previous Repair  
Poor Paint

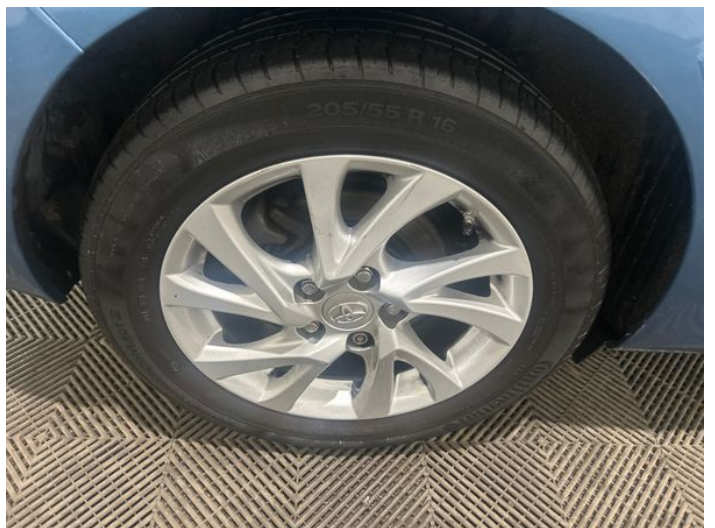
8: Wheel osr  
Scratched  
Over 50mm

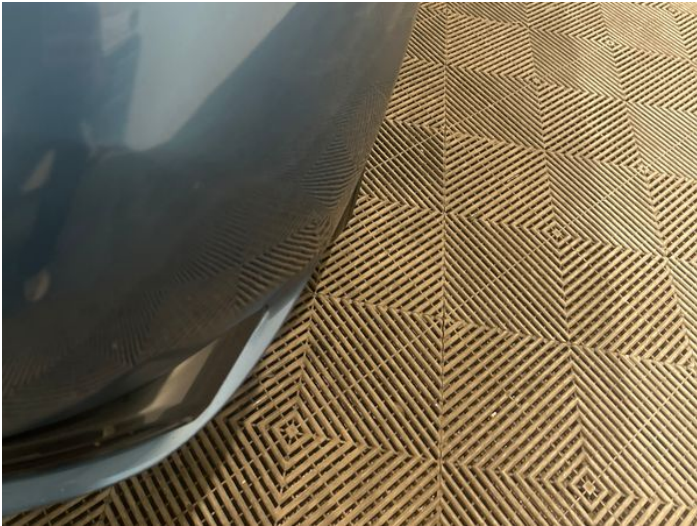
9: Bumper Rear  
Poor Previous Repair  
Poor Paint

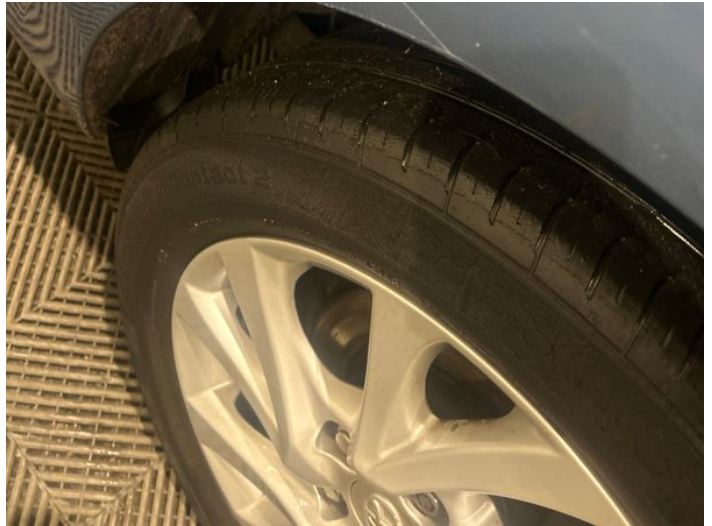
10: Qtr Panel nsr  
Scratched  
Over 25mm Thru Paint

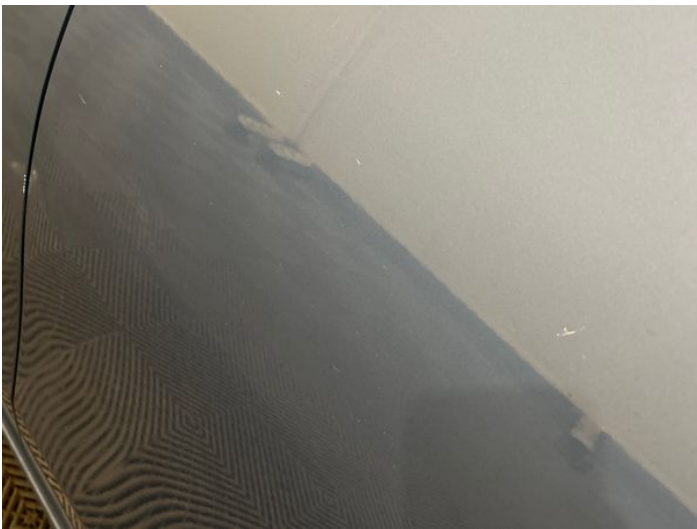
11: Door nsr  
Chipped  
1 To 5

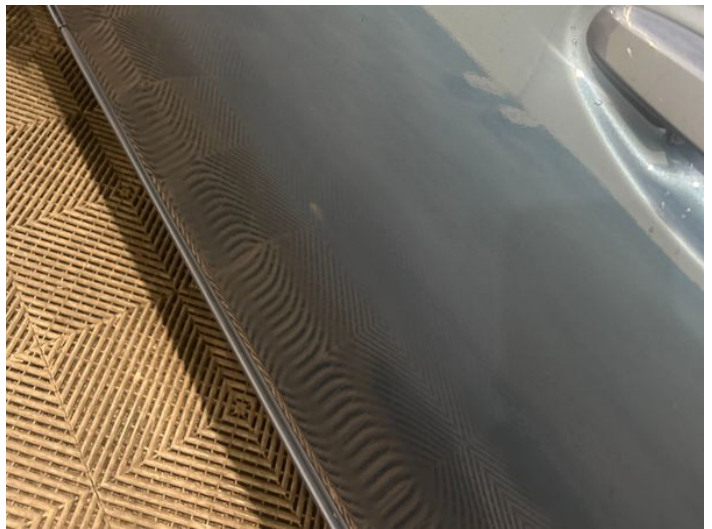
12: Door nsf  
Poor Previous Repair  
Poor Paint

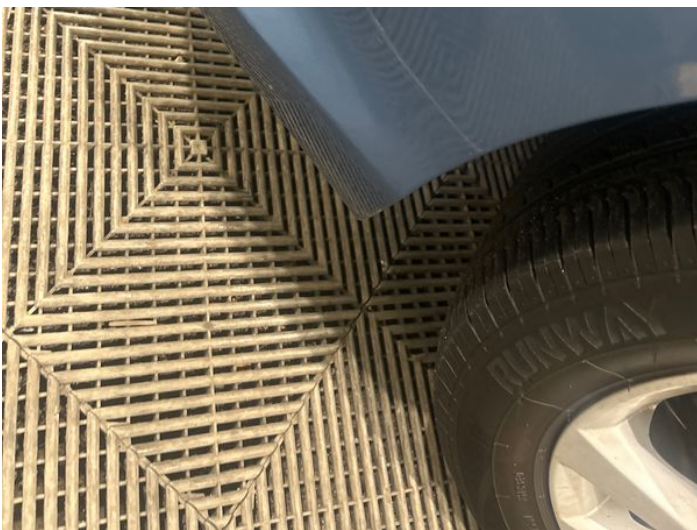
13: Bumper Front  
Scratched  
Over 100mm Thru Paint

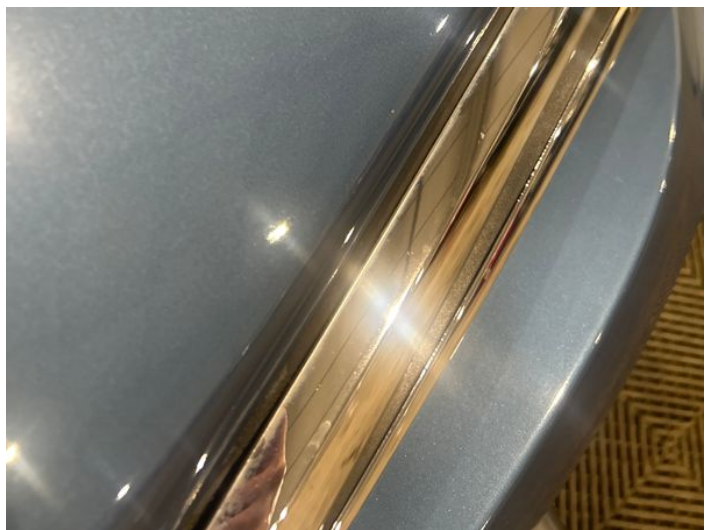
14: Bonnet  
Chipped  
1 To 5

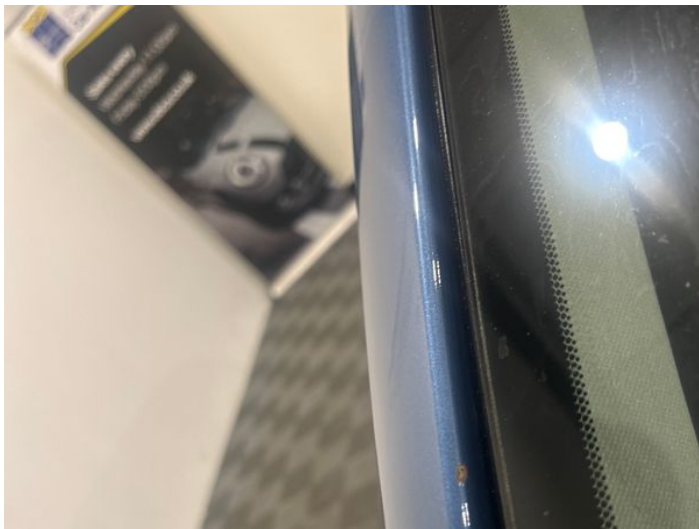
15: A Post os  
Chipped  
1 To 5
