## VEHICLE INSPECTION REPORT

**LK13XEA**

### Volkswagen Tiguan 2.0 TDi BlueMotion Tech R-Line 5dr DSG

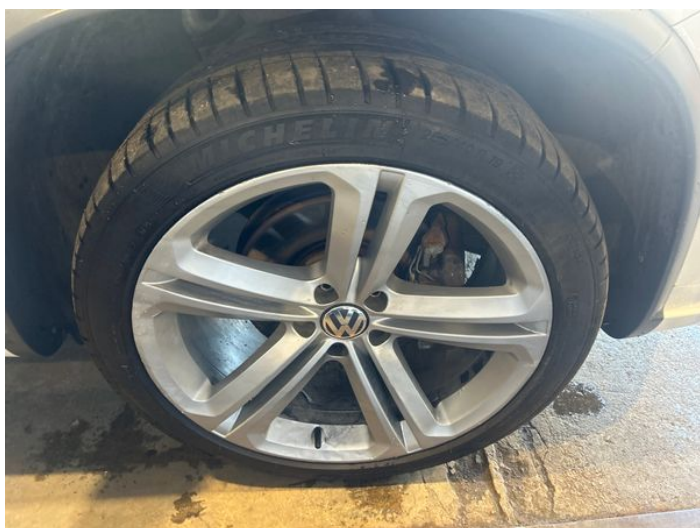
1: Wheel osf  
Scratched  
Over 50mm

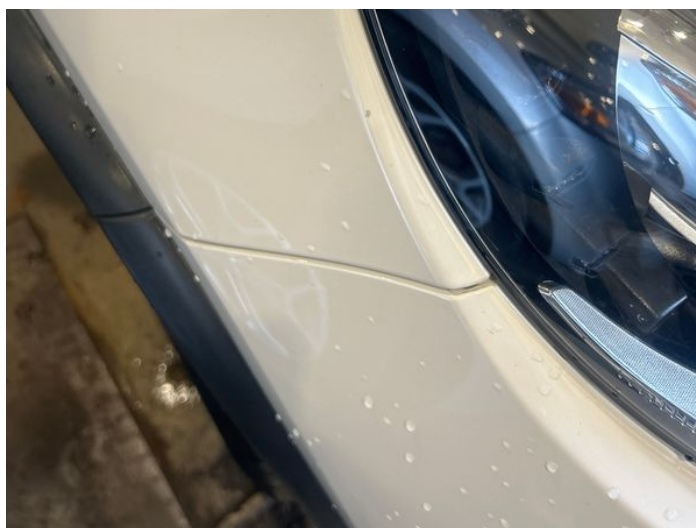
2: Wing osf  
Chipped  
1 To 5

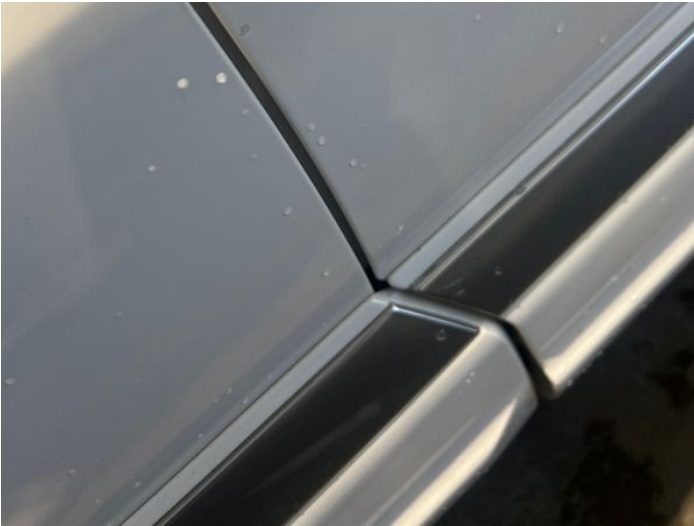
3: Door osf  
Chipped  
1 To 5

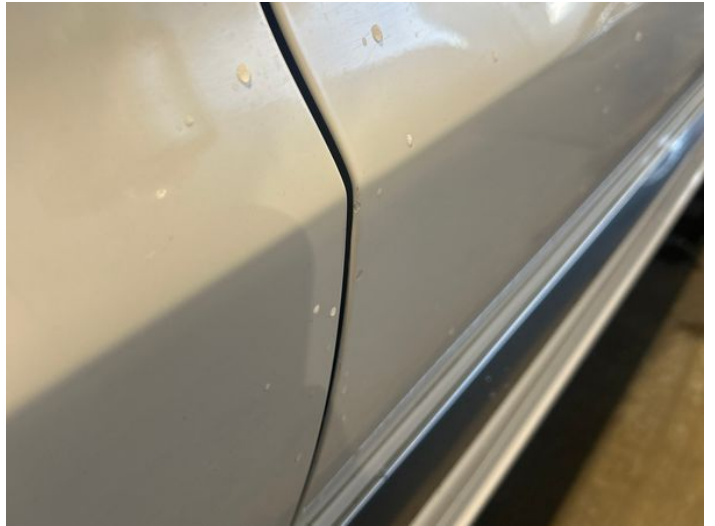
4: Door osf  
Chipped  
Edge Chip

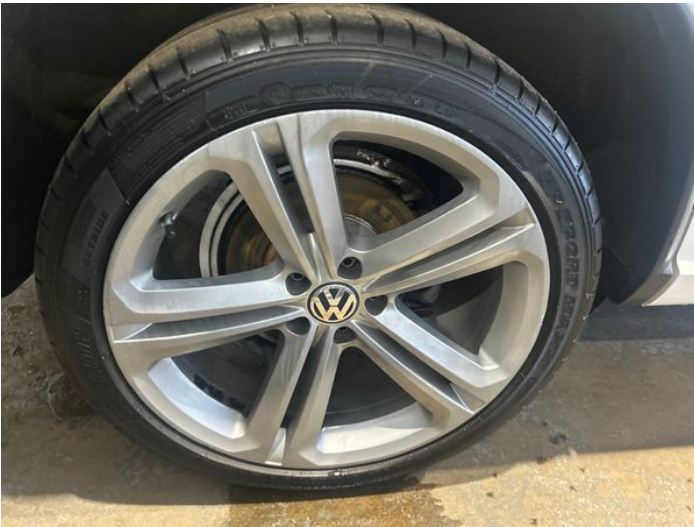
5: Wheel osr  
Scratched  
Up To 50mm

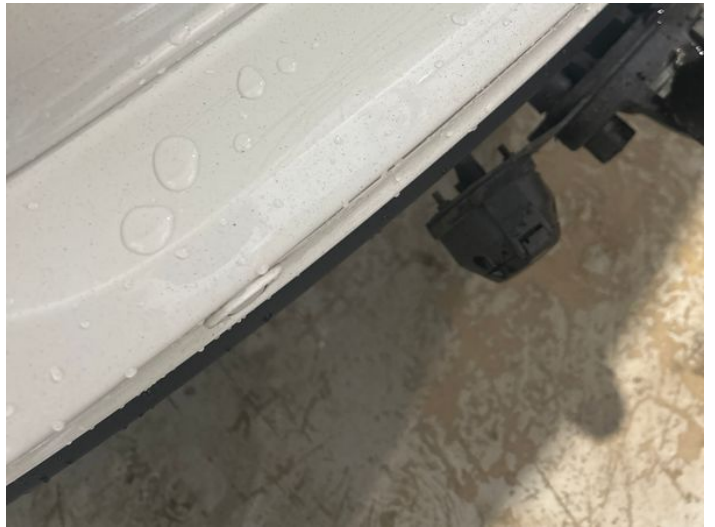
6: Bumper Rear  
Poor Previous Repair  
Paint Flake

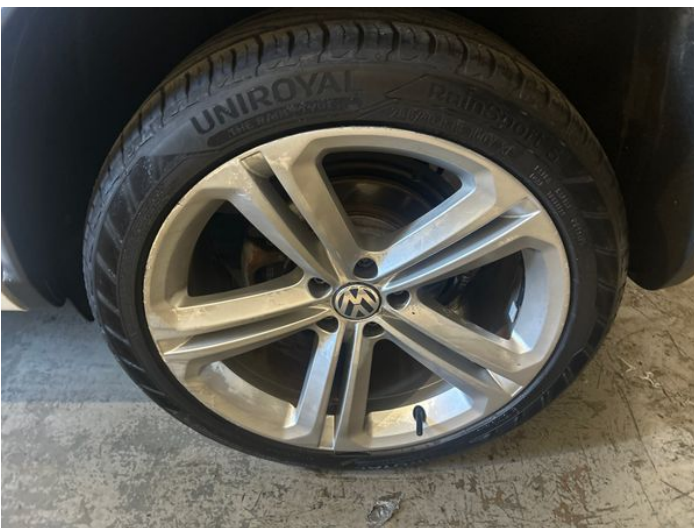
7: Wheel nsr  
Scratched  
Over 50mm

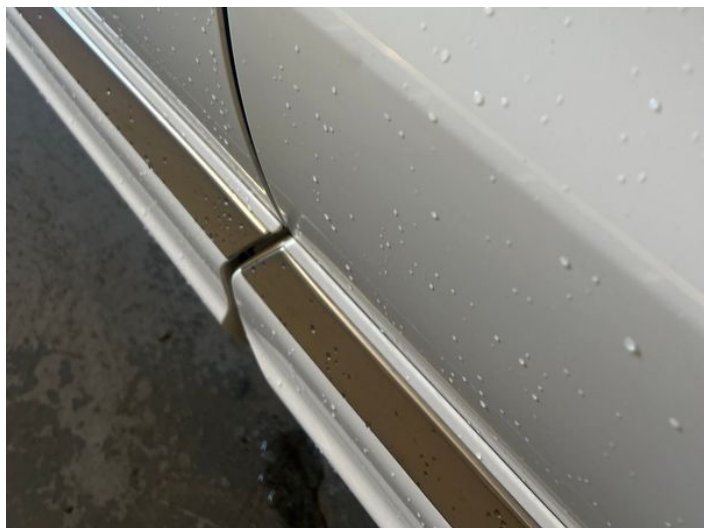
8: Door nsr  
Dented  
2 Or Less UpTo 10mm

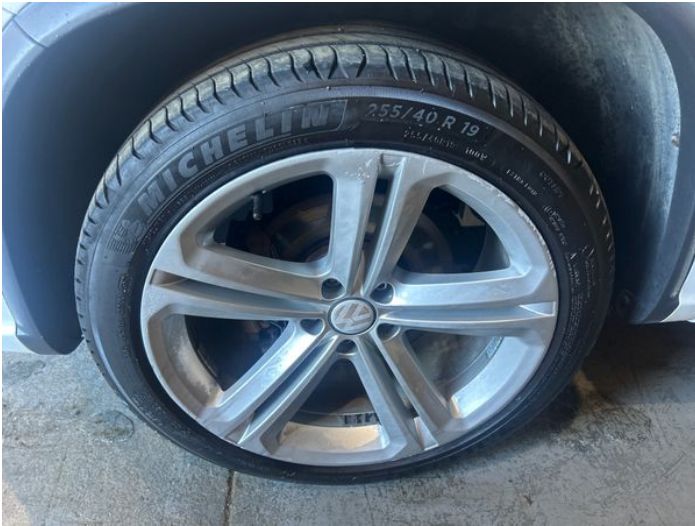
9: Wheel nsf  
Scratched  
Over 50mm

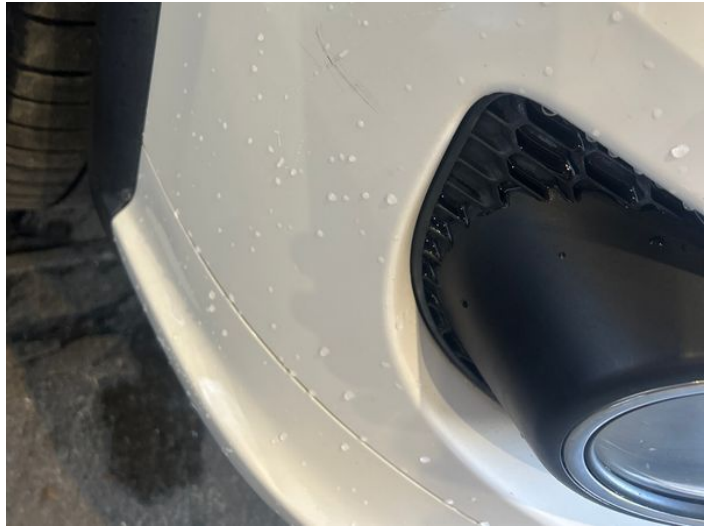
10: Bumper Front  
Scratched  
UpTo 25mm Thru Paint

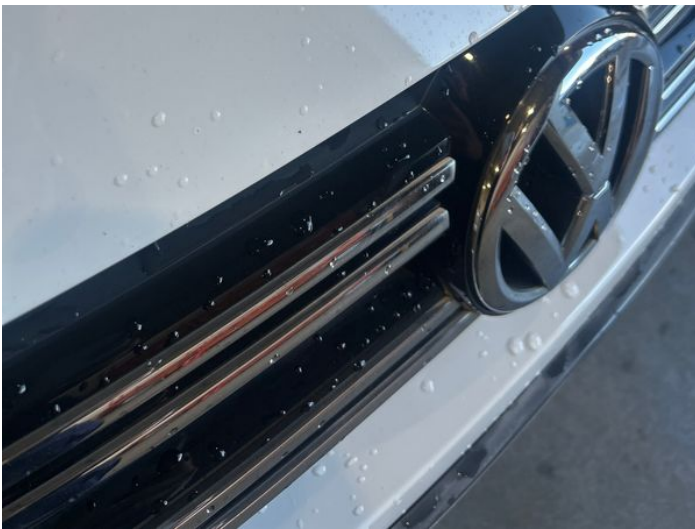
11: Bonnet  
Chipped  
1 To 5

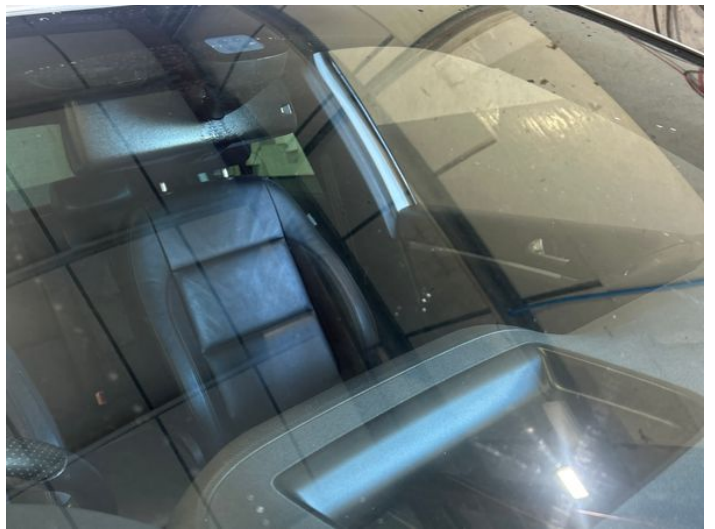
12: Screen Front  
Chipped  
UpTo 10mm

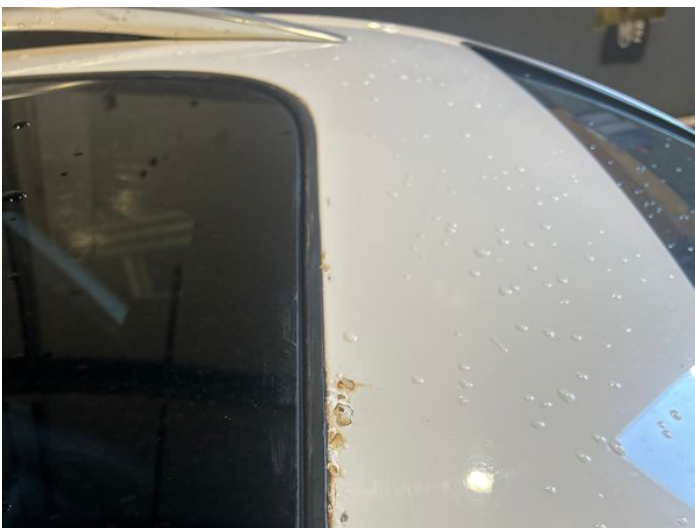
13: Roof  
Rusted  
Over 5mm

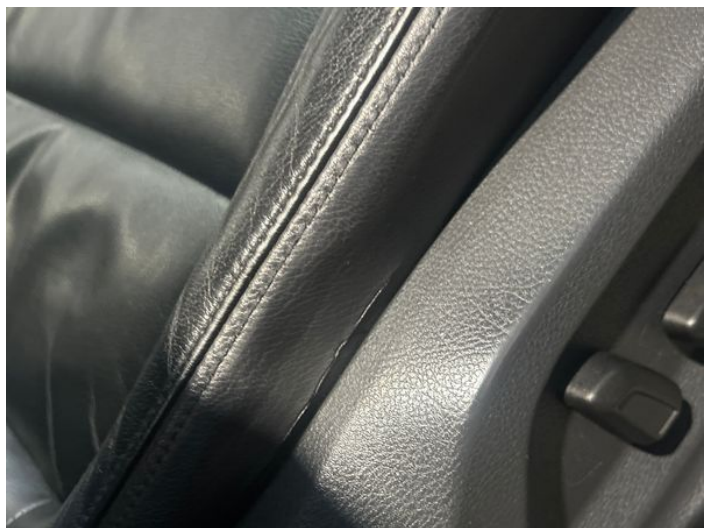
14: Seat Base Cover osf  
Torn  
Over 3mm

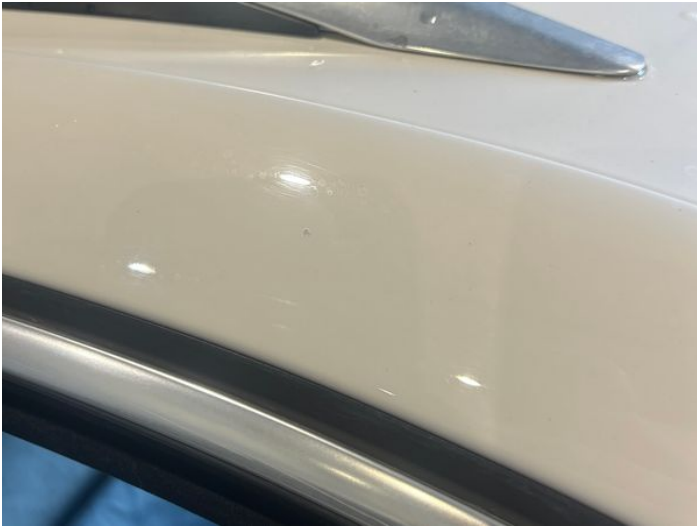
15: B Post os  
Chipped  
1 To 5

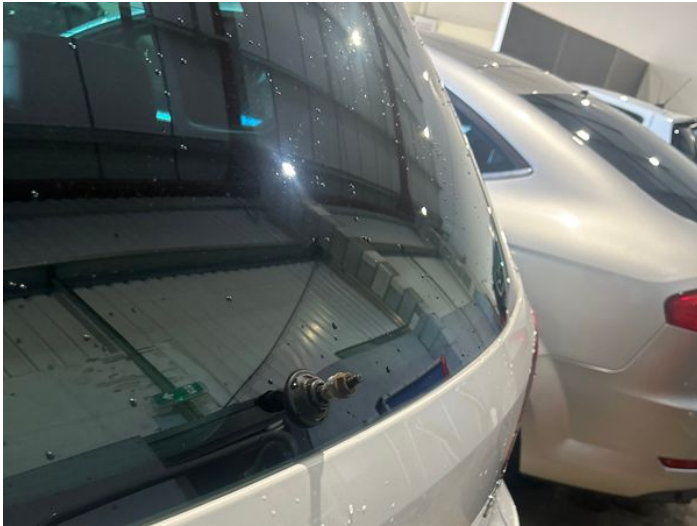
16: Wiper Rear  
Missing  
Replace

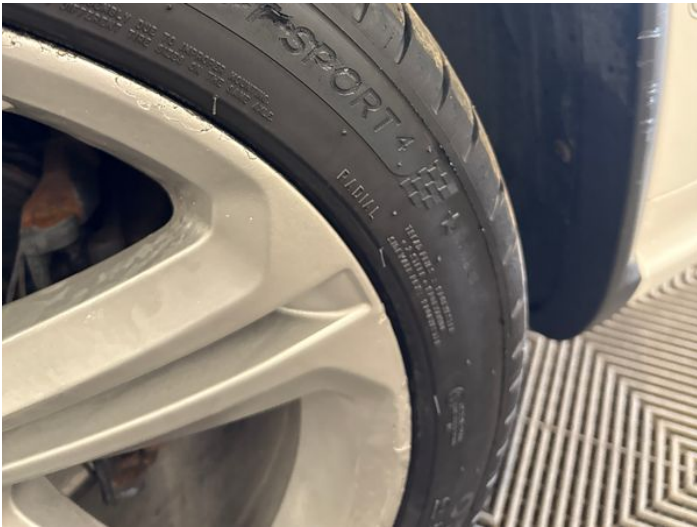
| OSF | MICHELIN | Damaged |

17: Tyre osf  
Damaged  
Replace

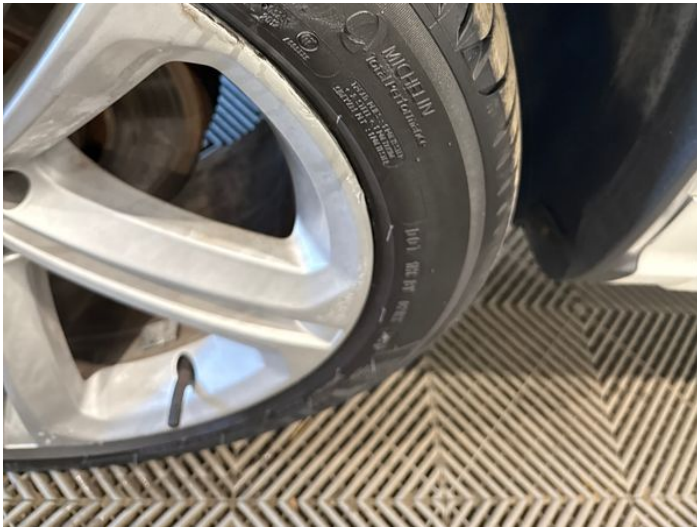
| NSF | MICHELIN | Damaged |

18: Tyre nsf  
Damaged  
Replace
