# VEHICLE INSPECTION REPORT

**WF67JPX**

## Kia Sportage 1.7 CRDi ISG 3 5dr

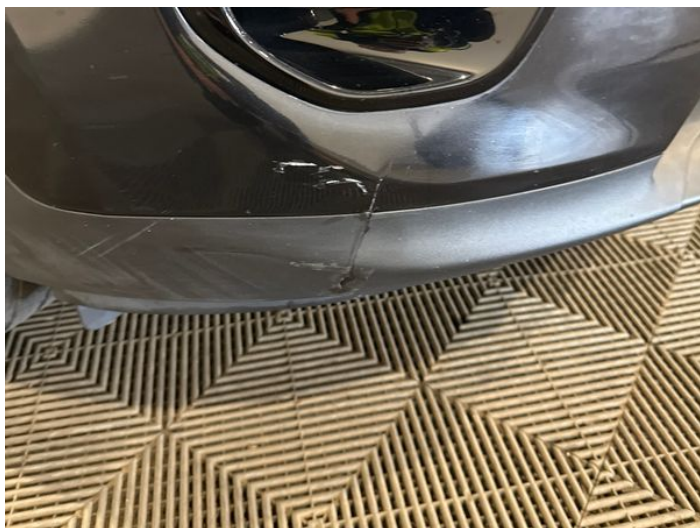
1: Bumper Front  
Cracked  
UpTo 25mm

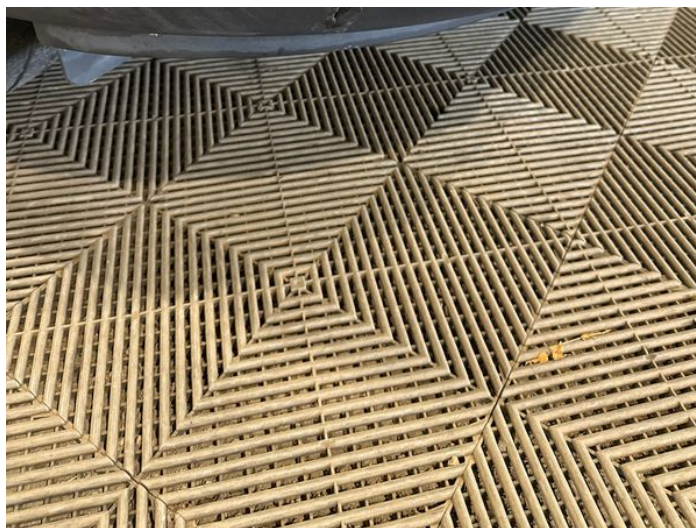
2: Bumper Front Moulding  
Broken  
Replace

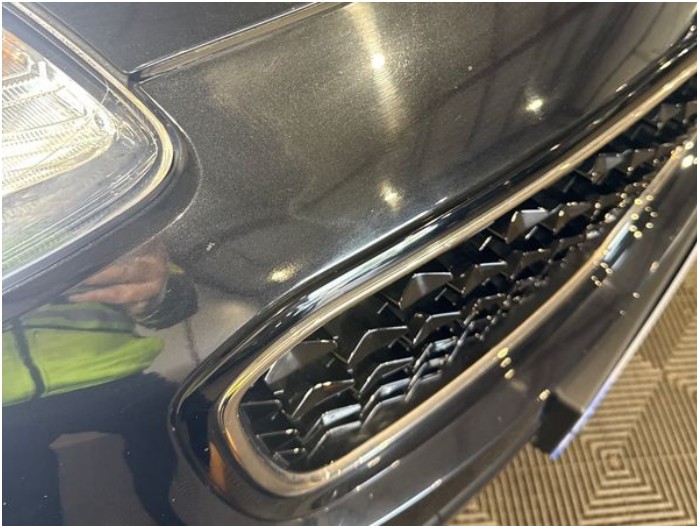
3: Bumper Front  
Poor Previous Repair  
Poor Paint

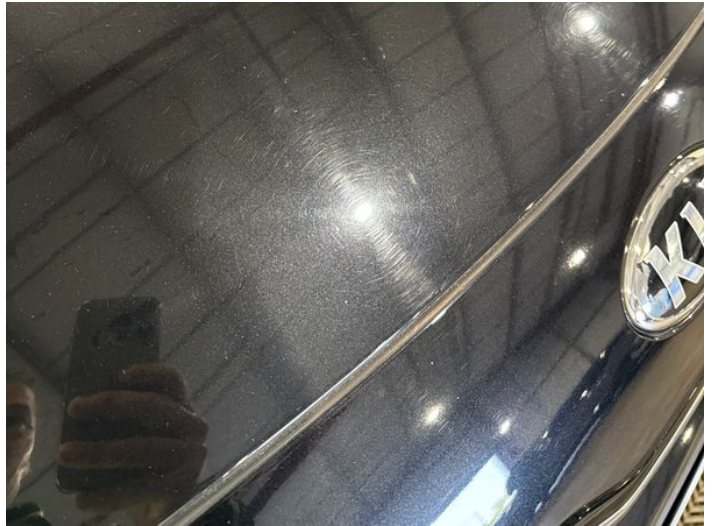
4: Bonnet  
Chipped  
1 To 5

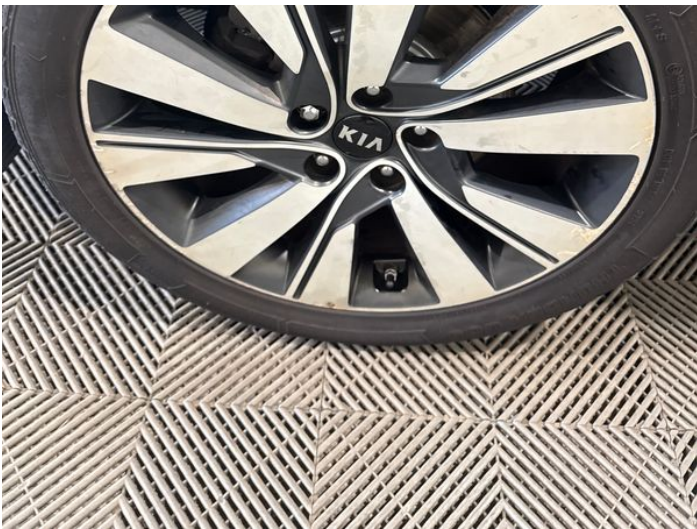
5: Wheel nsf  
Scratched  
Over 50mm

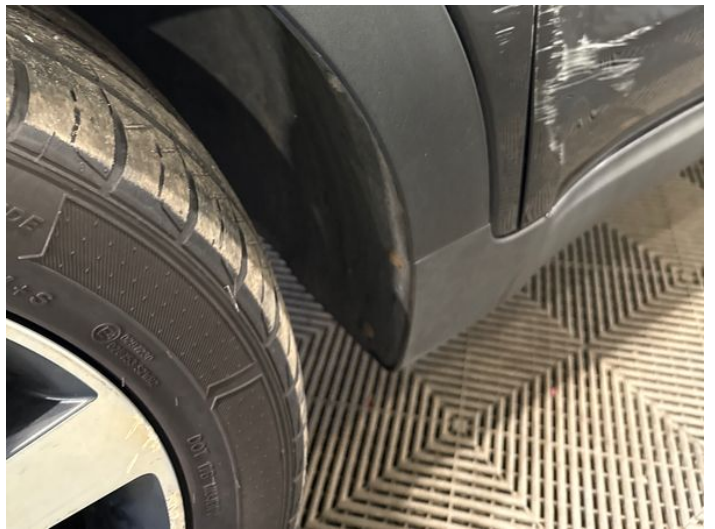
6: Wing nsf  
Scratched  
Over 25mm Thru Paint

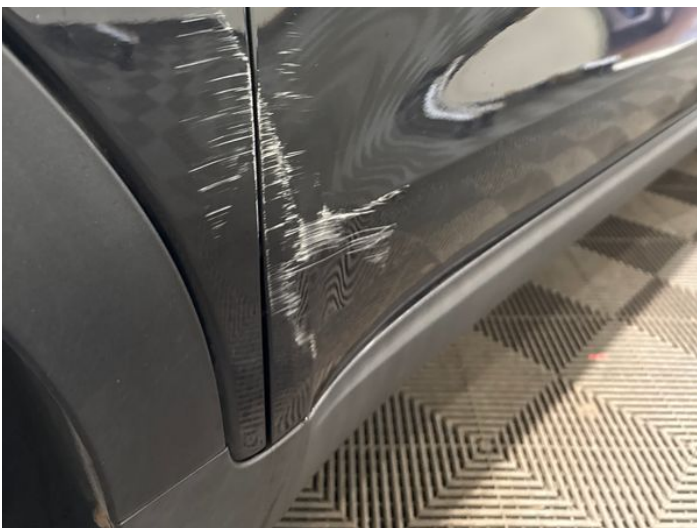
7: Door nsf  
Dented  
With Paint Damage

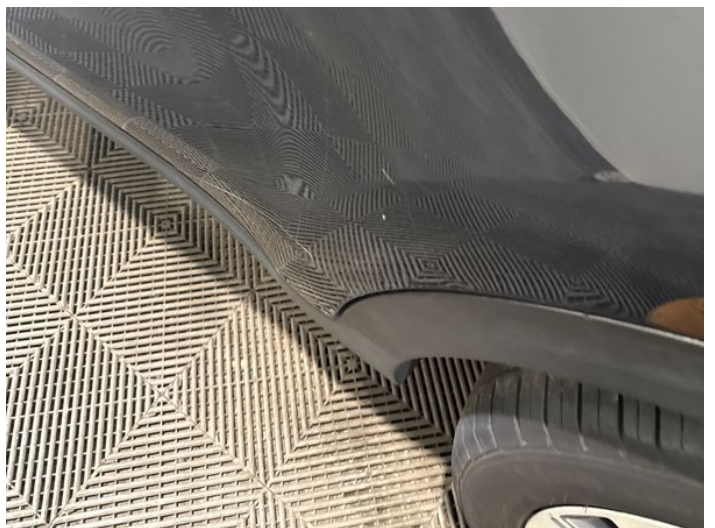
8: Door nsr  
Scratched  
Over 25mm Thru Paint

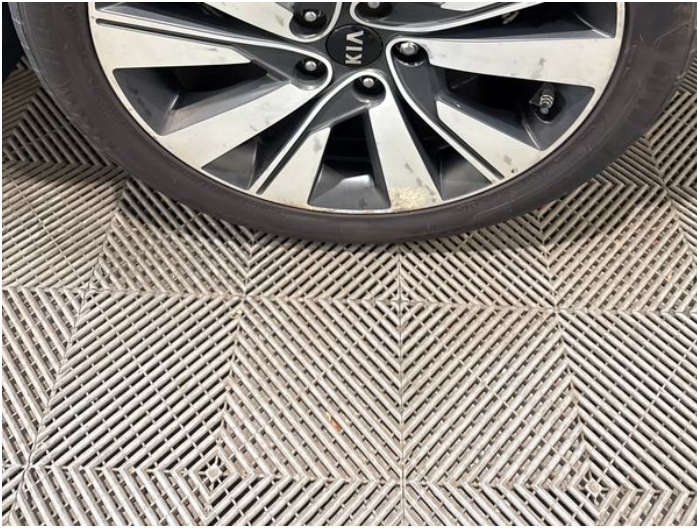
9: Wheel nsr  
Scratched  
Over 50mm

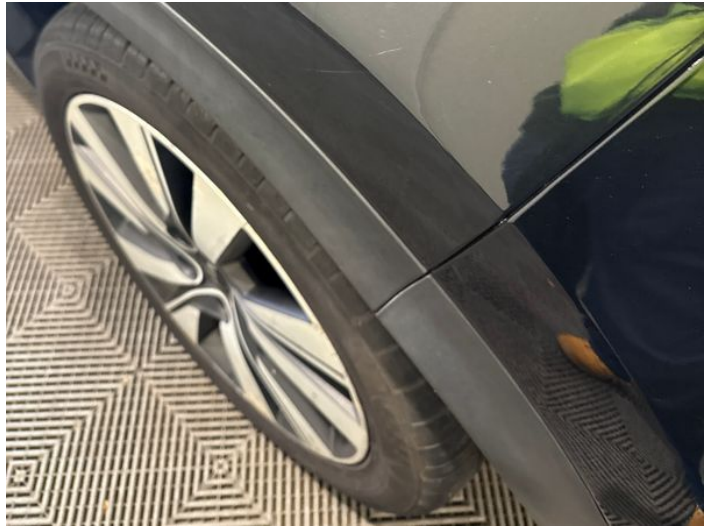
10: Qtr Panel nsr  
Scratched  
Over 25mm Thru Paint

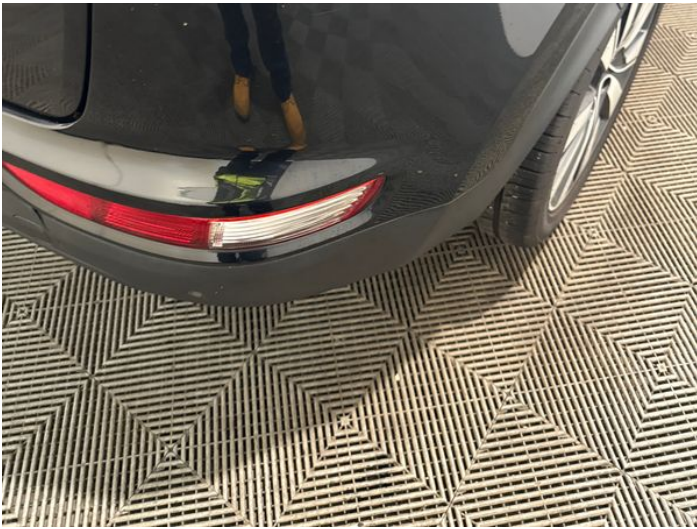
11: Bumper Rear  
Scratched  
25 to 100mm Thru Paint

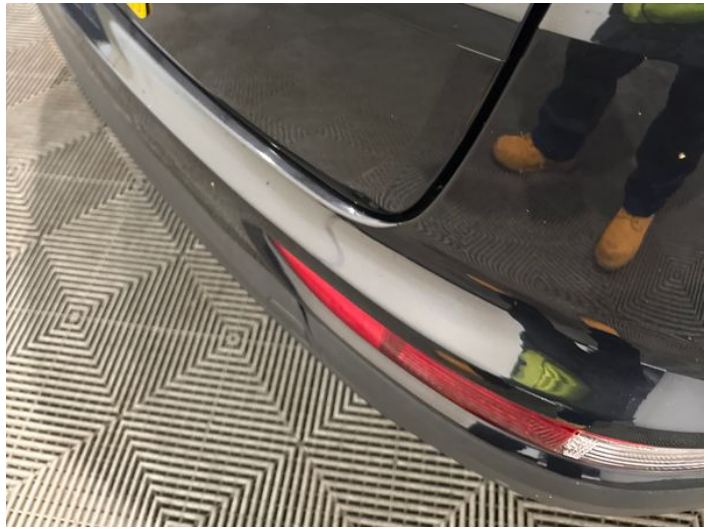
12: Tailgate  
Scratched  
Over 25mm Thru Paint

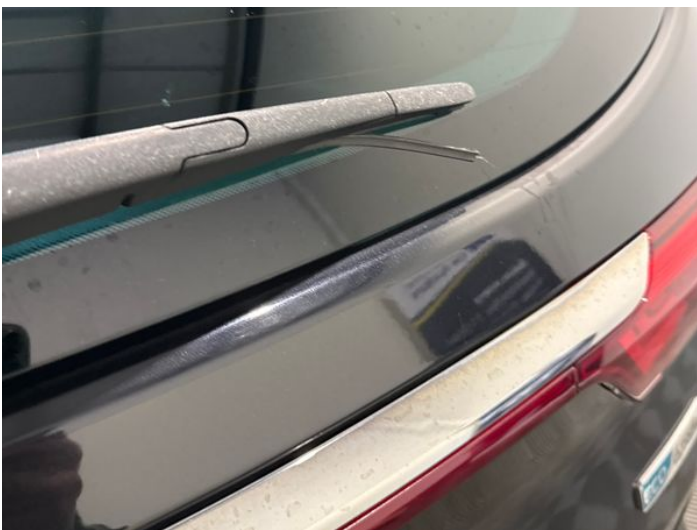
13: Wiper Rear  
Broken  
Replace

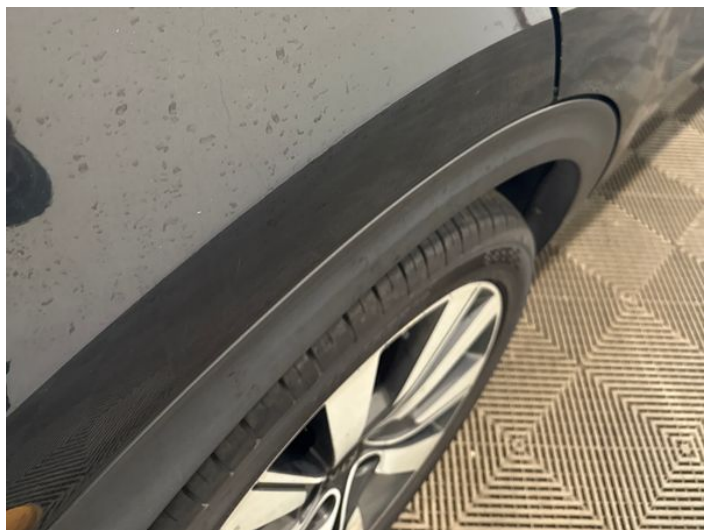
14: Qtr Panel osr  
Scratched  
Over 25mm Thru Paint

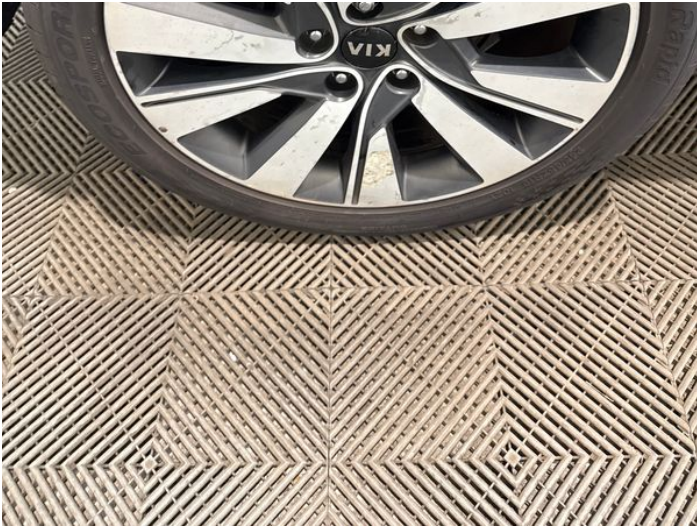
15: Wheel osr  
Scratched  
Over 50mm

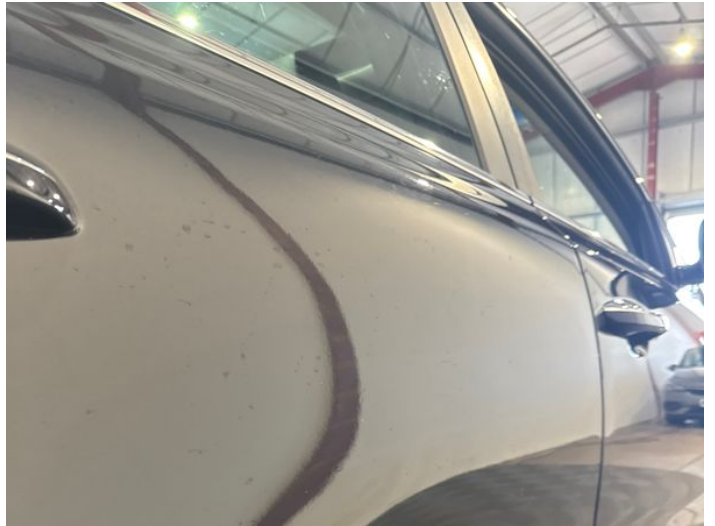
16: Door osr  
Dented  
Over 30mm

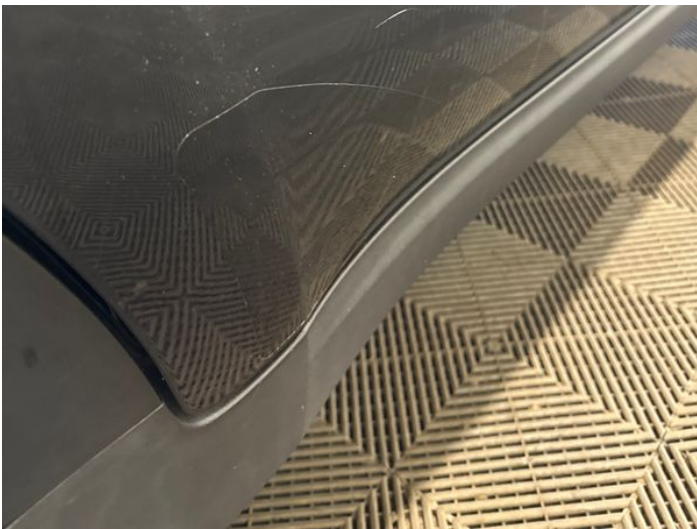
17: Door osr  
Scratched  
UpTo 25mm Thru Paint

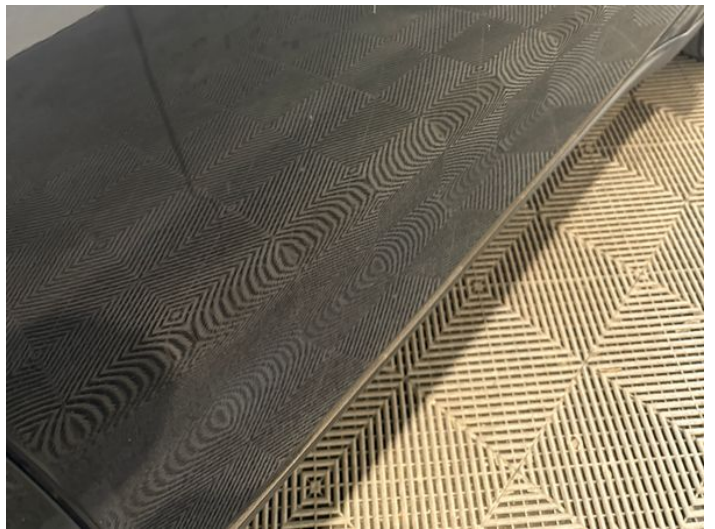
18: Door osf  
Dented  
Between 10mm + 30mm

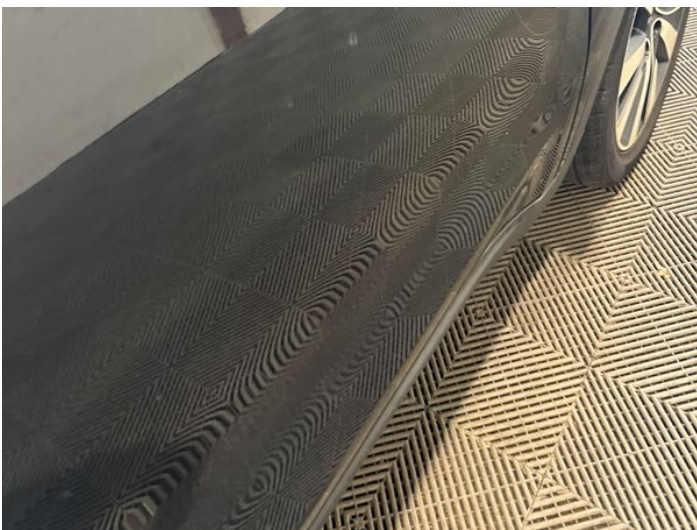
19: Door osf  
Scratched  
Over 25mm Thru Paint

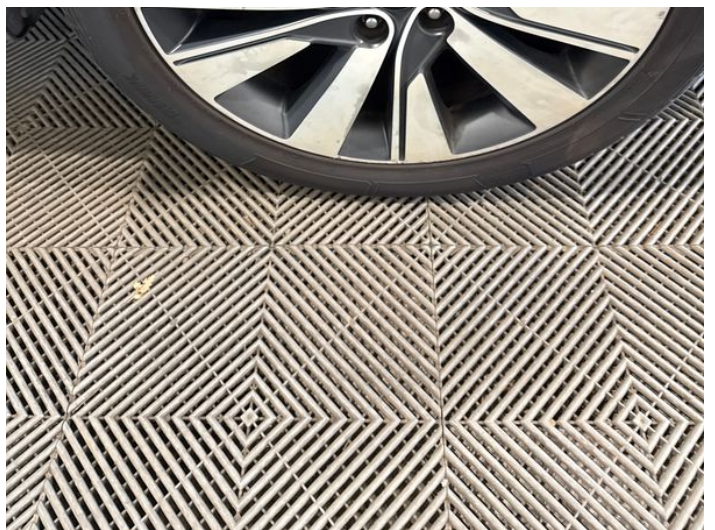
20: Wheel osf  
Scratched  
Over 50mm

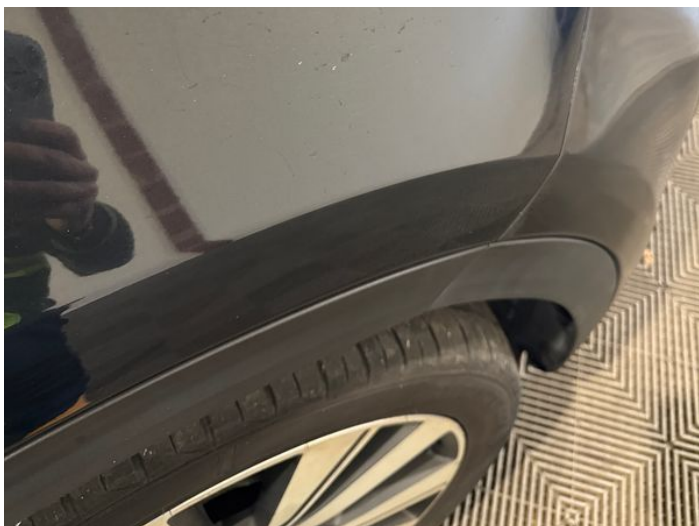
21: Wing osf  
Chipped  
1 To 5

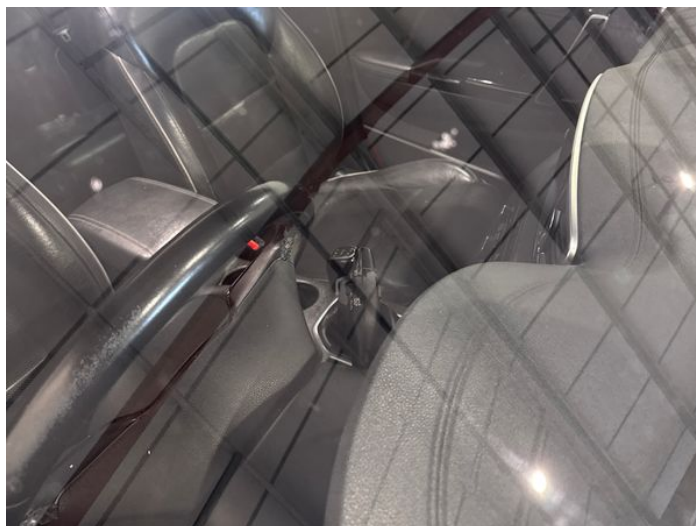
22: Screen Front  
Chipped  
Over 10mm
