# VEHICLE INSPECTION REPORT

**RX16EFR**

## Toyota Yaris 1.33 VVT-i Icon 5dr

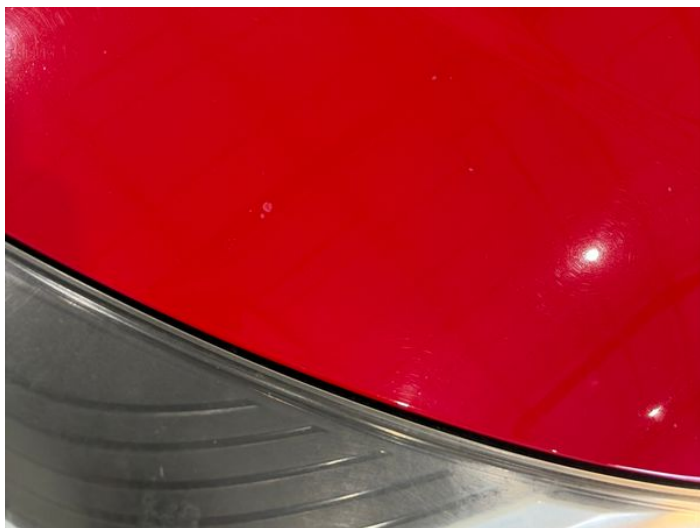
1: Bonnet  
Chipped  
1 To 5

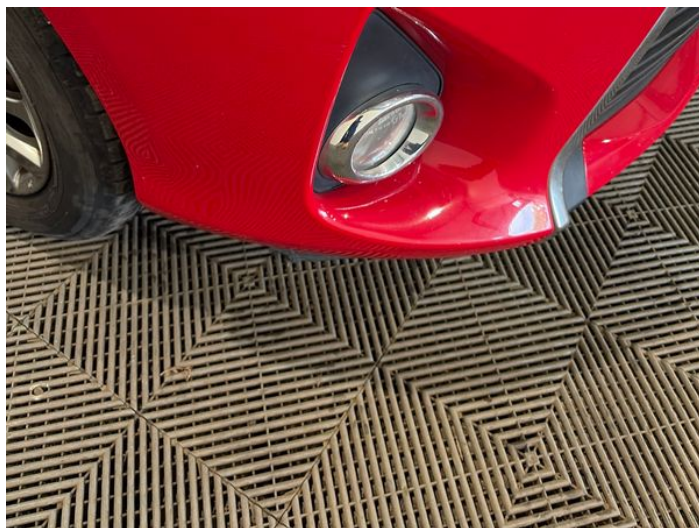
2: Bumper Front  
Scratched  
25 to 100mm Thru Paint

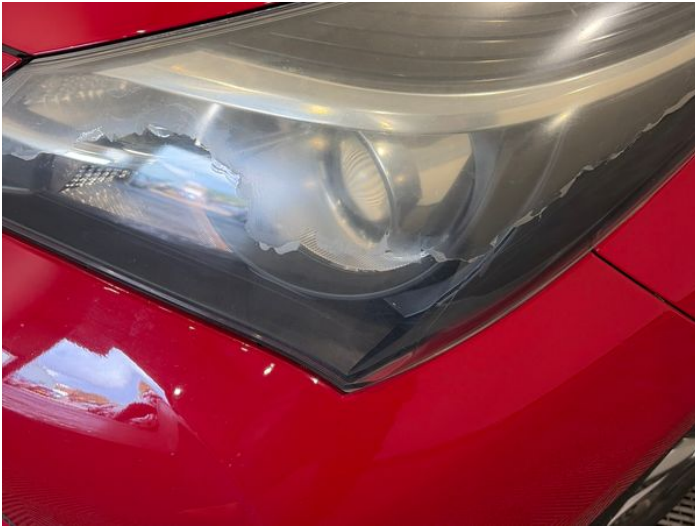
3: Other  
N/A  
N/A  
Lacquer pilling on headlight

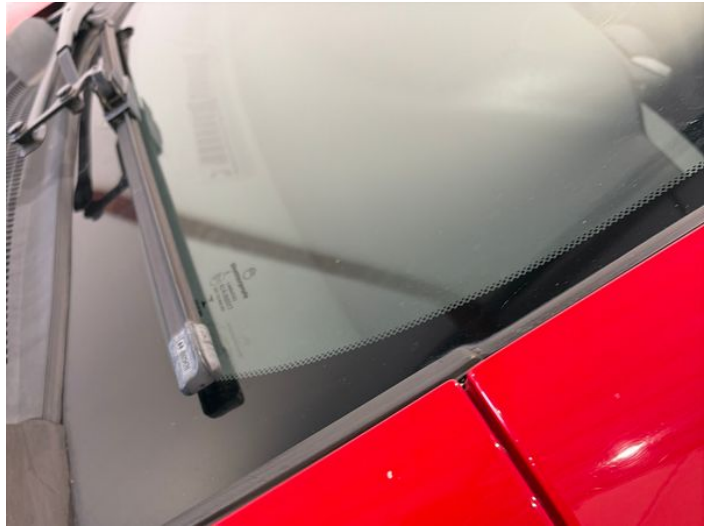
4: Wing nsf  
Chipped  
1 To 5

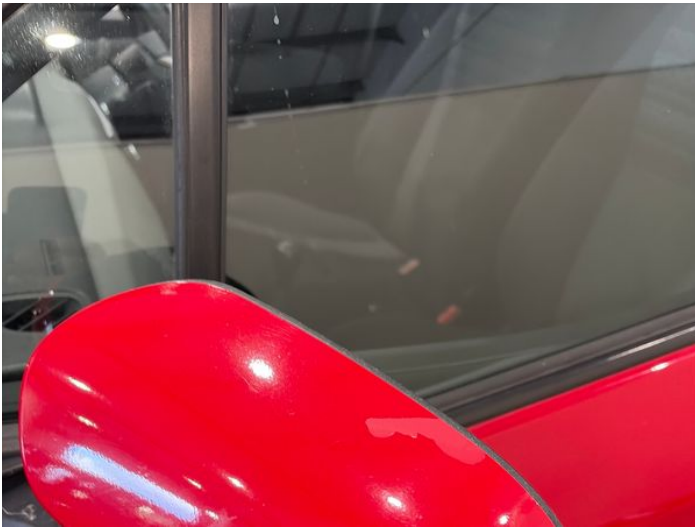
5: Door Mirror Assy nsf  
Scratched (Painted)  
Over 25mm Thru Paint

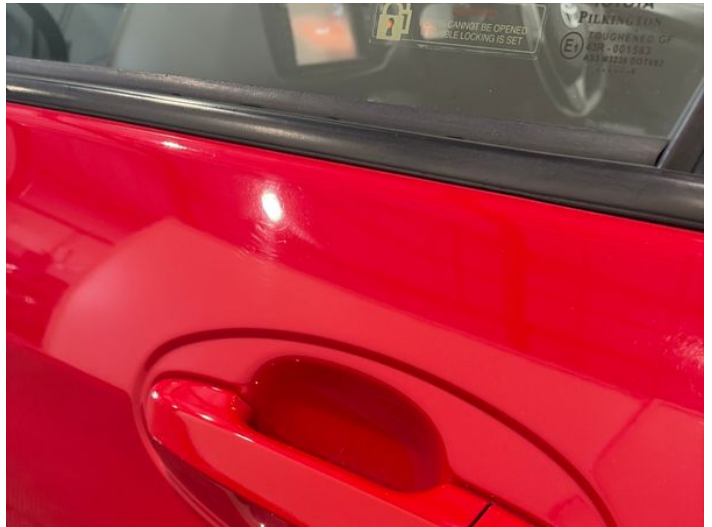
6: Handle Outer nsf  
Scratched (Painted)  
UpTo 25mm Thru Paint

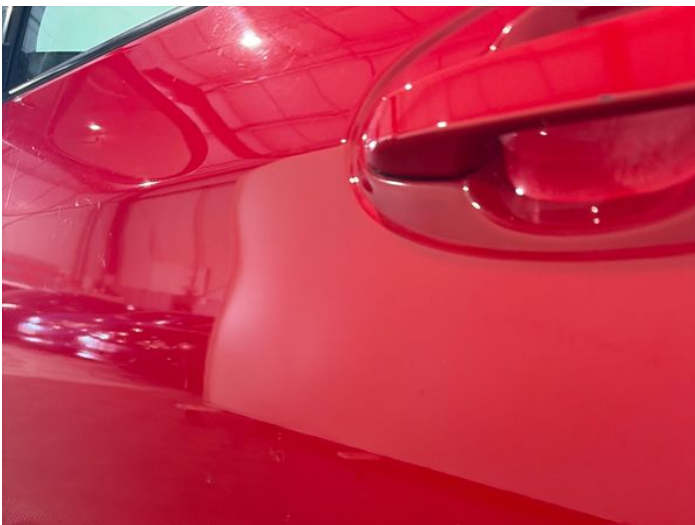
7: Door nsf  
Chipped  
1 To 5

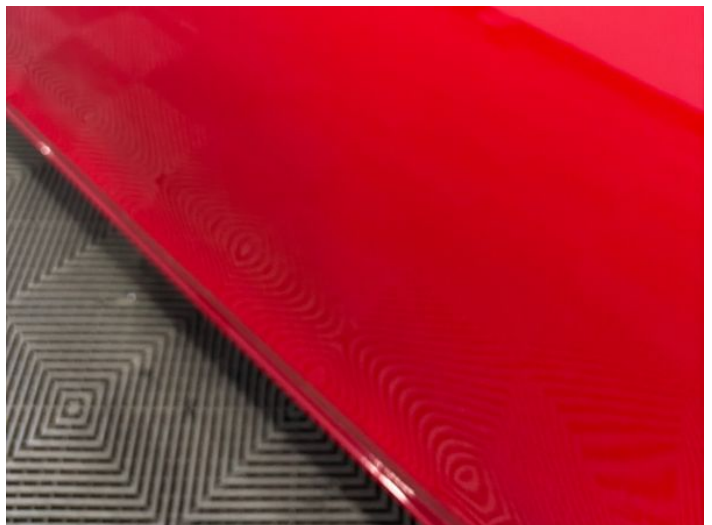
8: Door nsr  
Scratched  
UpTo 25mm Thru Paint

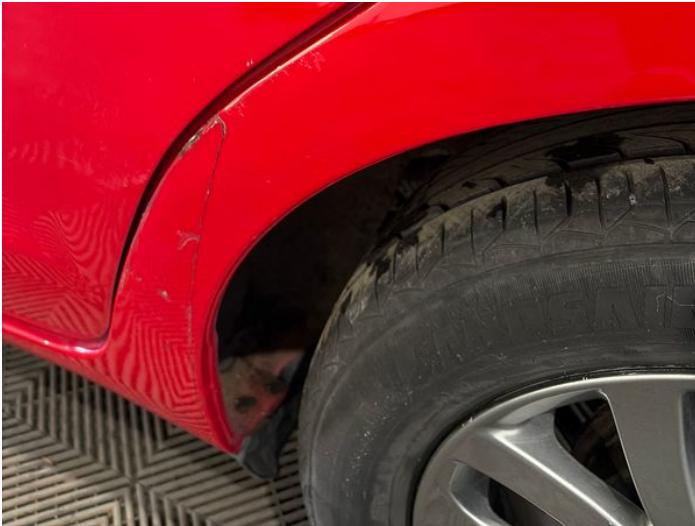
9: C Post ns  
Dented  
With Paint Damage

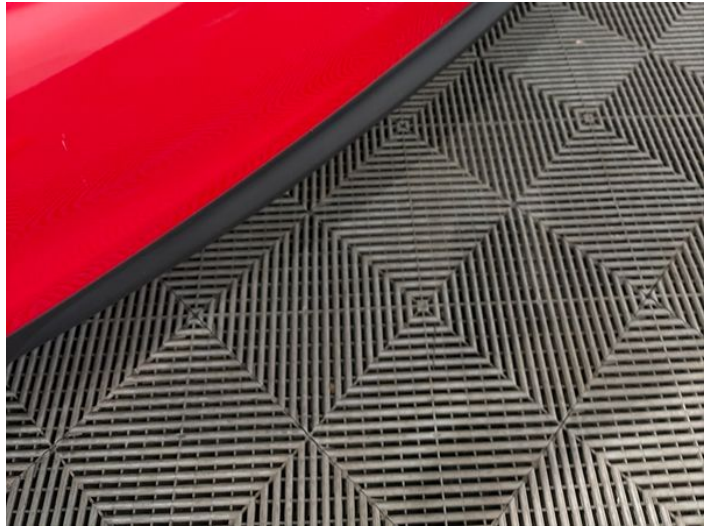
10: Bumper Rear  
Scratched  
25 to 100mm Thru Paint

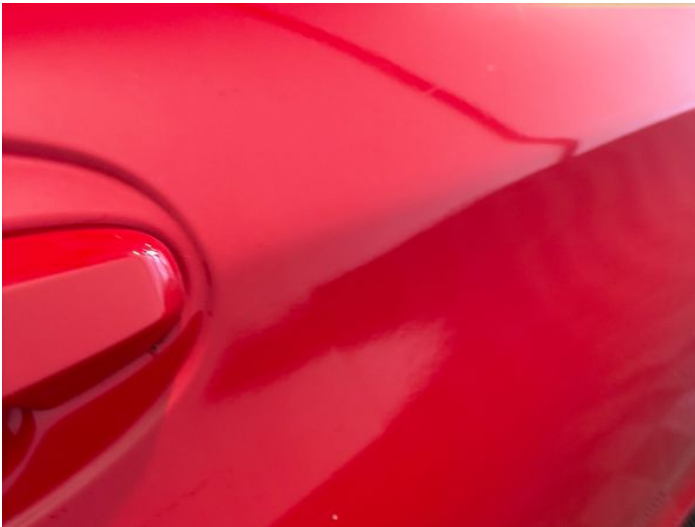
11: Door osr  
Chipped  
1 To 5

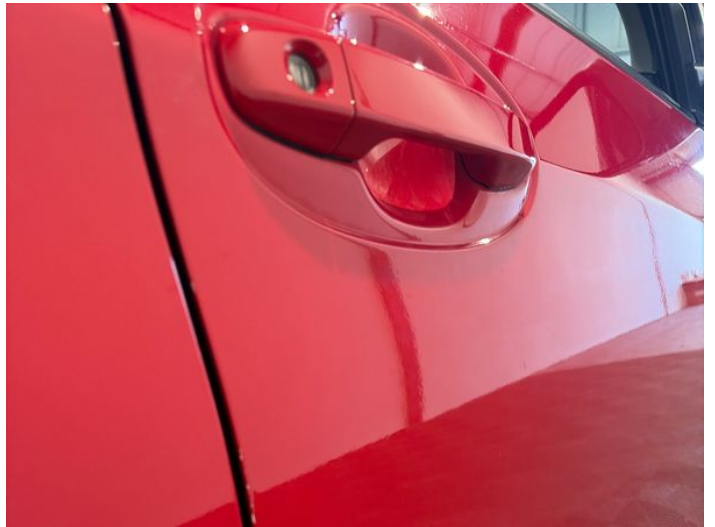
12: Door osf  
Chipped  
Edge Chip

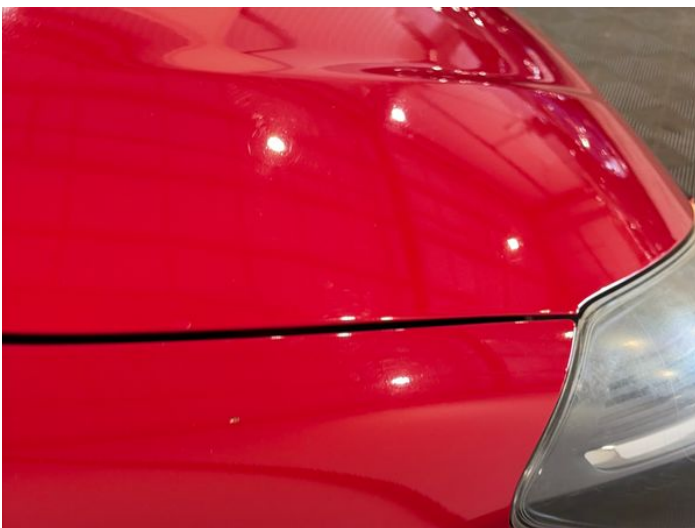
13: Wing osf  
Chipped  
1 To 5

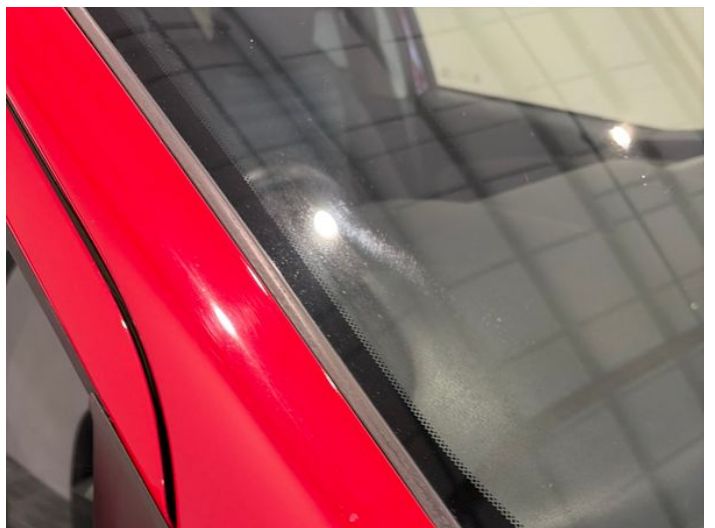
14: A Post os  
Chipped  
1 To 5

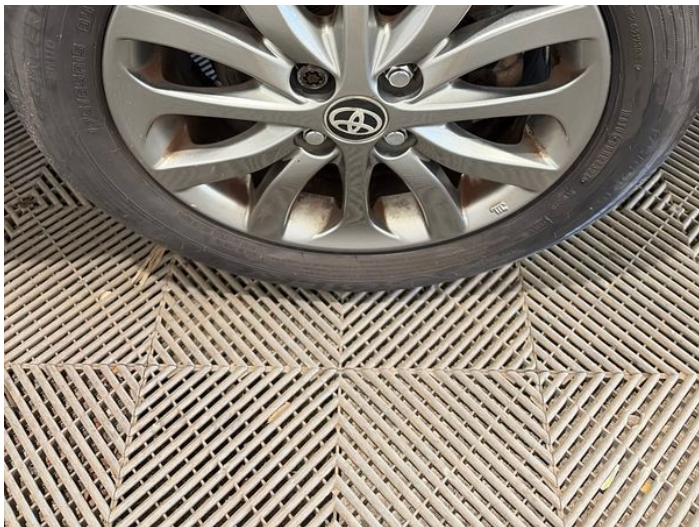
15: Wheel osf  
Scratched  
Up To 50mm

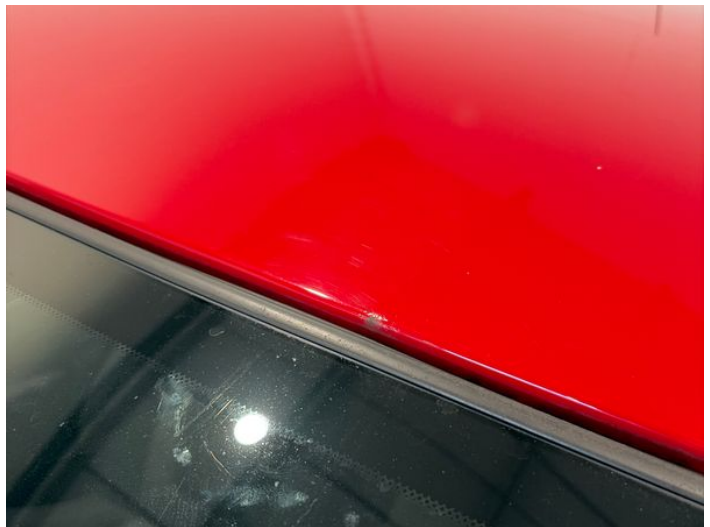
16: Roof  
Chipped  
Over 5mm
