# VEHICLE INSPECTION REPORT

**YO19MVF**

## Peugeot 308 1.2 PureTech 130 Allure 5dr

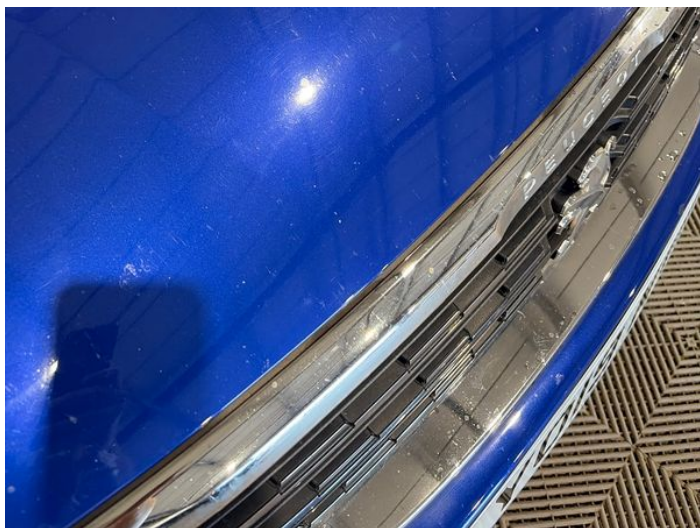
1: Bonnet  
Scratched  
Over 25mm Thru Paint

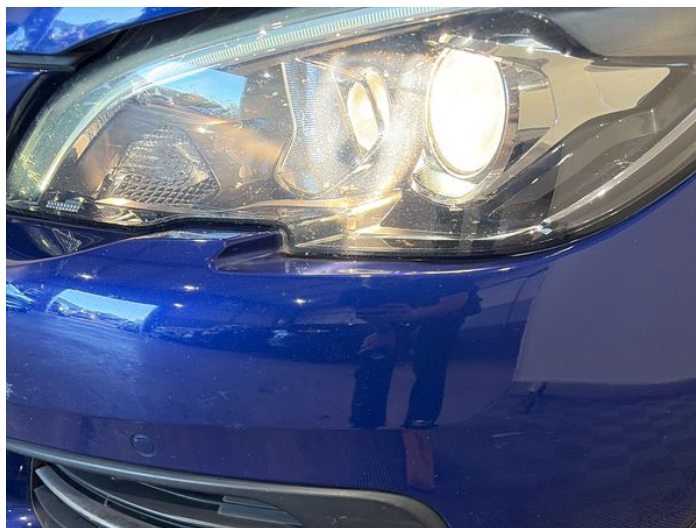
2: Bumper Front  
Scratched  
25 to 100mm Thru Paint

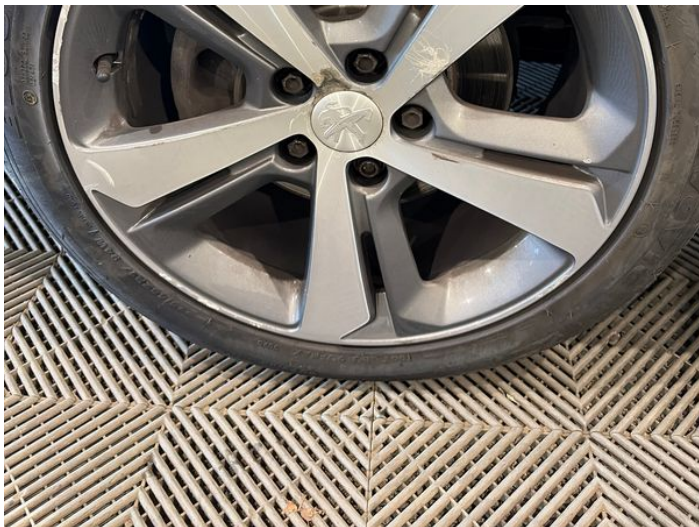
3: Wheel nsf  
Scratched  
Over 50mm

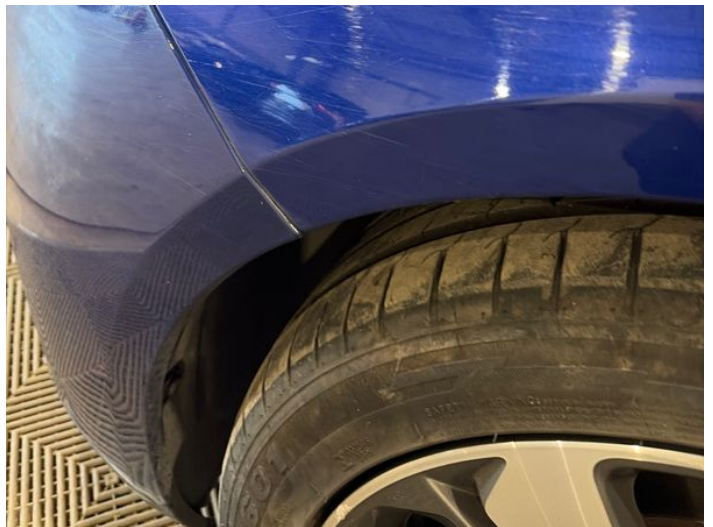
4: Wing nsf  
Scratched  
UpTo 25mm Thru Paint

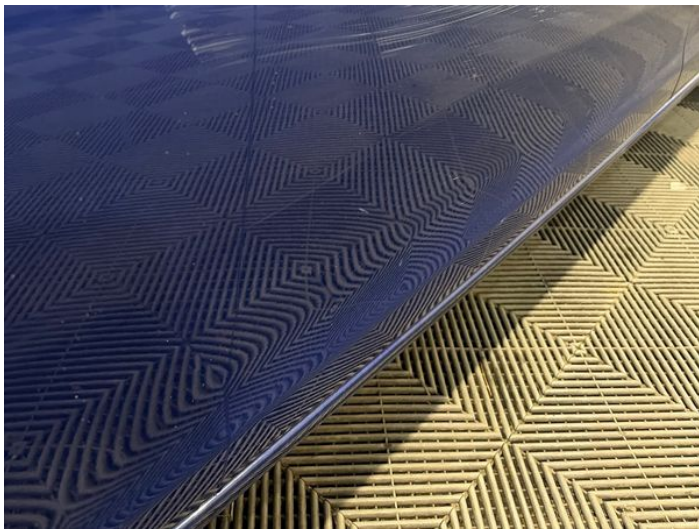
5: Door nsf  
Scratched  
Over 25mm Thru Paint

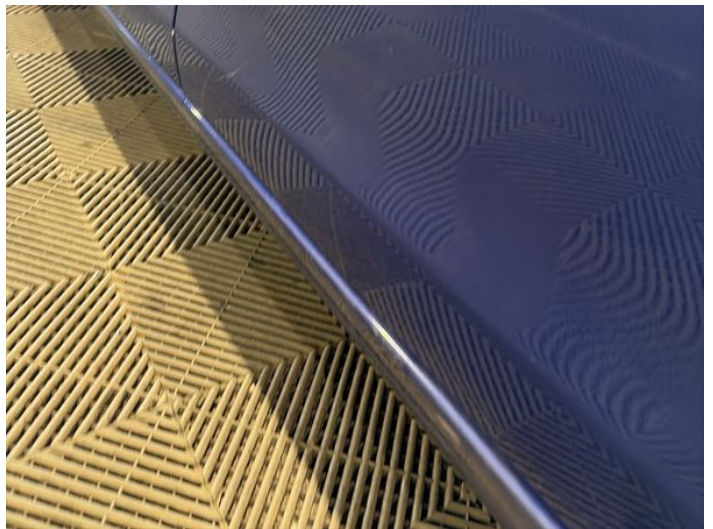
6: Door nsr  
Dented  
With Paint Damage

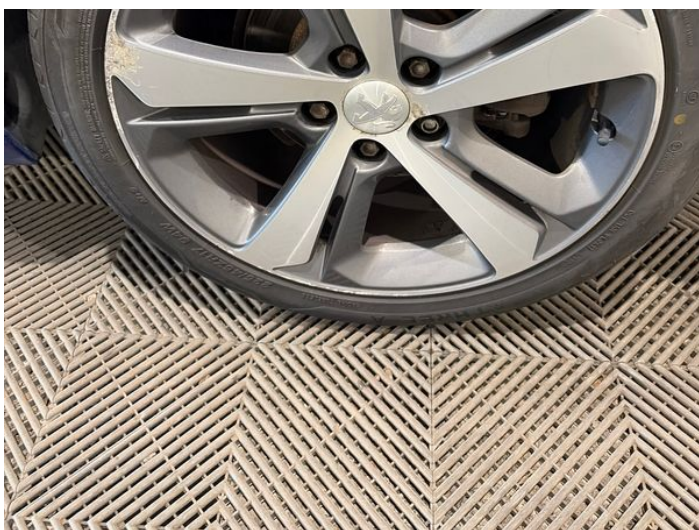
7: Wheel nsr  
Scratched  
Over 50mm

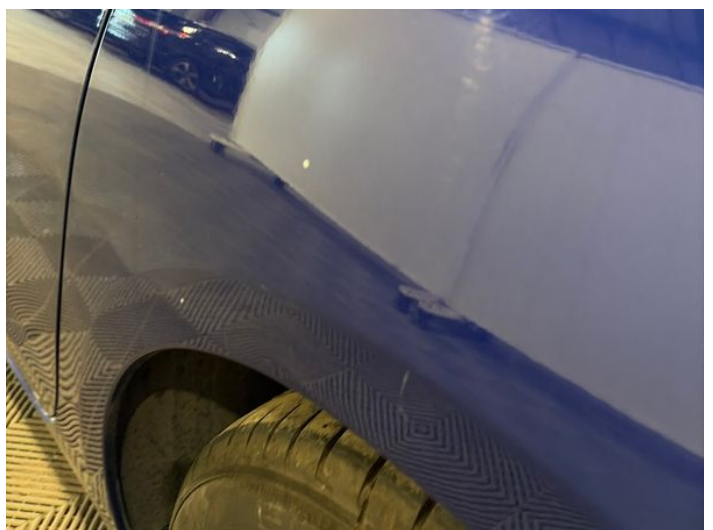
8: Qtr Panel nsr  
Dented  
Over 30mm

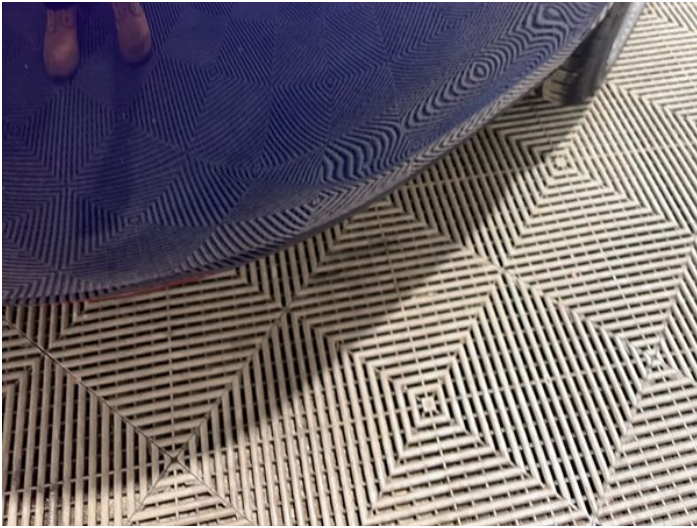
9: Bumper Rear  
Scratched  
25 to 100mm Thru Paint

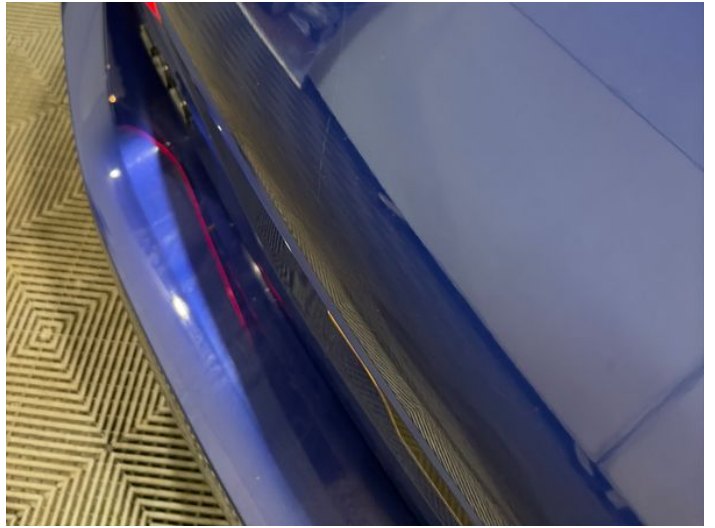
10: Tailgate  
Scratched  
Over 25mm Thru Paint

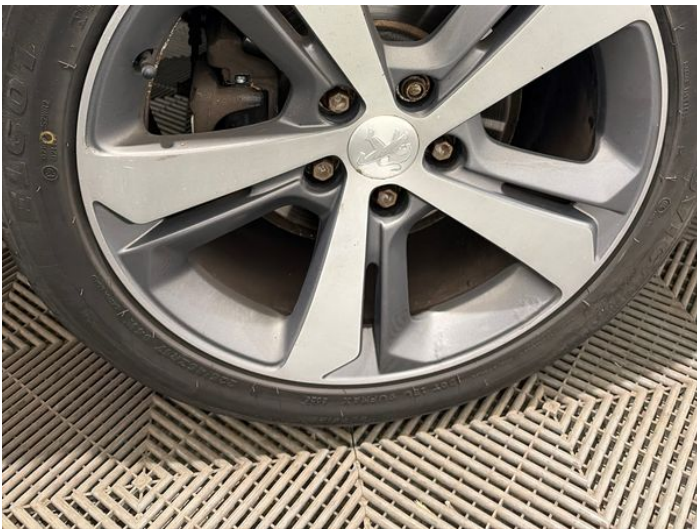
11: Wheel osr  
Corroded  
Light

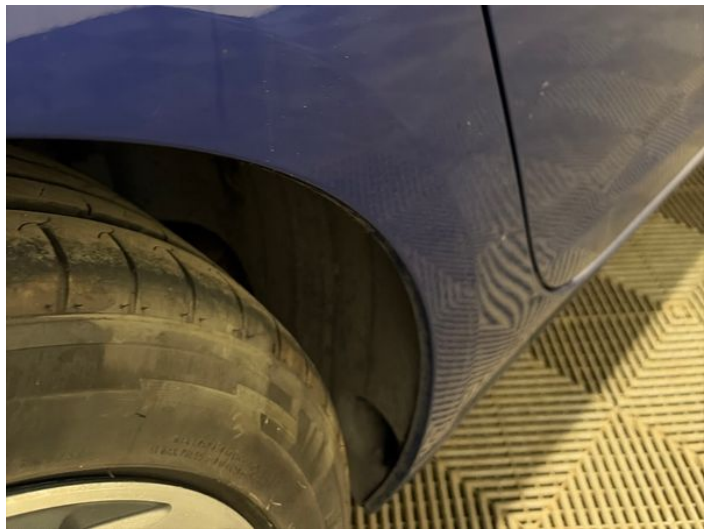
12: Qtr Panel osr  
Dented  
Between 10mm + 30mm

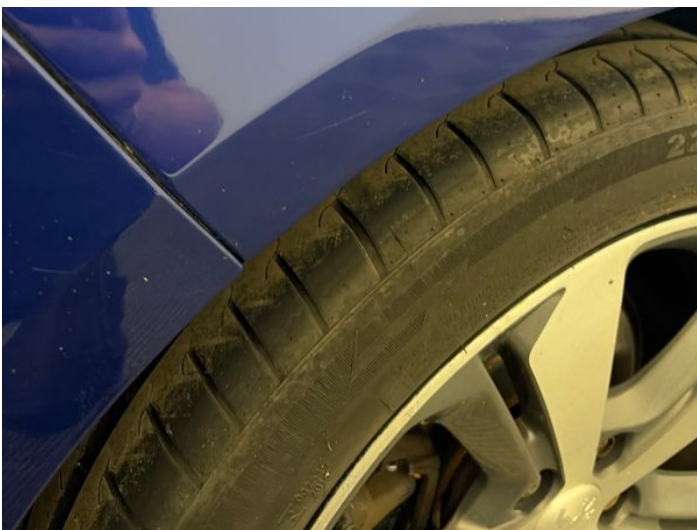
13: Qtr Panel osr  
Scratched  
UpTo 25mm Thru Paint

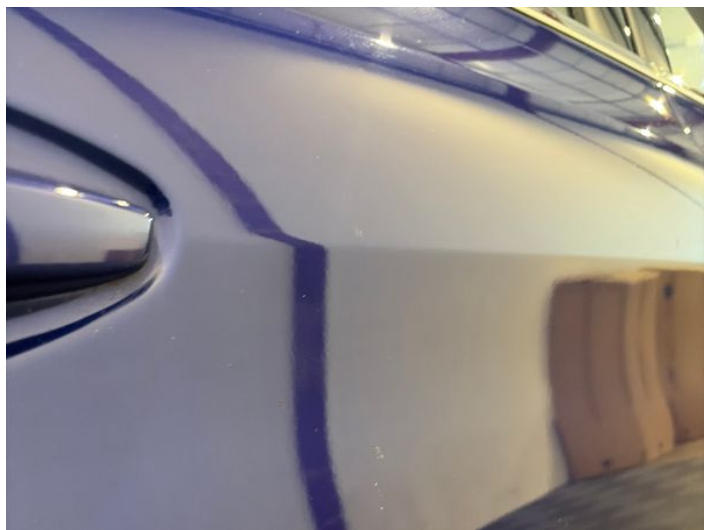
14: Door osr  
Scratched  
Over 25mm Thru Paint

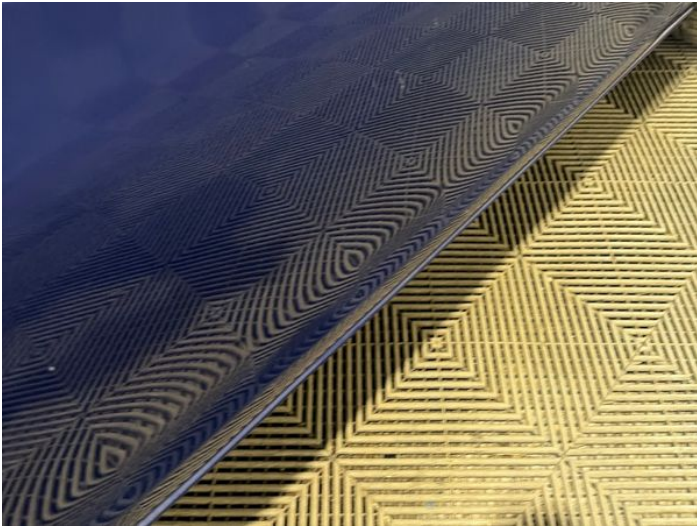
15: Door osf  
Scratched  
Over 25mm Thru Paint

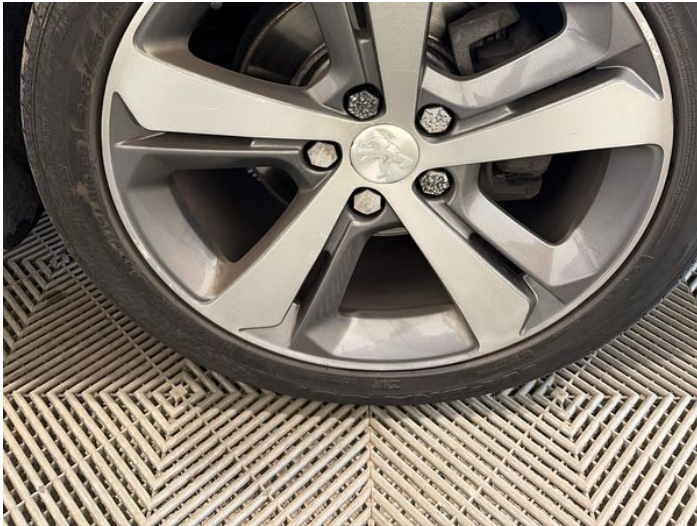
16: Wheel osf  
Scratched  
Over 50mm

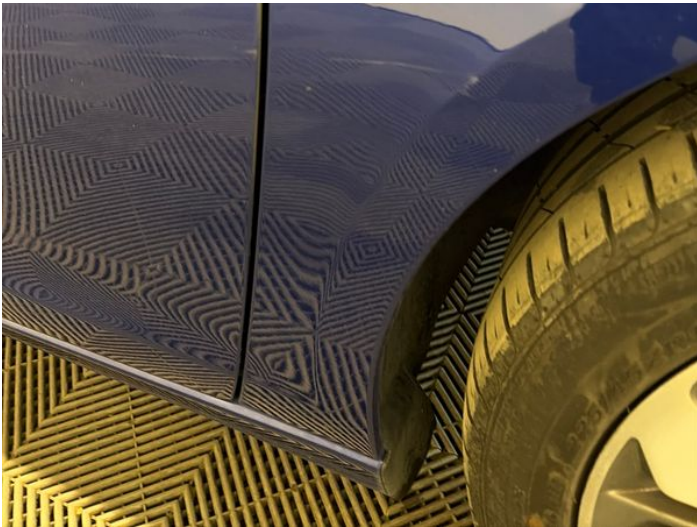
17: Wing osf  
Scratched  
Over 25mm Thru Paint

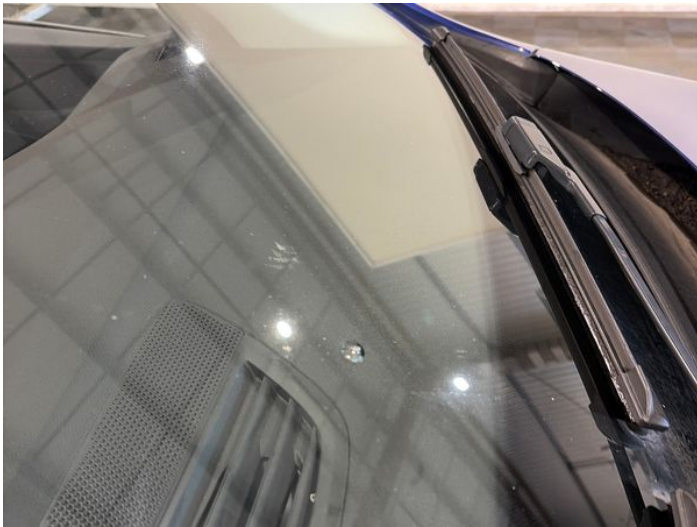
18: Screen Front  
Chipped  
Over 10mm
