## VEHICLE INSPECTION REPORT

**GV19ZYD**

### Suzuki Swift 1.2 Dualjet SZ3 5dr

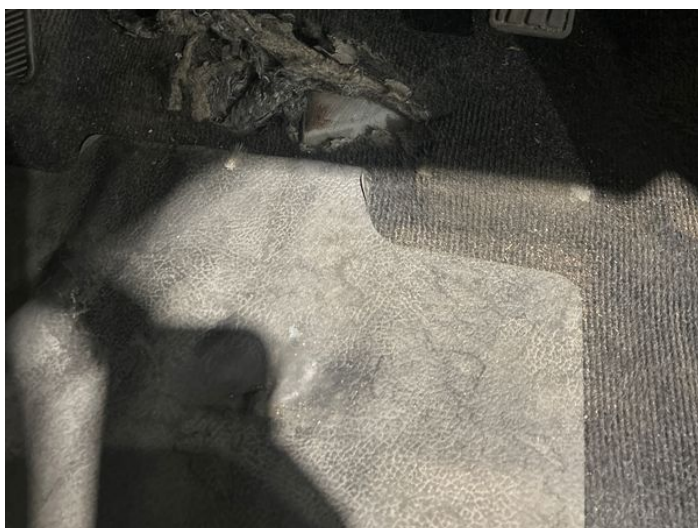
1: Carpets Front  
Torn  
Over 10mm

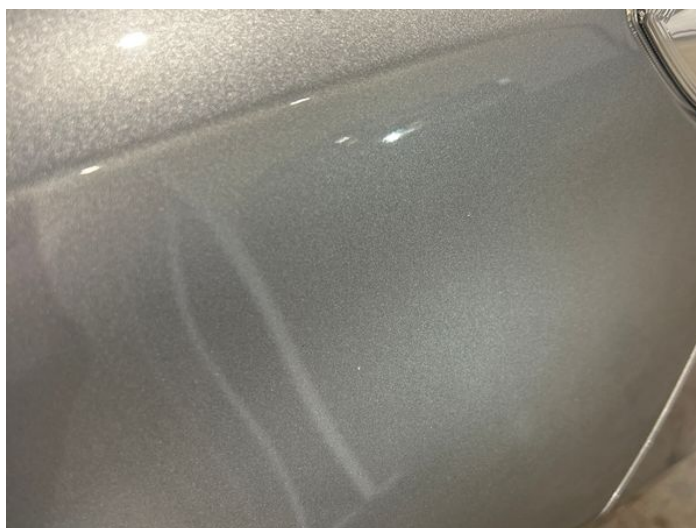
2: Wing osf  
Chipped  
1 To 5

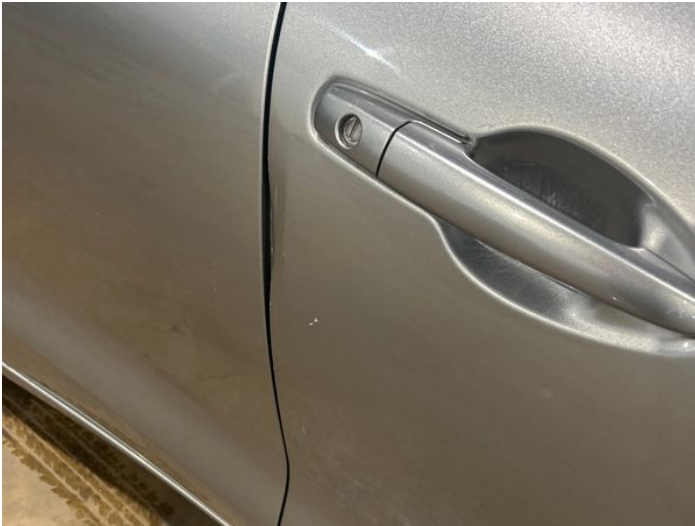
3: Door osf  
Dented  
With Paint Damage

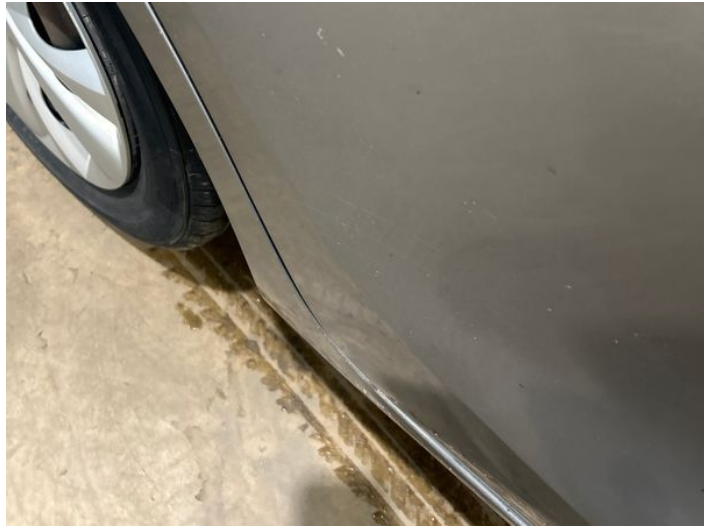
4: Door osr  
Chipped  
1 To 5

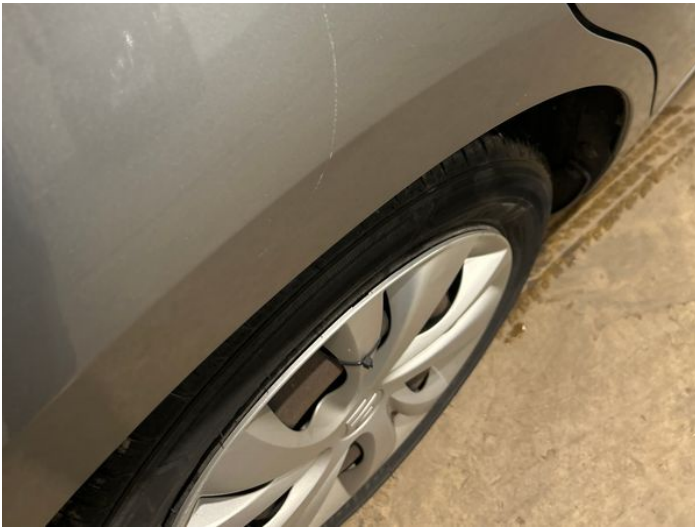
5: Qtr Panel osr  
Scratched  
Over 25mm Thru Paint

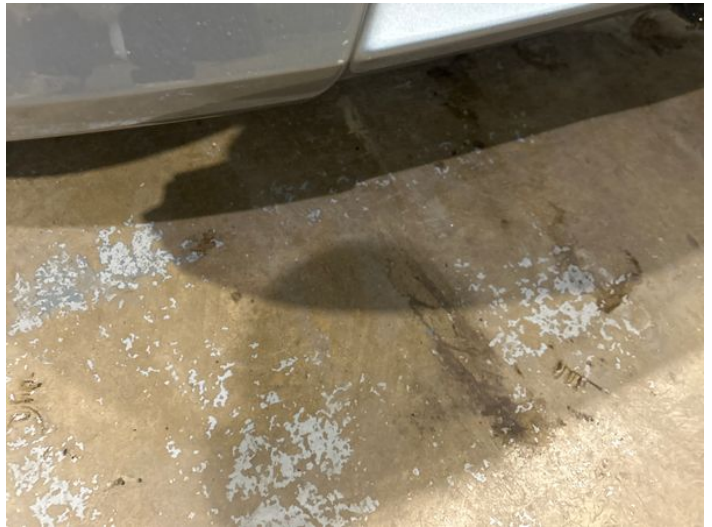
6: Bumper Rear  
Chipped  
1 To 5

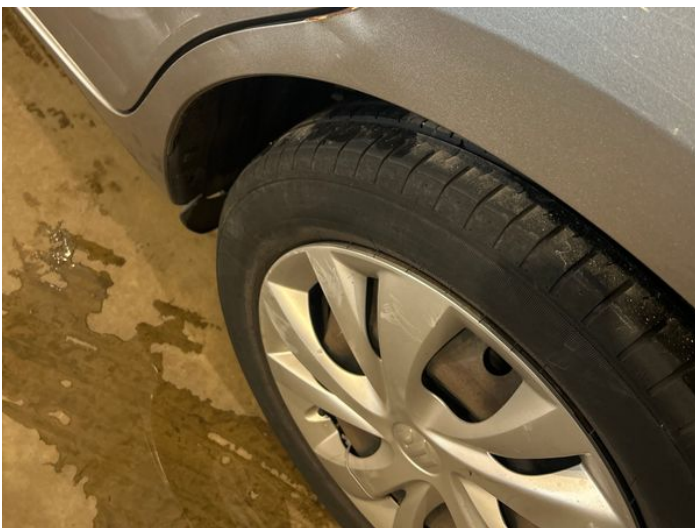
7: Qtr Panel nsr  
Dented  
With Paint Damage

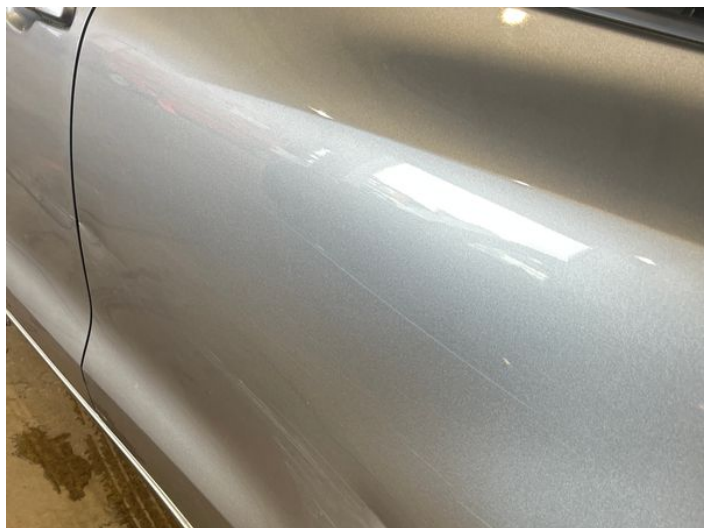
8: Door nsr  
Dented  
With Paint Damage

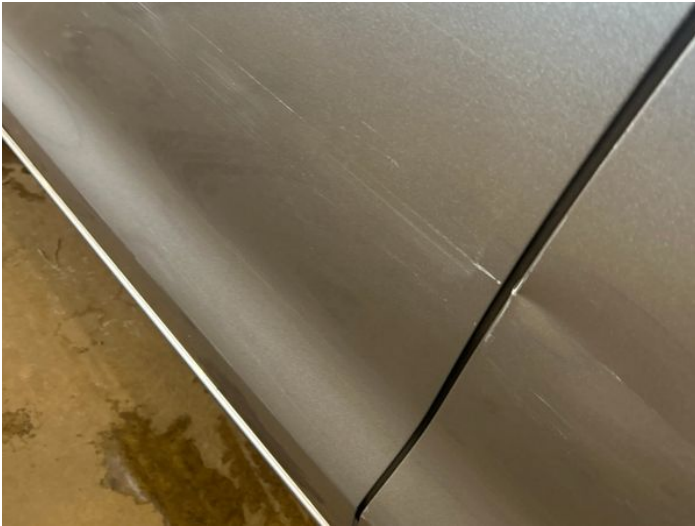
9: Door nsf  
Dented  
With Paint Damage

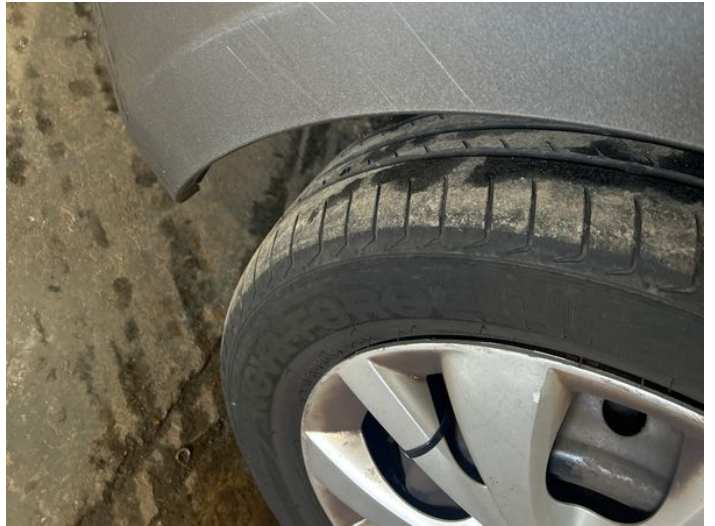
10: Bumper Front  
Scratched  
25 to 100mm Thru Paint

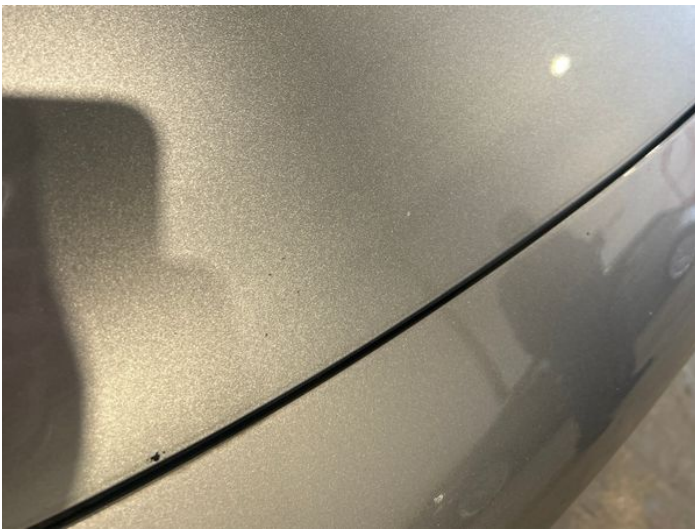
11: Bonnet  
Chipped  
1 To 5

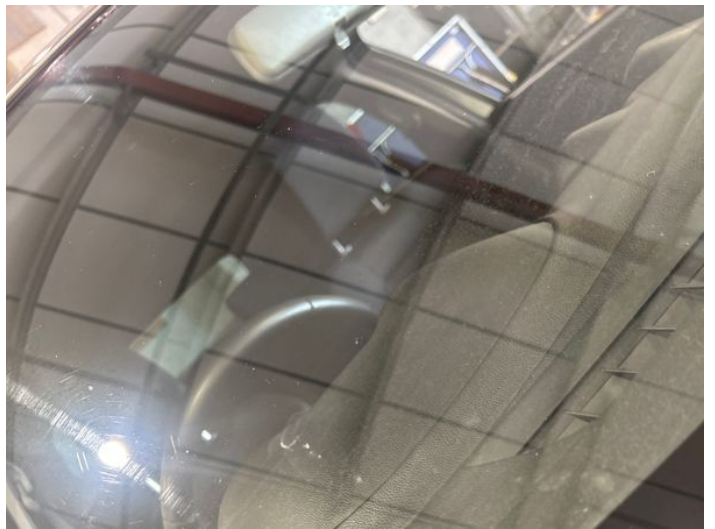
12: Screen Front  
Chipped  
UpTo 10mm

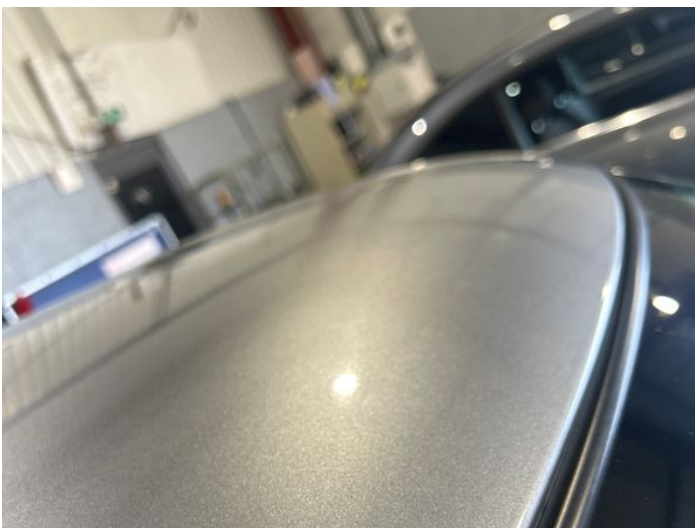
13: Roof  
Chipped  
1 To 5
