# VEHICLE INSPECTION REPORT

**GY70ULW**

## Vauxhall Astra 1.2 Turbo 145 Elite Nav 5dr

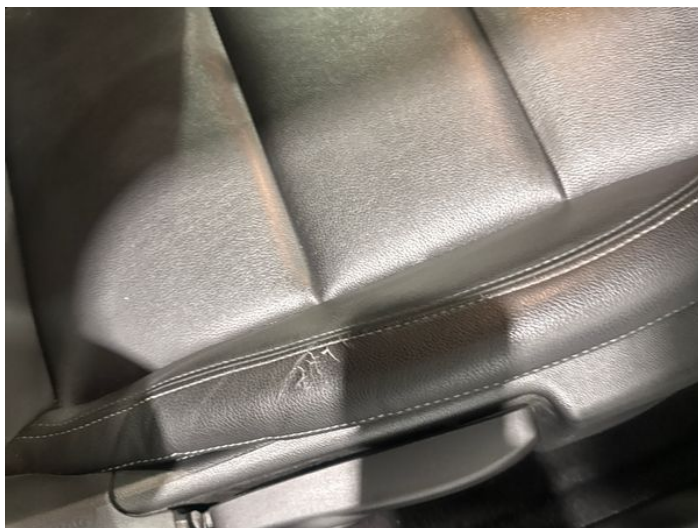
1: Seat Base Cover osf  
Scuffed  
Over 25mm

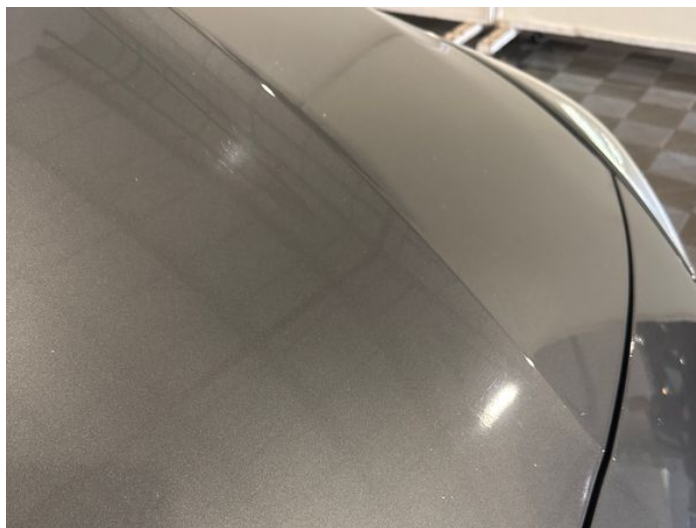
2: Bonnet  
Chipped  
Multiple Chips

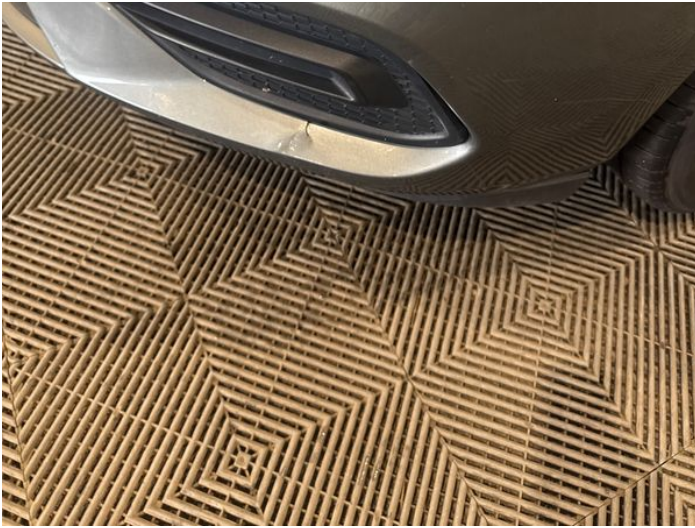
3: Bumper Front  
Cracked  
UpTo 25mm

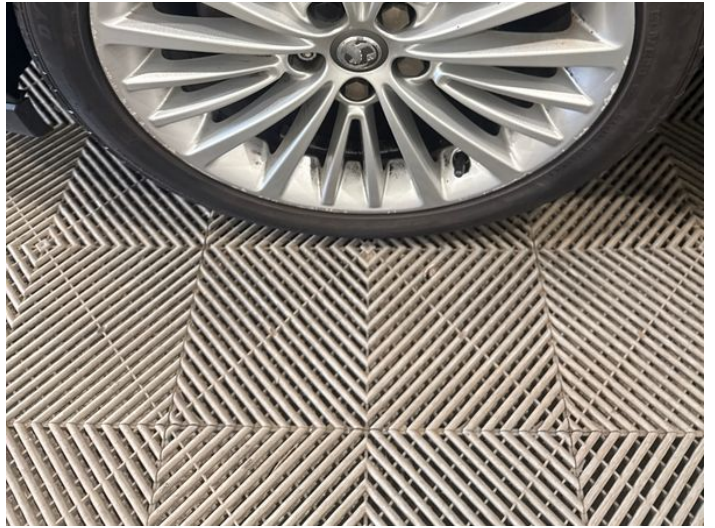
4: Wheel nsf  
Scratched  
Over 50mm

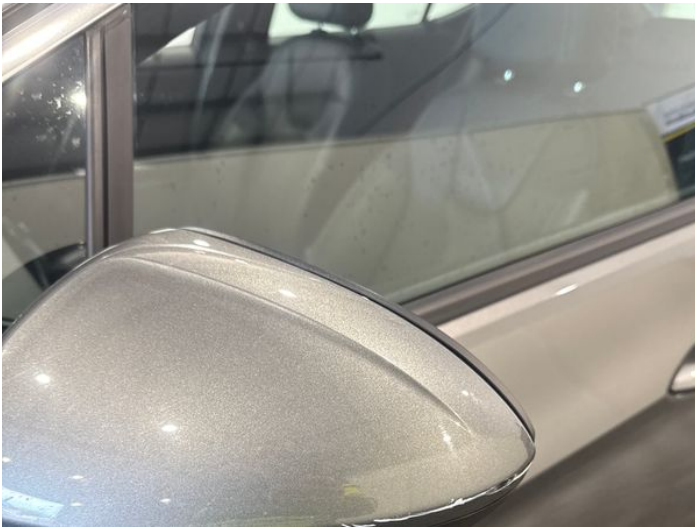
5: Door Mirror Assy nsf  
Scratched (Painted)  
Over 25mm Thru Paint

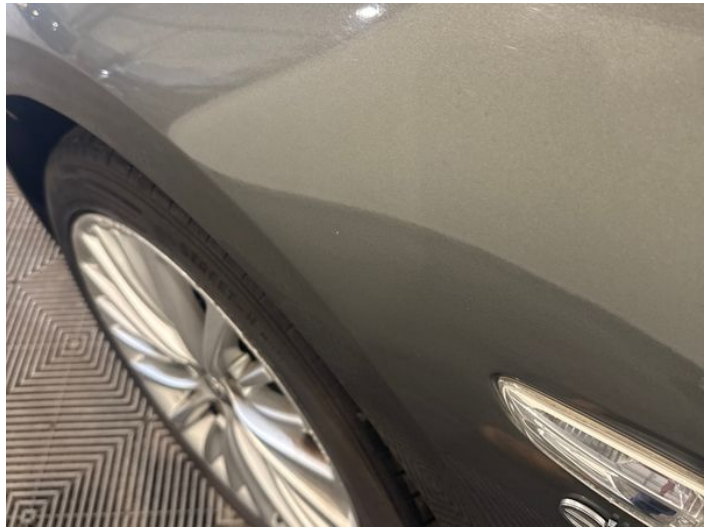
6: Wing nsf  
Chipped  
1 To 5

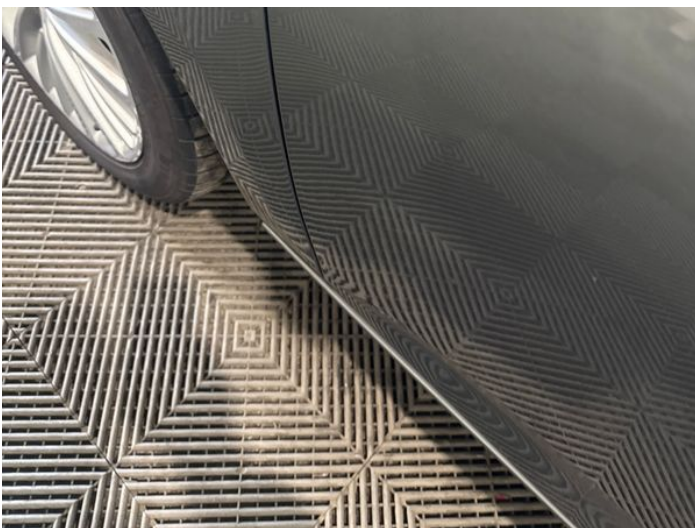
7: Door nsf  
Chipped  
1 To 5

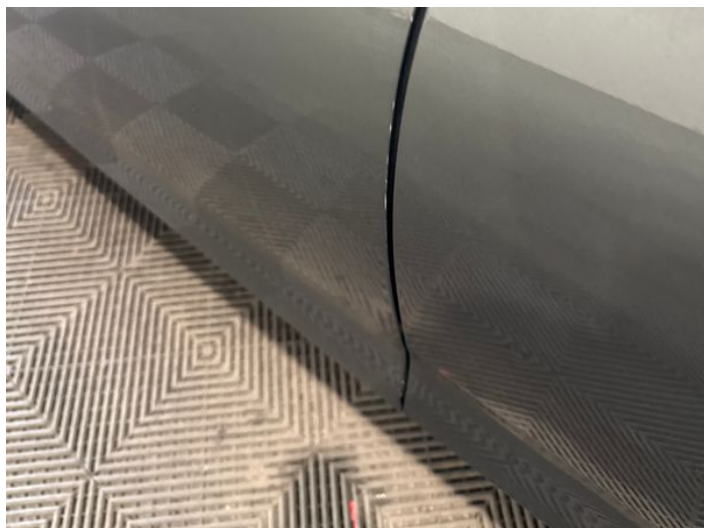
8: Door nsf  
Chipped  
Edge Chip

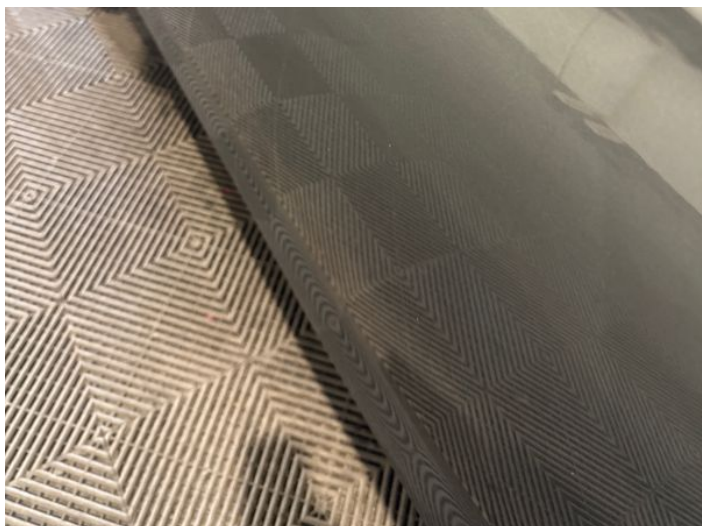
9: Door nsf  
Dented  
Between 10mm + 30mm

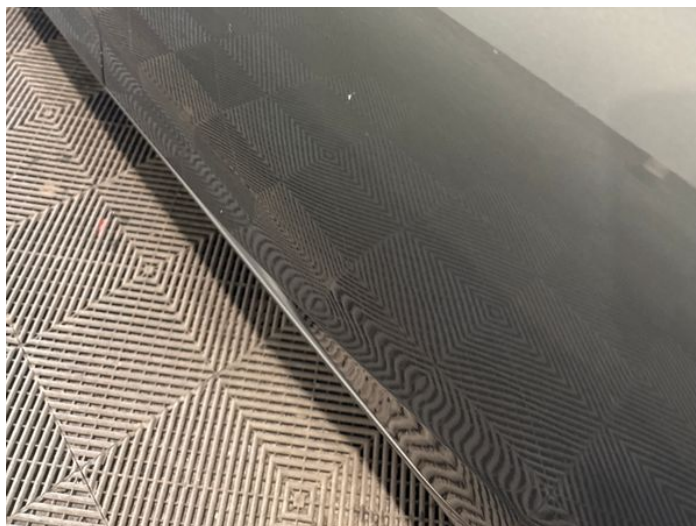
10: Door nsr  
Scratched  
Over 25mm Thru Paint

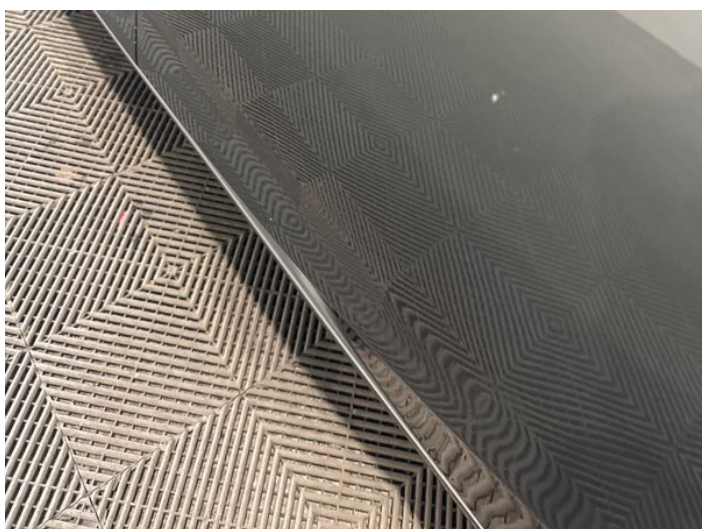
11: Door nsr  
Dented  
Between 10mm + 30mm

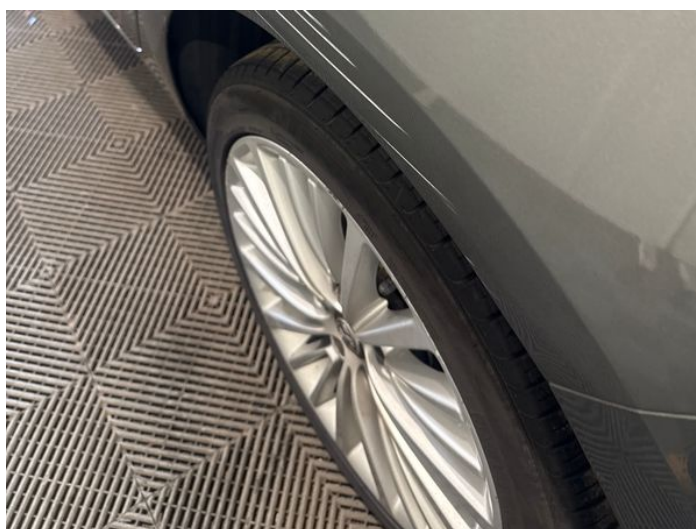
12: Qtr Panel nsr  
Dented  
With Paint Damage

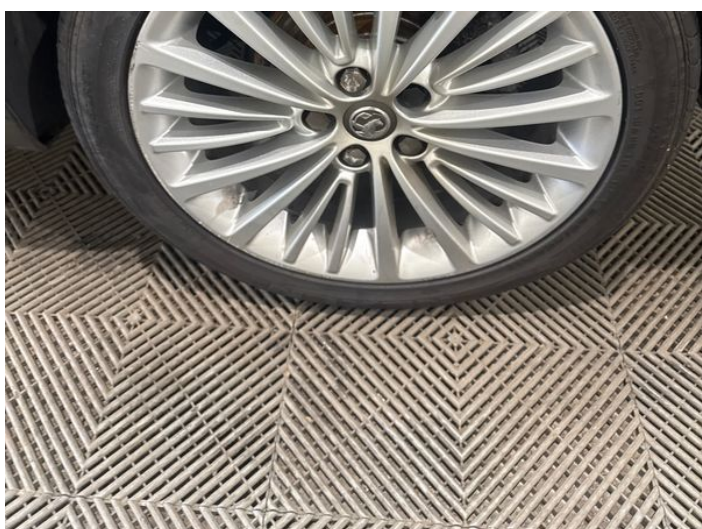
13: Wheel nsr  
Scratched  
Over 50mm

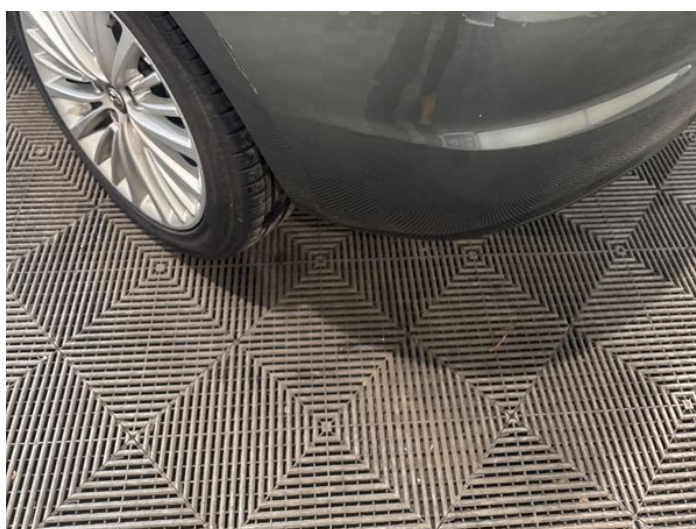
14: Bumper Rear  
Scratched  
25 to 100mm Thru Paint

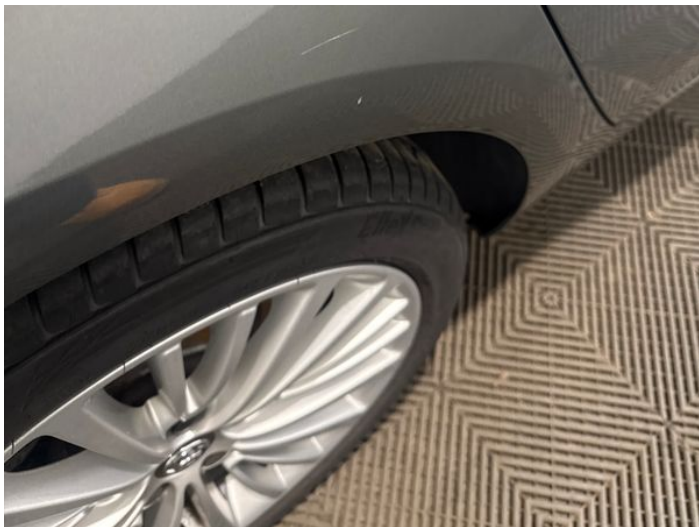
15: Qtr Panel osr  
Scratched  
Over 25mm Thru Paint

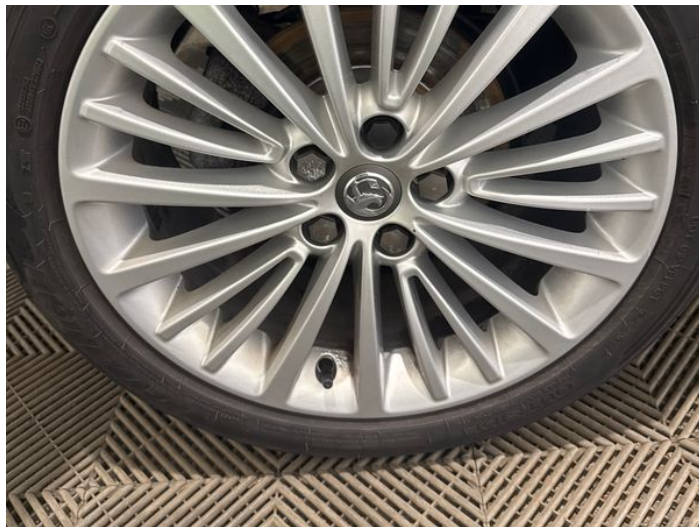
16: Wheel osr  
Scratched  
Up To 50mm

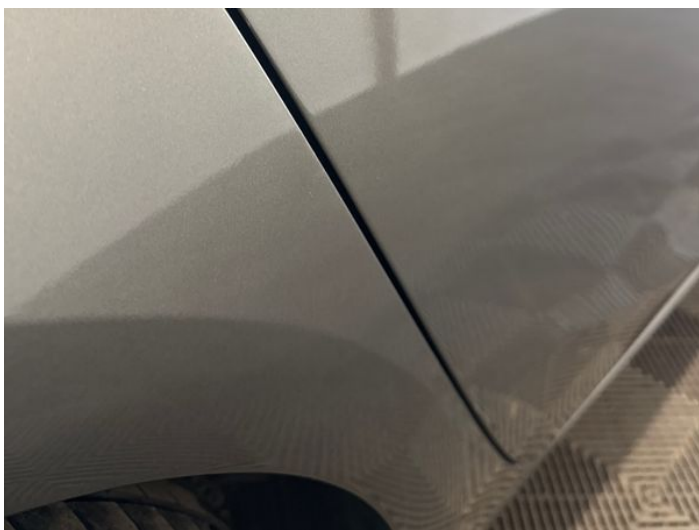
17: Door osr  
Chipped  
Edge Chip

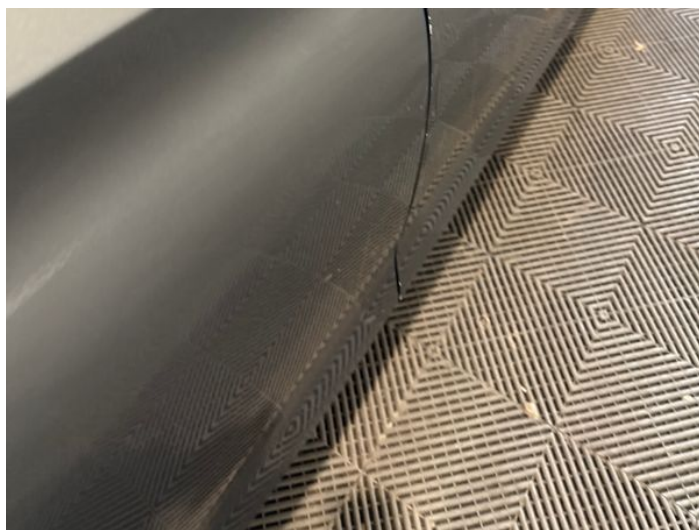
18: Door osr  
Dented  
2 Or Less UpTo 10mm

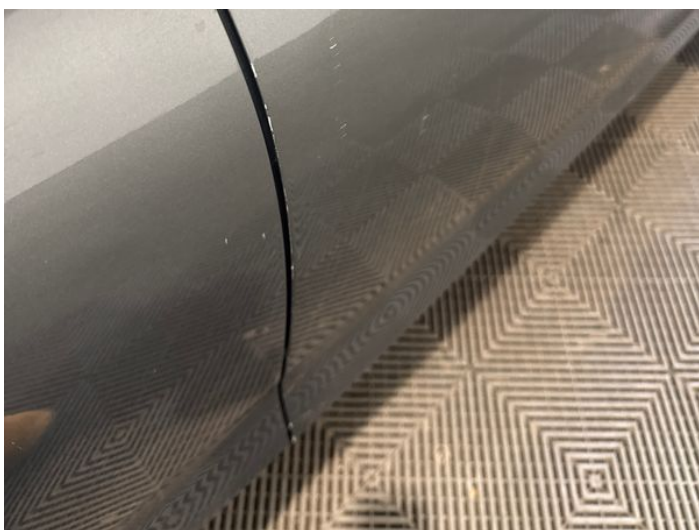
19: Door osf  
Dented  
With Paint Damage

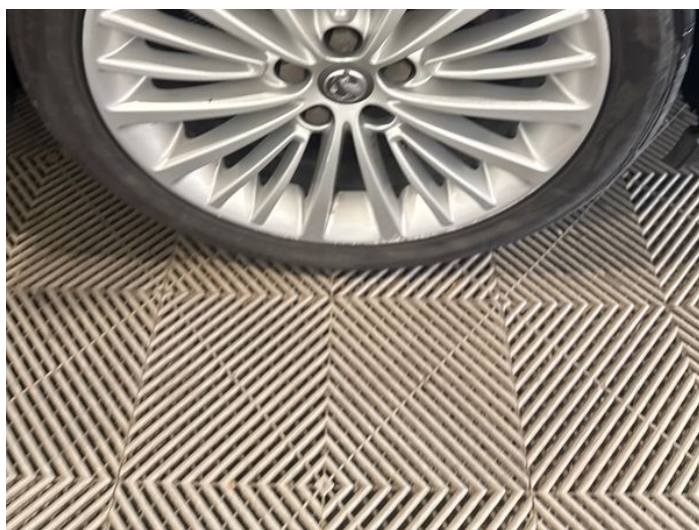
20: Wheel osf  
Scratched  
Over 50mm

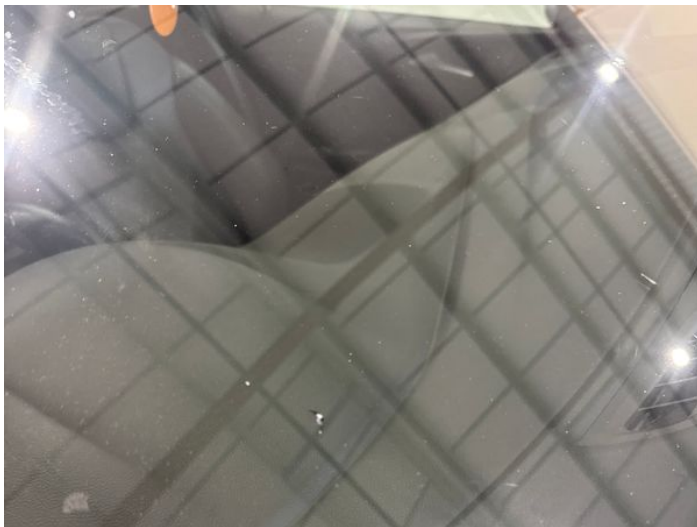
21: Screen Front  
Chipped  
UpTo 10mm

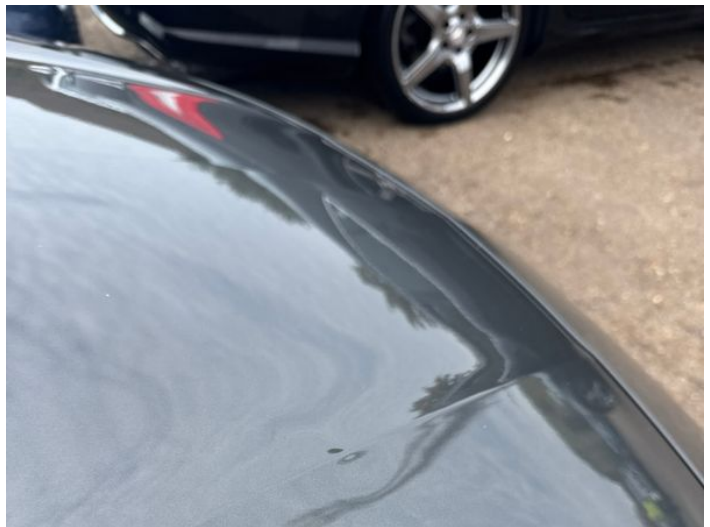
22: Bonnet  
Dented  
Between 10mm + 30mm
