# VEHICLE INSPECTION REPORT

**WX69WCZ**

## Suzuki Swift 1.0 Boosterjet SHVS SZ5 5dr

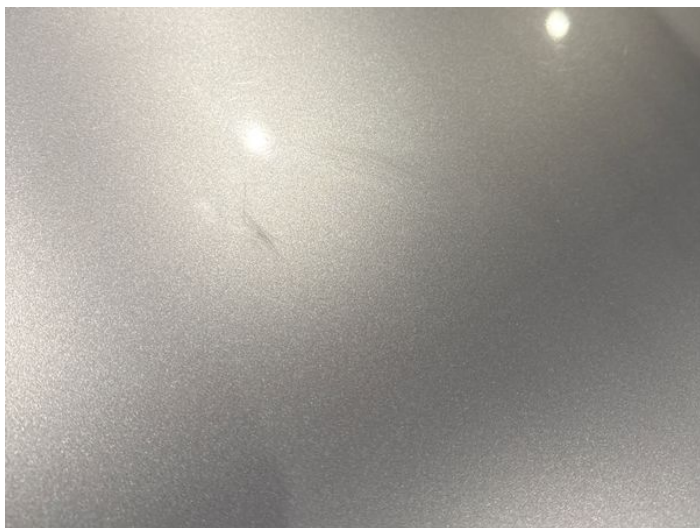
1: Bonnet  
Scratched  
Over 25mm Thru Paint

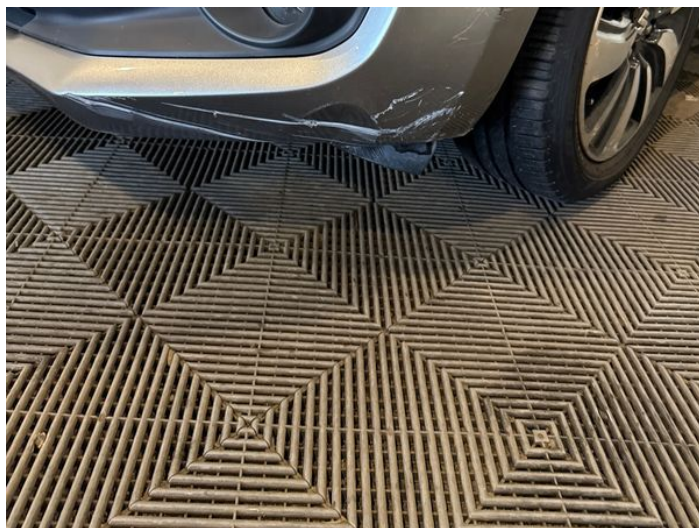
2: Bumper Front  
Dented  
With Paint Damage

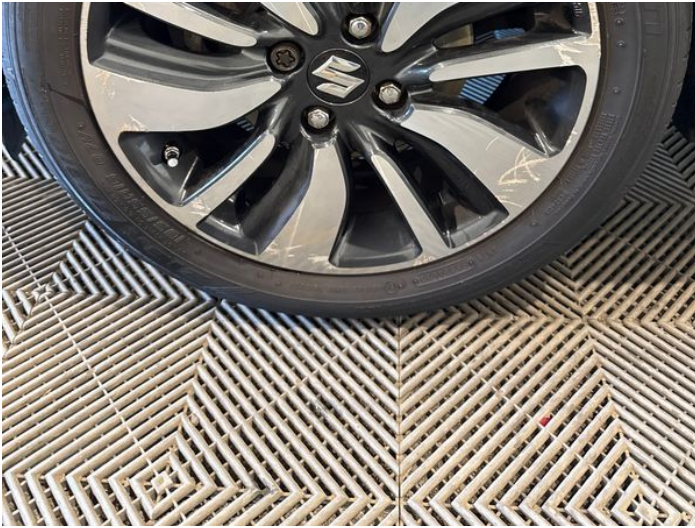
3: Wheel nsf  
Scratched  
Over 50mm

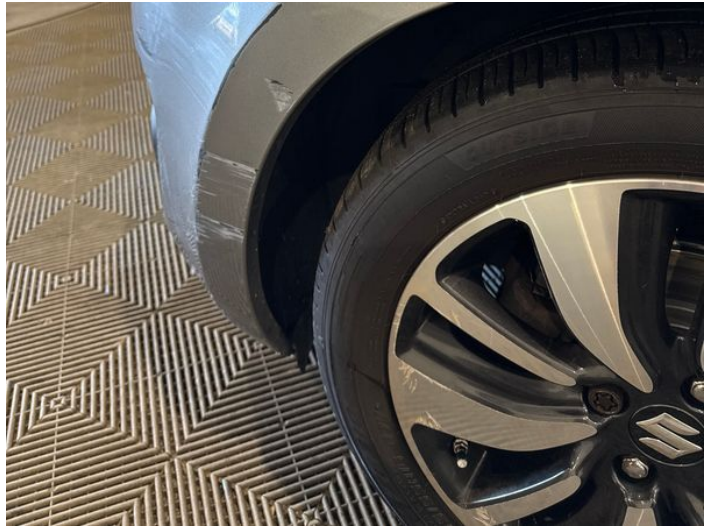
4: Bumper Front  
Insecure  
Action Required

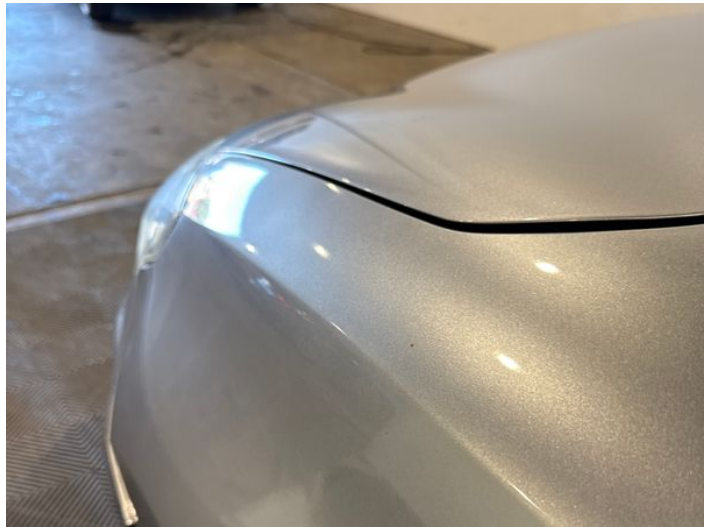
6: Wing nsf  
Dented  
Over 30mm

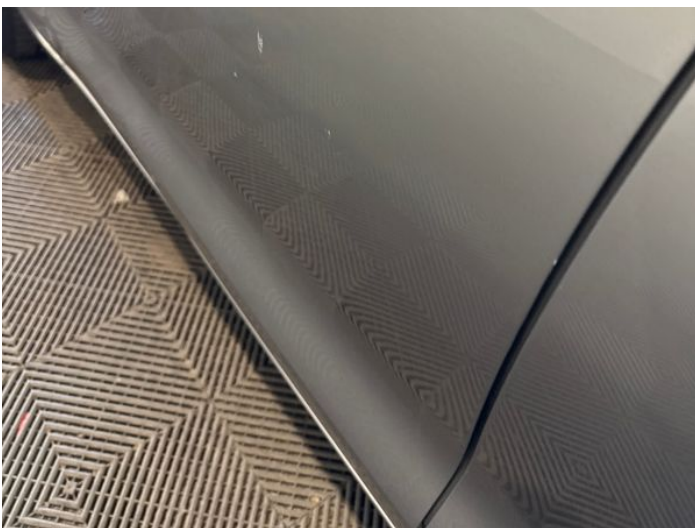
7: Door nsf  
Dented  
With Paint Damage

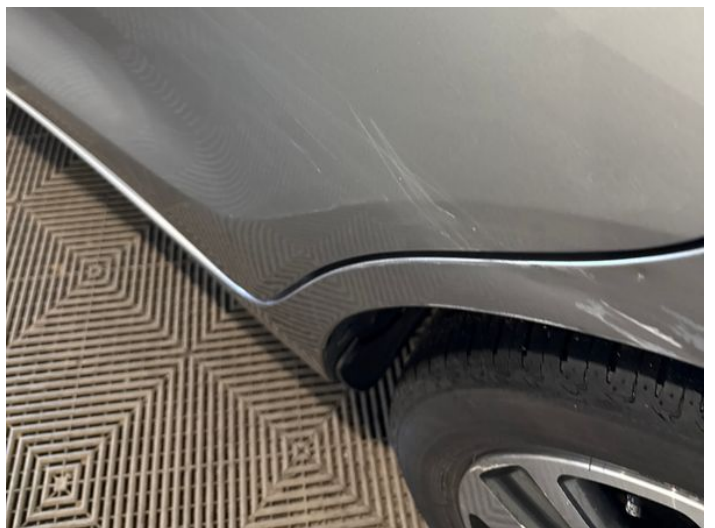
8: Door nsr  
Dented  
With Paint Damage

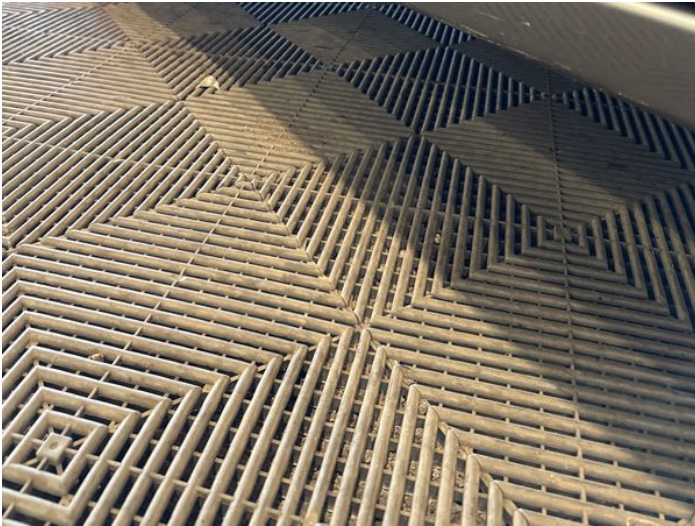
9: Sill ns  
Dented  
Over 30mm

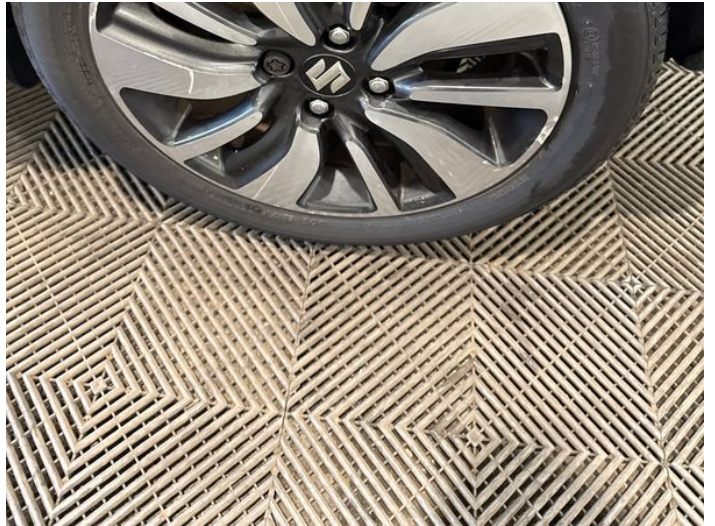
10: Wheel nsr  
Scratched  
Over 50mm

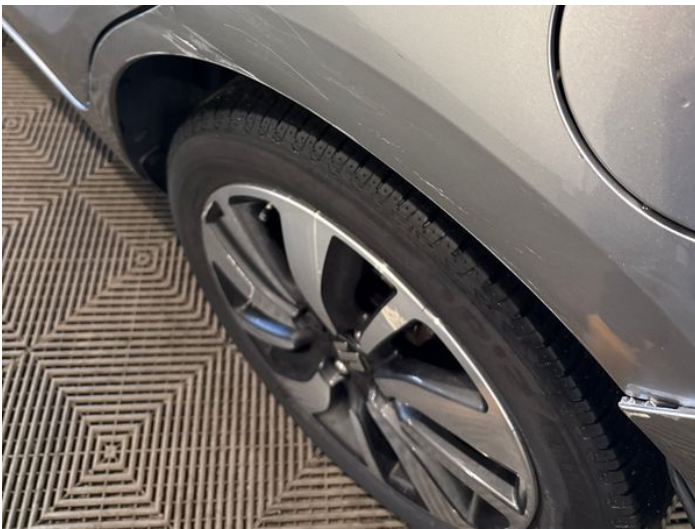
11: Qtr Panel nsr  
Dented  
With Paint Damage

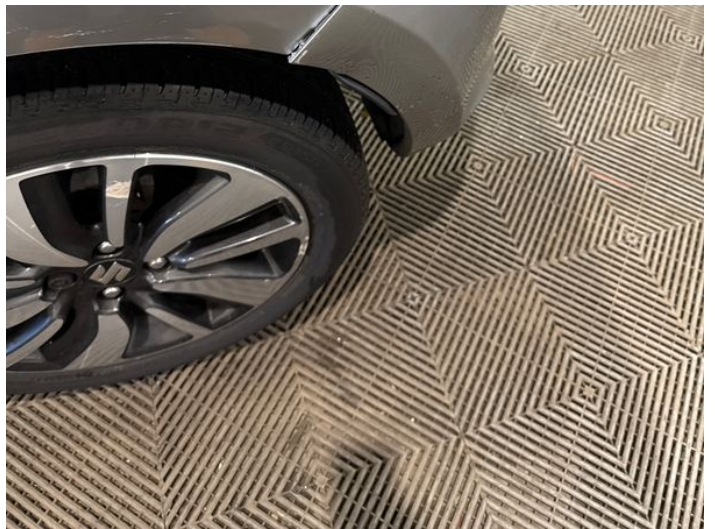
12: Bumper Rear  
Insecure  
Action Required

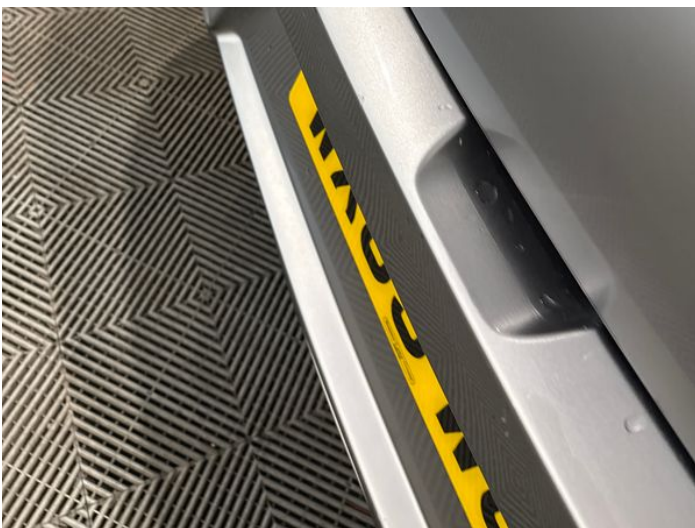
13: Bumper Rear  
Scratched  
25 to 100mm Thru Paint

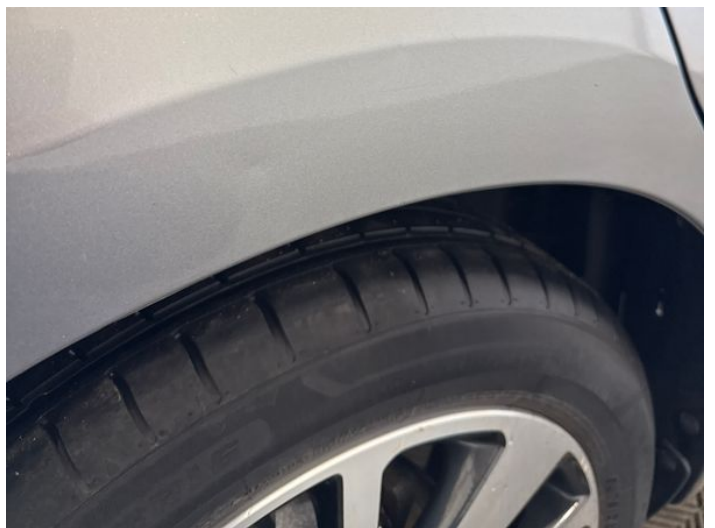
14: Qtr Panel osr  
Dented  
Between 10mm + 30mm

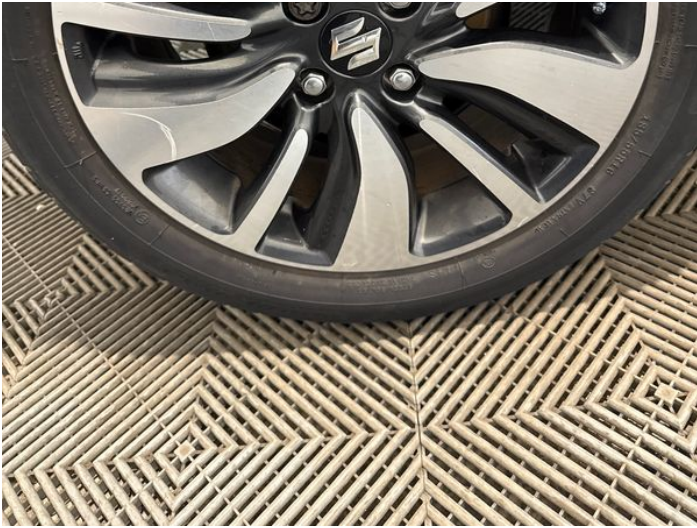
15: Wheel osr  
Scratched  
Over 50mm

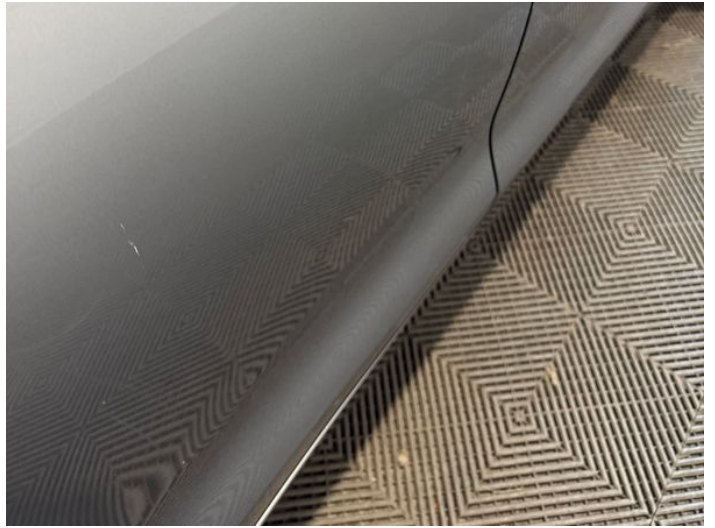
16: Door osr  
Dented  
Between 10mm + 30mm

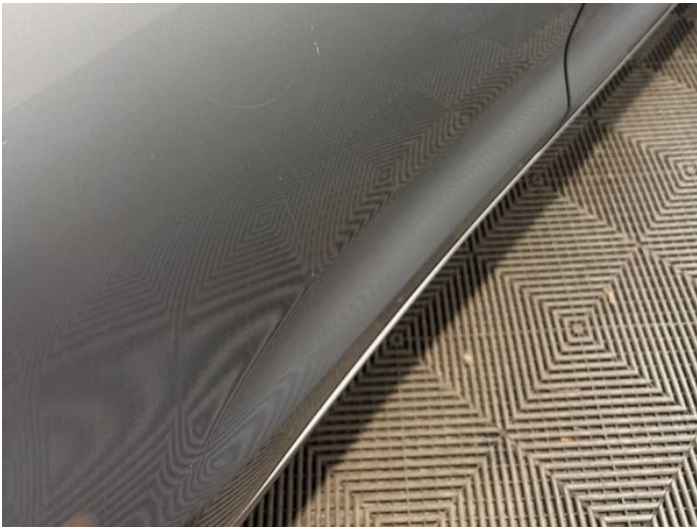
17: Door osr  
Scratched  
Over 25mm Thru Paint

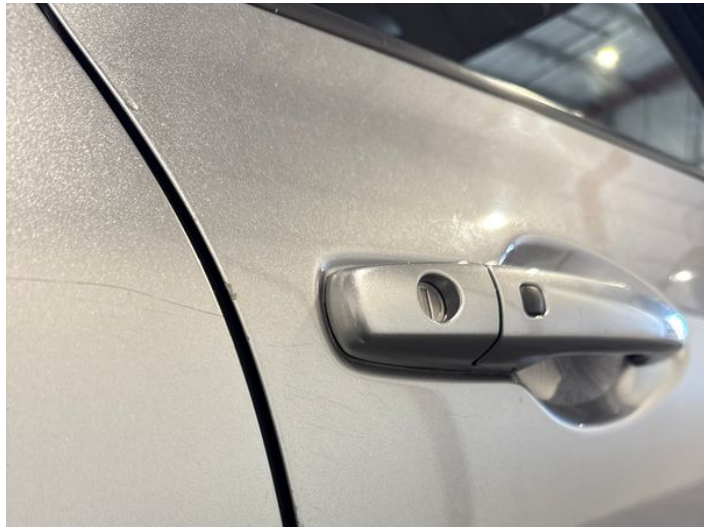
18: Door osf  
Chipped  
Edge Chip

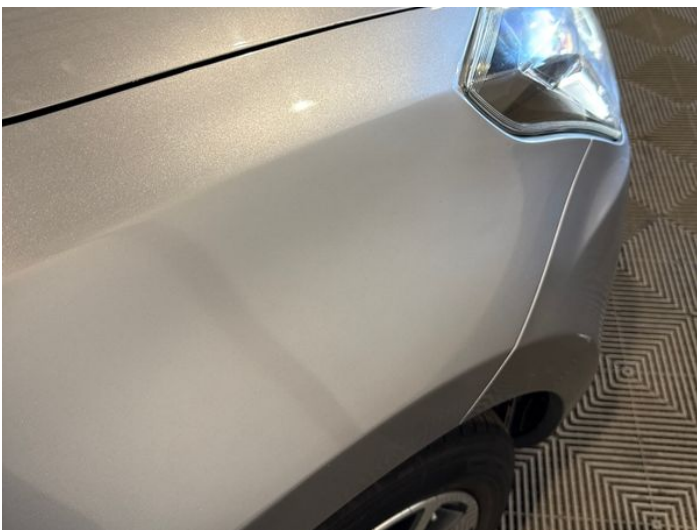
19: Wing osf  
Poor Previous Repair  
Poor Paint

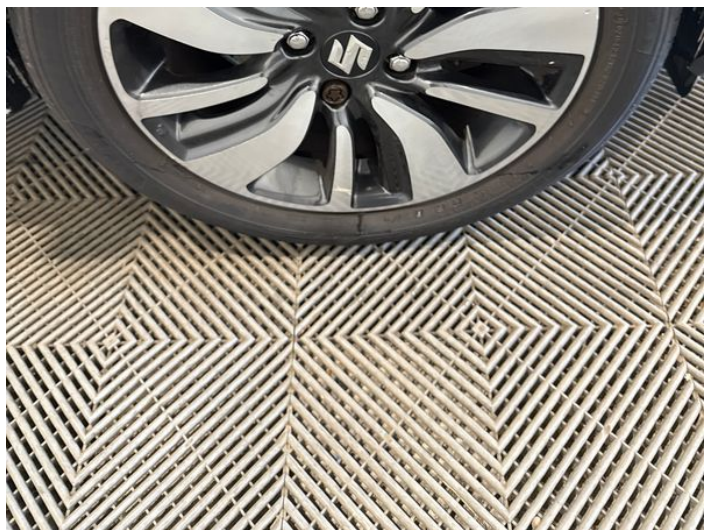
20: Wheel osf  
Scratched  
Over 50mm

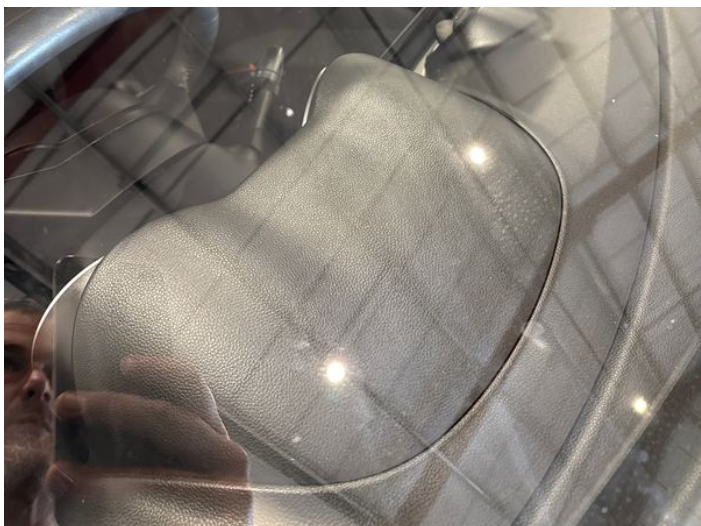
21: Screen Front  
Chipped  
UpTo 10mm
