# VEHICLE INSPECTION REPORT

DE64OHY

## Volkswagen Golf 2.0 TSI R 5dr

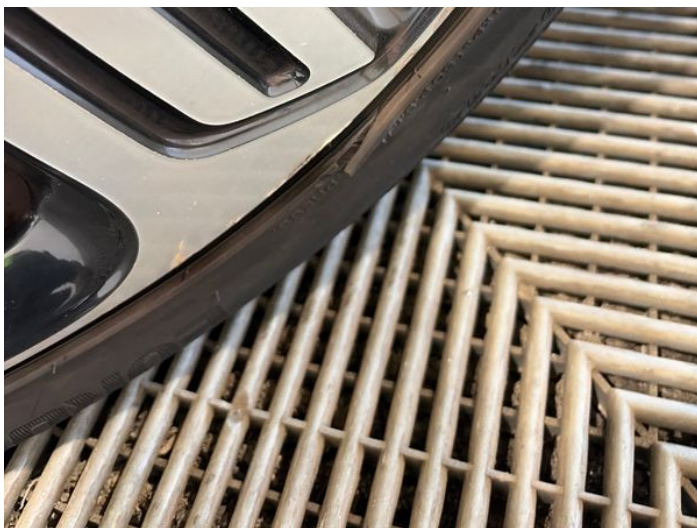
1: Tyre osf  
Damaged  
Replace

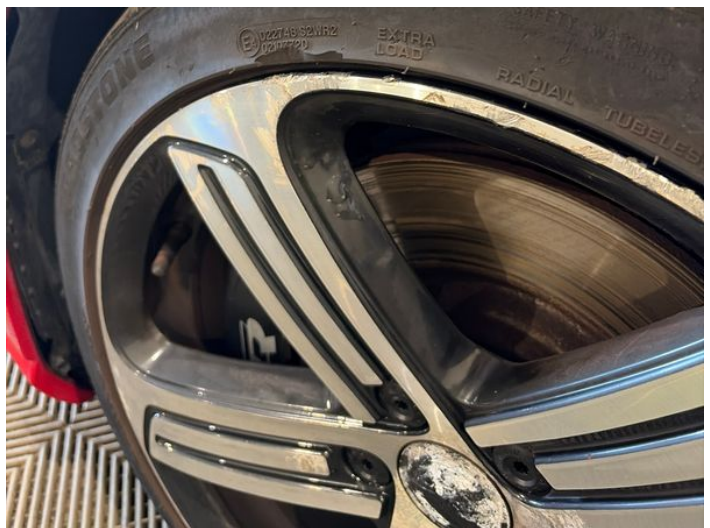
2: Tyre nsf  
Damaged  
Replace

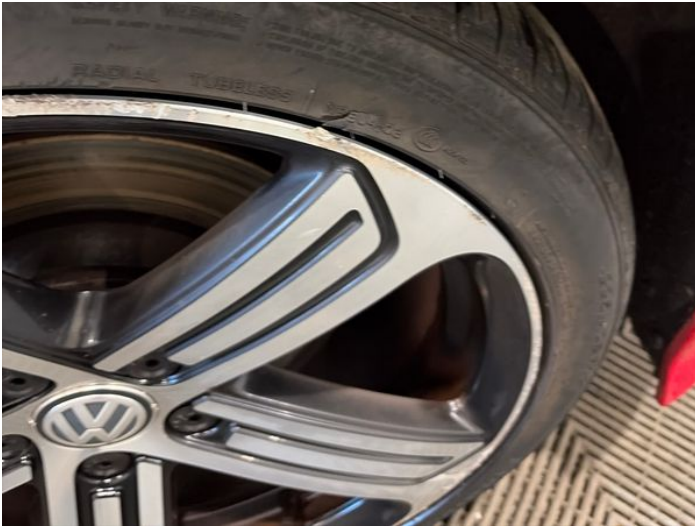
3: Tyre nsr  
Damaged  
Replace

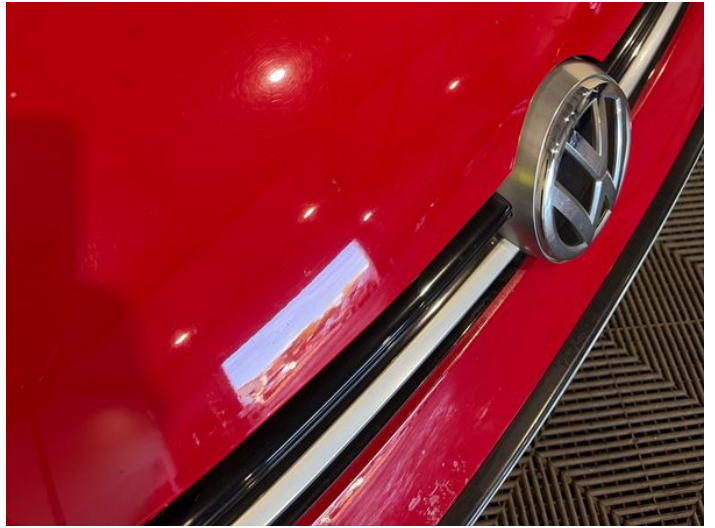
4: Bonnet  
Chipped  
1 To 5

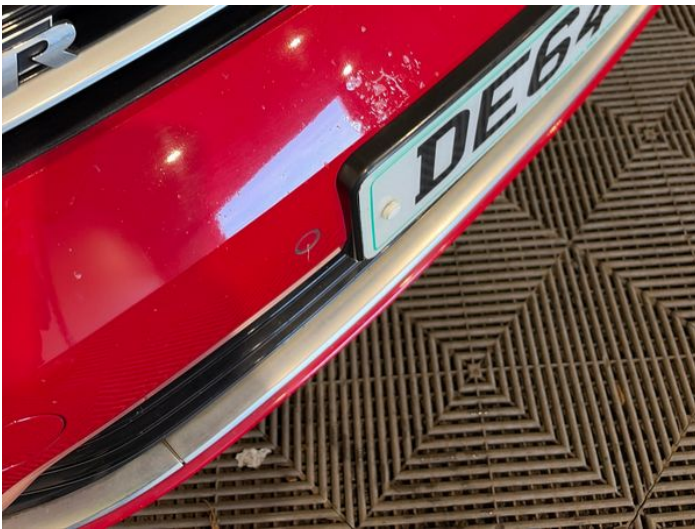
5: Bumper Front  
Poor Previous Repair  
Paint Flake

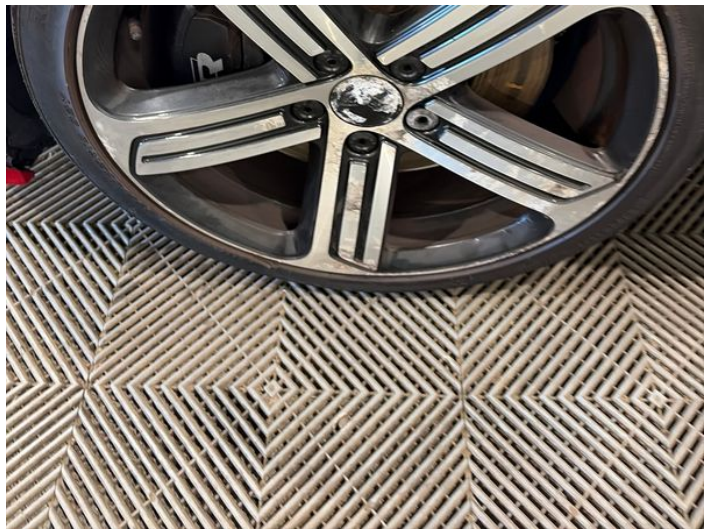
6: Wheel nsf  
Scratched  
Over 50mm

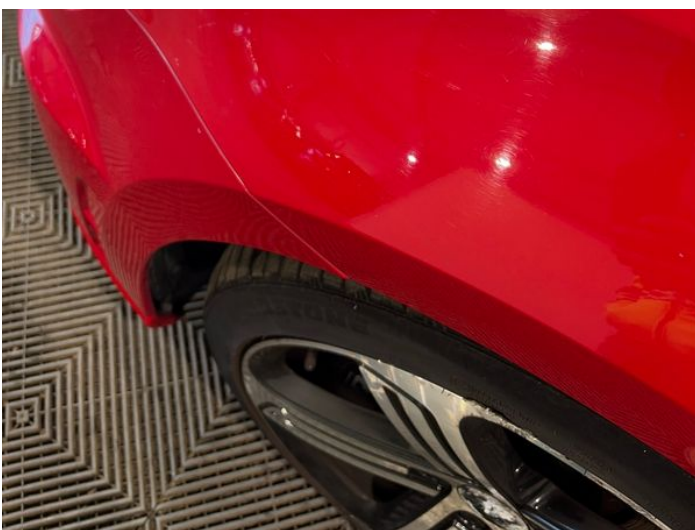
7: Wing nsf  
Chipped  
1 To 5

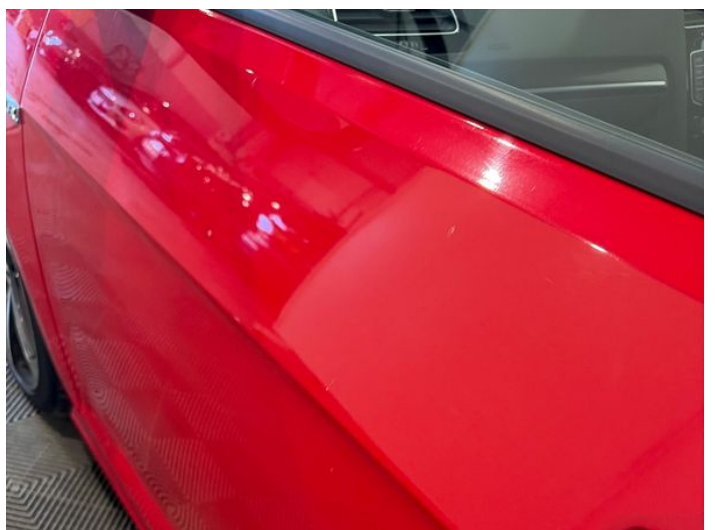
8: Door nsf  
Chipped  
1 To 5

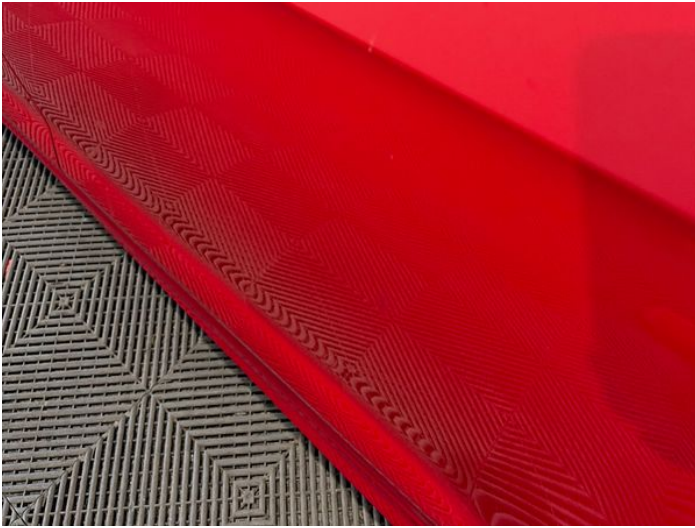
9: Door nsr  
Chipped  
1 To 5

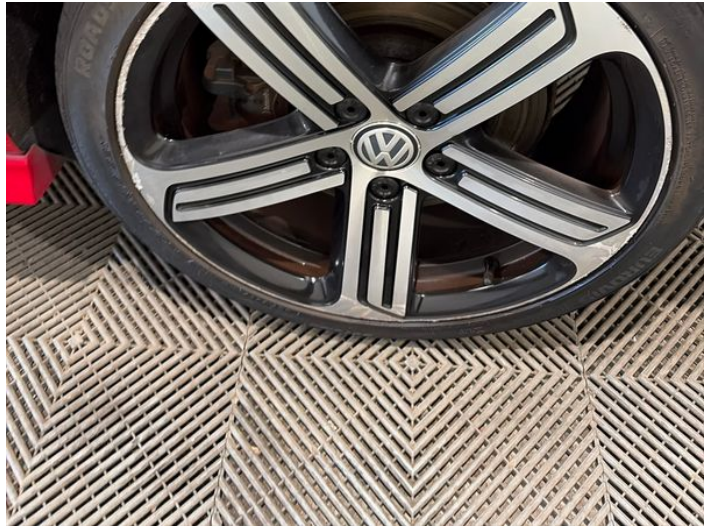
10: Wheel nsr  
Scratched  
Over 50mm

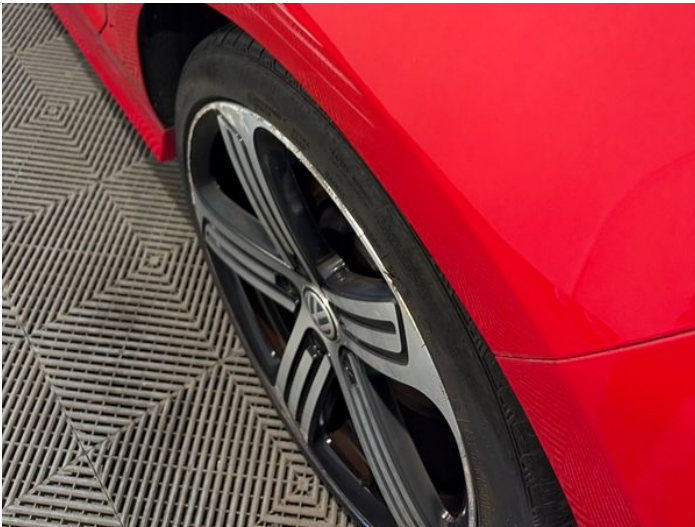
11: Qtr Panel nsr  
Dented  
With Paint Damage

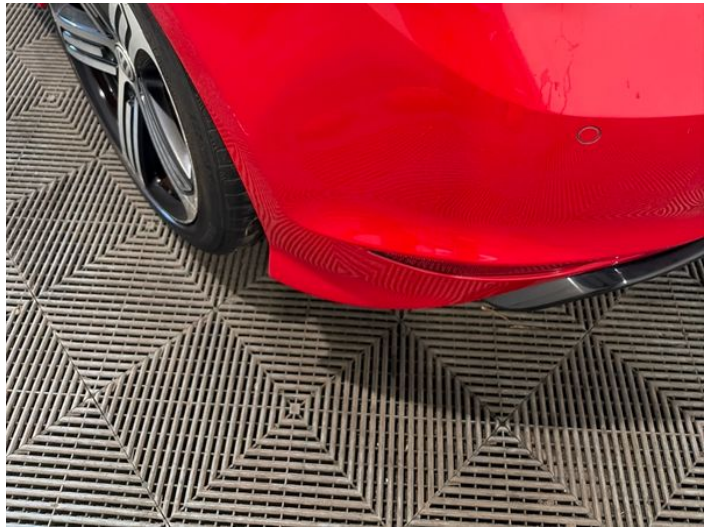
12: Bumper Rear  
Scratched  
25 to 100mm Thru Paint

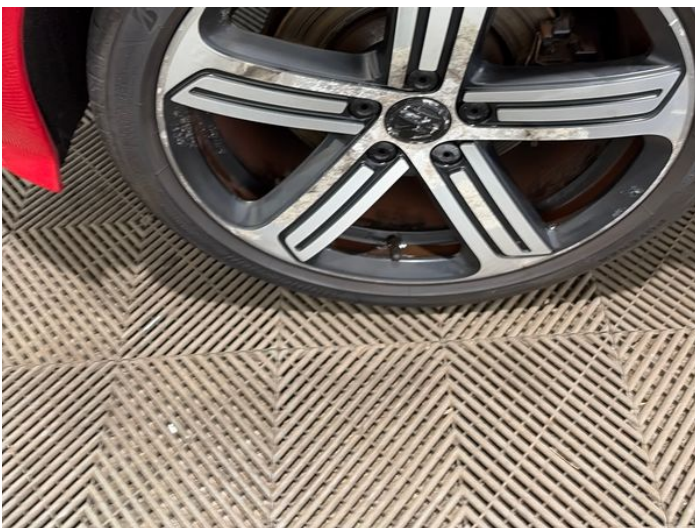
13: Wheel osr  
Scratched  
Over 50mm

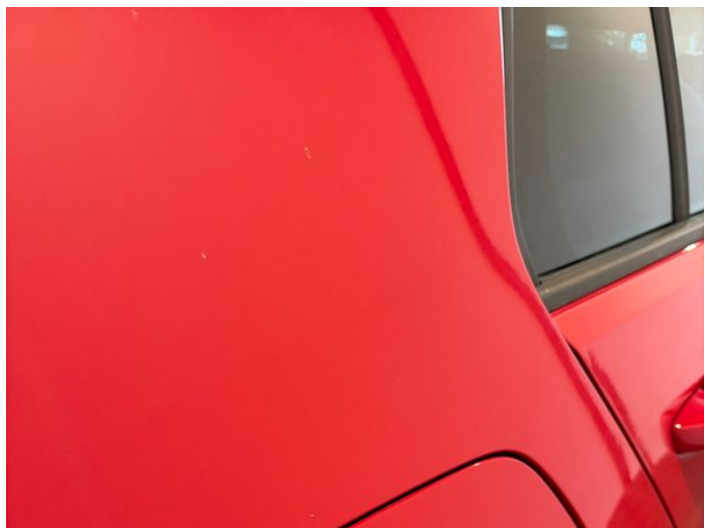
14: Qtr Panel osr  
Chipped  
1 To 5

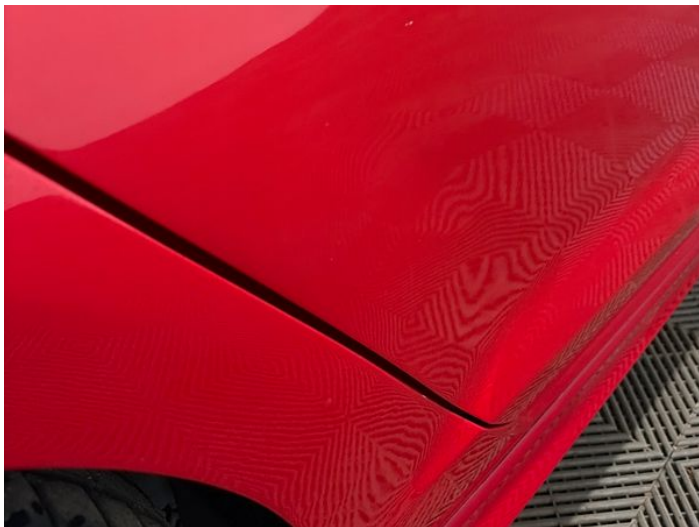
15: Door osr  
Scratched  
Over 25mm Thru Paint

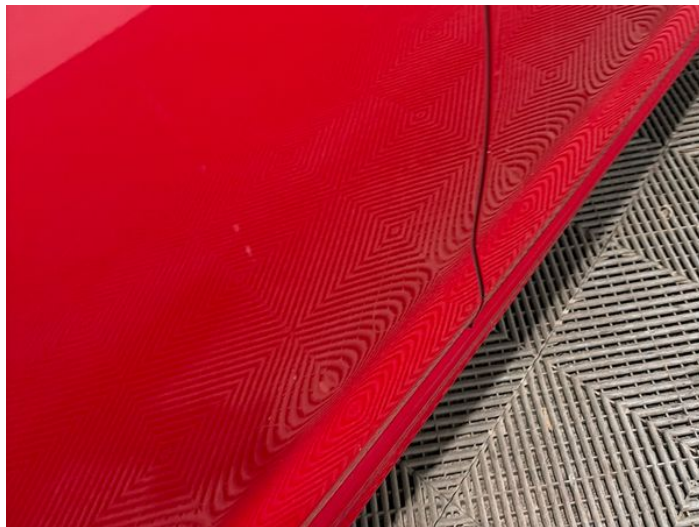
16: Door osr  
Dented  
Between 10mm + 30mm

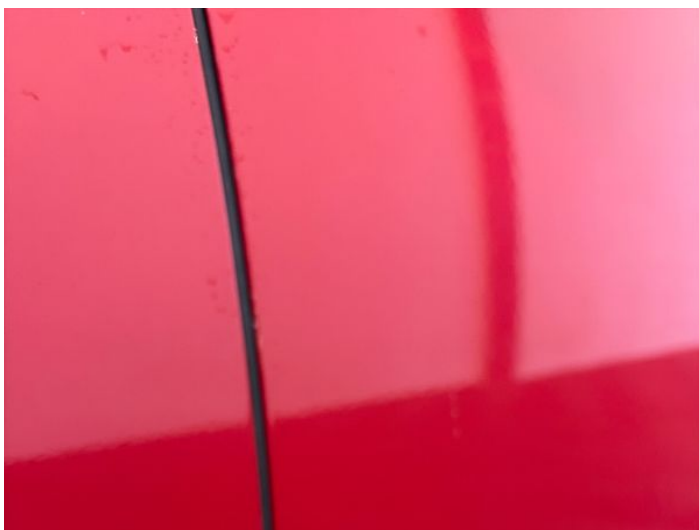
17: Door osf  
Chipped  
Edge Chip

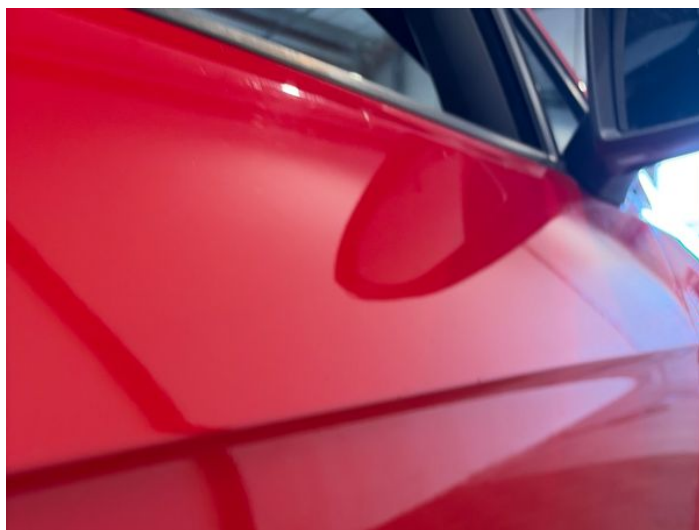
18: Door osf  
Chipped  
1 To 5

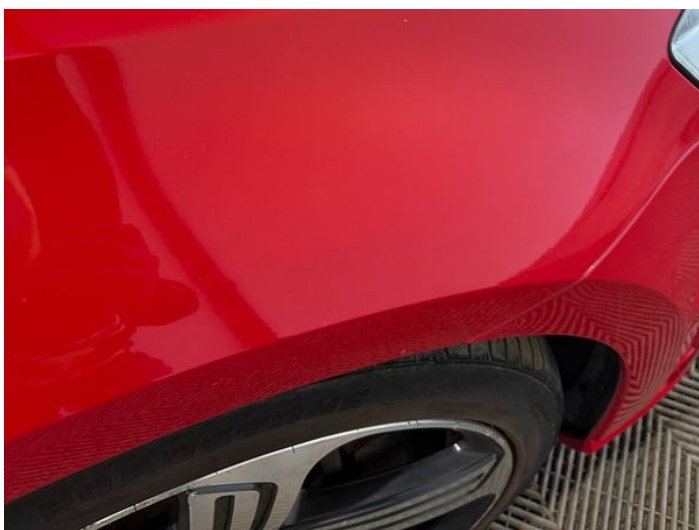
19: Wing osf  
Chipped  
1 To 5

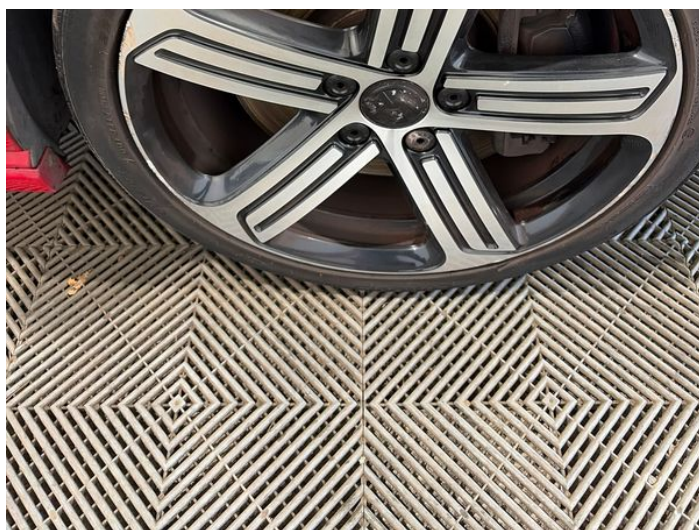
20: Wheel osf  
Scratched  
Over 50mm

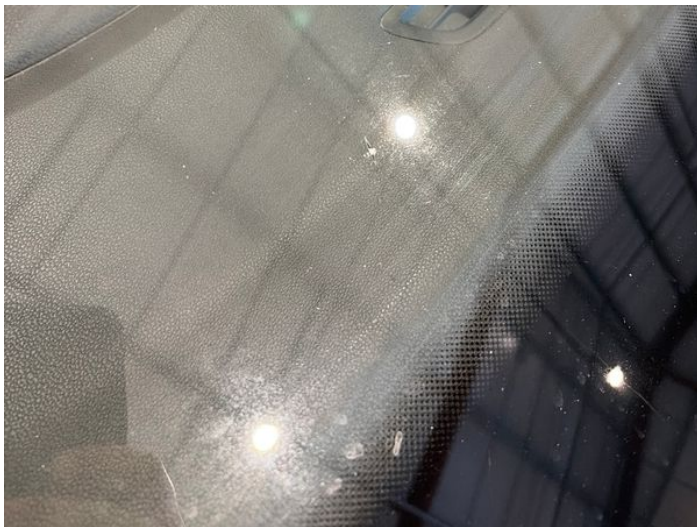
21: Screen Front  
Chipped  
Over 10mm

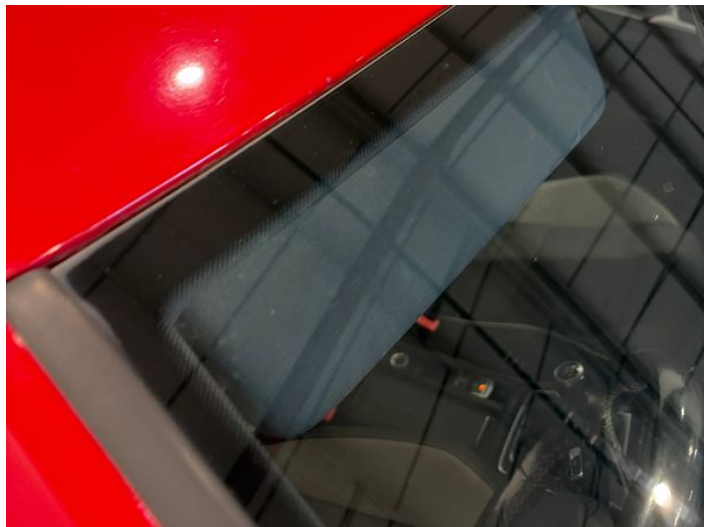
22: Roof  
Chipped  
Edge Chip
