## VEHICLE INSPECTION REPORT

**GU15PUX**

### Volvo XC60 D4 [181] SE Lux Nav 5dr Geartronic

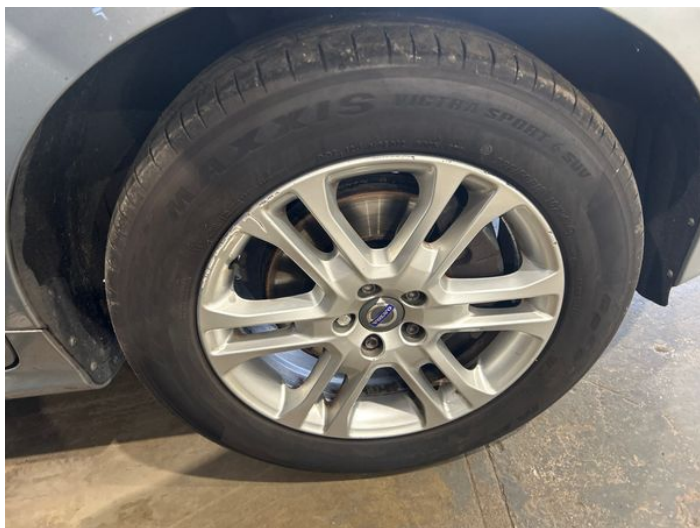
1: Wheel osf  
Scratched  
Over 50mm

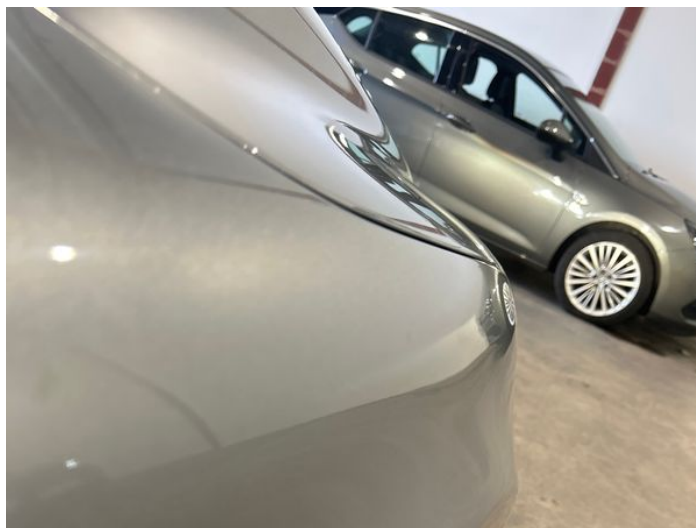
2: Wing osf  
Dented  
2 Or Less UpTo 10mm

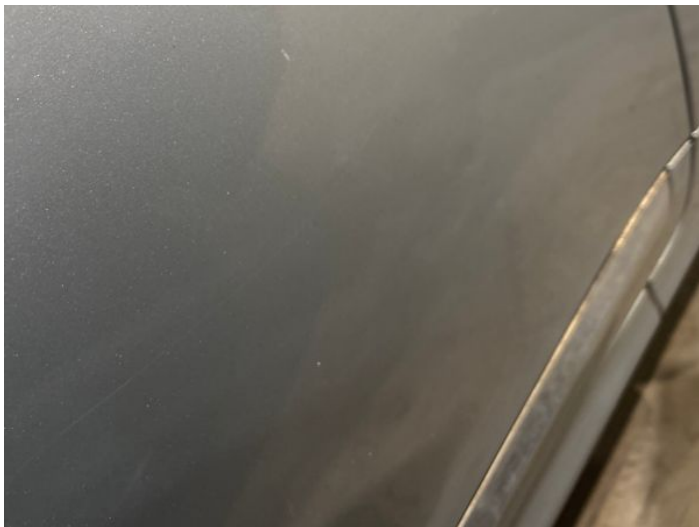
3: Door osf  
Chipped  
1 To 5

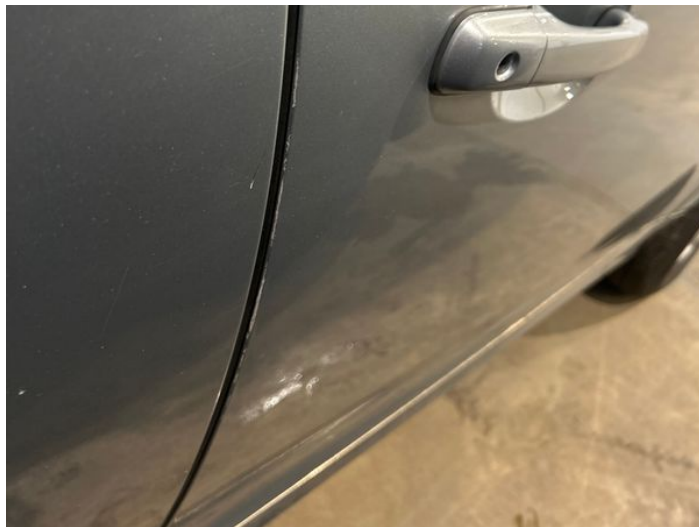
4: Door osf  
Chipped  
Edge Chip

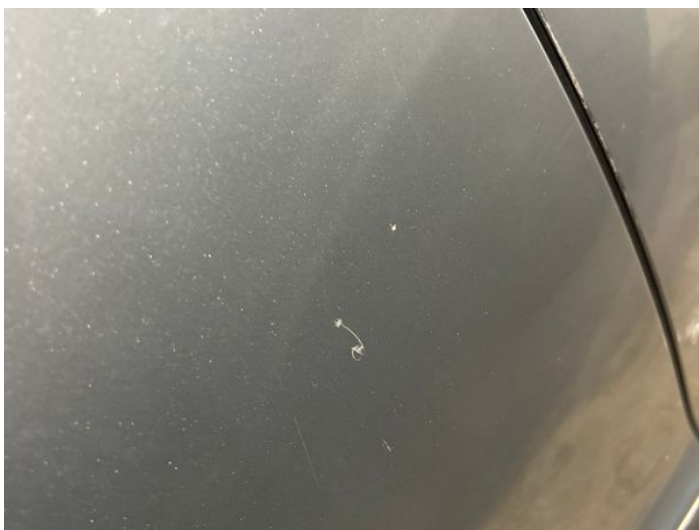
5: Door osr  
Scratched  
UpTo 25mm Thru Paint

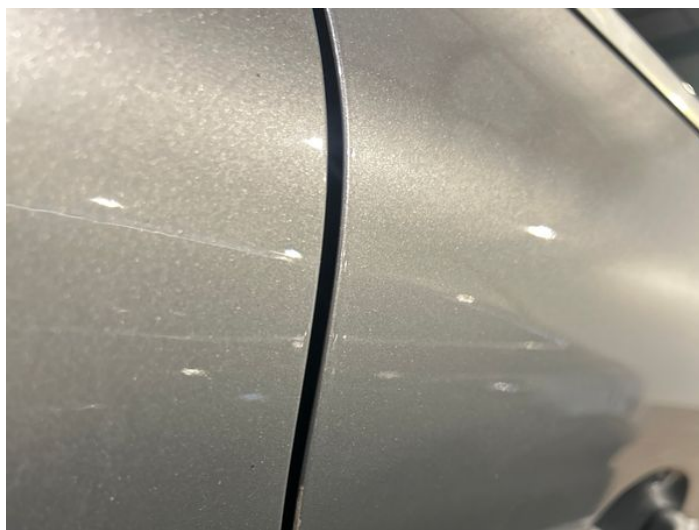
6: Door osr  
Chipped  
Edge Chip

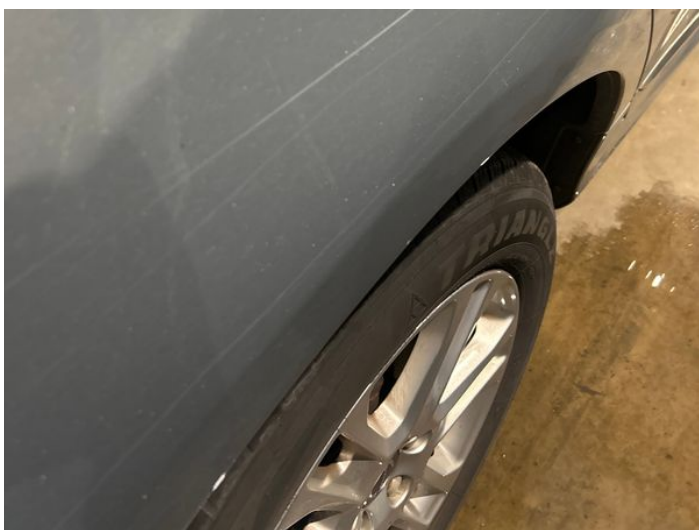
7: Qtr Panel osr  
Scratched  
Over 25mm Thru Paint

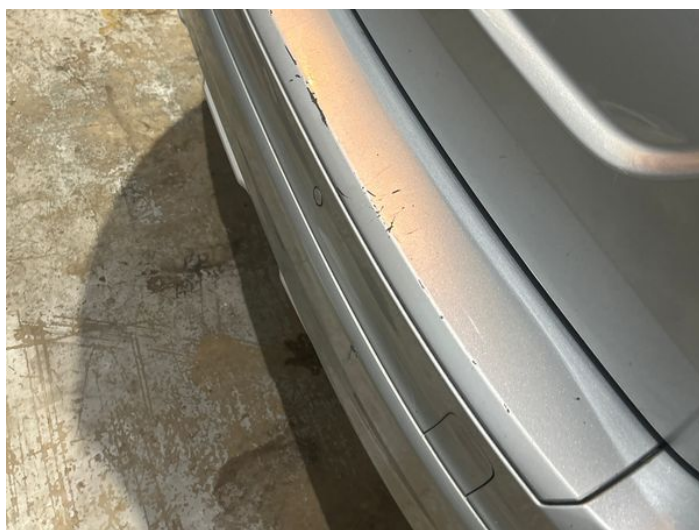
8: Bumper Rear  
Scratched  
Over 100mm Thru Paint

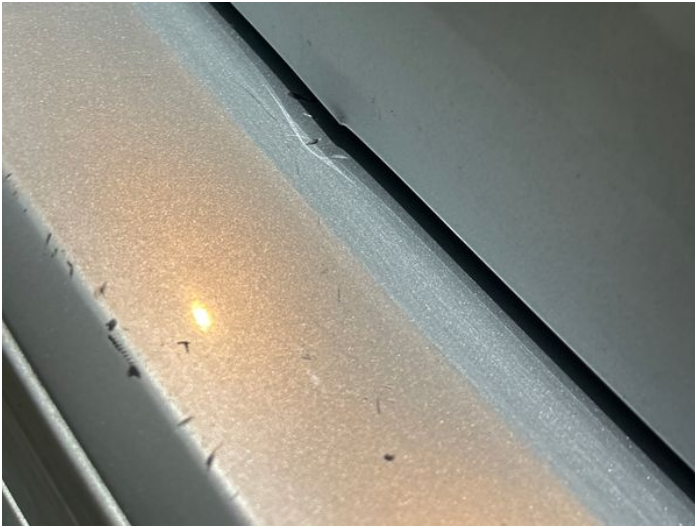
9: Tailgate  
Dented  
Between 10mm + 30mm

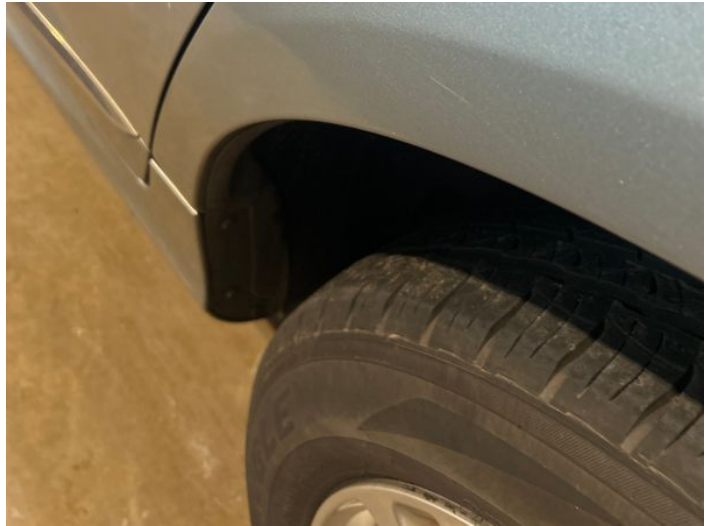
10: Qtr Panel nsr  
Dented  
Between 10mm + 30mm

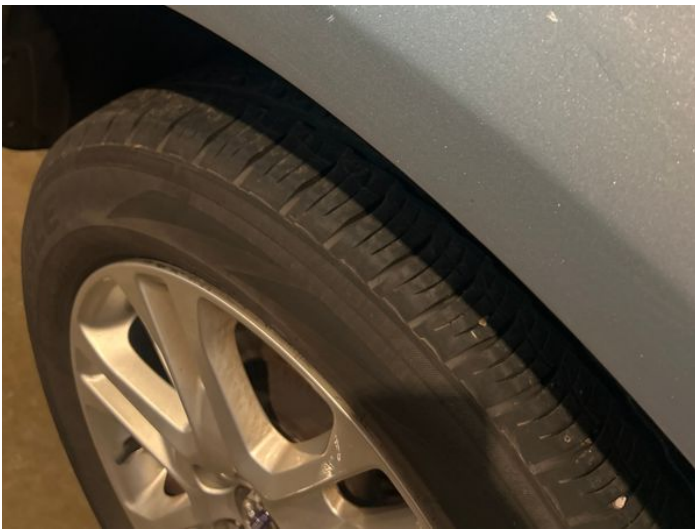
11: Qtr Panel nsr  
Chipped  
1 To 5

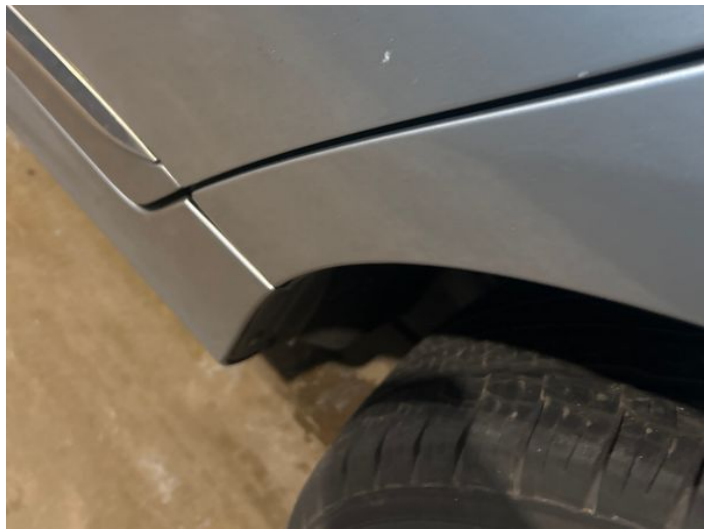
12: Door nsr  
Chipped  
1 To 5

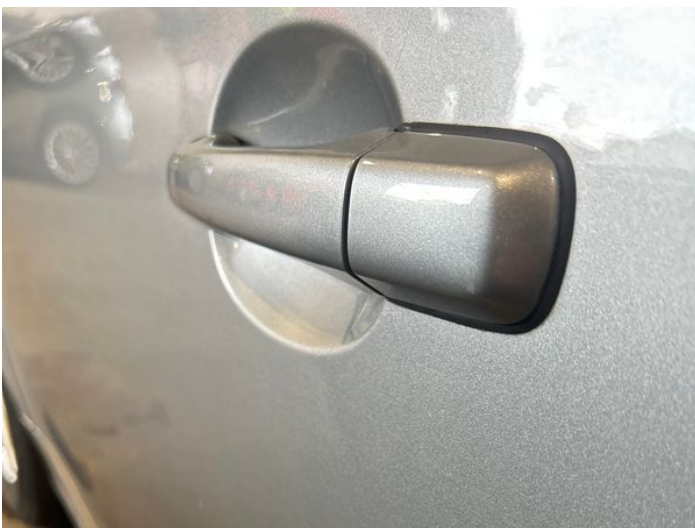
13: Door nsf  
Dented  
2 Or Less UpTo 10mm

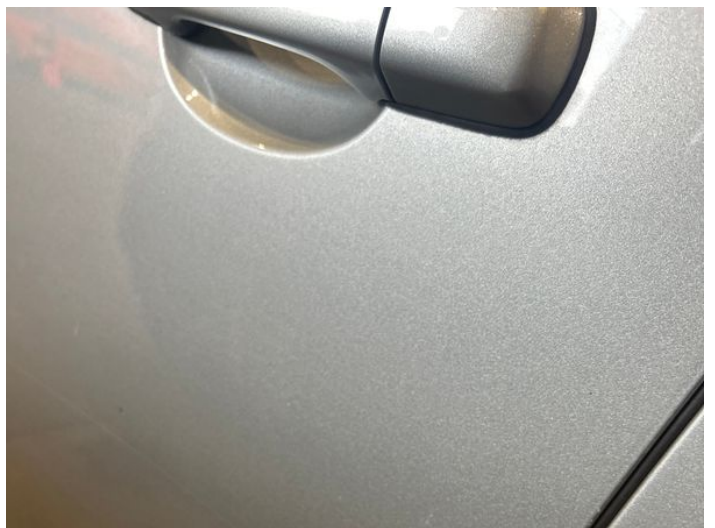
14: Door nsf  
Chipped  
1 To 5

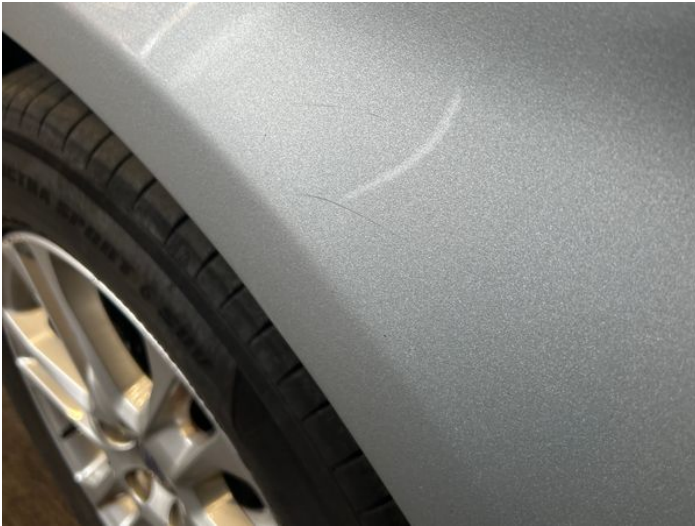
15: Wing nsf  
Scratched  
Over 25mm Thru Paint

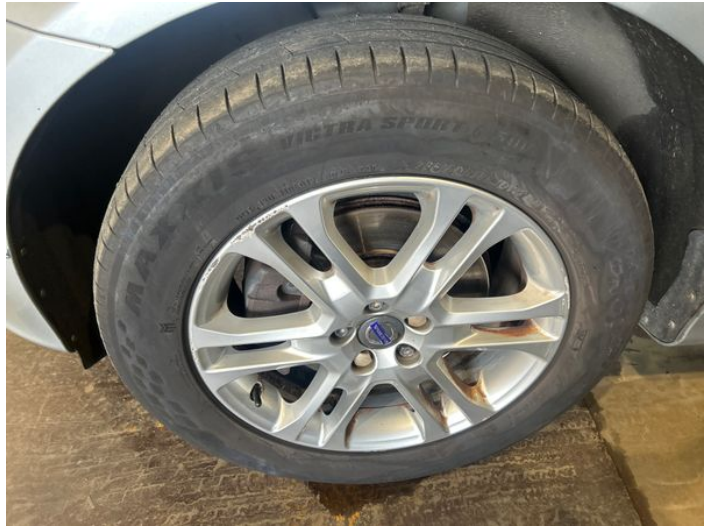
16: Wheel nsf  
Scratched  
Over 50mm

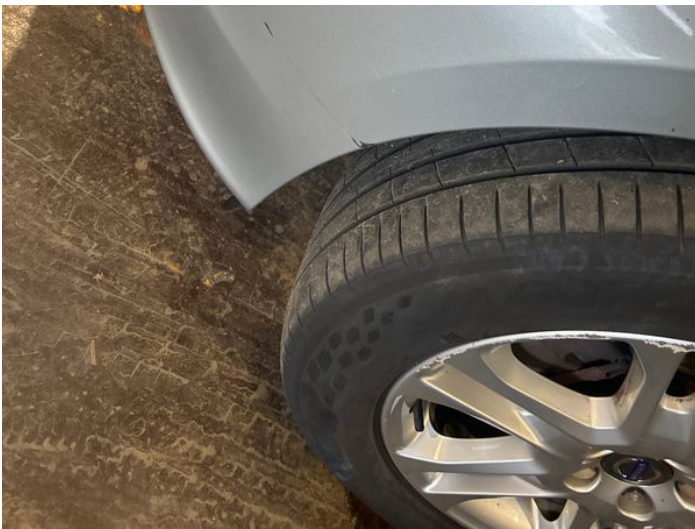
17: Bumper Front  
Scratched  
25 to 100mm Thru Paint

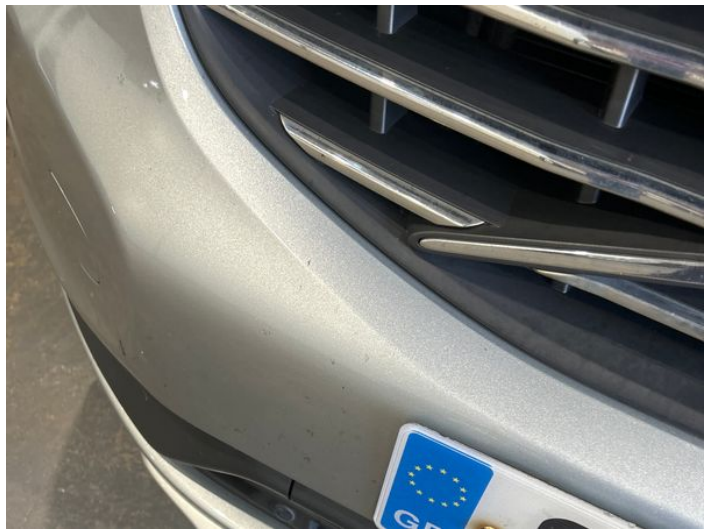
18: Bumper Front  
Chipped  
Multiple Chips

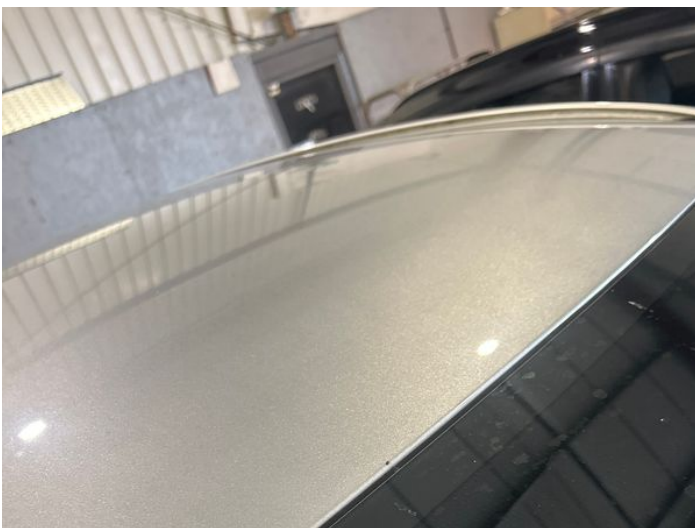
19: Roof  
Chipped  
1 To 5
