# VEHICLE INSPECTION REPORT

**VU68ANR**

## Vauxhall Grandland X 1.2 Turbo SE 5dr

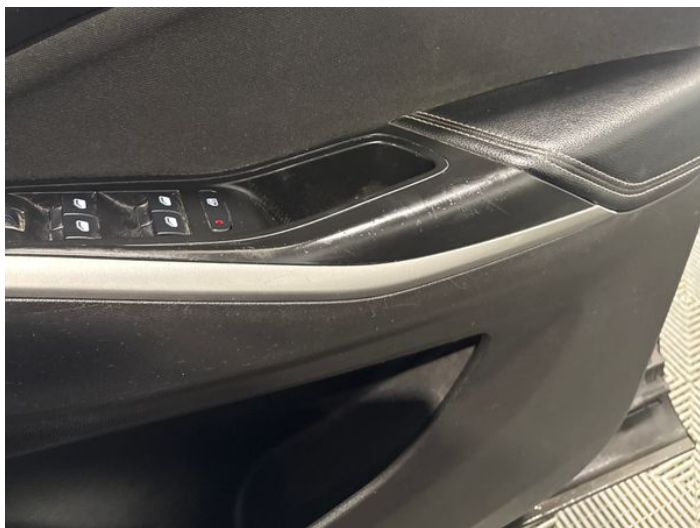
1: Door Pad osf  
Scuffed  
Over 25mm

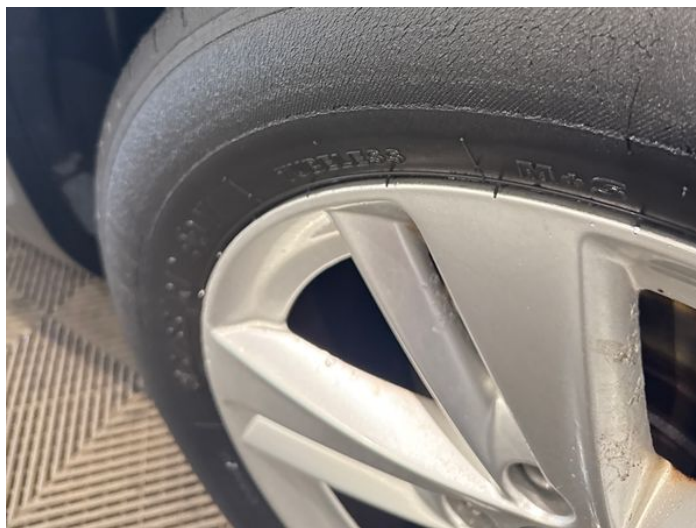
| NSR | KORMORAN | Damaged |

2: Tyre nsr  
Damaged  
Replace

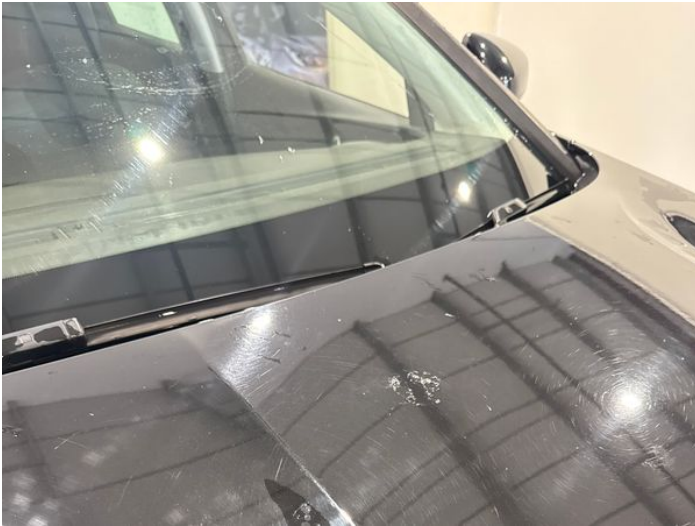
3: Bonnet  
Scratched  
Over 25mm Thru Paint

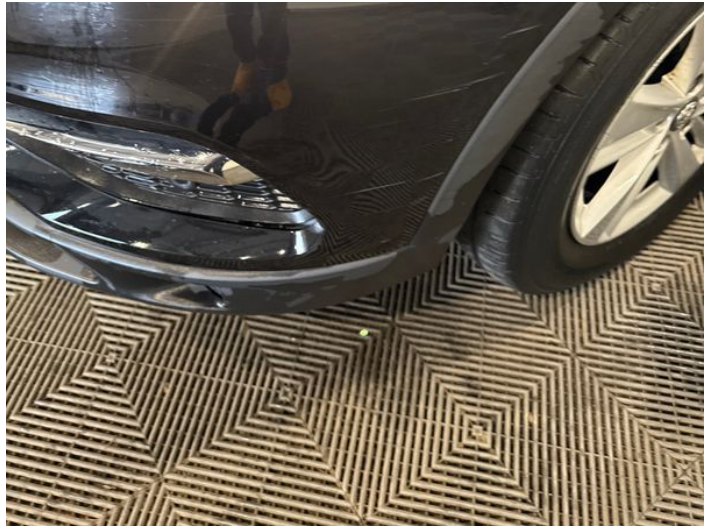
4: Bumper Front  
Scratched  
Over 100mm Thru Paint

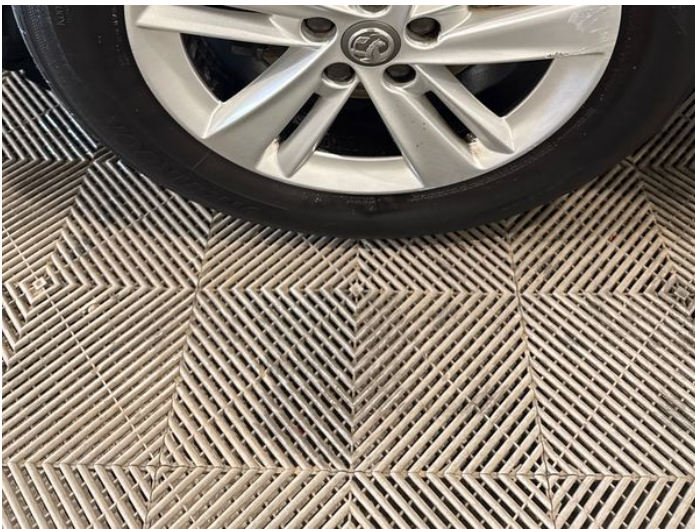
5: Wheel nsf  
Scratched  
Over 50mm

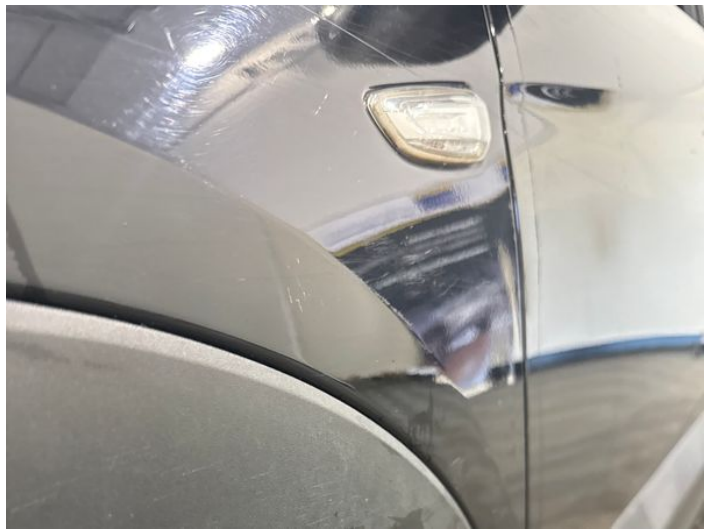
6: Wing nsf  
Dented  
Between 10mm + 30mm

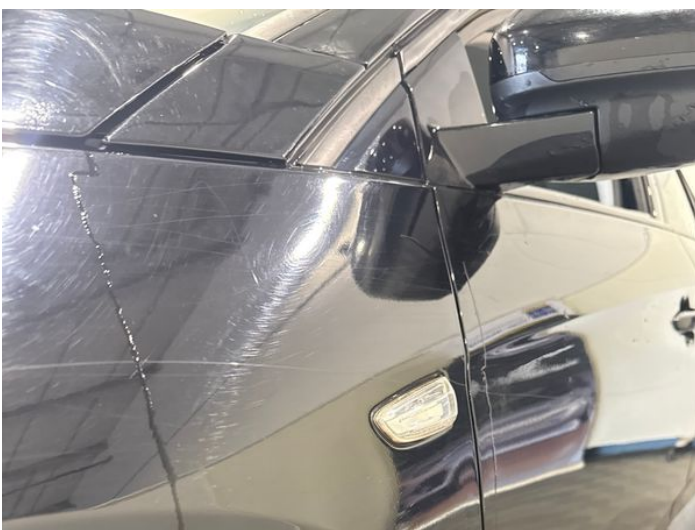
7: Wing nsf  
Scratched  
Over 25mm Thru Paint

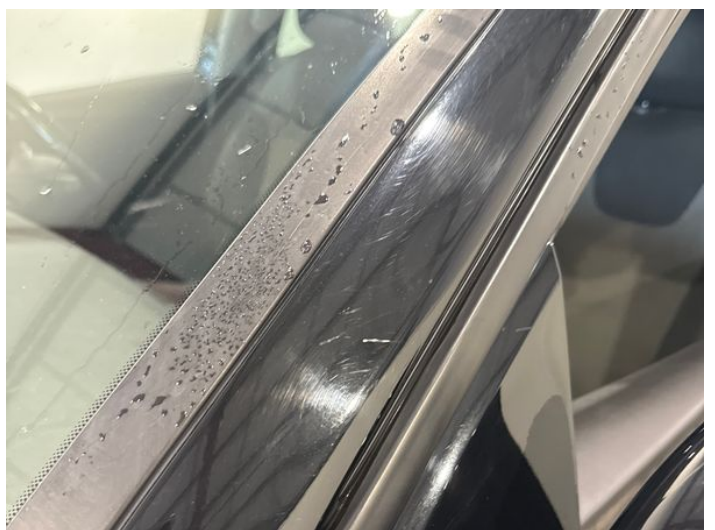
8: A Post ns  
Scratched  
UpTo 25mm Thru Paint

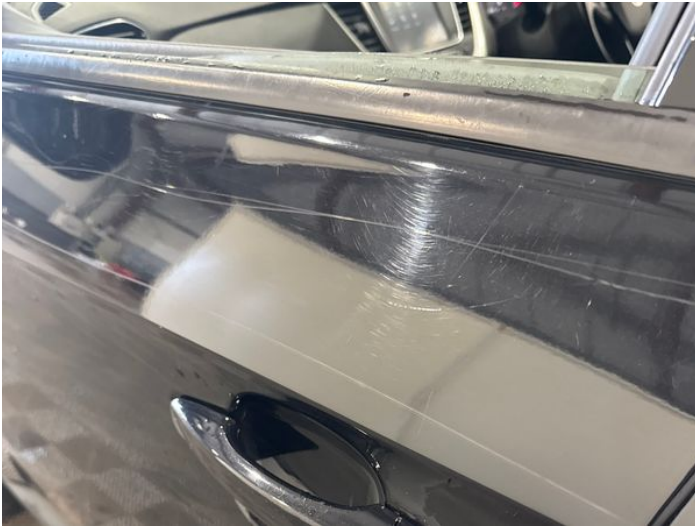
9: Door nsf  
Scratched  
Over 25mm Thru Paint

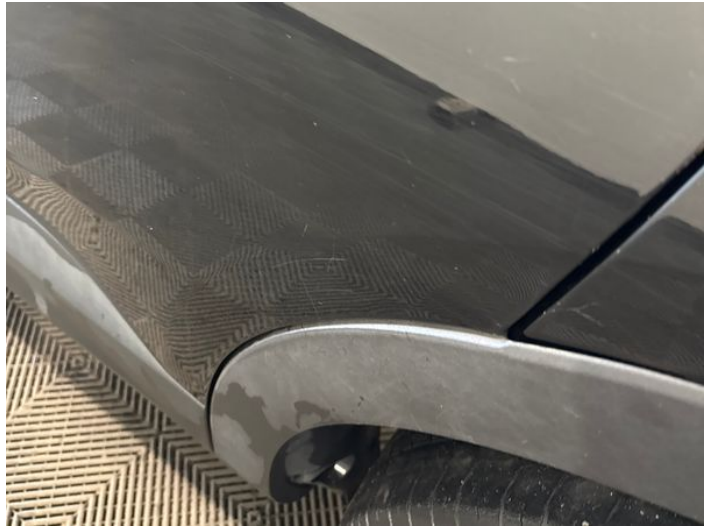
10: Door nsr  
Scratched  
Over 25mm Thru Paint

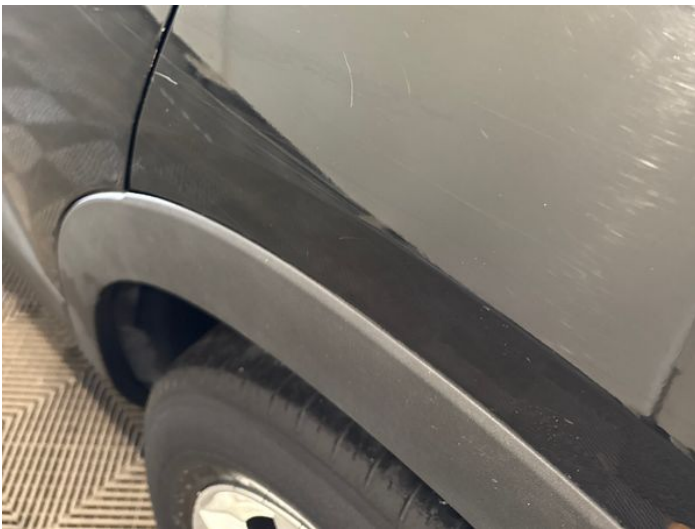
11: Qtr Panel nsr  
Scratched  
Over 25mm Thru Paint

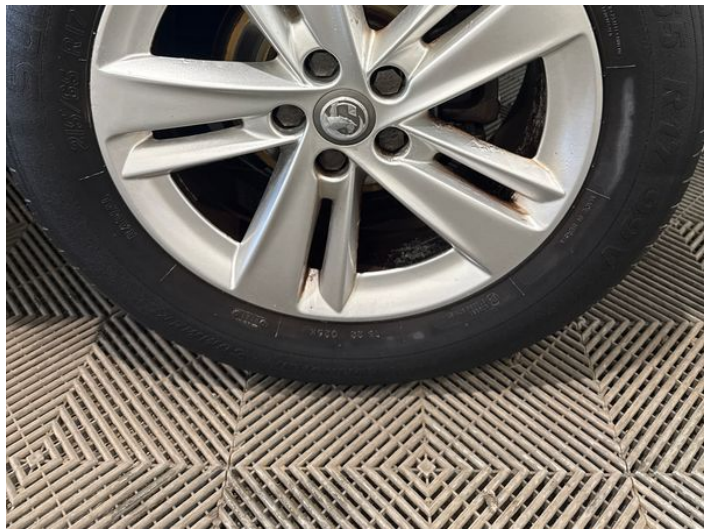
12: Wheel nsr  
Corroded  
Light

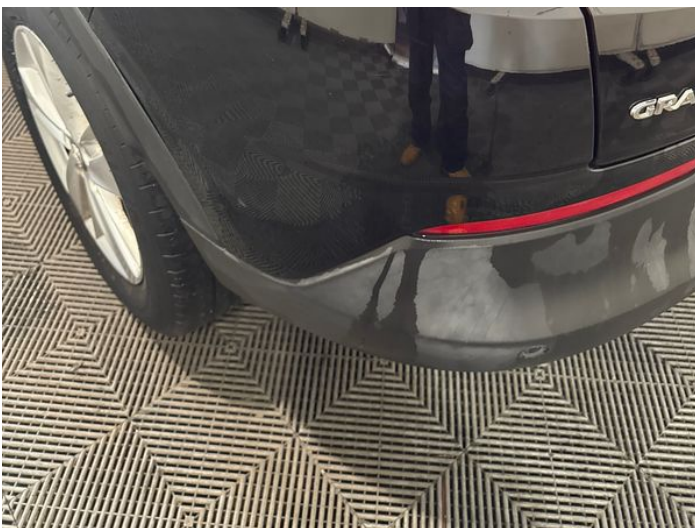
13: Bumper Rear  
Scratched  
25 to 100mm Thru Paint

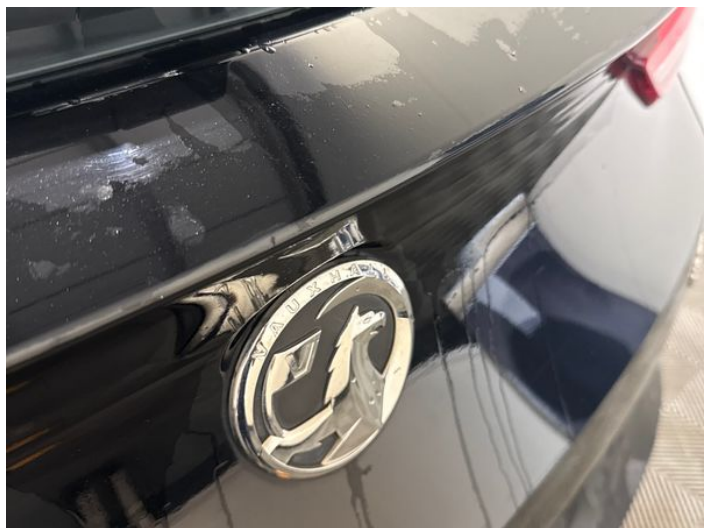
14: Tailgate  
Chipped  
1 To 5

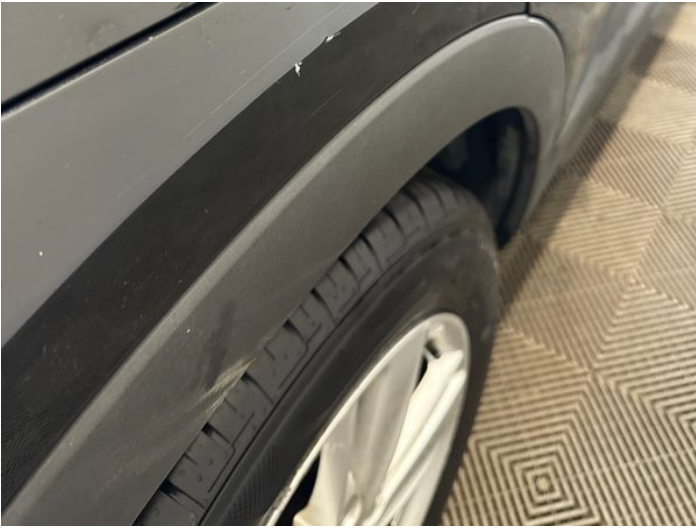
15: Qtr Panel osr  
Dented  
Between 10mm + 30mm

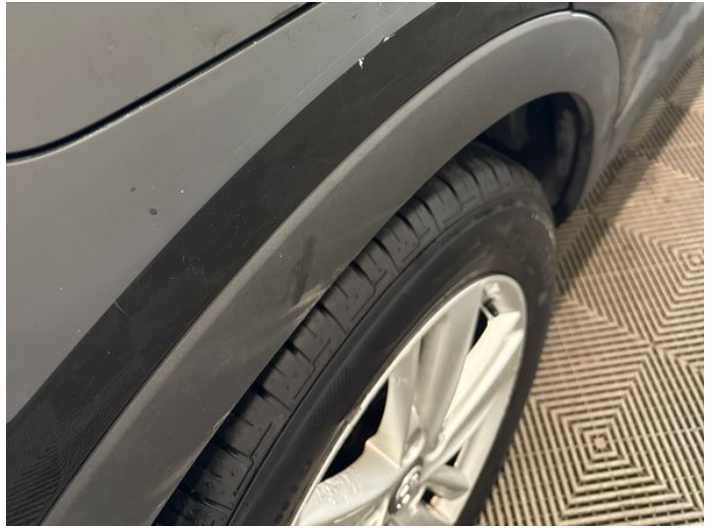
16: Qtr Panel osr  
Chipped  
1 To 5

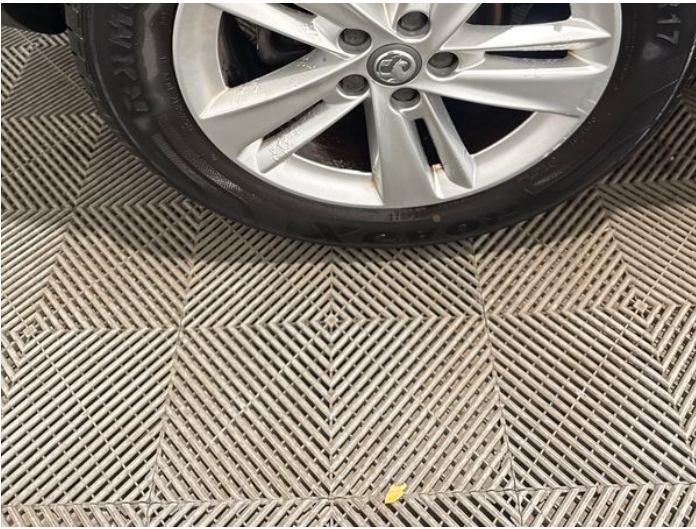
17: Wheel osr  
Scratched  
Over 50mm

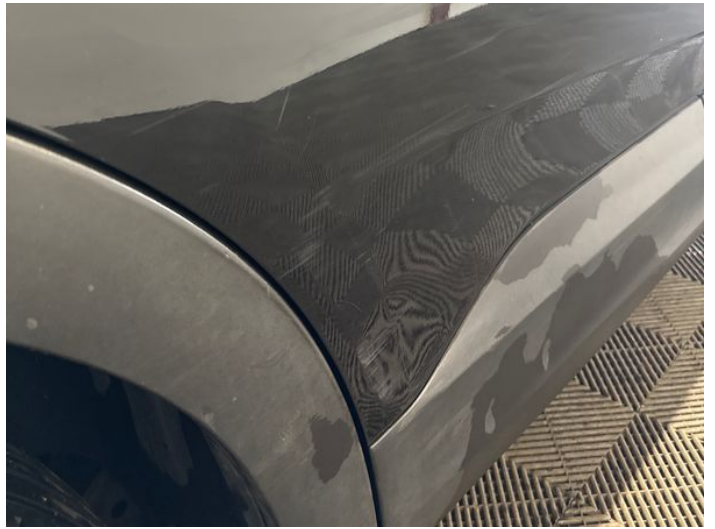
18: Door osr  
Dented  
With Paint Damage

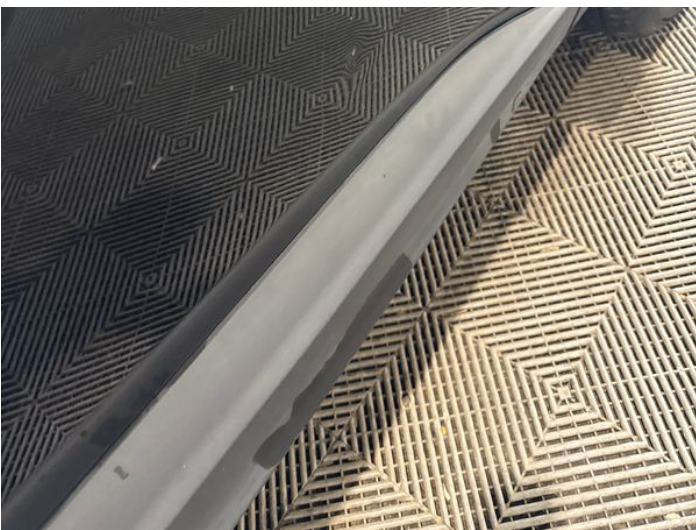
19: Door osf  
Dented  
Between 10mm + 30mm

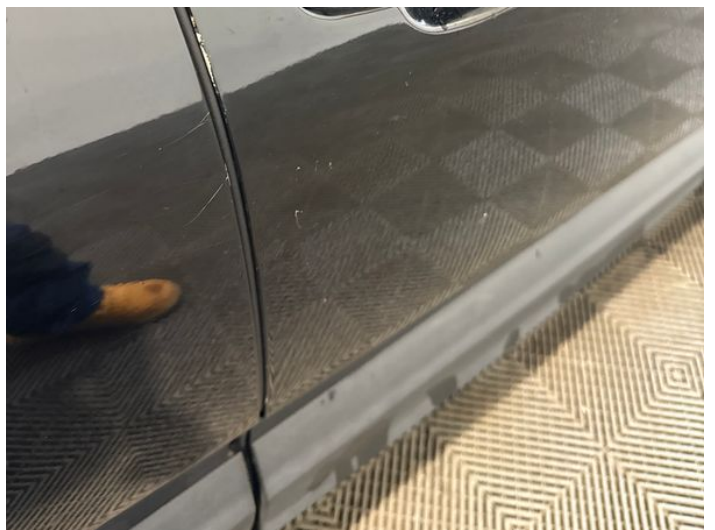
20: Door osf  
Scratched  
Over 25mm Thru Paint

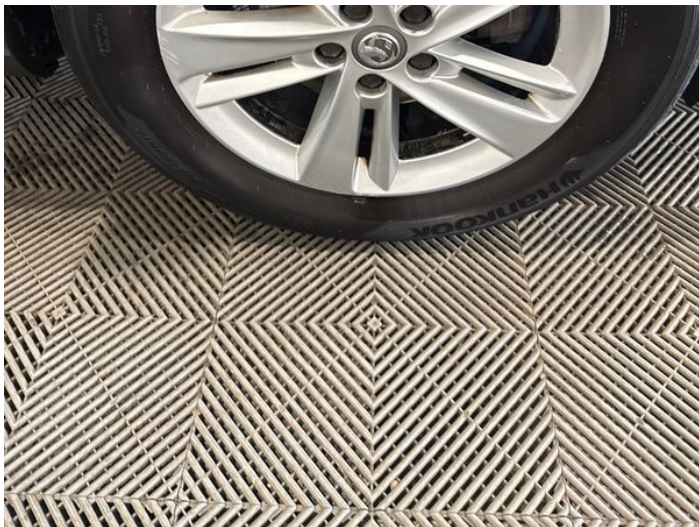
21: Wheel of  
Scratched  
Over 50mm

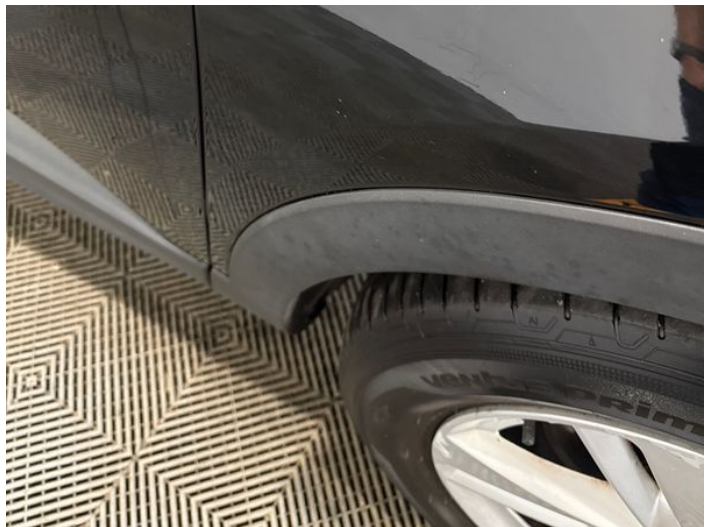
22: Wing of  
Chipped  
1 To 5

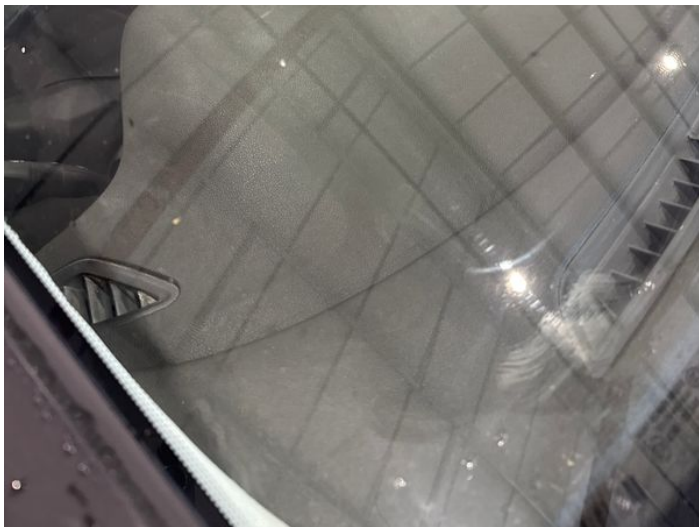
23: Screen Front  
Chipped  
Up To 10mm

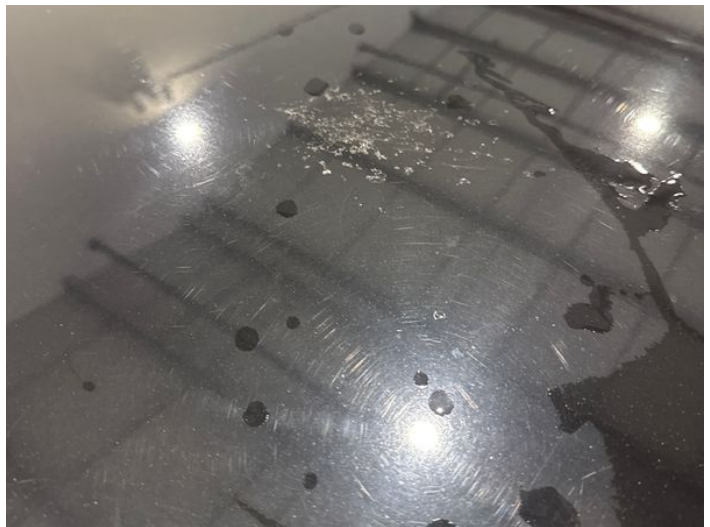
24: Roof  
Scratched  
Over 25mm Thru Paint
