## VEHICLE INSPECTION REPORT

**GV70EXO**

### Kia Sportage 1.6 CRDi 48V ISG GT-Line S 5dr DCT Auto [AWD]

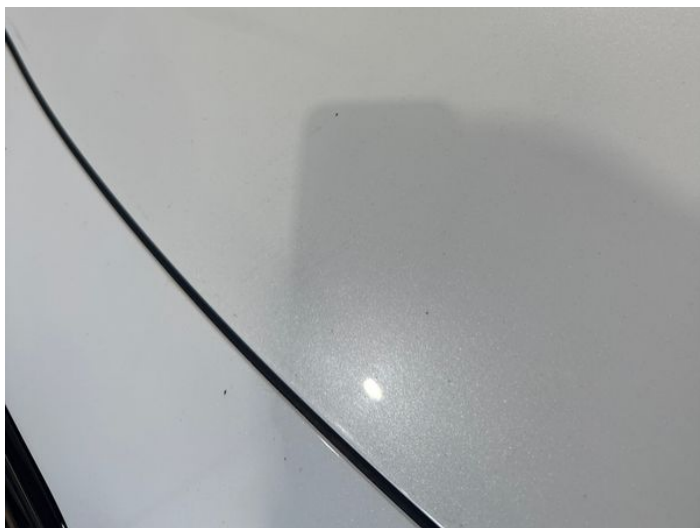
1: Bonnet  
Chipped  
1 To 5

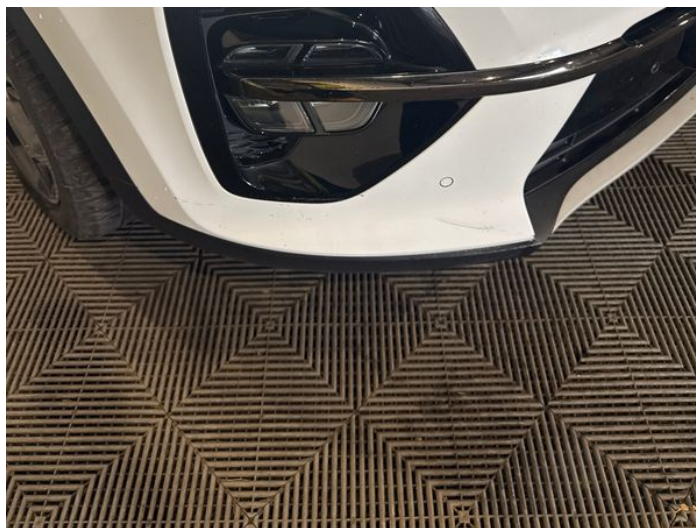
2: Bumper Front  
Scratched  
25 to 100mm Thru Paint

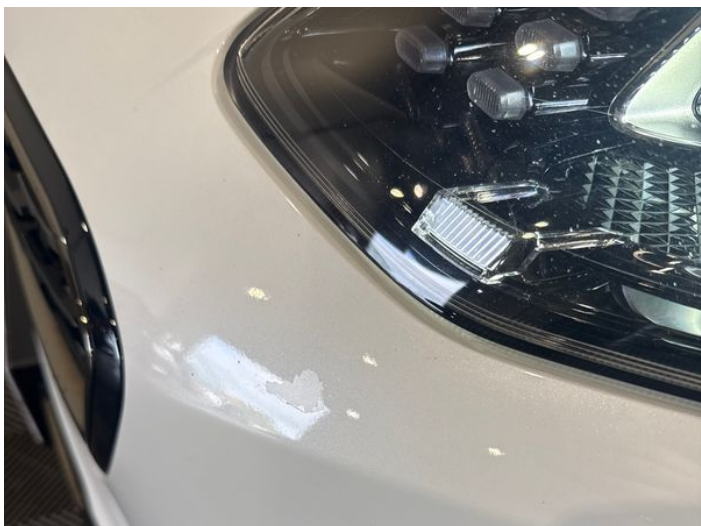
3: Bumper Front  
Poor Previous Repair  
Paint Flake

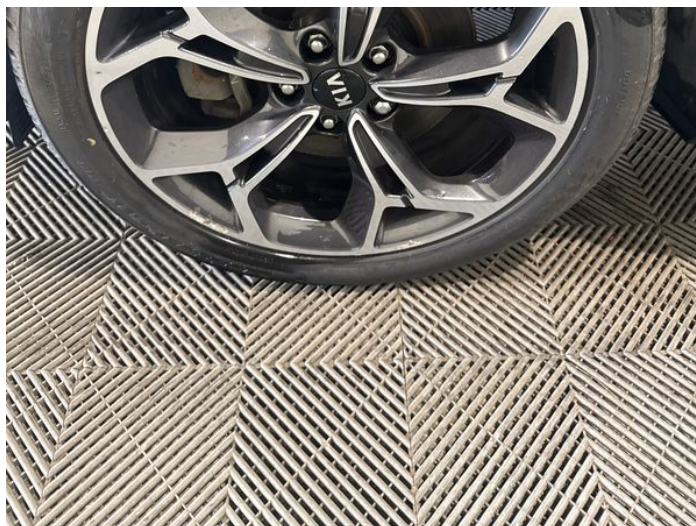
4: Wheel nsf  
Scratched  
Over 50mm

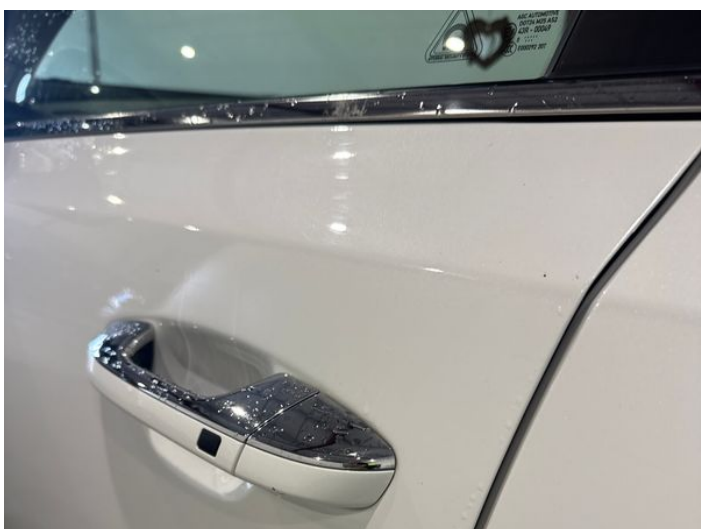
5: Door nsf  
Chipped  
1 To 5

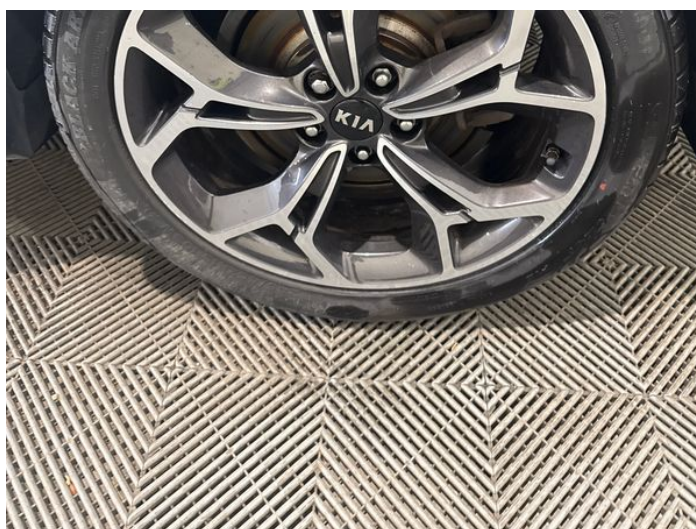
6: Wheel nsr  
Scratched  
Up To 50mm

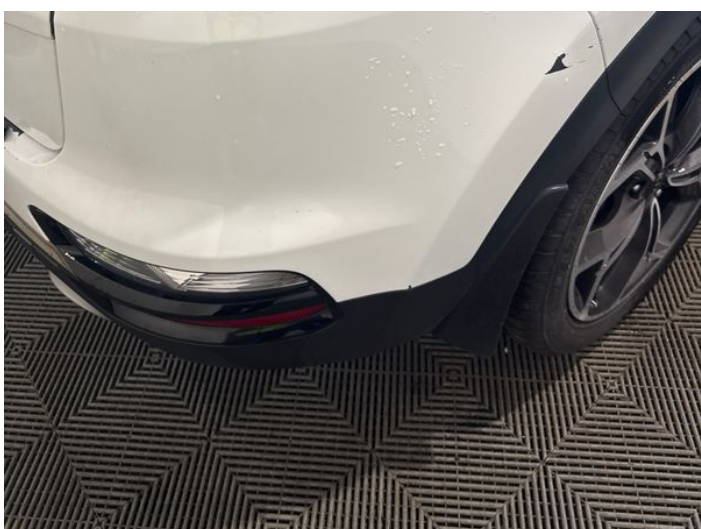
7: Bumper Rear  
Scratched  
25 to 100mm Thru Paint

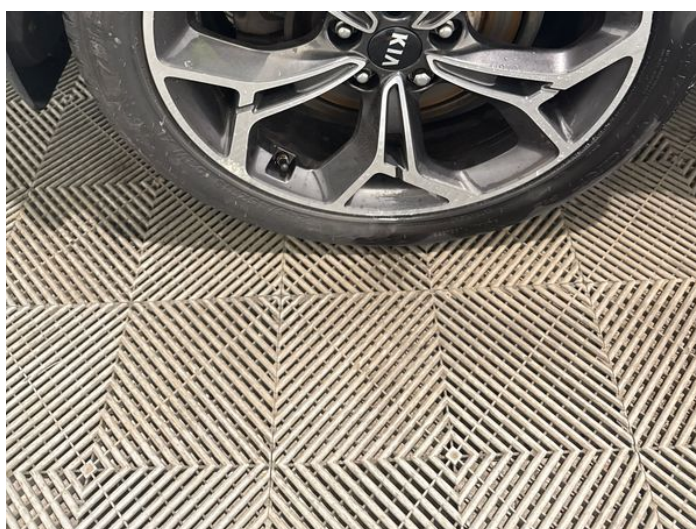
8: Wheel osr  
Scratched  
Over 50mm

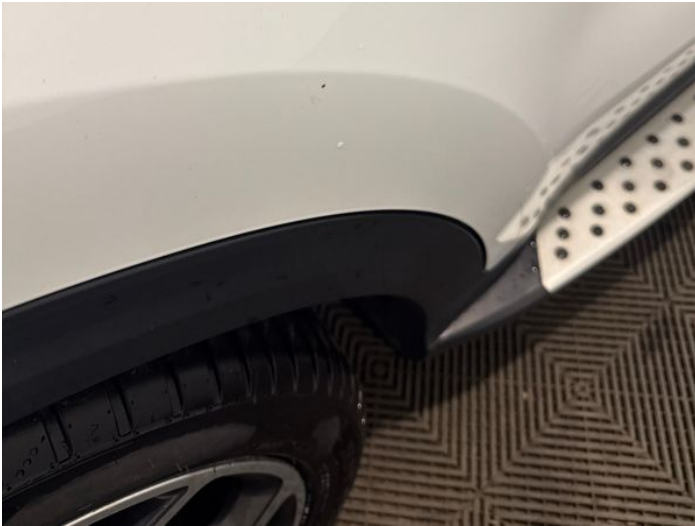
9: Door osr  
Chipped  
1 To 5

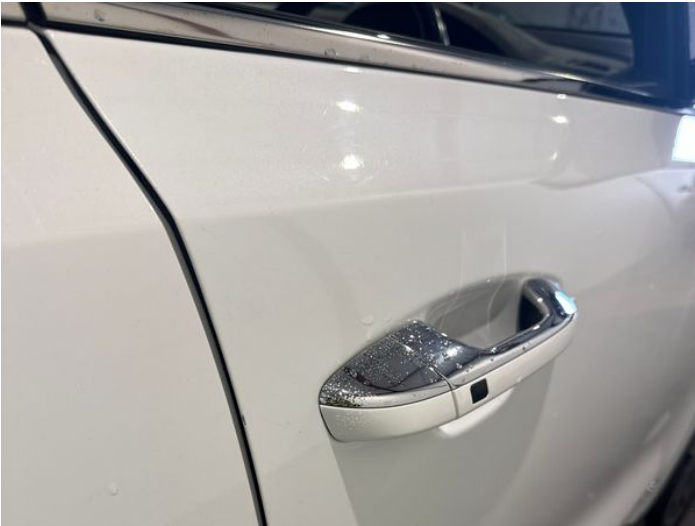
10: Door osf  
Chipped  
Edge Chip

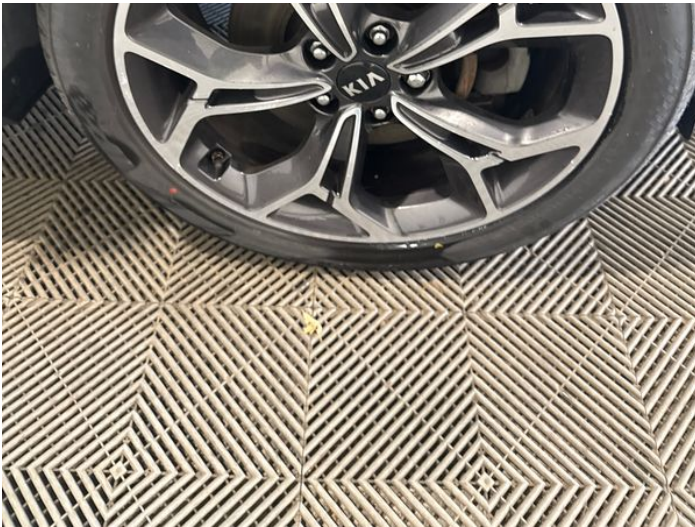
11: Wheel osf  
Scratched  
Over 50mm

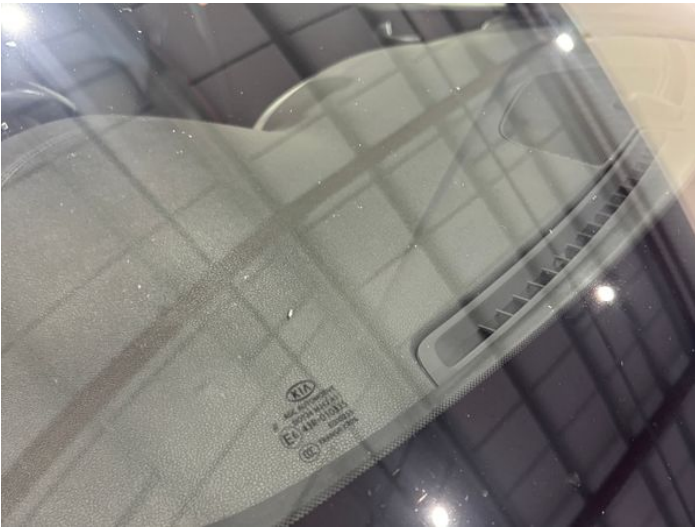
12: Screen Front  
Chipped  
UpTo 10mm
